**MINERALS PROGRAM INSPECTION REPORT**  
**PHONE: (303) 866-3567**

<b>MINE NAME:</b> CBC Gravel Pit	<b>MINE/PROSPECTING ID#:</b> M-2009-030	<b>MINERAL:</b> Gravel and sand	<b>COUNTY:</b> Dolores
<b>INSPECTION TYPE:</b> Monitoring	<b>INSPECTOR(S):</b> Dustin Czapla	<b>INSP. DATE:</b> April 27, 2021	<b>INSP. TIME:</b> 17:00
<b>OPERATOR:</b> Coal Bed Creek Construction, Inc.	<b>OPERATOR REPRESENTATIVE:</b>	<b>TYPE OF OPERATION:</b> 110c - Construction Limited Impact	
<b>REASON FOR INSPECTION:</b> Normal I&E Program	<b>BOND CALCULATION TYPE:</b> Complete Bond	<b>BOND AMOUNT:</b> \$10,166.62	
<b>DATE OF COMPLAINT:</b> NA	<b>POST INSP. CONTACTS:</b> None	<b>JOINT INSP. AGENCY:</b> None	
<b>WEATHER:</b> Clear	<b>INSPECTOR'S SIGNATURE:</b>

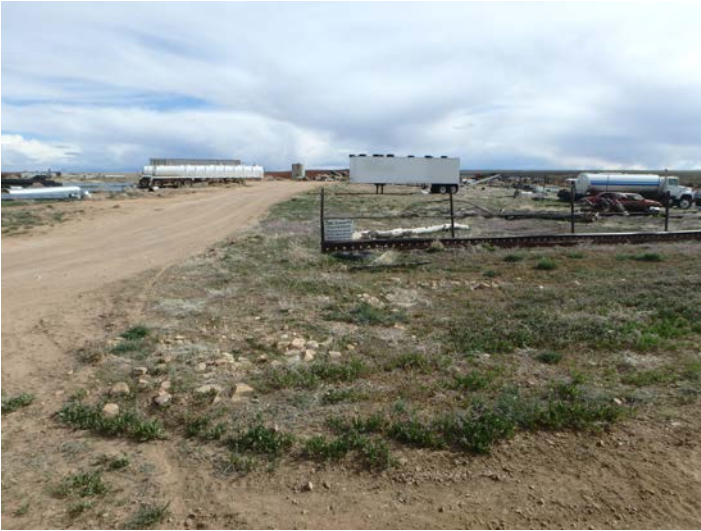
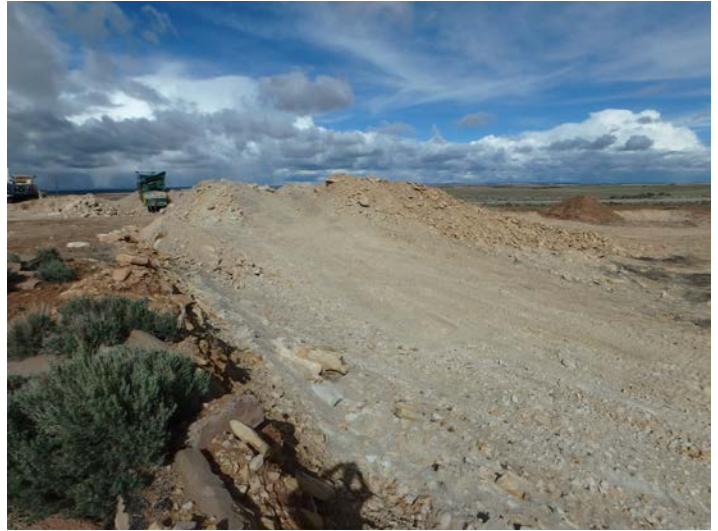
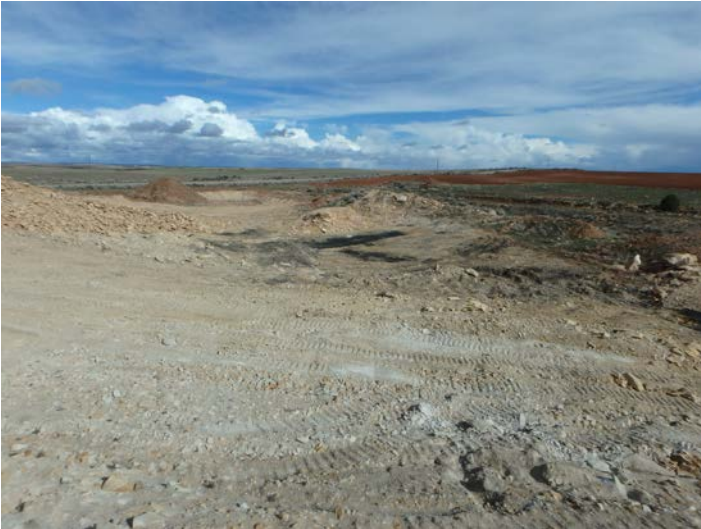
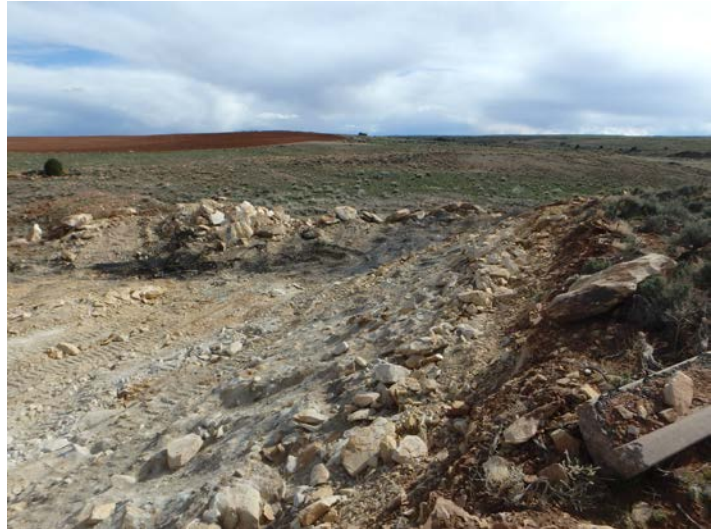
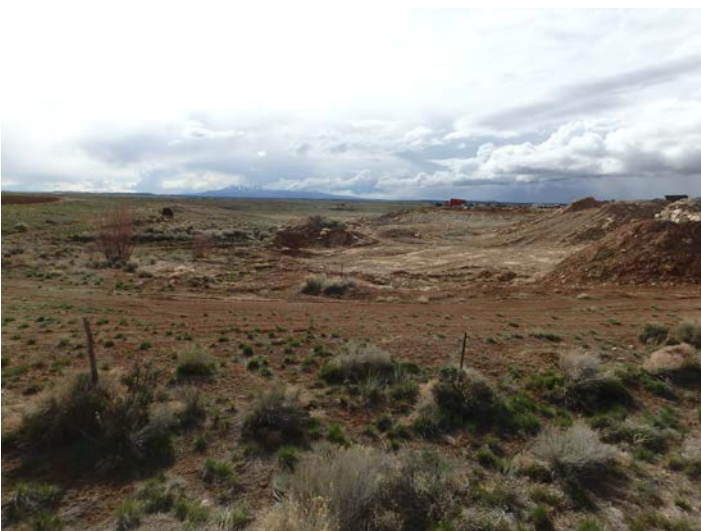
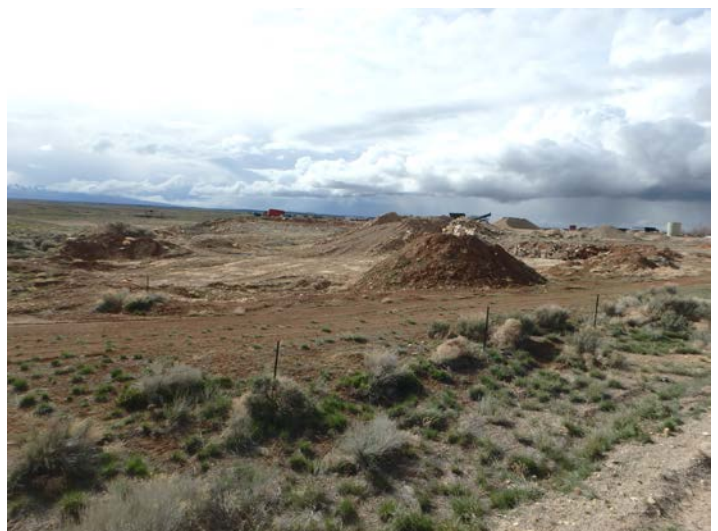
## PHOTOGRAPHS

Mining is progressing from the southeast part of the affected area to the north and west. A crushing unit is stationed at the north side of the affected area. Various materials stockpiles are located throughout the pit area. Most of the slopes around the pit are graded to 2-3H:1V. Overall the pit area is orderly. No stability or erosion issues were noted. Noxious weed infestations were not observed.

This inspection was conducted as part of the Division of Reclamation, Mining and Safety's (Division) normal monitoring program. A representative for the operator was not present. Photographs are included with this report in order to illustrate some of the conditions observed.
