MINERALS PROGRAM INSPECTION REPORT
PHONE: (303) 866-3567

MINE NAME: Lily Mines	MINE/PROSPECTING ID#: M-1987-028	MINERAL: Marble	COUNTY: Chaffee
INSPECTION TYPE: Monitoring	INSPECTOR(S): Dustin Czapla	INSP. DATE: May 24, 2021	INSP. TIME: 16:10
OPERATOR: Monarch Mountain Minerals and Aggregates, LLC	OPERATOR REPRESENTATIVE:	TYPE OF OPERATION: 112c - Construction Regular Operation

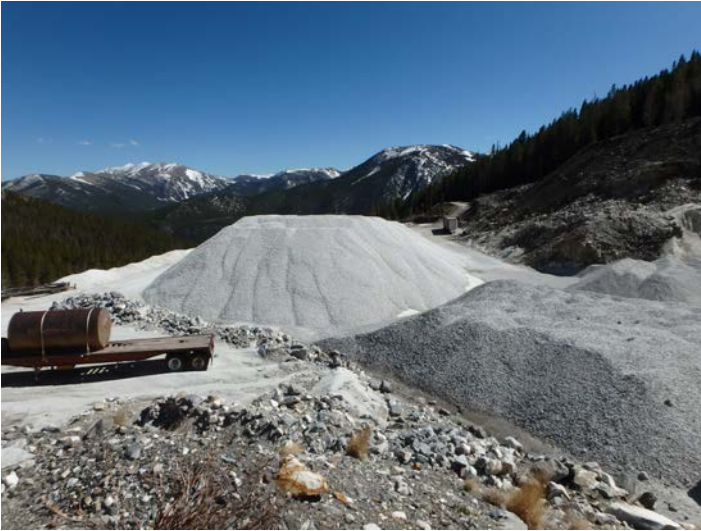
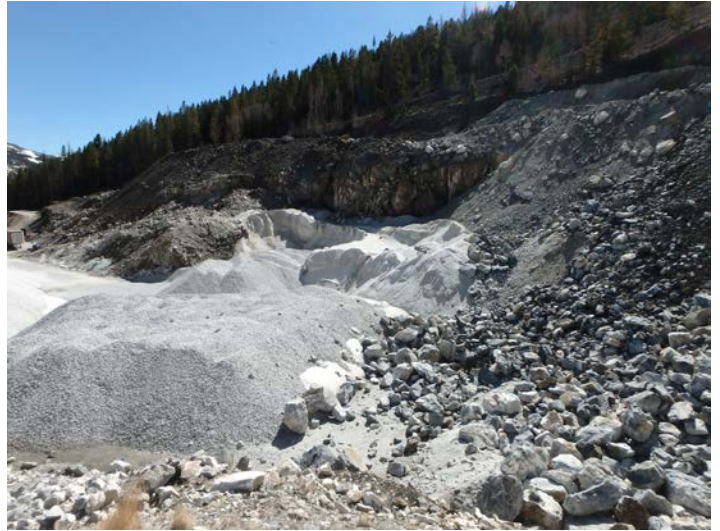
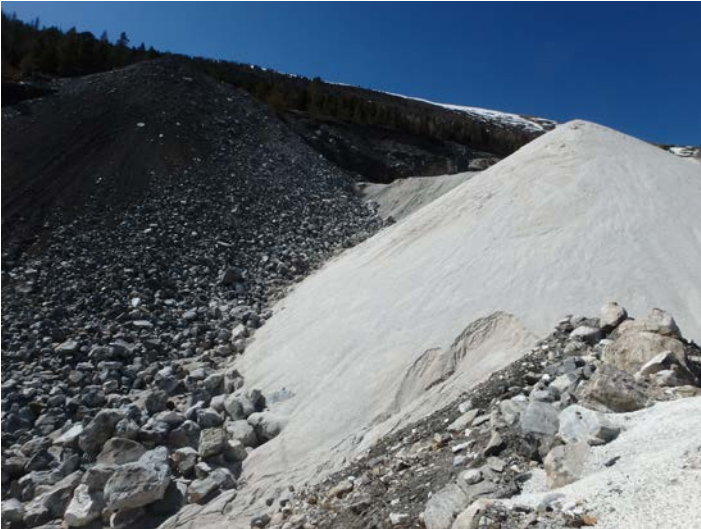
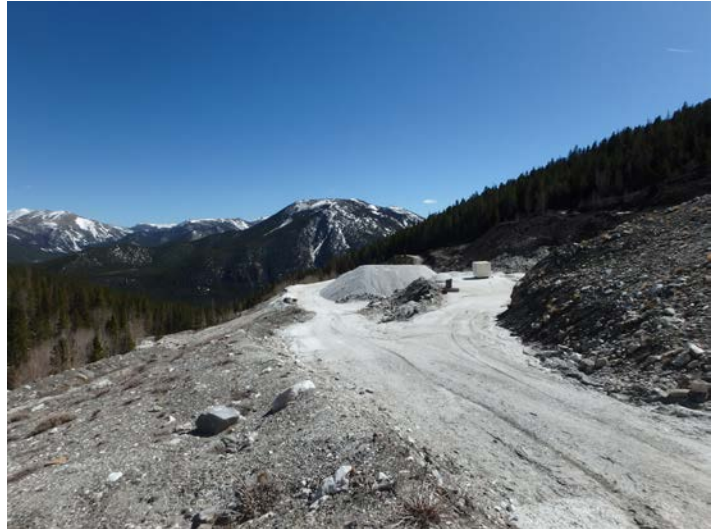
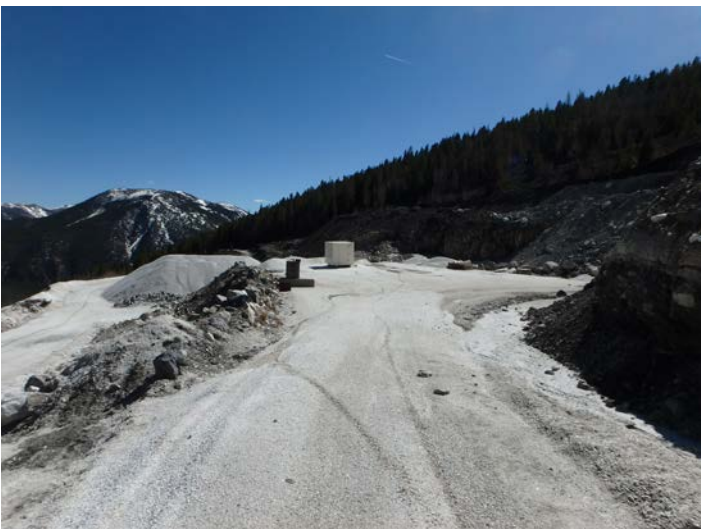
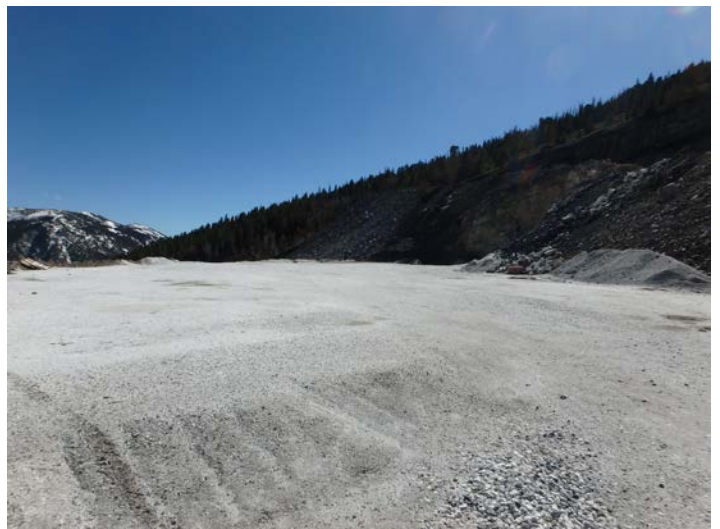
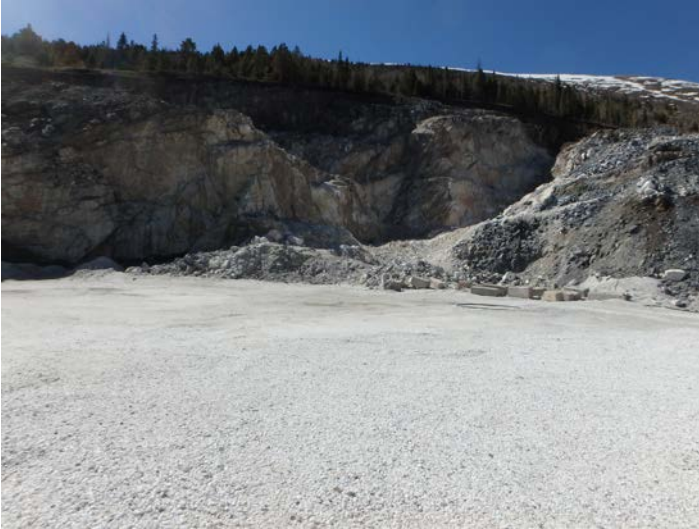
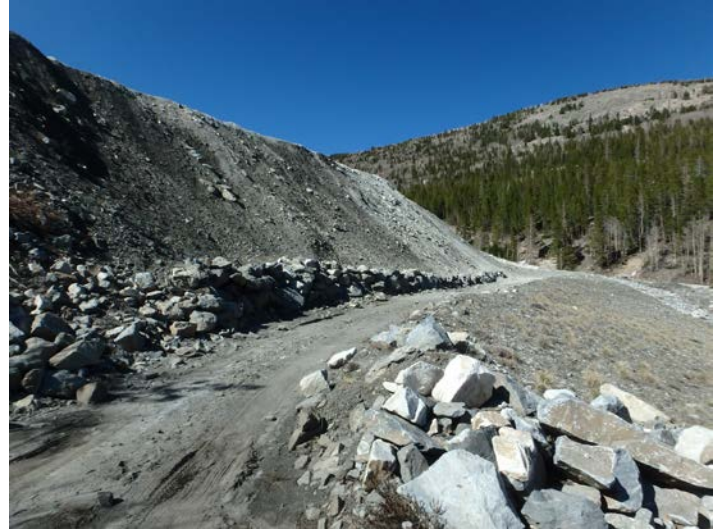
PHOTOGRAPHS

This inspection was conducted as part of the Division of Reclamation, Mining and Safety's (Division) normal monitoring program. A representative for the operator was not present. Photographs are included with this report in order to illustrate some of the conditions observed.

The reclaimed slope in the south permit area adjacent to Taylor Gulch is becoming well vegetated and appears stable. Rills or gullies were not observed on the slope.

The rip-rap areas of Taylor Gulch below FR 228 appear stable.
