**Re: Henderson Mine Point of Compliance Well MNGW-1 Low pH Status Update Response to DRMS Comments, Climax Molybdenum Company, Henderson Operations Permit No. M-1977-342**

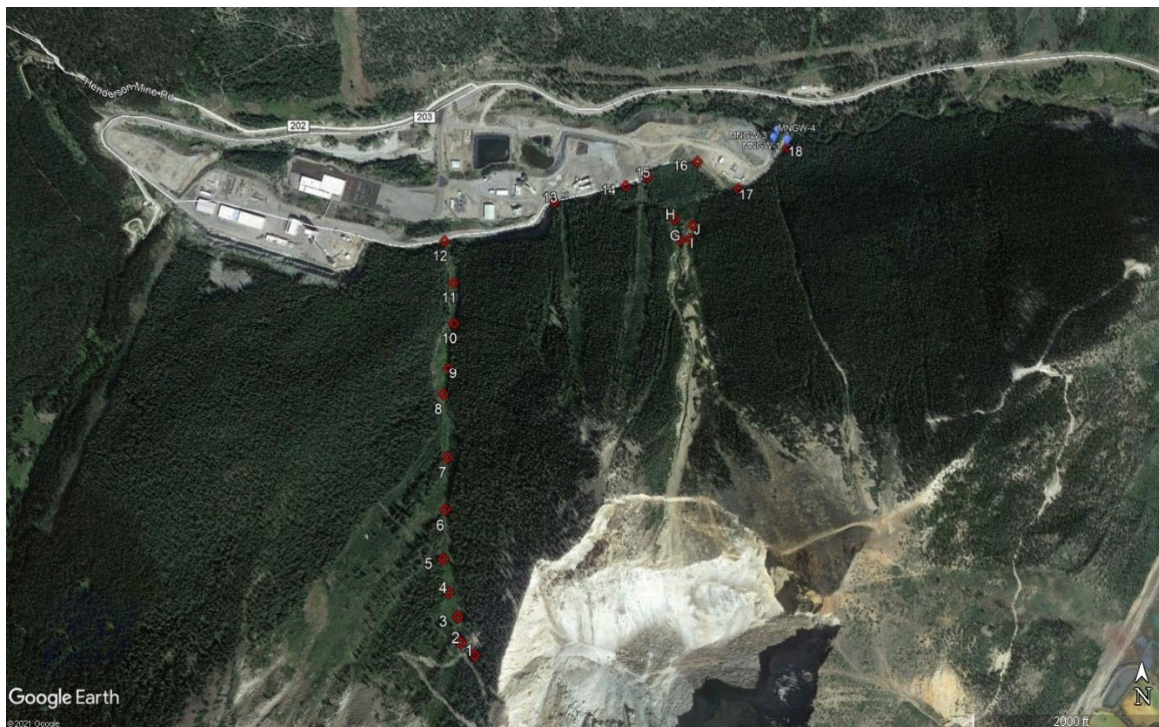
In 2017, Henderson collected samples from several additional sampling points on the north slope of Red Mountain, including within a separate side drainage located east of NNG (see points G, H, I, J on map below). The water samples from these locations had pH values of 3.6 to 4.05, suggesting that naturally acidic run-off occurs outside of the NNG drainage and are also likely contributing to low pH conditions at the MNGW monitor wells.
