**Re: Mountain Coal Company, LLC - West Elk Mine, CDRMS Permit No. C-1980-007  
Pond and Mine Site Quarterly Self-Inspection Reports –3<sup>rd</sup> Quarter 2021**

## REFUSE PILE EXPANSION EAST CERTIFICATION

## RELATIVE COMPACTION TEST RESULTS

**PROJECT:** West Elk Mine RPEE 2021

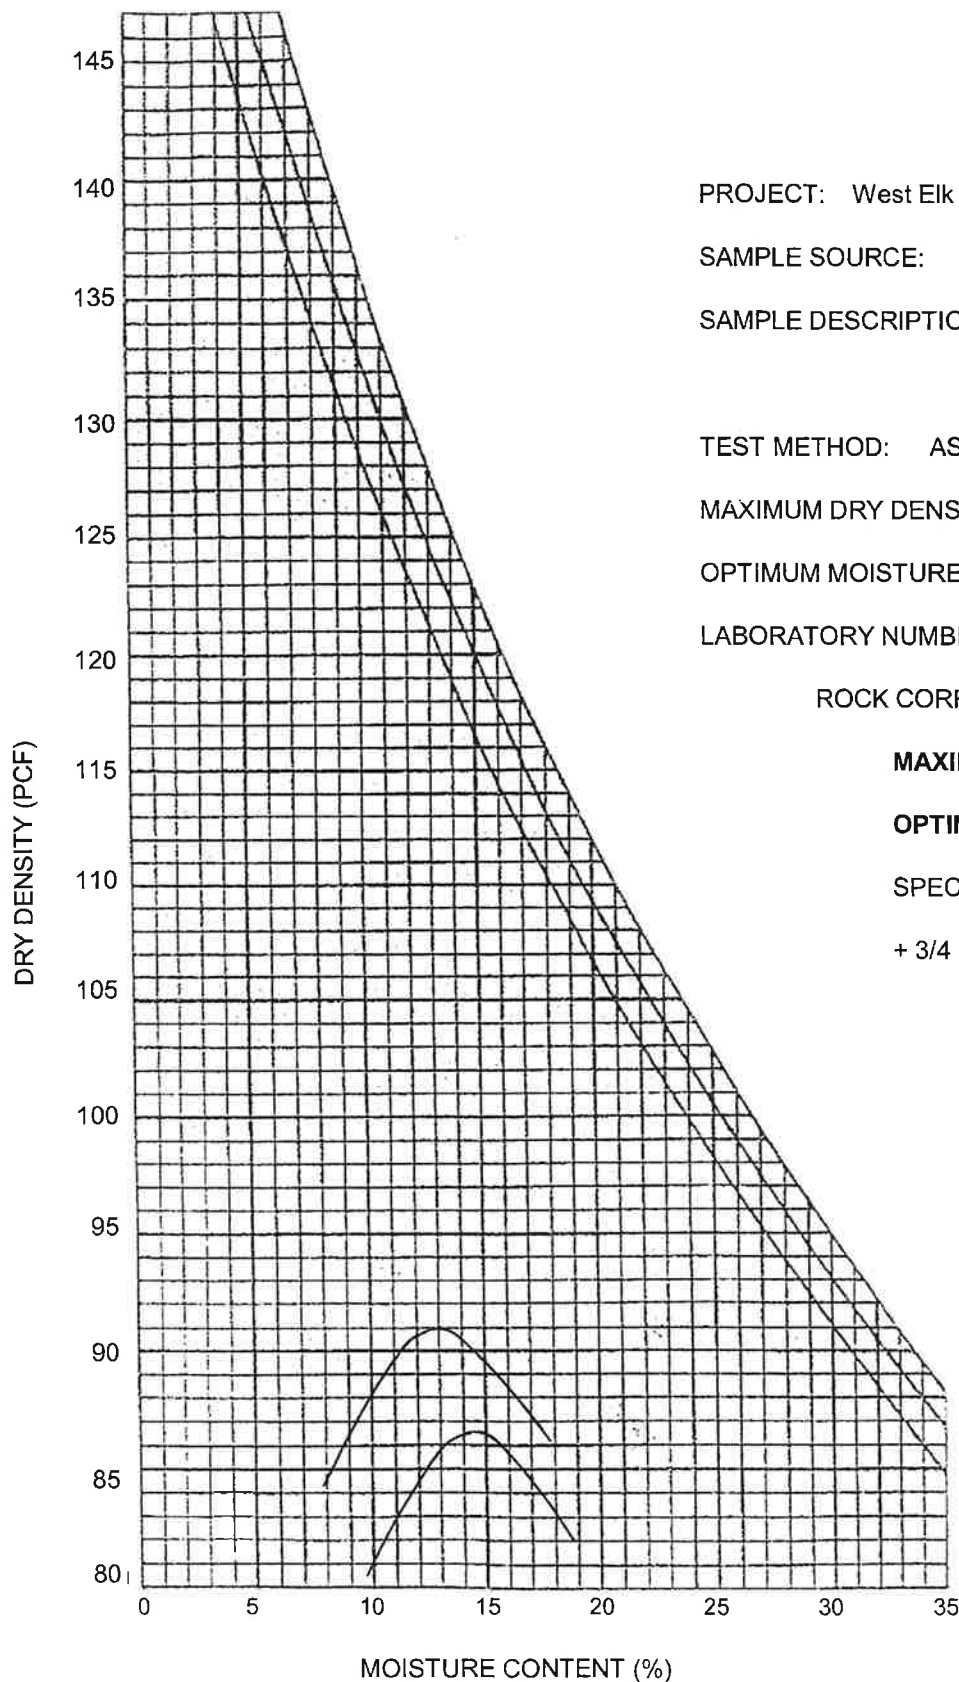
PROJECT: West Elk Mine

SAMPLE SOURCE: Somerset, Co

OPTIMUM MOISTURE CONTENT: 14.5 %

**OPTIMUM MOISTURE CONTENT: 13.0%**

SPECIFIC GRAVITY: 1.85

+ 3/4 INCH = 19.6 % TOTAL WEIGHT

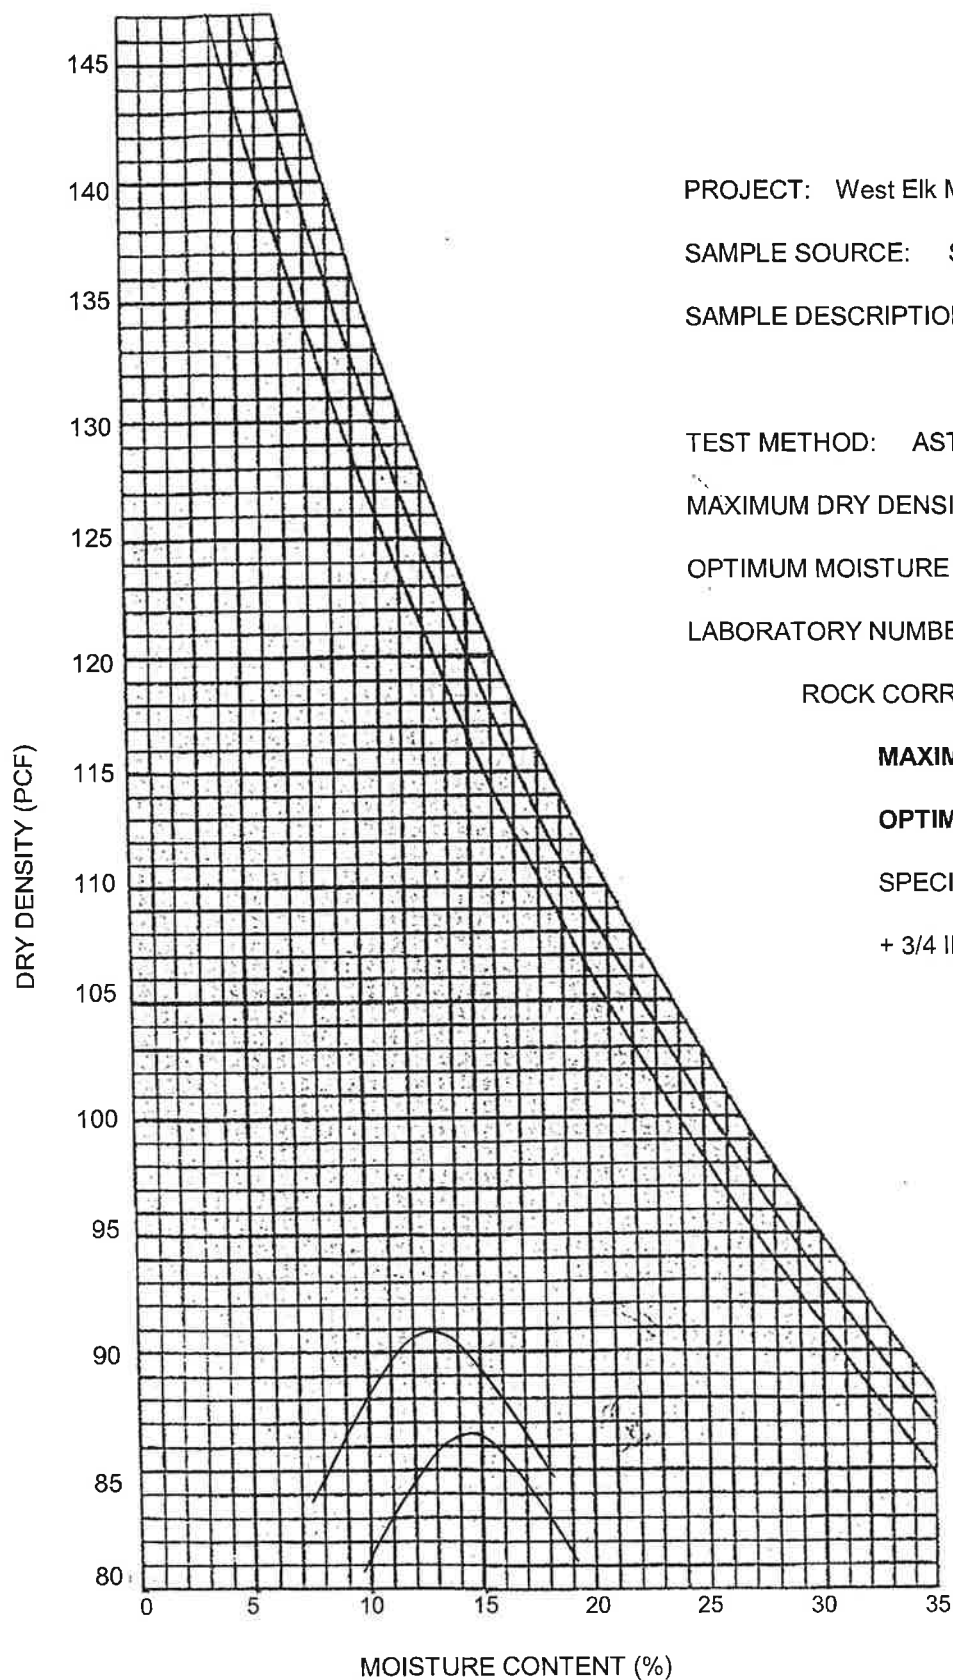
PROJECT: West Elk Mine

SAMPLE SOURCE: Somerset, Co

OPTIMUM MOISTURE CONTENT: 14.5 %

OPTIMUM MOISTURE CONTENT: 13.0%

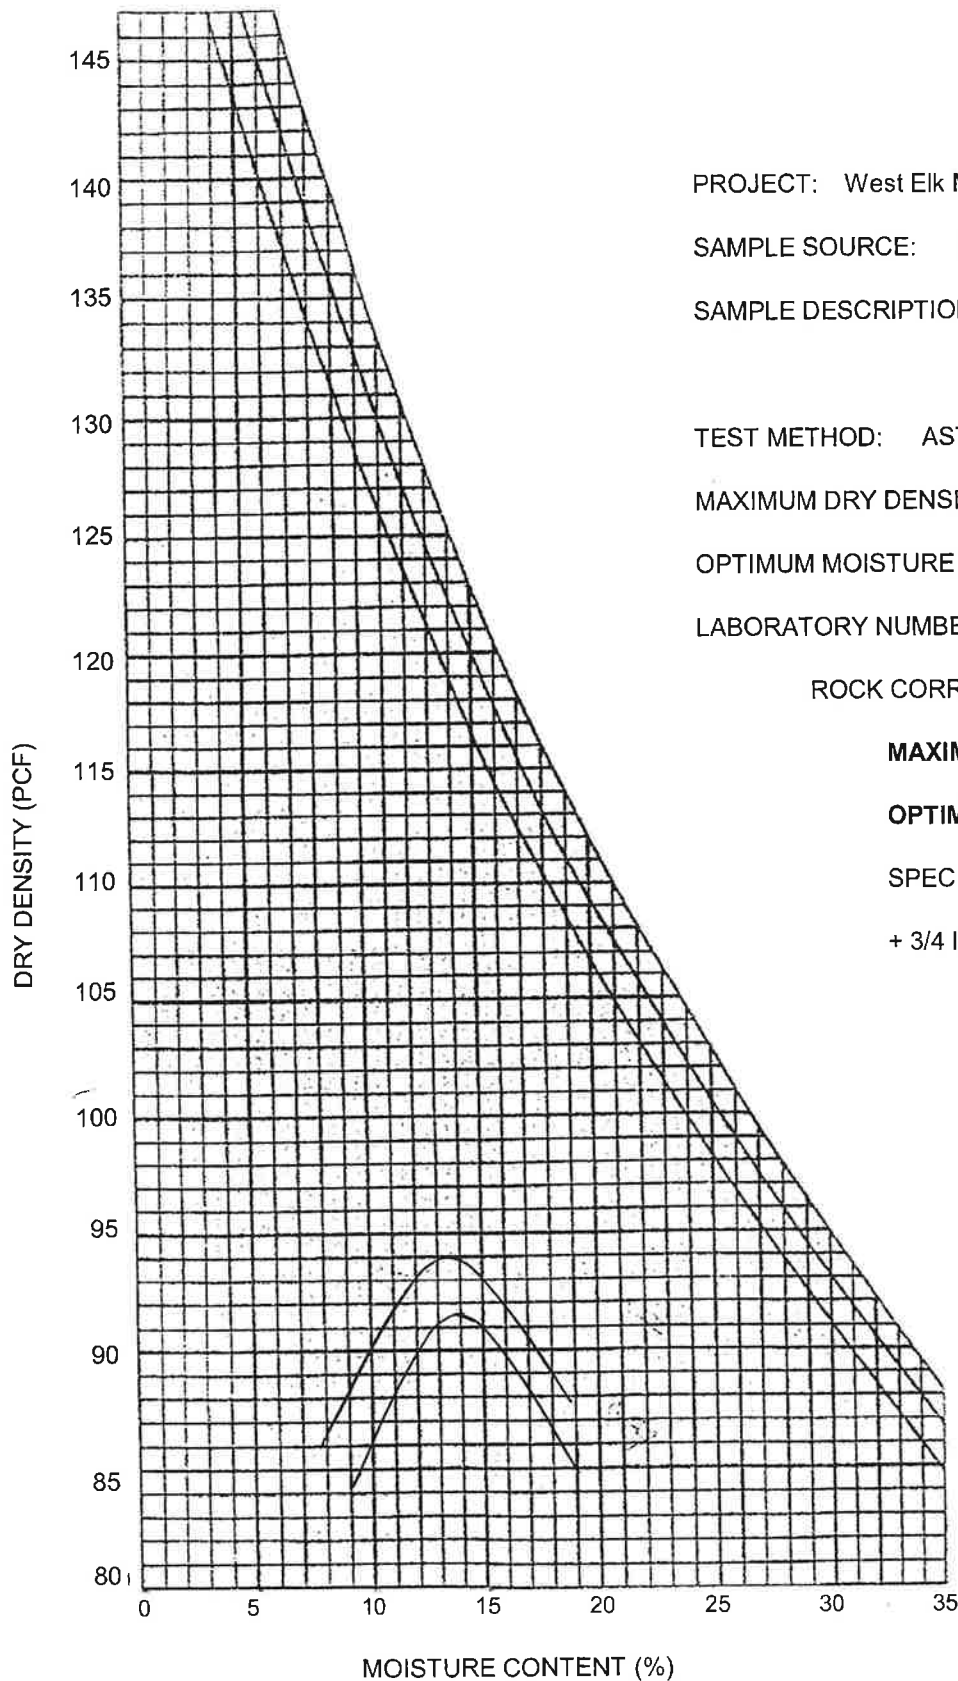
PROJECT: West Elk Mine

SAMPLE SOURCE: Somerset, Co

OPTIMUM MOISTURE CONTENT: 14.0 %

**OPTIMUM MOISTURE CONTENT: 13.5%**
