TMOP East Groundwater Levels - 12092021

Please see the attached groundwater level data from the Pueblo East pits. We were able to collect water levels from all but one of the wells. Well MW - 7 was not found, and may have been impacted by mining at some point in the past. Three of us tried to find it and couldn't. We'll make another effort next month to locate the structure.

Figure 2
Castle Concrete Aggregates - Pueblo East Pit - Monitoring Wells
Depth to Ground Water
Phase 1 Area

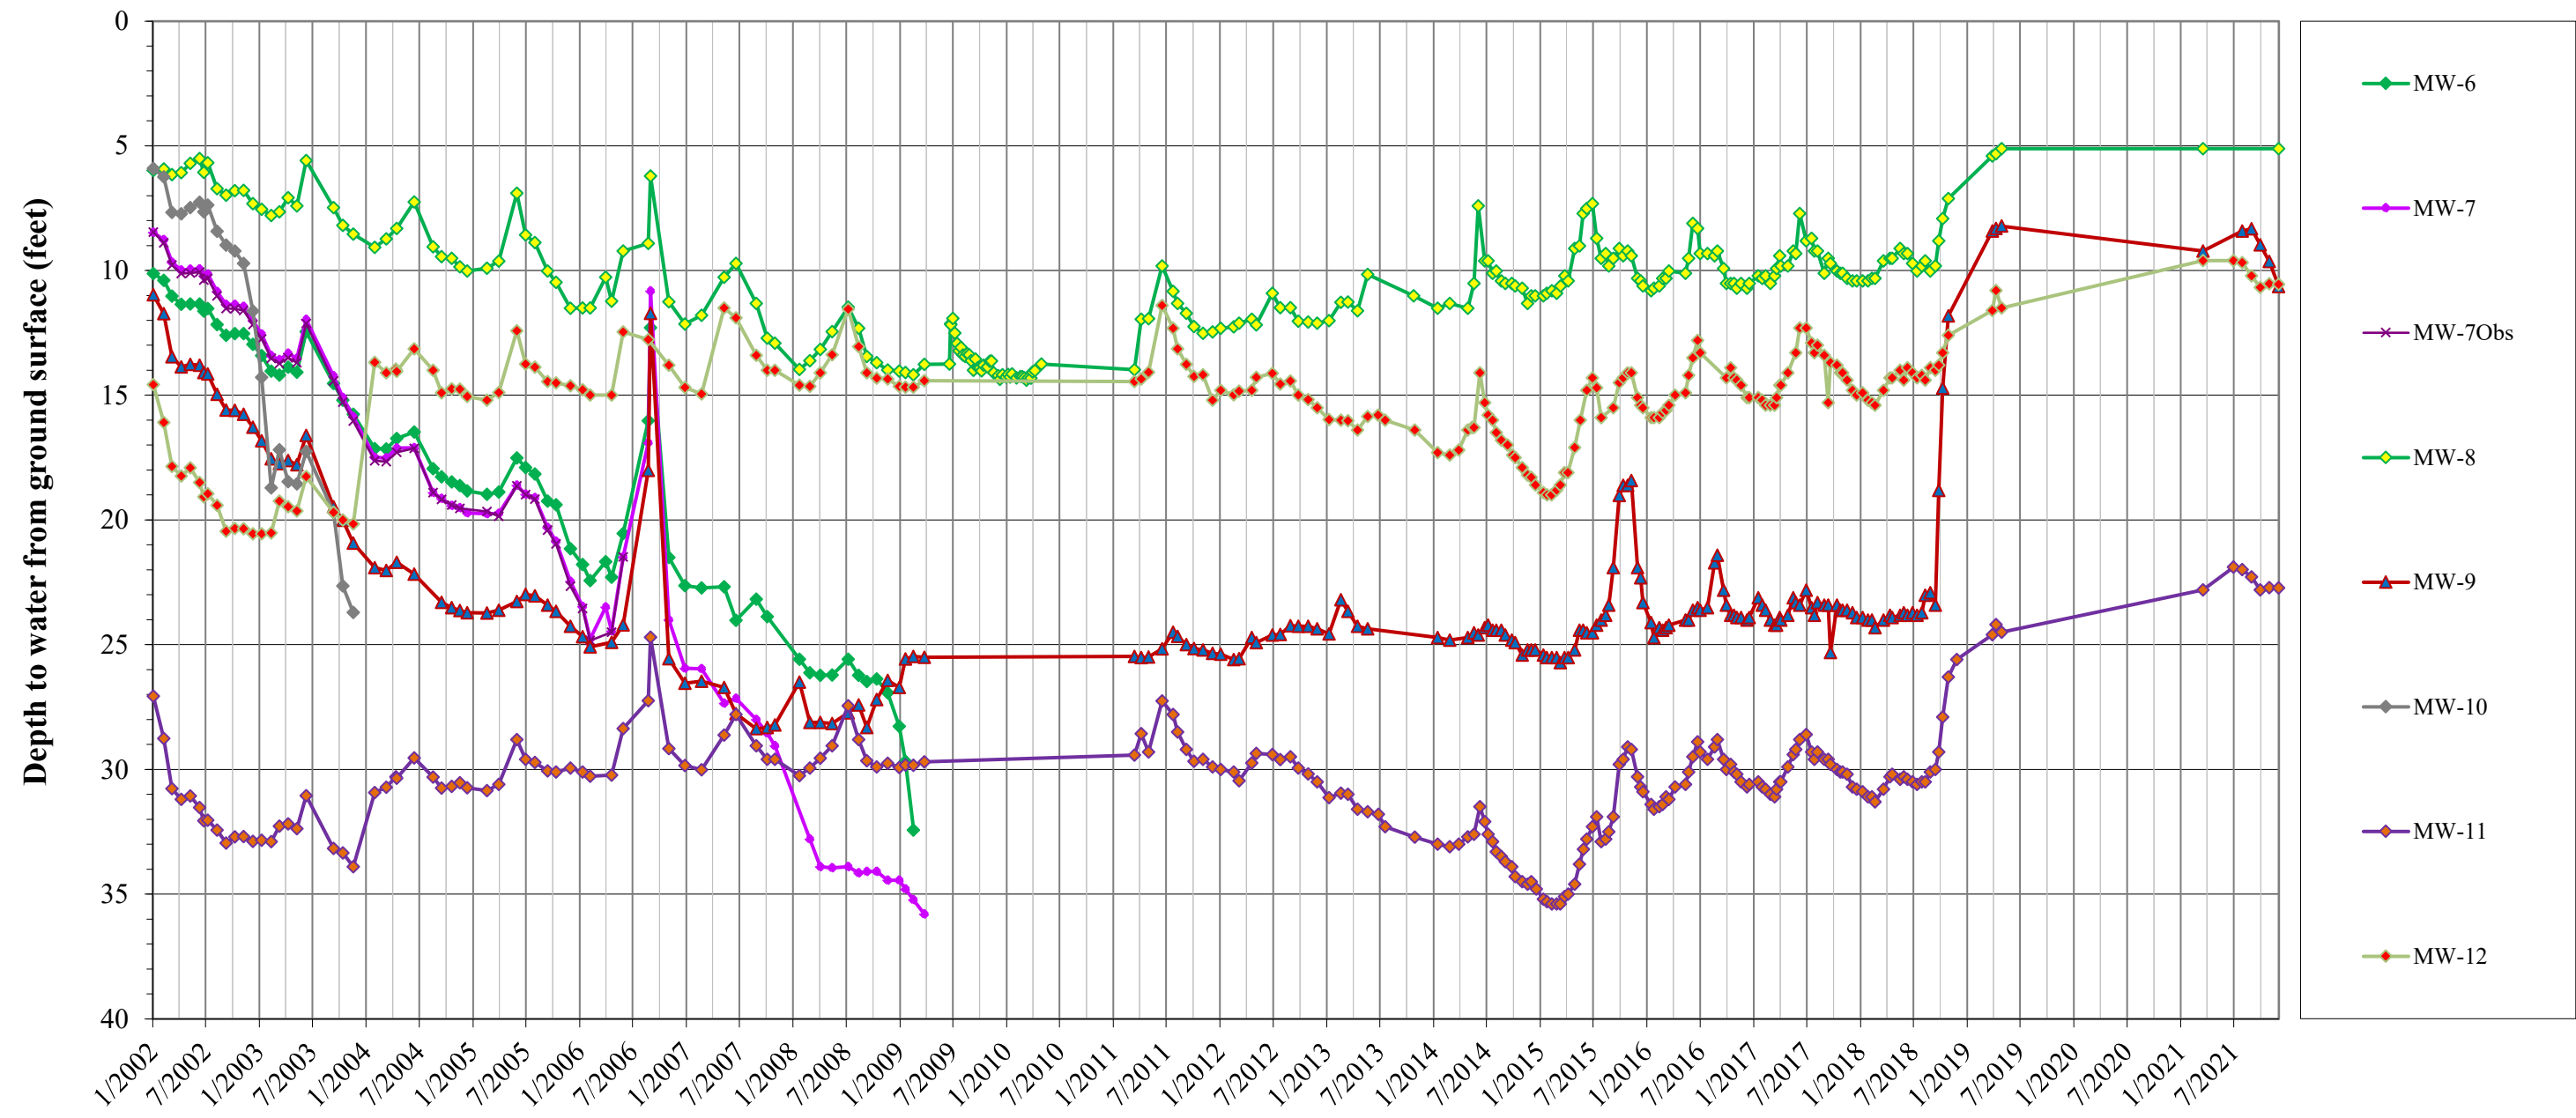
Notes:
 -Several wells, including MW-6, 7, 7Obs and 10, have either been mined through and abandoned or are inaccessible and are no longer measured.
 -Significant decrease in depth to ground water in wells in September 2018 due to cessation of dewatering activities at the Phase 1 pit.

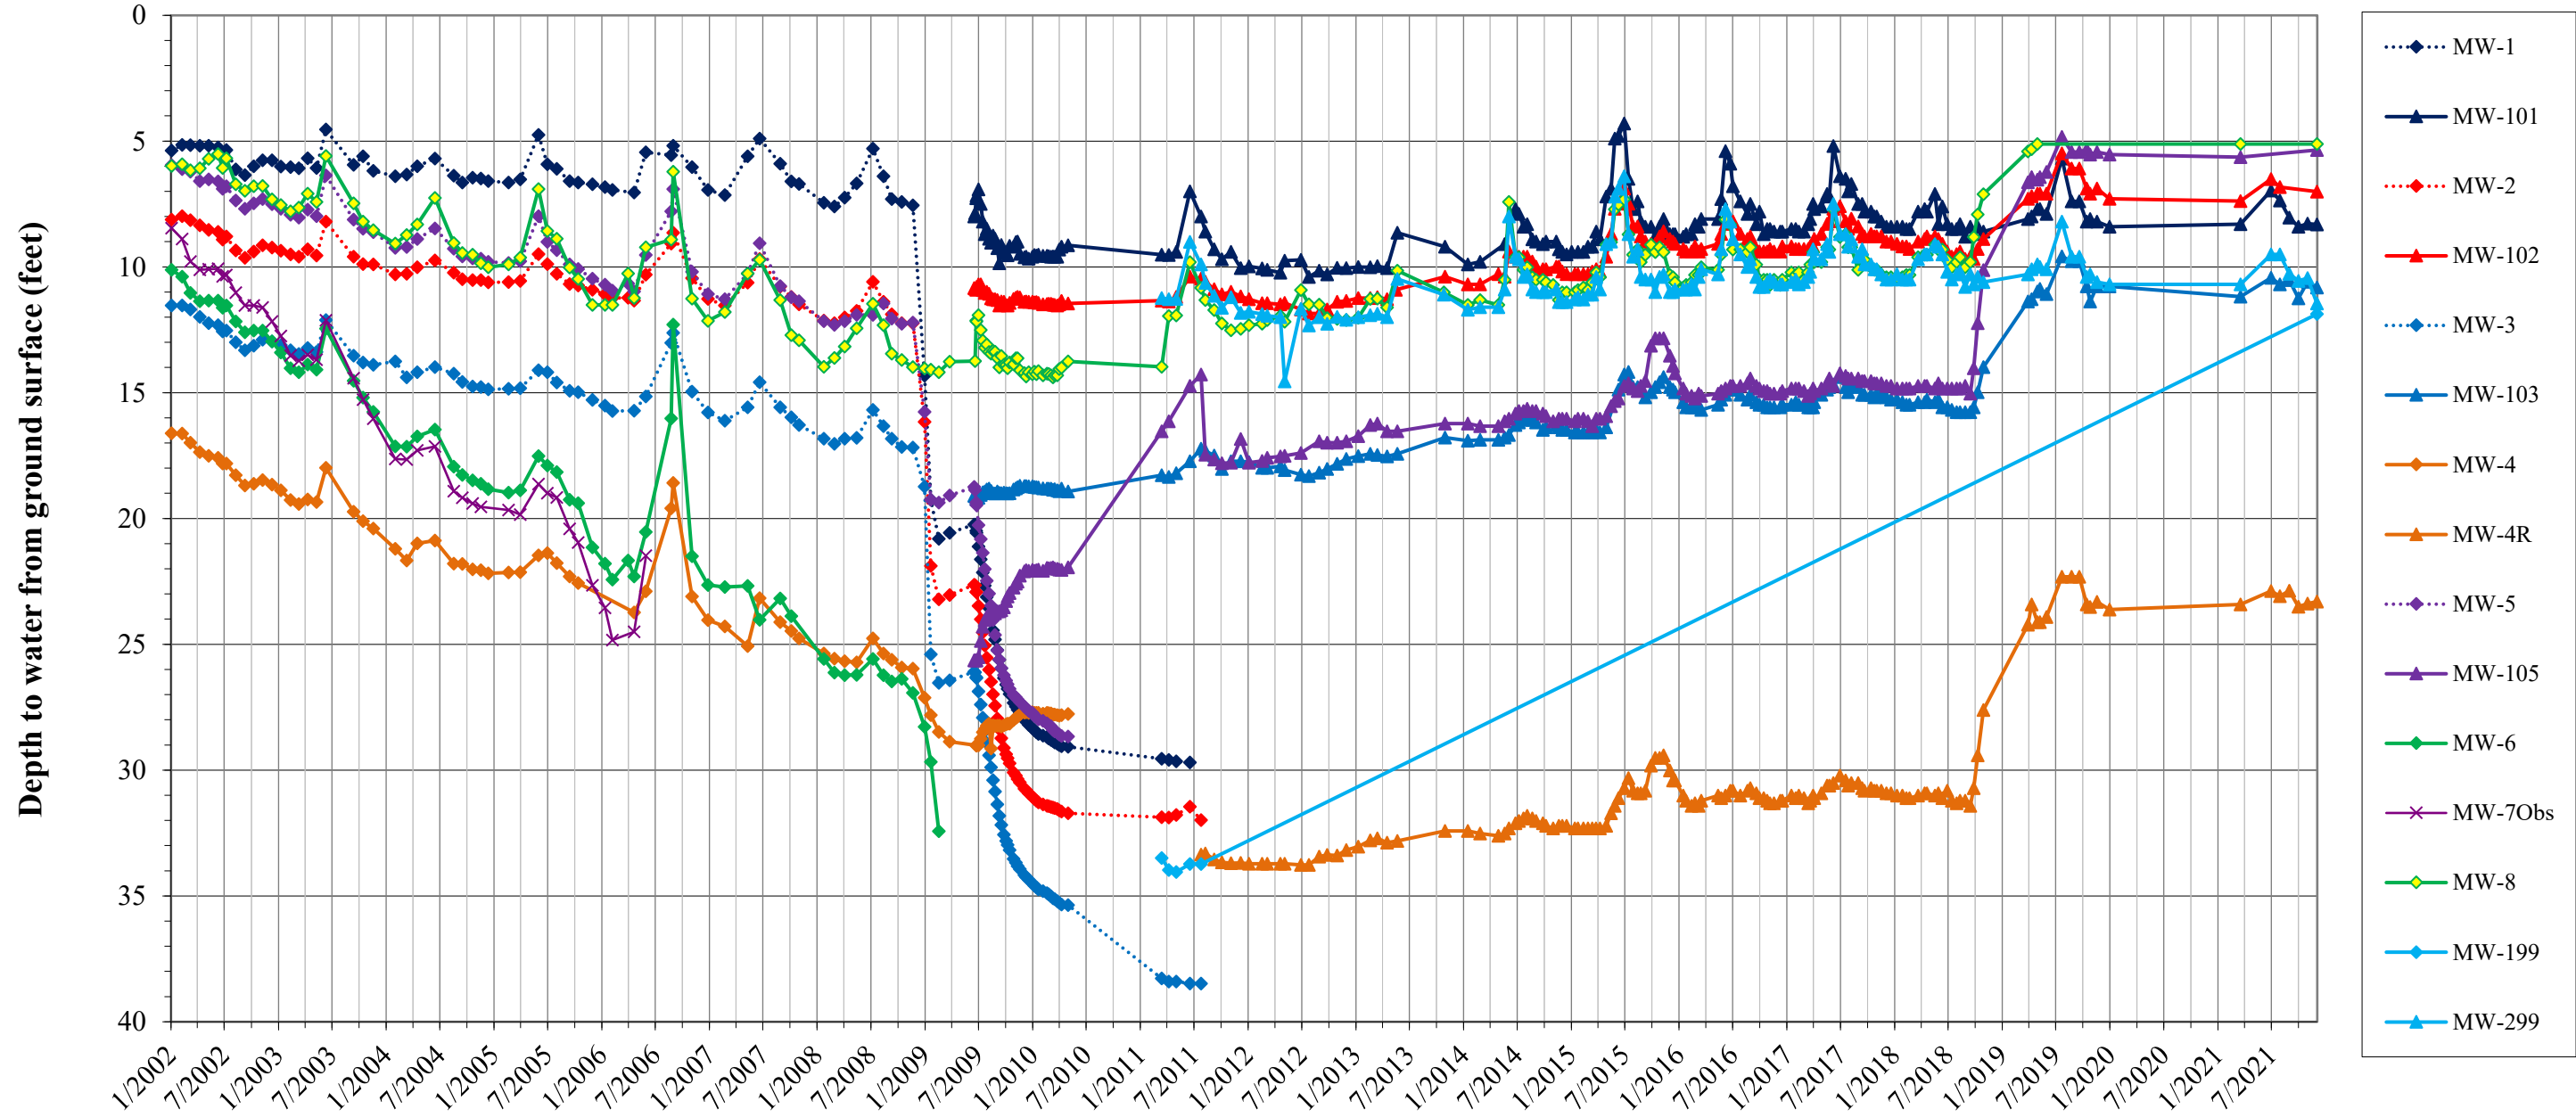
Figure 3
Castle Concrete Aggregates- Pueblo East Pit - Monitoring Wells
Depth to Ground Water
Phase 2 Area

- Several wells, including MW-1, 199, 2, 3, 4, 5, 6, 7 and 7Obs have either been mined through and abandoned or are inaccessible and are no longer measured.
- Wells MW-1, MW-2, MW-3, MW-5, and MW-199 were located within the slurry wall, and are not representative of local ground water conditions after November 2008.
- MW-4R is located at higher elevation than MW-4, resulting in a greater depth to water than in MW-4. Offset between MW-4 data in May 2010 and MW-4R data from July 2011 to present are the result of differing ground surface elevations.
- Depth to water for MW-101,102,103 and 105 assume the same measuring height above ground surface as MW-1,2,3 and 5, respectively.
- Significant decrease in depth to ground water in certain wells in September 2018 due to cessation of dewatering activities at the Phase 1 pit.

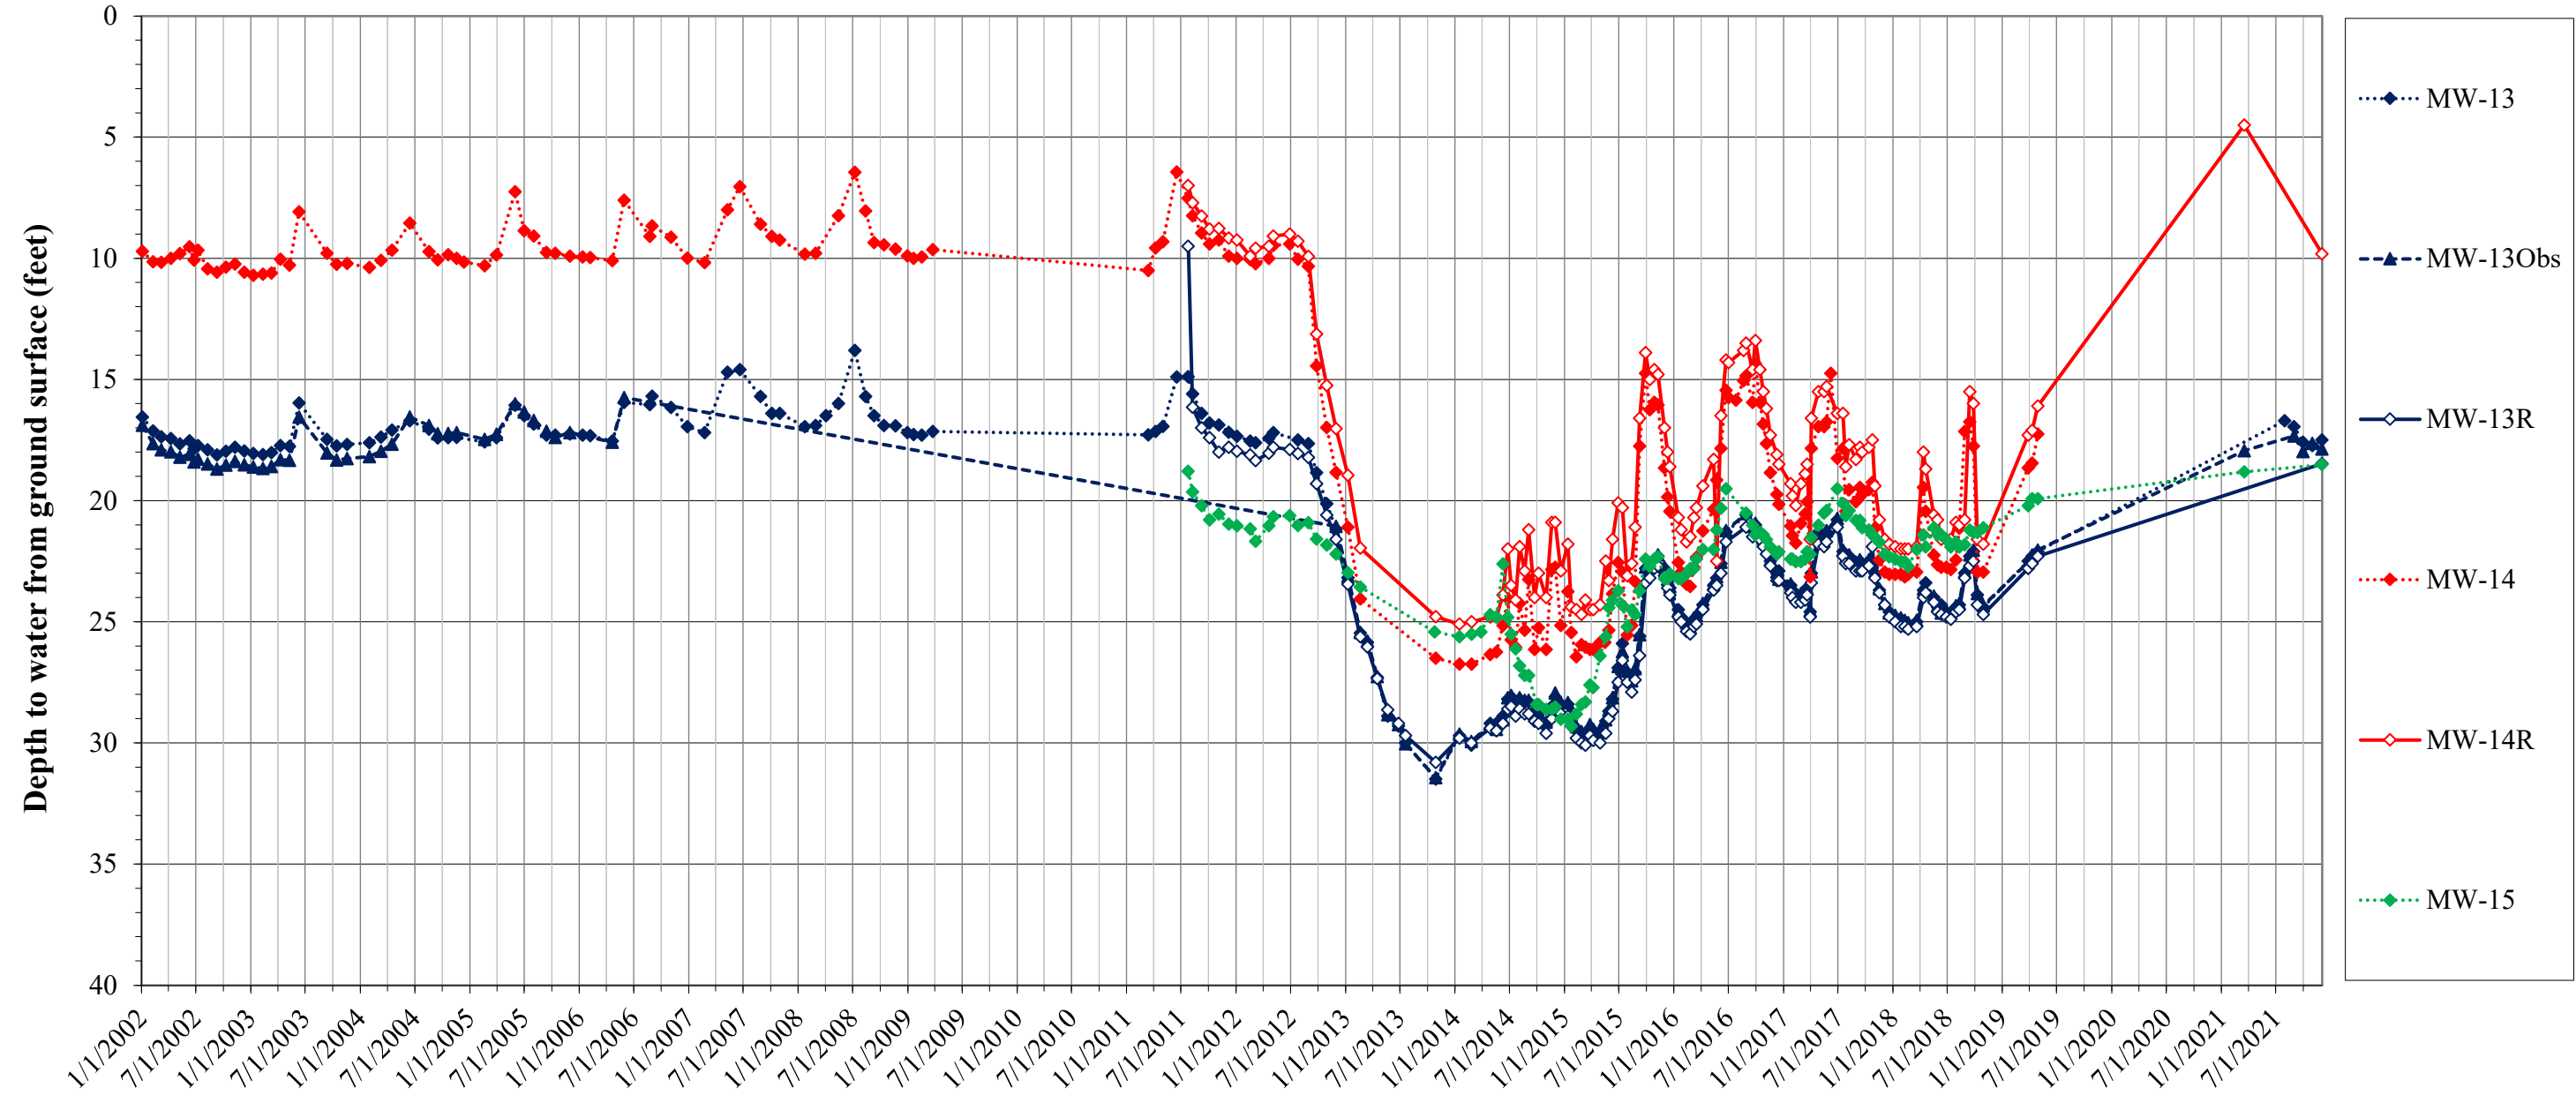
Figure 4
Castle Concrete Aggregates- Pueblo East Pit - Monitoring Wells
Depth to Ground Water
Phase 7 Area

Notes:
 -Increase in depth to water starting in late 2012 due to beginning of dewatering operations at Phase 7.
 -Gradual decrease in depth to water from late 2015 to April 2019 present due to reduction in the footprint of the dewatered area. Significant decrease in depth to ground water as of March 2021 due to cessation of dewatering activities at Phase 7 pit in October 2020.

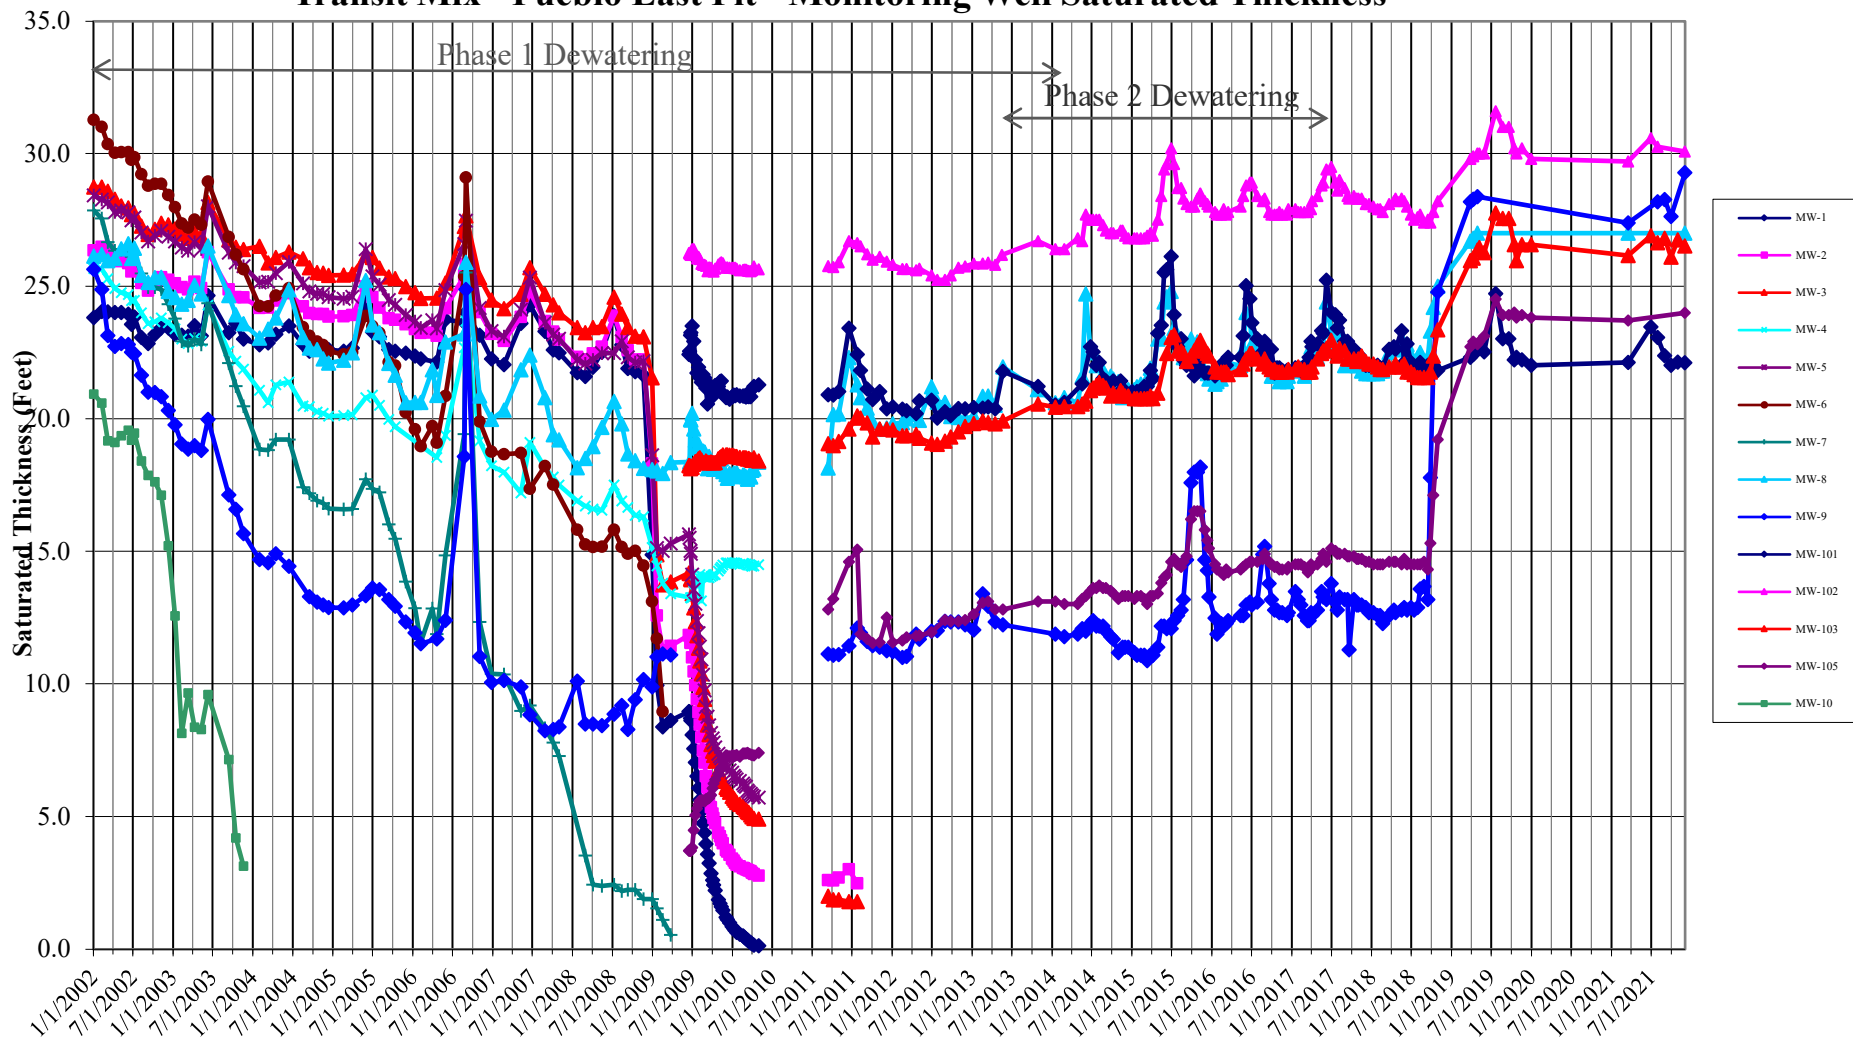
Transit Mix - Pueblo East Pit - Monitoring Well Saturated Thickness

Note: Water level measuring points for MW-101,102,103 and 105 assumed to be the same elevation as MW-1,2,3 and 5. Further clarification may be needed. Pit was flooded in July and August 2006.
Recharge to recharge pit in May 2006

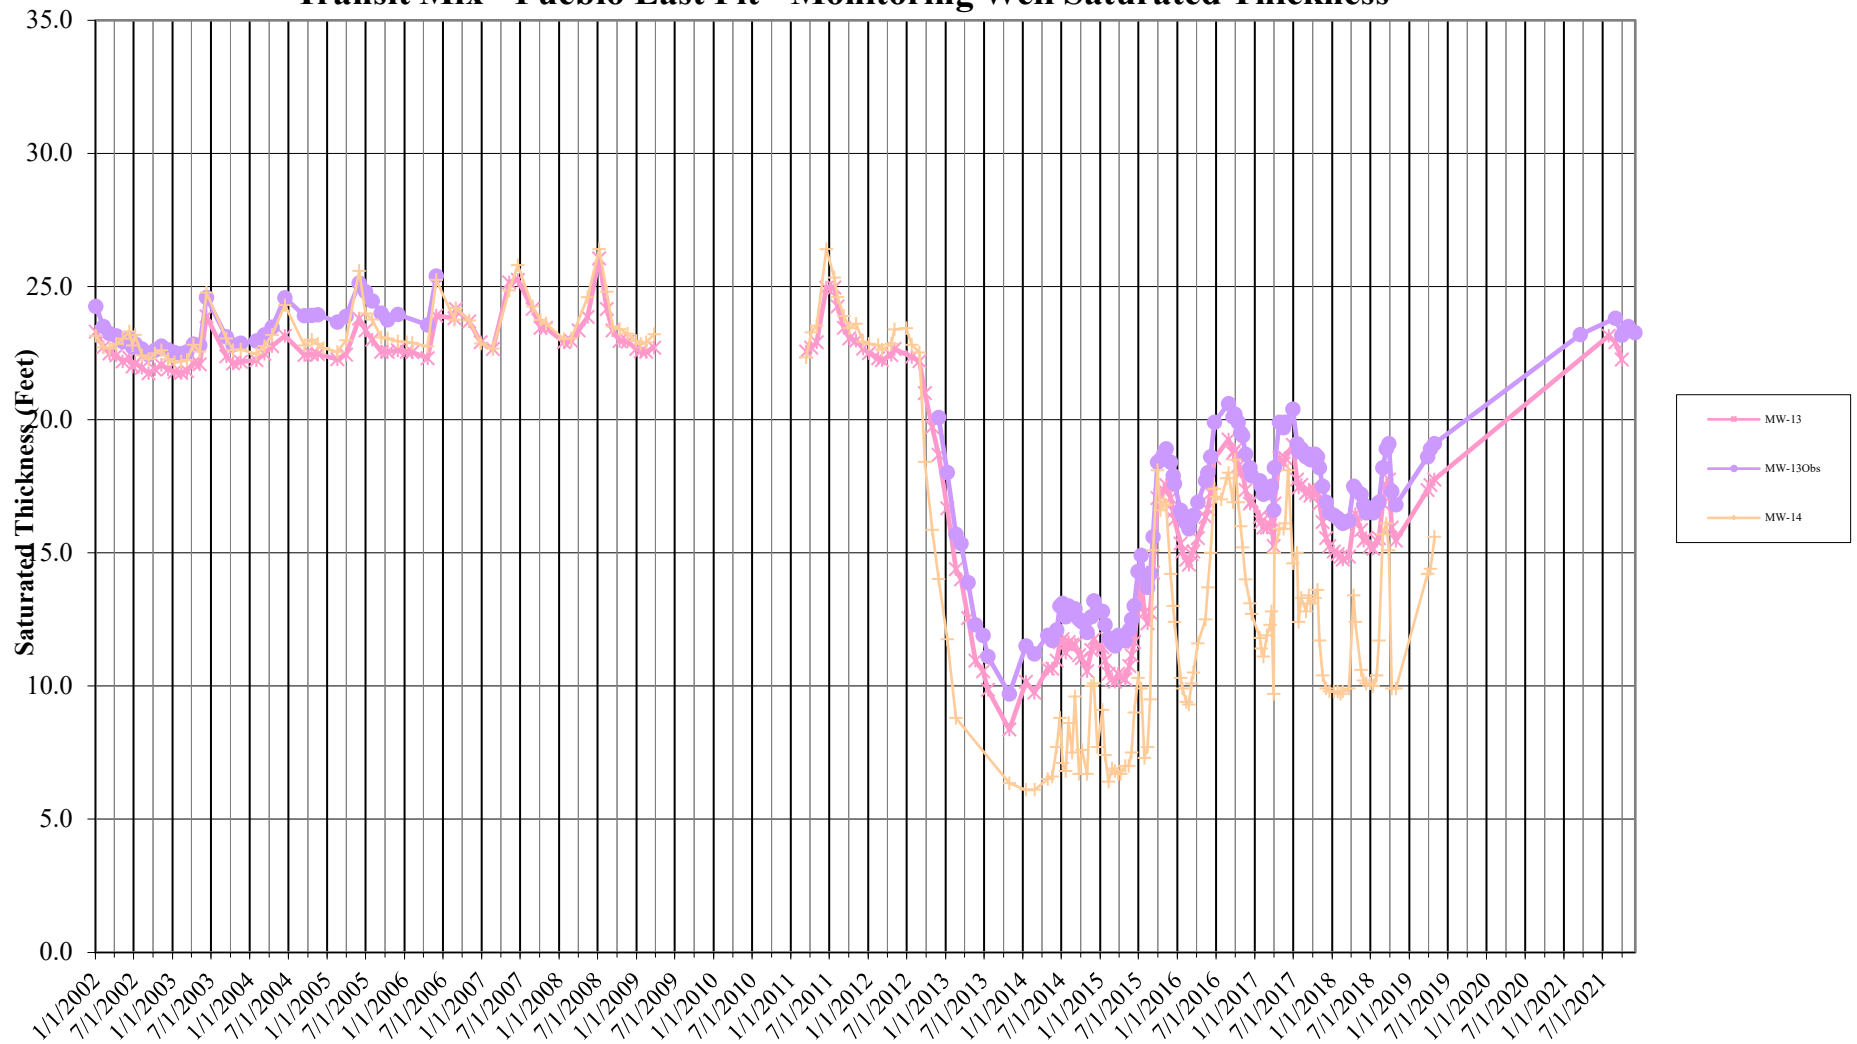
Figure G-4
Transit Mix - Pueblo East Pit - Monitoring Well Saturated Thickness

Note: Water level measuring points for MW-101,102,103 and 105 assumed to be the same elevation as MW-1,2,3 and 5. Further clarification may be needed.
Pit was flooded in July and August 2006.
Recharge to recharge pit in May 2006

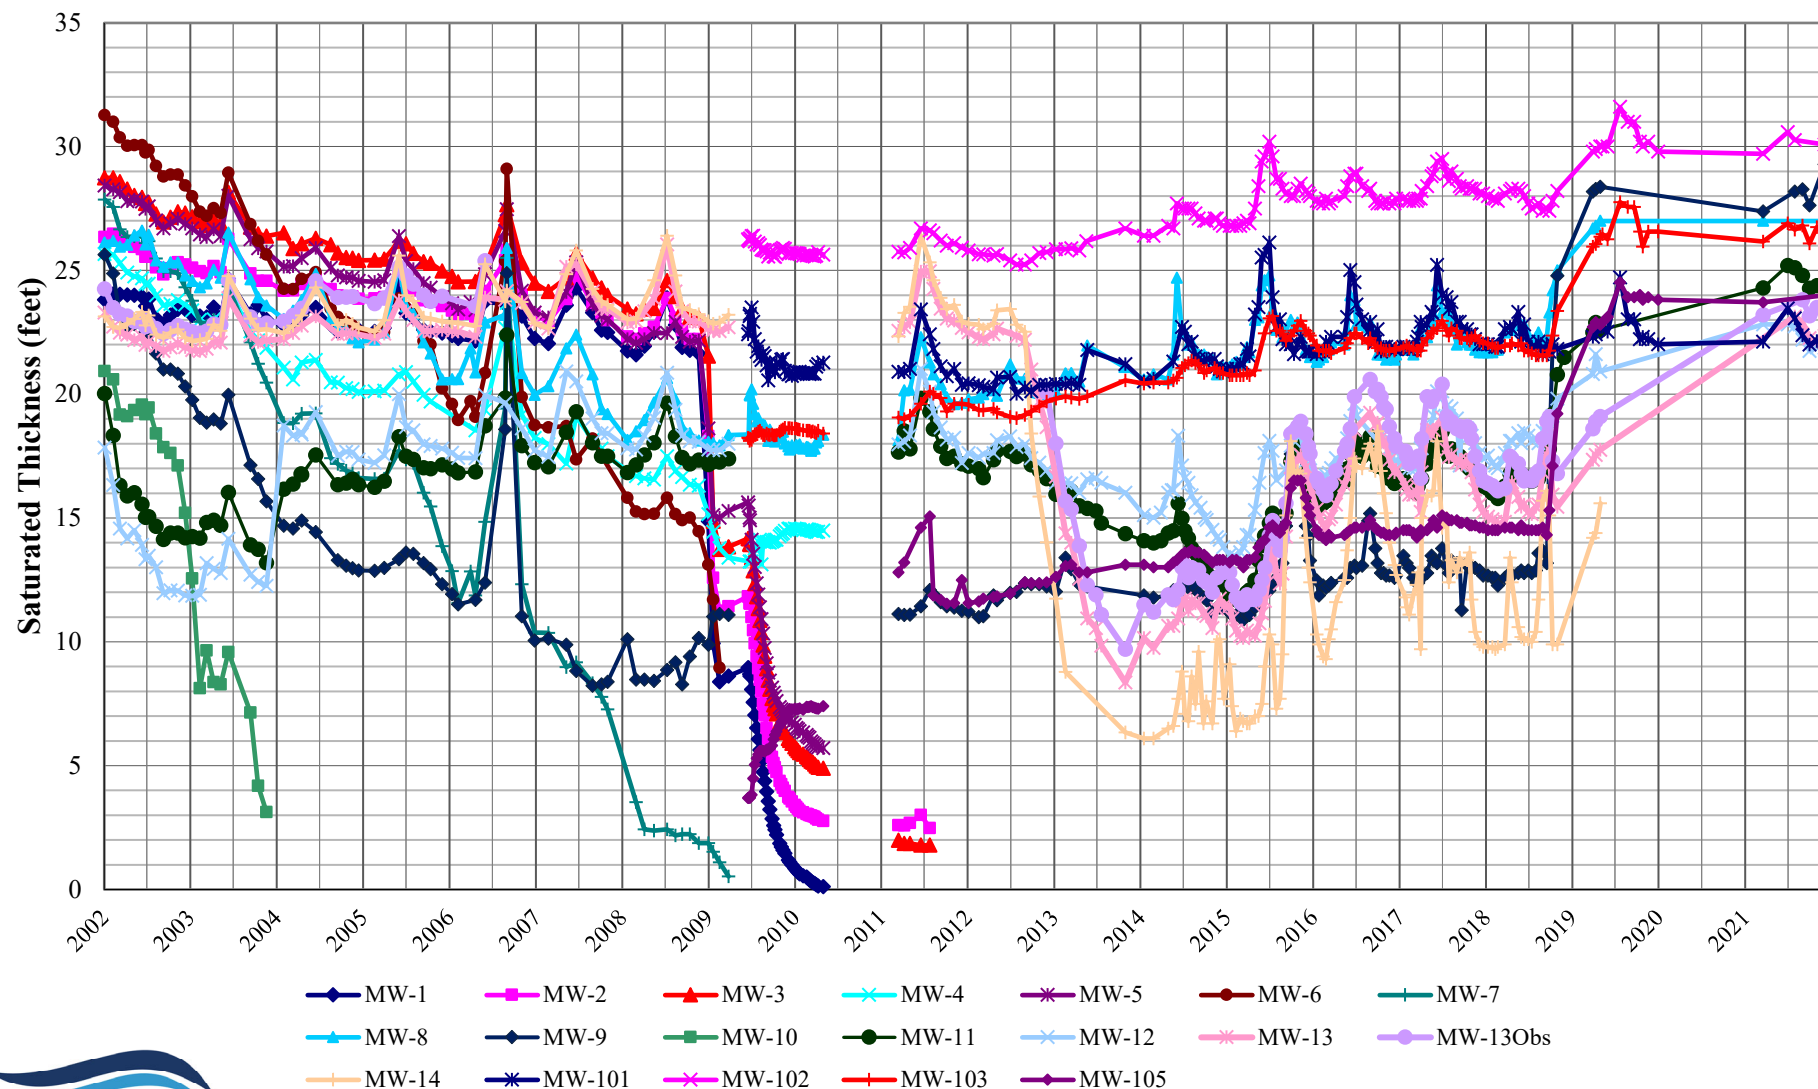
Castle Aggregates Pueblo East Pit Monitoring Well Saturated Thickness

Note: Further clarification may be needed regarding the measuring point elevation.
The label for each year is on January 1.
Pit was flooded in July and August 2006.
Recharge to recharge pit in May 2006.
Dewatering was temporarily ceased in 2018, through the present.
