M-1997-054 / Parkdale Quarry AM-2 Revised Geotechnical Stability Exhibit

RULE 6.5 GEOTECHNICAL STABILITY EXHIBIT
FRONT RANGE AGGREGATES
PARKDALE QUARRY
FREMONT COUNTY, COLORADO

Prepared by David W. Bieber, PG, PGP, CEG, CHG
Martin Marietta Manager of Geology/Survey

December 21, 2021

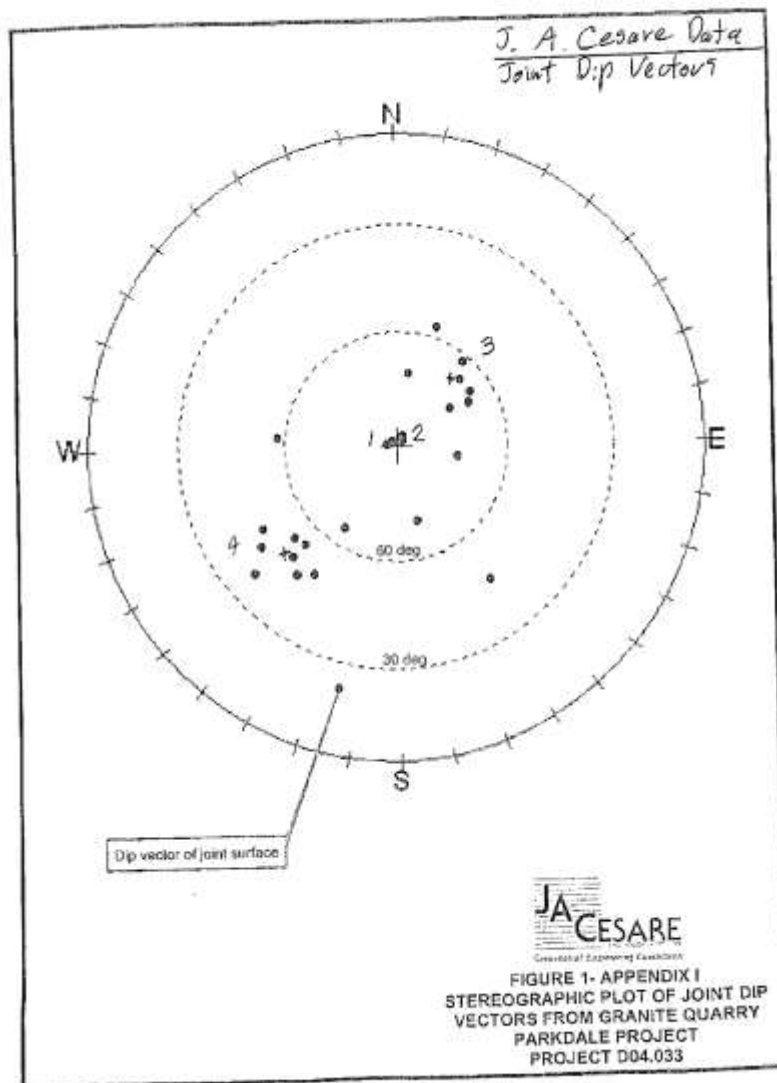
Figure 2B - Stereonet Plot – 2008 Stability Report

J. A. Cesare Data

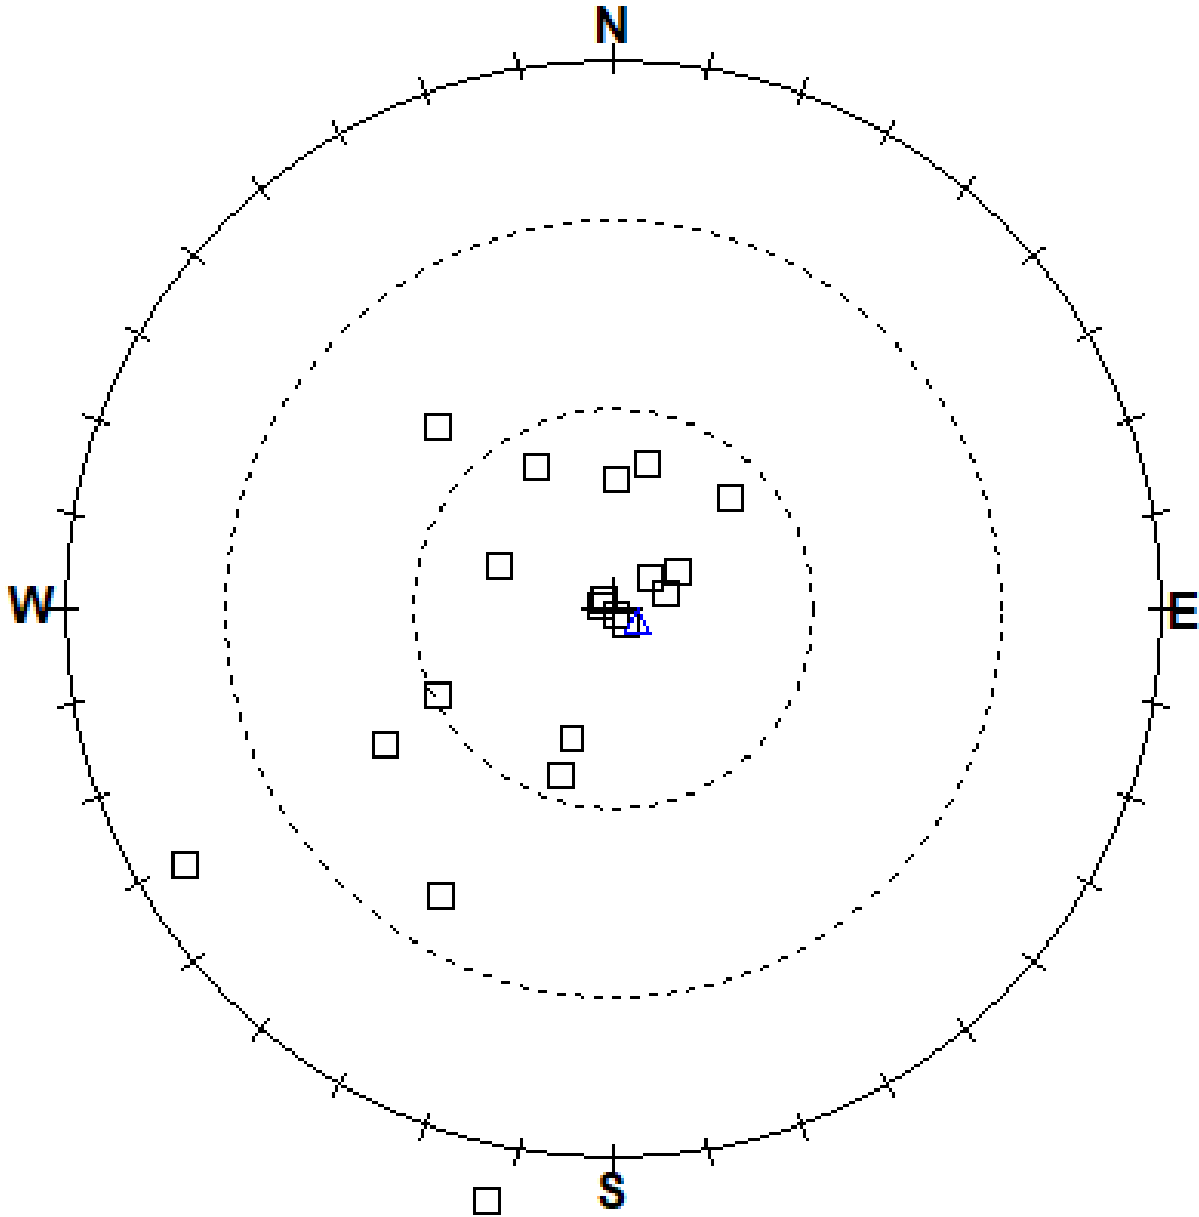
Figure 3A - Stereonet Plot – 2021 Granite Quarry Data
Combined BLM and Private
Front Range Aggregates, LLC
Parkdale Quarry
Fremont County, Colorado
DRMS Mining Permit M1997-054

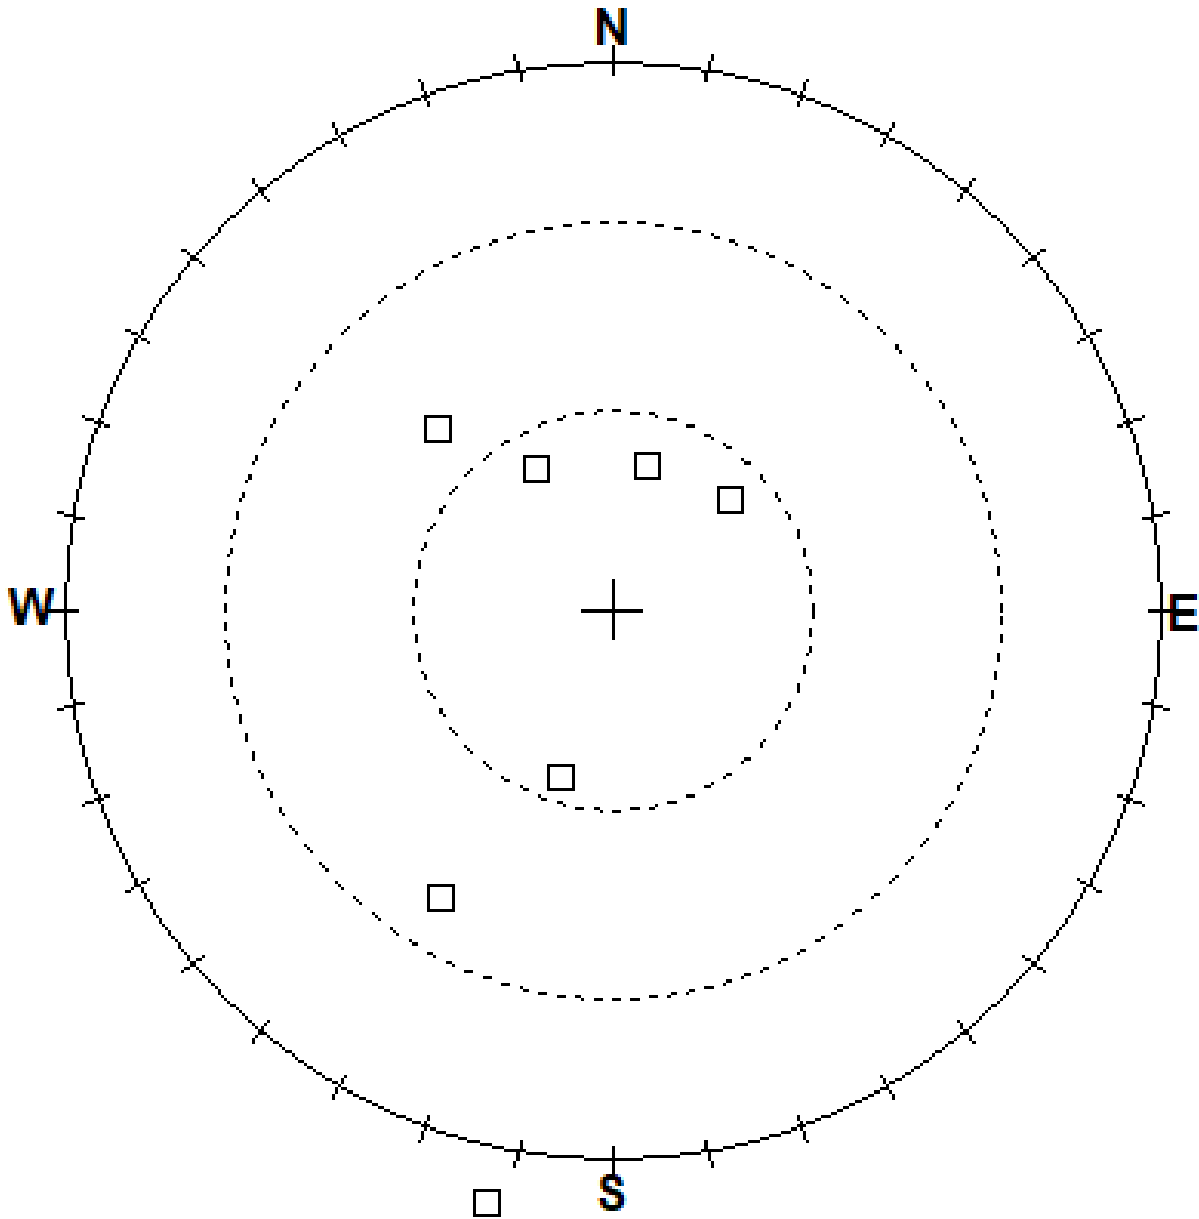
Figure 3B - Stereonet Plot – 2021 Granite Quarry Data

Private Land Granite Quarry Data

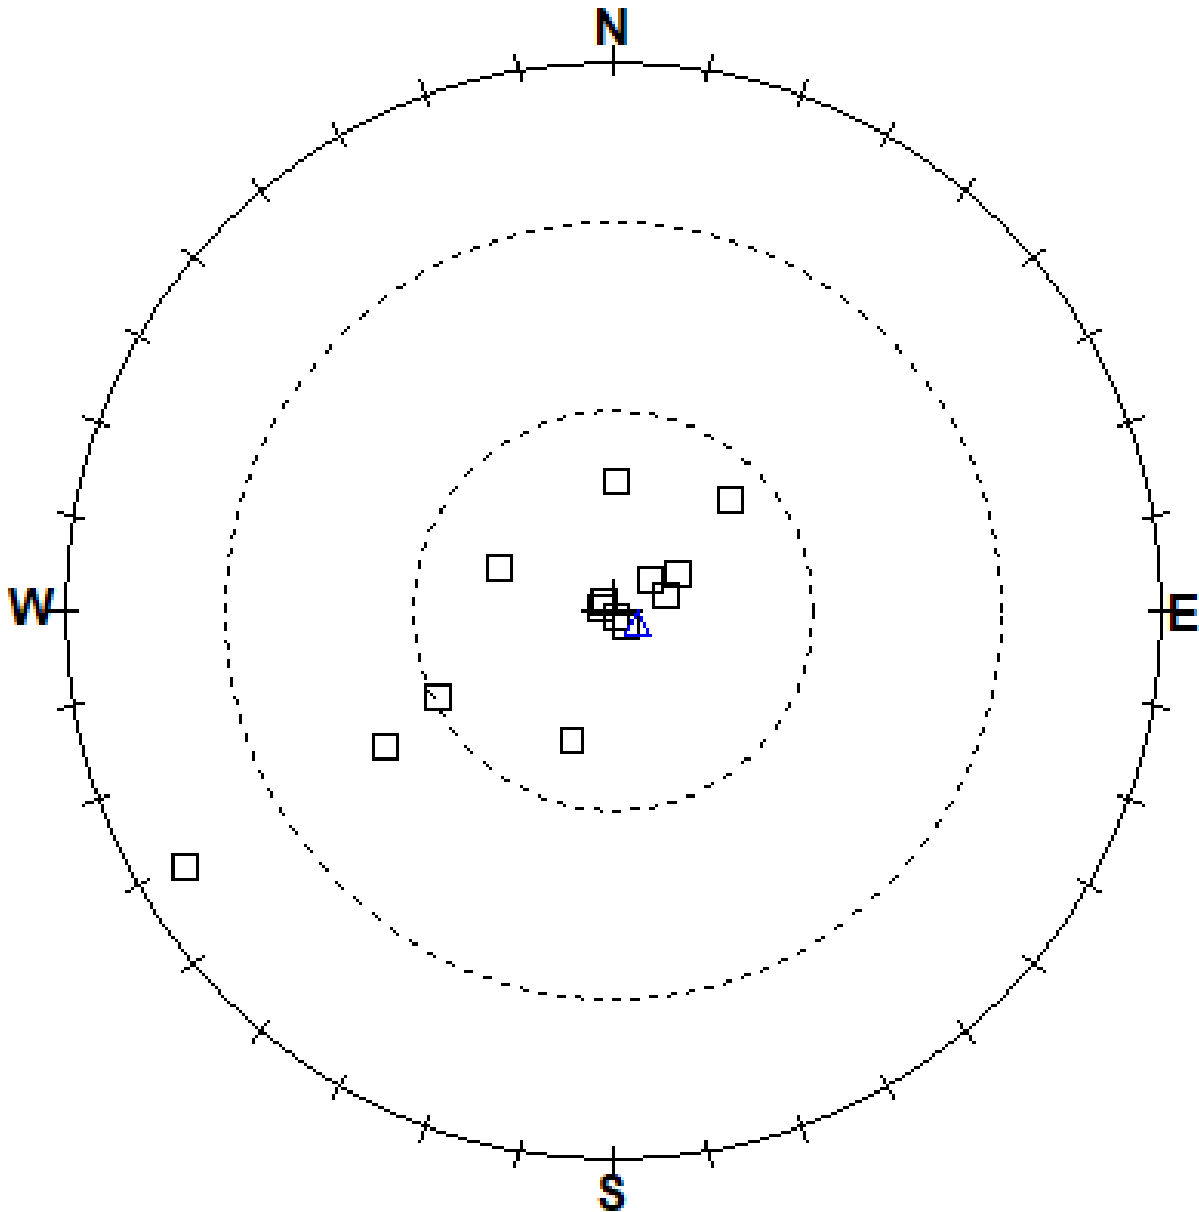
Figure 3C - Stereonet Plot – 2021 Granite Quarry Data

BLM Expansion Area Data

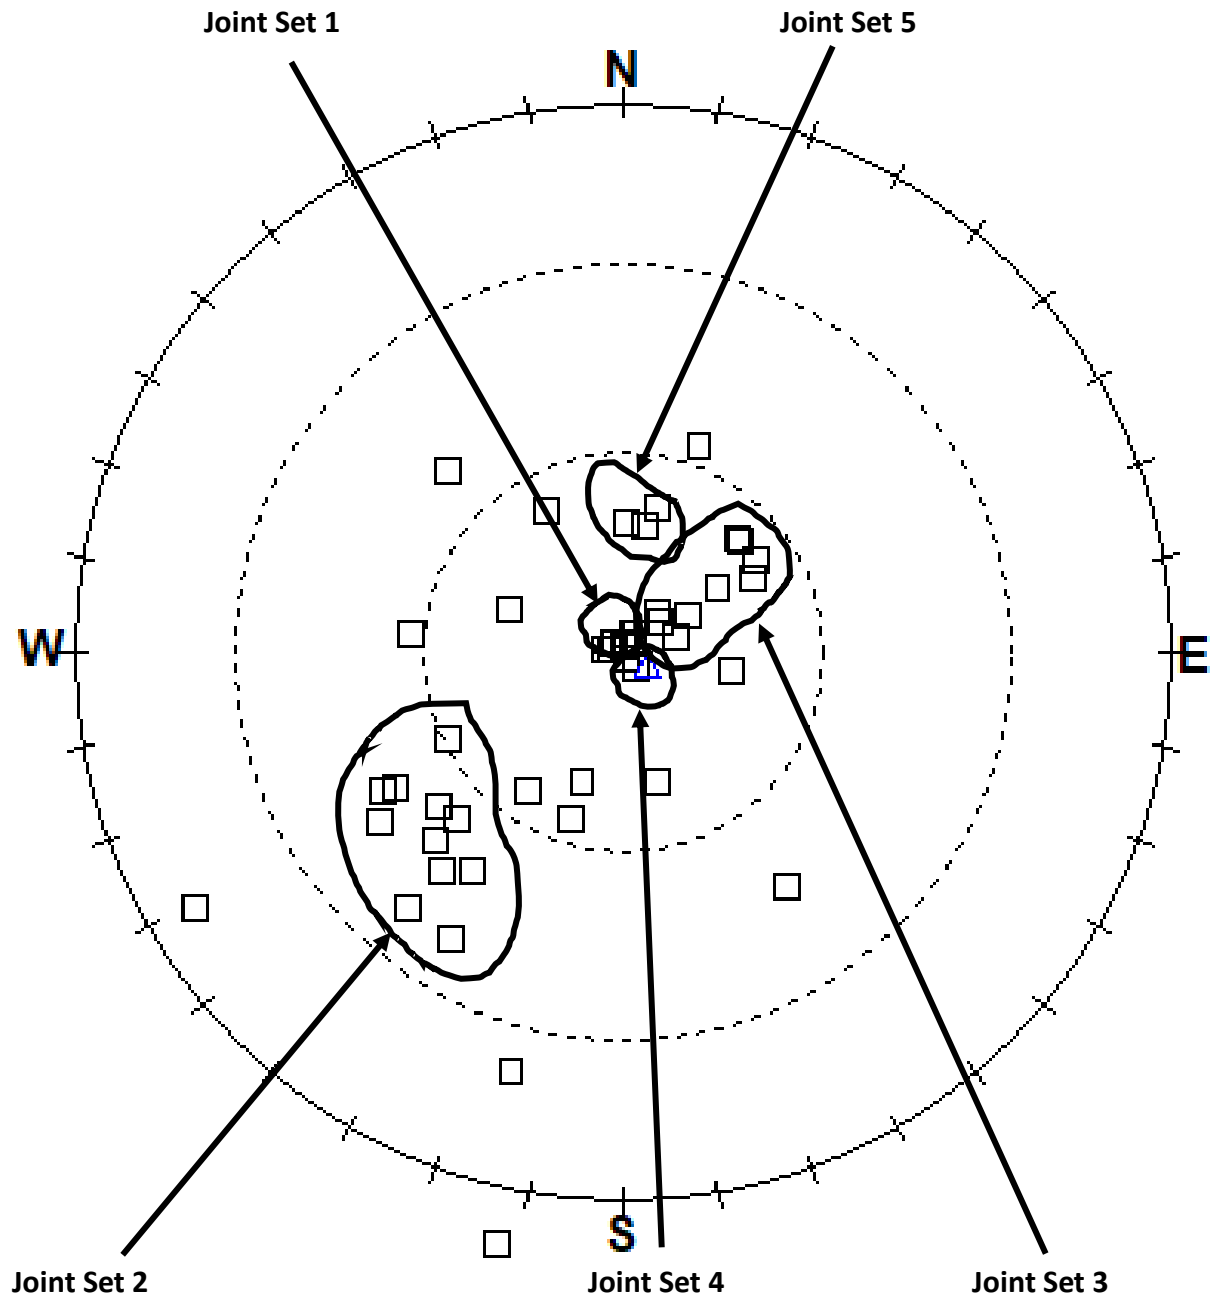
**Figure 4- Stereonet Plot – 2008 and 2021 Data
Private and BLM Areas**

No large-scale random joints with a low strength such as from historic sliding, weathering, or clay infilling were observed by during the 2021 investigation, or reported by LHI, and J. A. LHI's data on joint orientation and characteristics are consistent with the July, 2021 measurements and observations of joints in the active granite quarry area and on the BLM expansion area. The correlation between the July, 2021 data and that reported by Cesare and LHI is demonstrated by the Stereonet plots from the 2008 analysis (Figures 2A and 2B) versus Stereonet plots of data collected in July 2021 (Figures 3A, 3B, and 3C), and a Stereonet plot of the combined 2008 and 2021 date (Figure 4). Two main joint set orientations show up in each of the three (Martin Marietta, LHI, and Cesare) data sets. Three other joint sets were observed in two of the three data sets. The joint set orientations from each data set and the interpreted average orientation for each joint set are shown in Table 1. The Table I data summarizes the five interpreted major joint orientations present on the site based on evaluation of the individual mapped joints, each of which is represented by one of the poles shown on figures 2A through 4. The poles representing the individual joints making up each joint set and the interpreted joint set are shown on Figure 4.

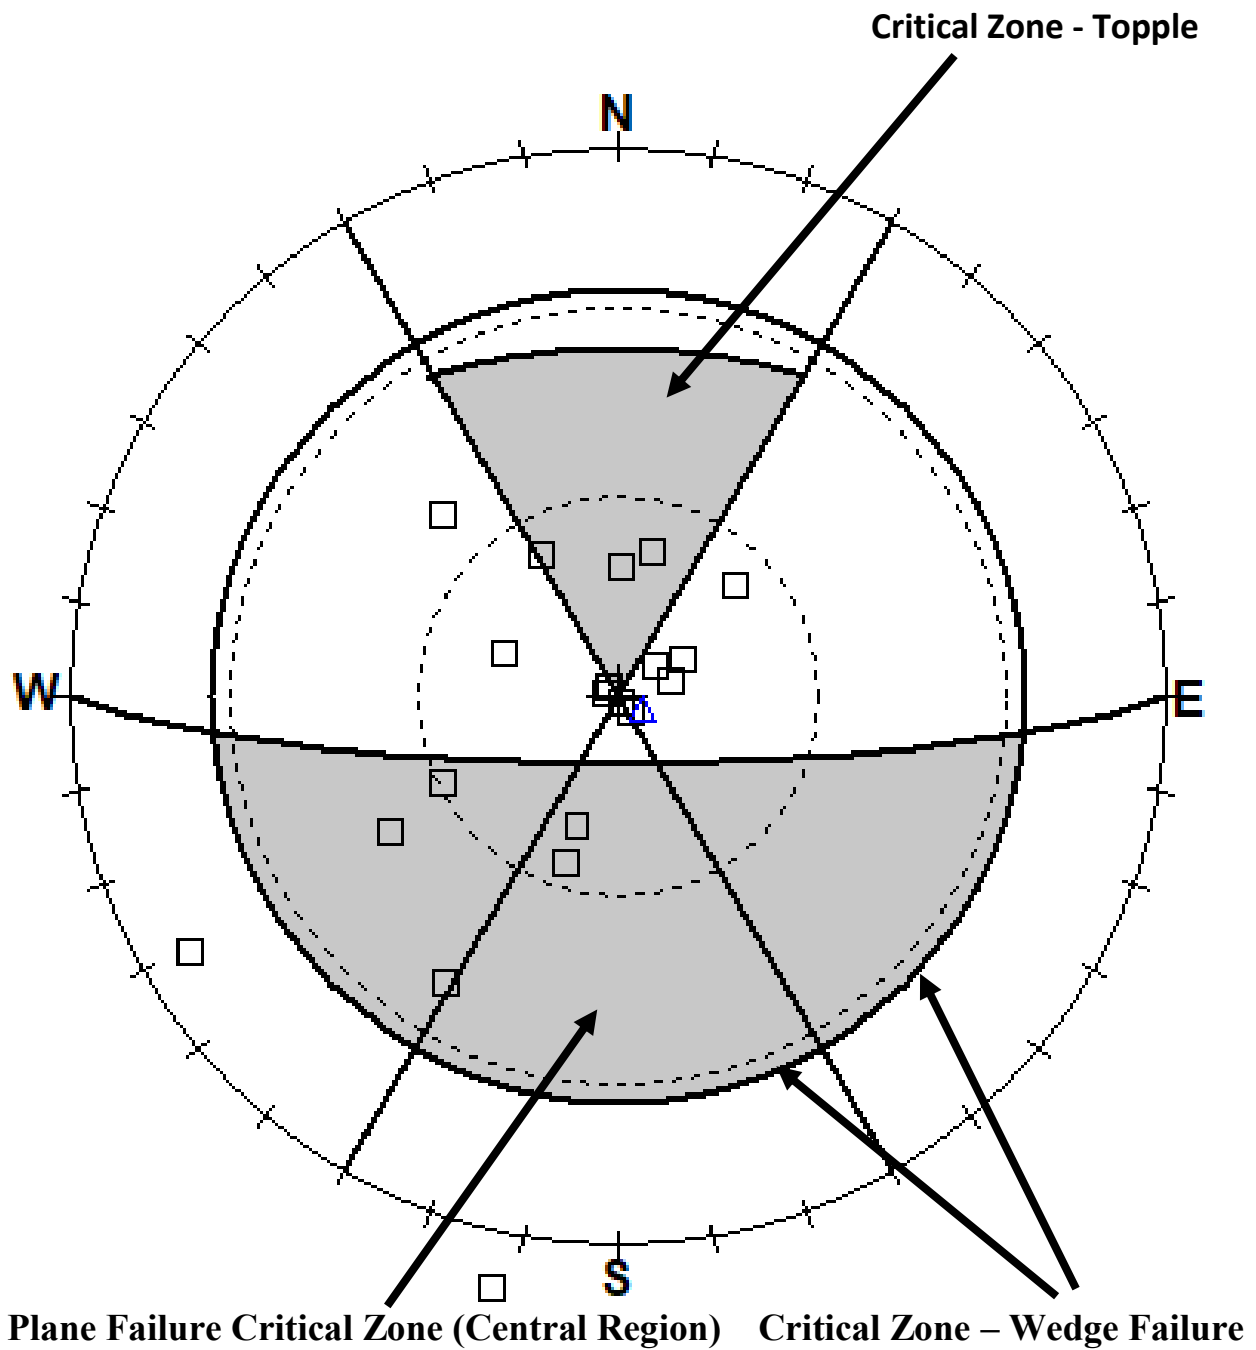
**Figure 5 - Stereonet Plot – North Highwall
Granite Quarry - Private Land (N-P)**
Front Range Aggregates, LLC
Parkdale Quarry

The current and proposed mining and reclamation rock slopes were analyzed using the RockPack III computer program. RockPack III uses the stability analysis methodology developed by Hoek and Brown, 1997, as modified in 1988, and was designed to analyze the slope stability of a rock slope subjected to several critical situations that may occur during the life of the slope. The program uses stereonet plots to evaluate the joint orientations likely to result in rock slope failure along joint plans, either as wedge failures, topple failures, or sliding failures. Once discontinuities having unfavorable orientations are identified, safety factors against translational sliding may be determined by calculating the ratio of resisting forces to driving forces along discontinuities. A detailed explanation of the use of stereonets for failure analysis and factor of safety analysis is presented in the appended RockPack III user's Manual. The critical zones indicating the potential failure mechanisms are shaded in gray in Figures 5 through 26 and explained on Figure 5. The Table I data summarizes the five interpreted major joint orientations

Potential failure mechanisms for active mining bench slopes were analyzed as shown in the stereonet plots of jointing verses mining slope orientations for each of the final mining slope orientations (Figures 5, 7, 9, 11, 13, 15, 17, 19, 21, 23, and 25). The 2021 analysis indicates that there is a low potential for toppling and sliding of slivers associated with vertical and sub-vertical jointing on mining highwalls. The analysis does indicate that there is the potential for sliding of blocks, slabs, and wedges associated with non-vertical random jointing on mining highwalls in situations where the potential slide angle is steeper than the joint friction angle, which based on joint properties is assumed to be 45 degrees. Where quarry walls are steeper,

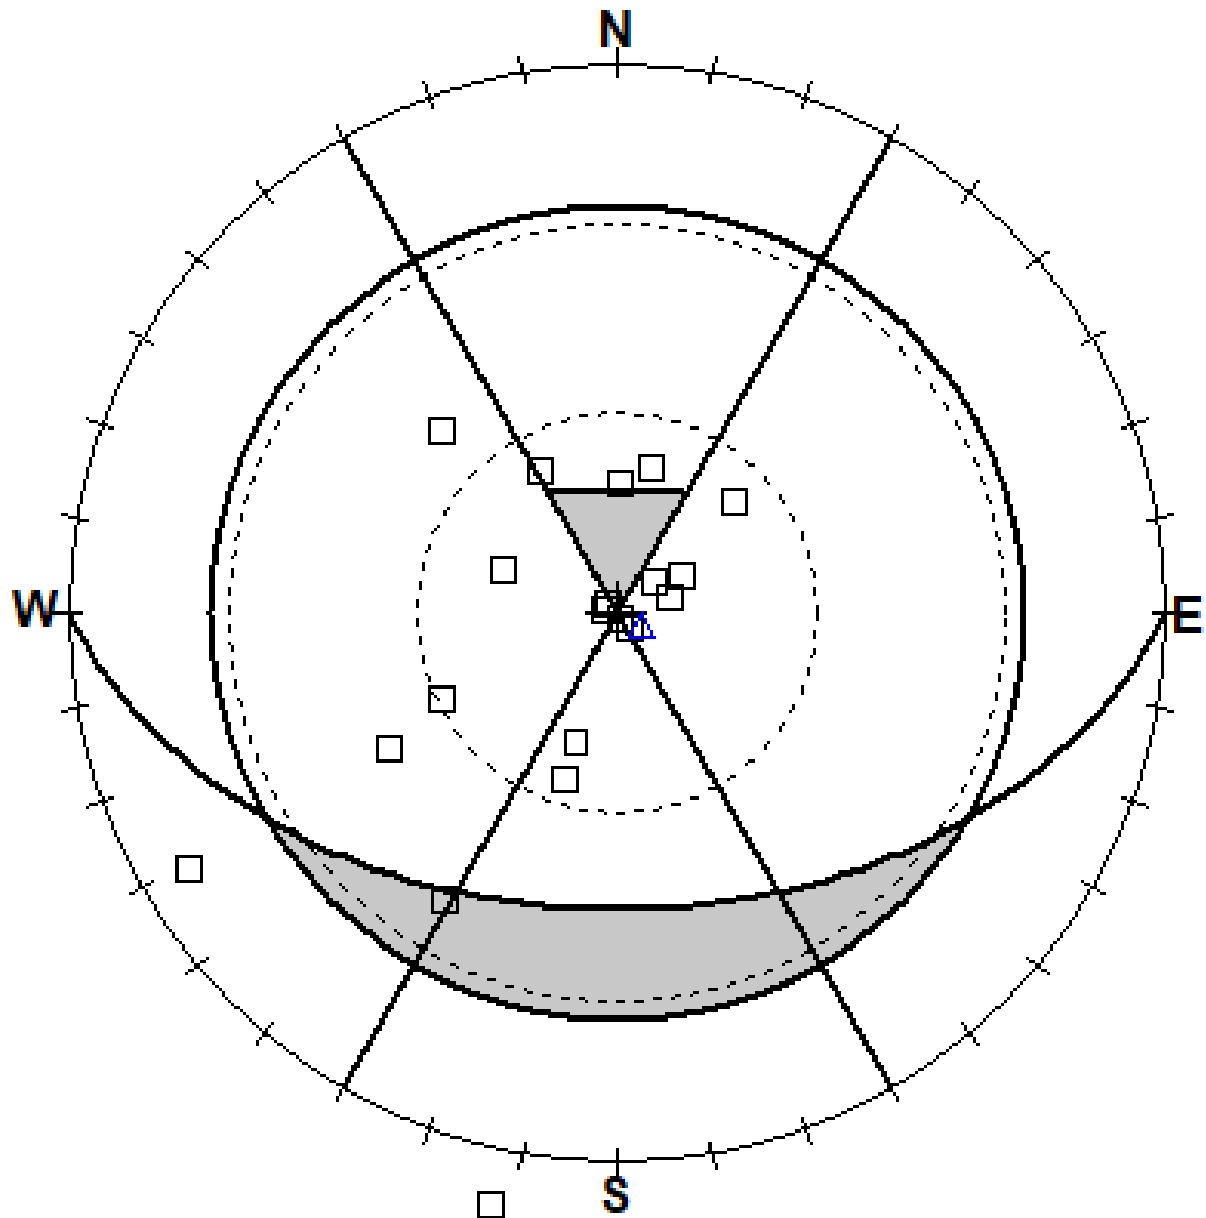
**Figure 6 - Stereonet Plot – North Reclamation Slope
Granite Quarry - Private Land (N-P)**
Front Range Aggregates, LLC
Parkdale Quarry
Fremont County, Colorado
DRMS Mining Permit M1997-054

As seen in stereonet plots of jointing verses reclamation slope orientations for each of the final reclamation slopes (Figures 6, 8, 10, 12, 14, 16, 18, 20, 22, 24, and 26), only three joints intercepted the critical zone for wedge or planar failures in any orientation, therefore large-scale wedge and planar failures are unlikely to occur. Some joints did intercept the critical zone for topple failure, but if they occurred, topple failures would be localized for the reasons stated above. Based on current information there is no reason to believe that there would be a significant risk for large scale failures of rock slopes.

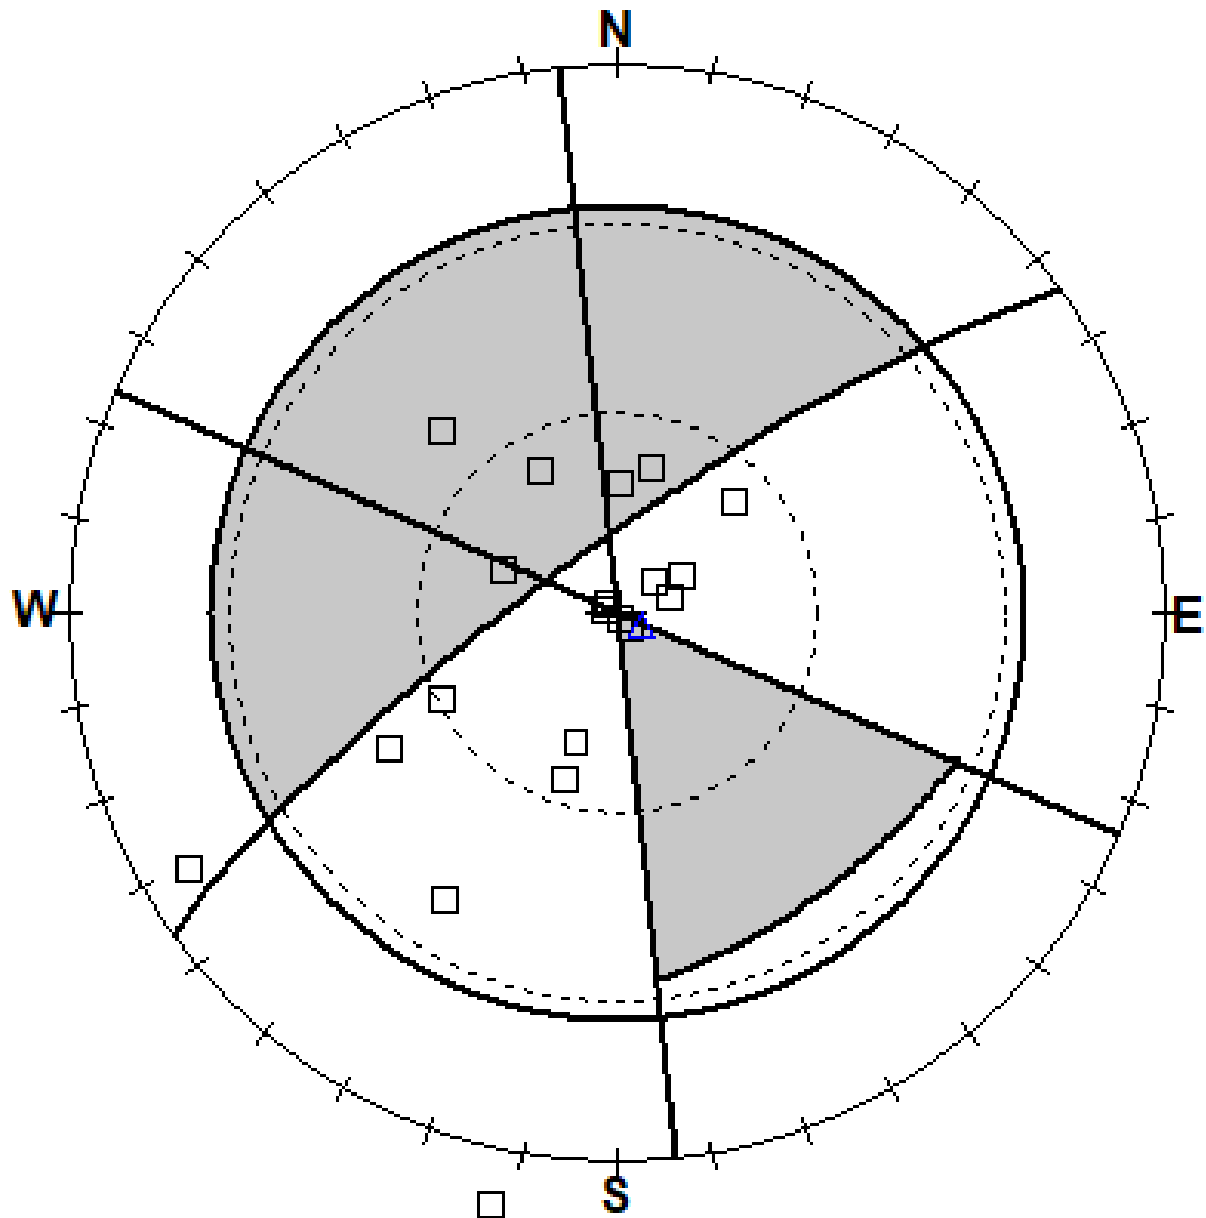
**Figure 7 - Stereonet Plot – Southeast Highwall
Granite Quarry - Private Land (SE-P)**

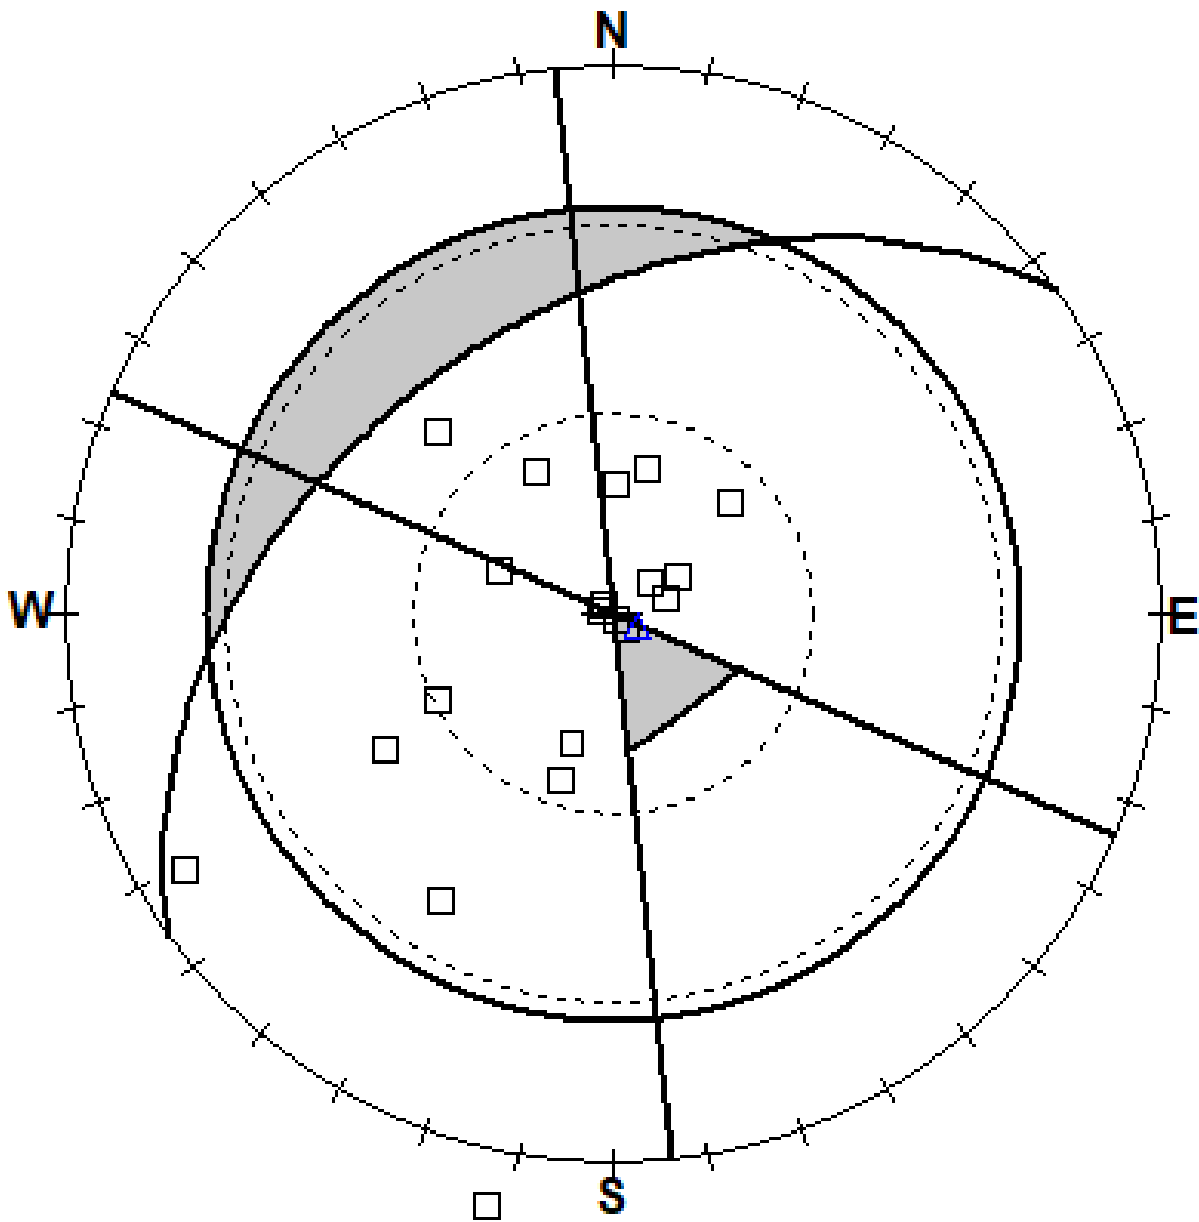
**Figure 8 - Stereonet Plot – Southeast Reclamation Slope
Granite Quarry - Private Land (SE-P)**

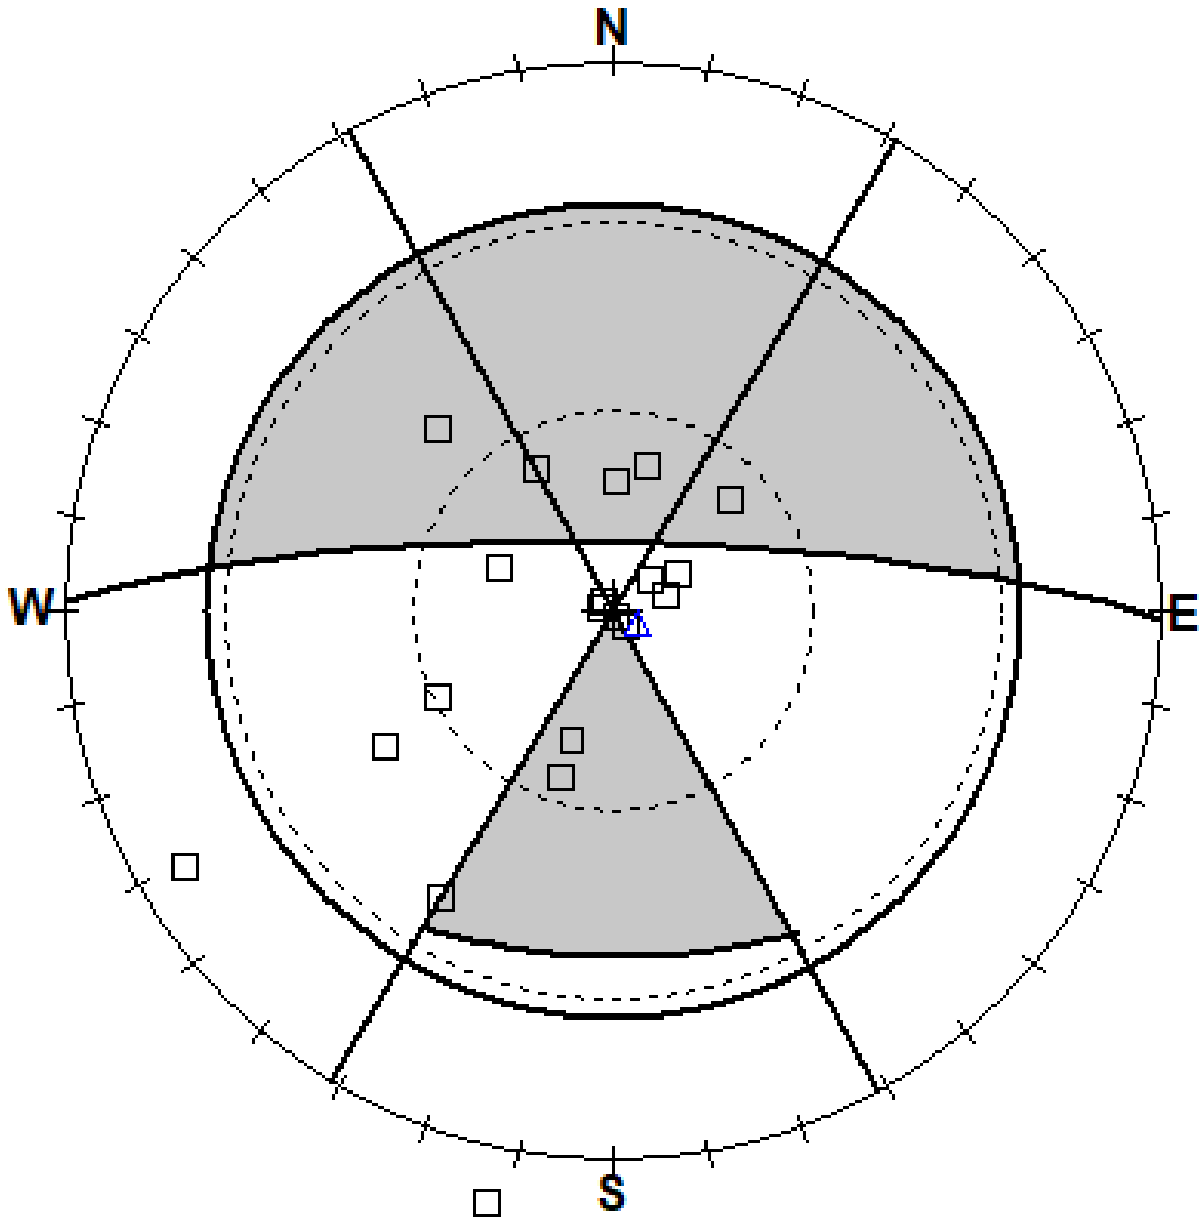
**Figure 9 - Stereonet Plot – South Highwall
Granite Quarry - Private Land (S-P)**
Front Range Aggregates, LLC
Parkdale Quarry
Fremont County, Colorado
DRMS Mining Permit M1997-054

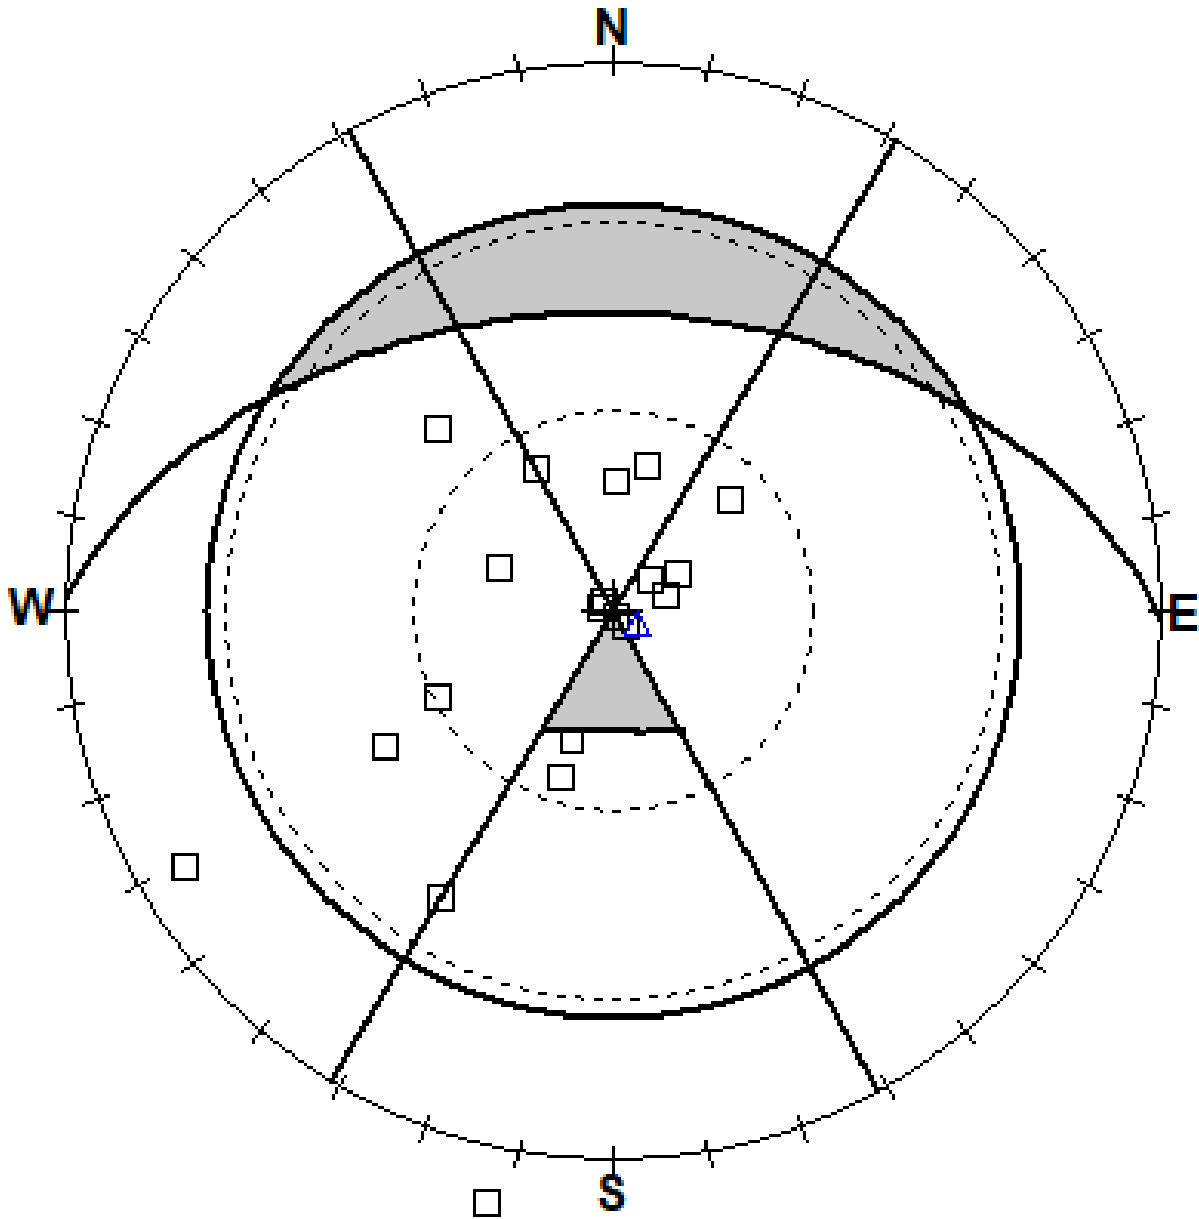
**Figure 10 - Stereonet Plot – South Reclamation Slope
Granite Quarry - Private Land (S-P)**
Front Range Aggregates, LLC
Parkdale Quarry
Fremont County, Colorado
DRMS Mining Permit M1997-054

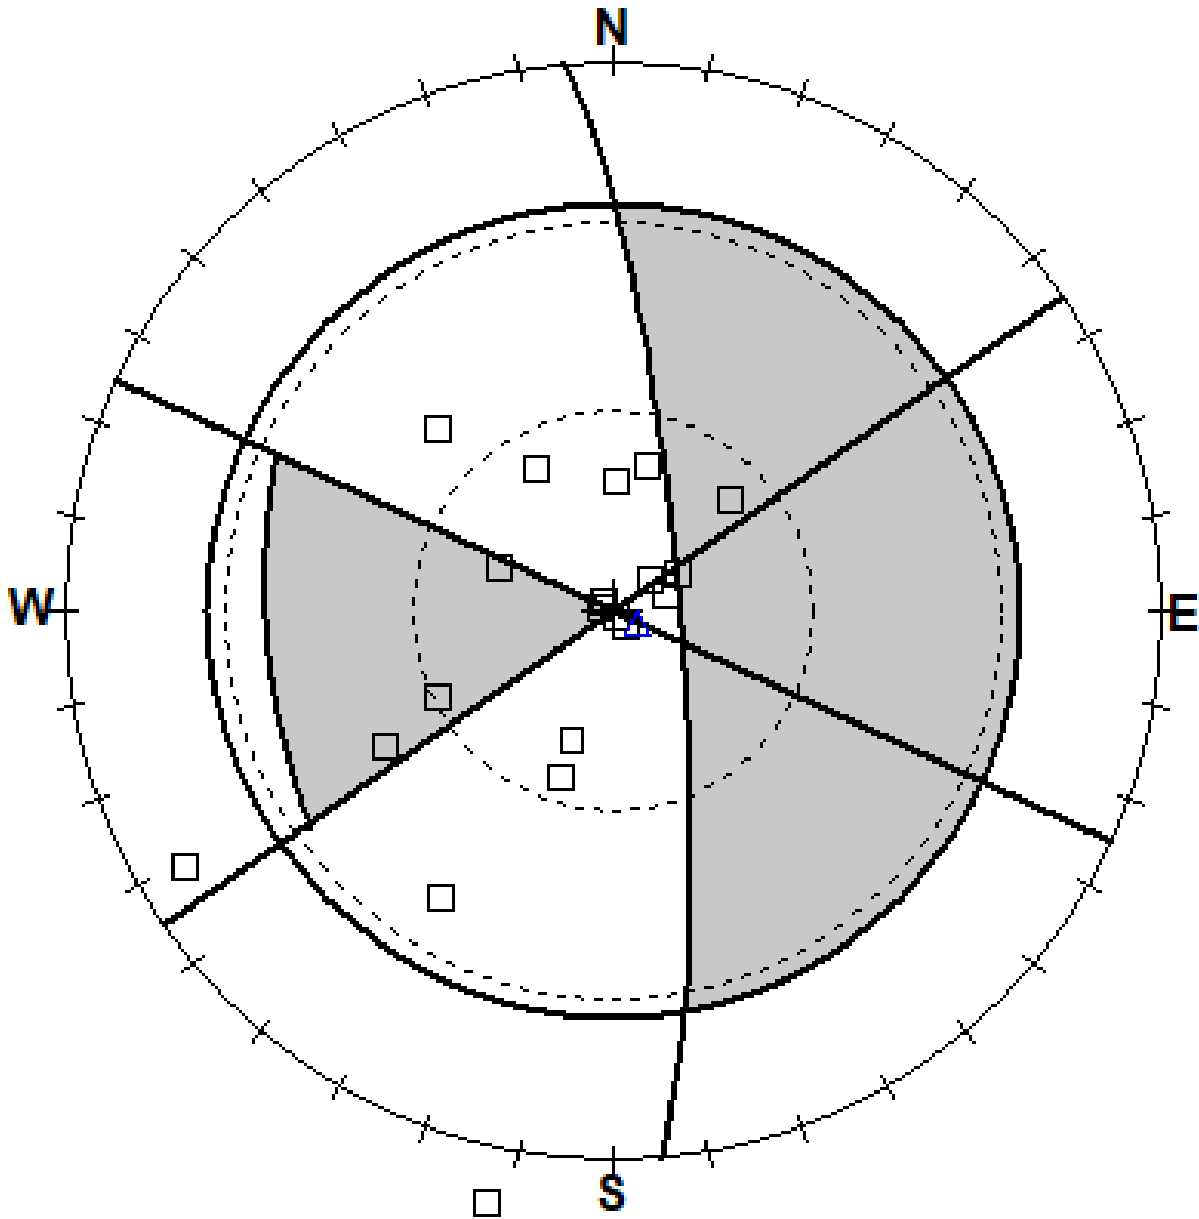
**Figure 11 - Stereonet Plot – West Highwall
Granite Quarry - Private Land (W-P)**
Front Range Aggregates, LLC
Parkdale Quarry
Fremont County, Colorado
DRMS Mining Permit M1997-054

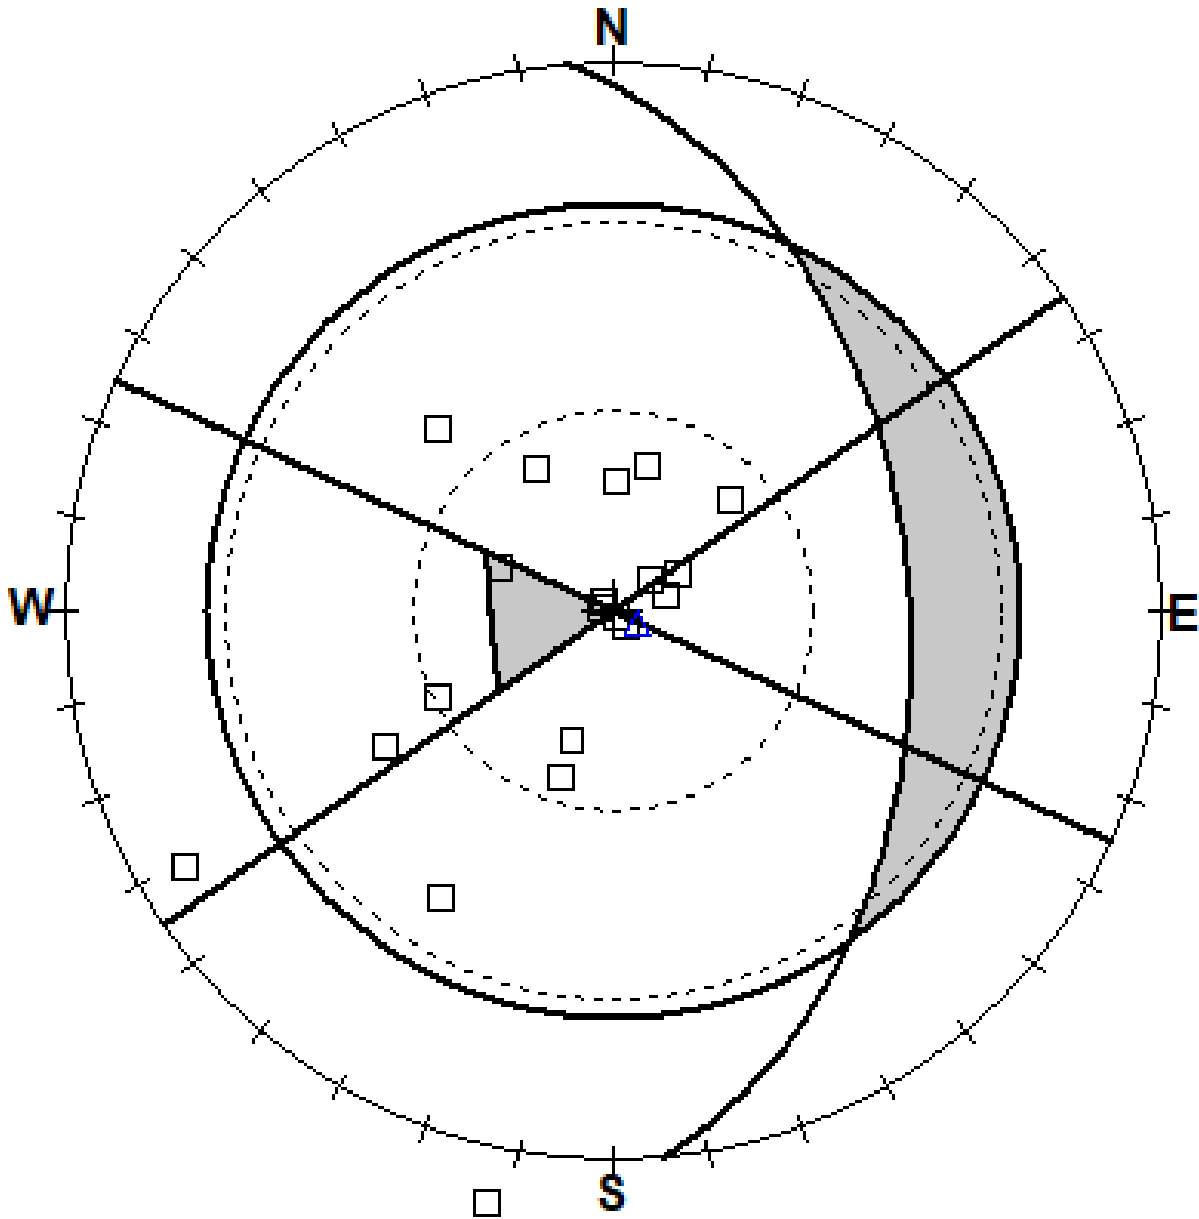
**Figure 12 - Stereonet Plot – West Reclamation Slope
Granite Quarry - Private Land (W-P)**

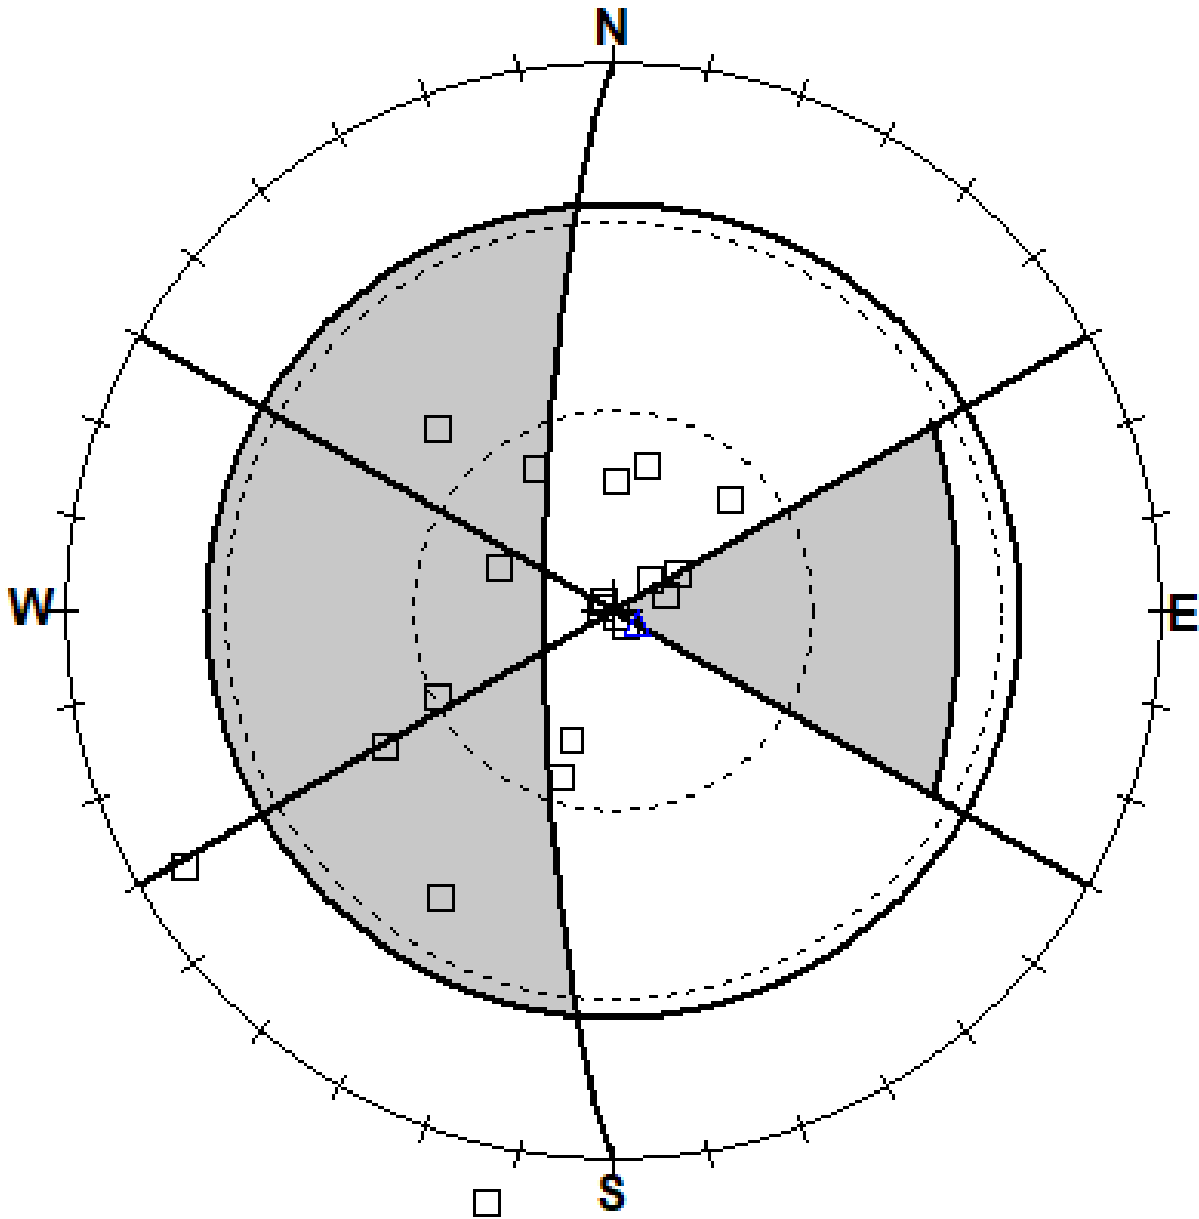
**Figure 13 - Stereonet Plot – East Highwall
Granite Quarry - BLM Area (E-BLM)**
Front Range Aggregates, LLC
Parkdale Quarry
Fremont County, Colorado
DRMS Mining Permit M1997-054
