M-1997-054 / Parkdale Quarry AM-2 Revised Geotechnical Stability Exhibit

RULE 6.5 GEOTECHNICAL STABILITY EXHIBIT
FRONT RANGE AGGREGATES
PARKDALE QUARRY
FREMONT COUNTY, COLORADO

Prepared by David W. Bieber, PG, PGP, CEG, CHG
Martin Marietta Manager of Geology/Survey

December 21, 2021

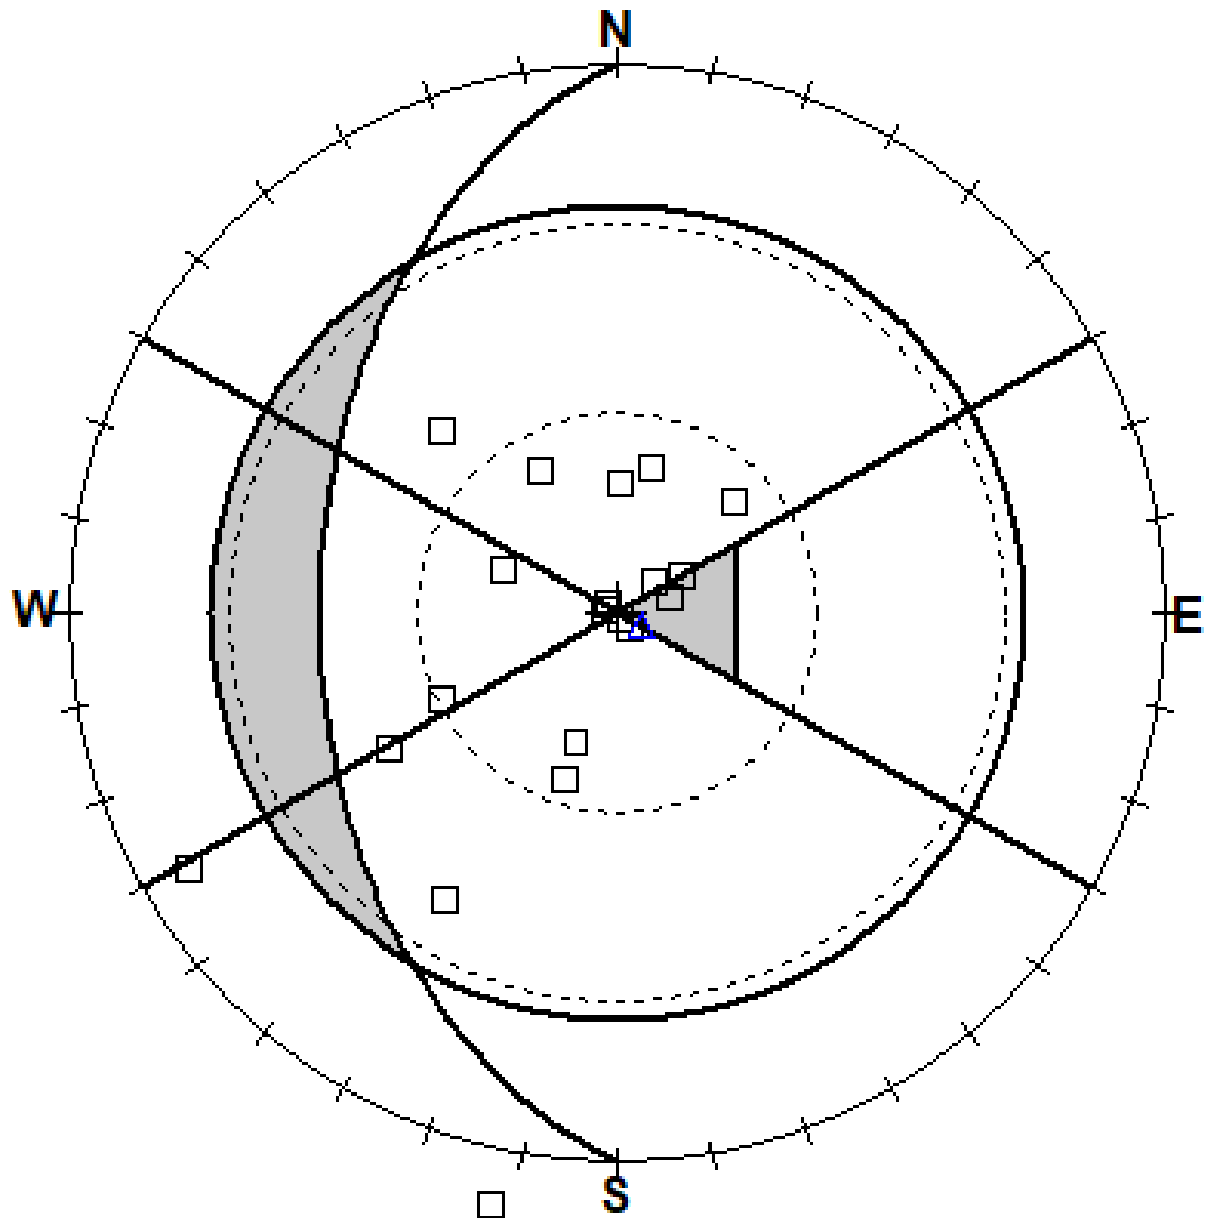
**Figure 14 - Stereonet Plot – East Reclamation Slope
Granite Quarry - BLM Area (E-BLM)**
Front Range Aggregates, LLC
Parkdale Quarry
Fremont County, Colorado
DRMS Mining Permit M1997-054

As seen in stereonet plots of jointing verses reclamation slope orientations for each of the final reclamation slopes (Figures 6, 8, 10, 12, 14, 16, 18, 20, 22, 24, and 26), only three joints intercepted the critical zone for wedge or planar failures in any orientation, therefore large-scale wedge and planar failures are unlikely to occur. Some joints did intercept the critical zone for topple failure, but if they occurred, topple failures would be localized for the reasons stated above. Based on current information there is no reason to believe that there would be a significant risk for large scale failures of rock slopes.

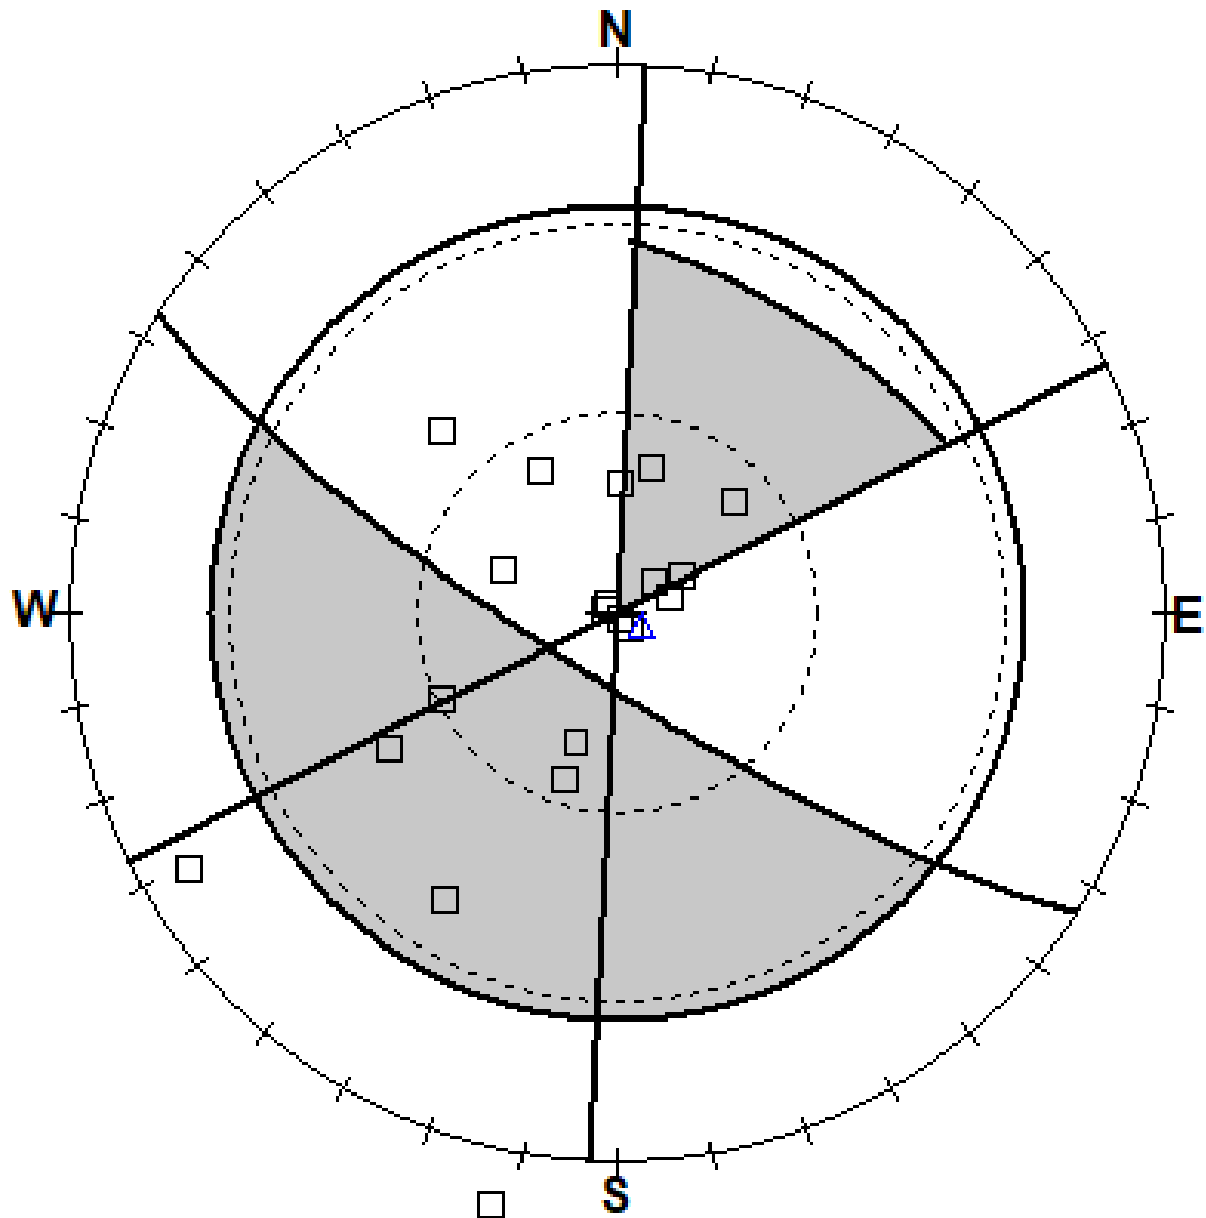
**Figure 15 - Stereonet Plot – Northeast Highwall
Granite Quarry - BLM Area (NE-BLM)**

Potential failure mechanisms for active mining bench slopes were analyzed as shown in the stereonet plots of jointing verses mining slope orientations for each of the final mining slope orientations (Figures 5, 7, 9, 11, 13, 15, 17, 19, 21, 23, and 25). The 2021 analysis indicates that there is a low potential for toppling and sliding of slivers associated with vertical and sub-vertical jointing on mining highwalls. The analysis does indicate that there is the potential for sliding of blocks, slabs, and wedges associated with non-vertical random jointing on mining highwalls in situations where the potential slide angle is steeper than the joint friction angle, which based on joint properties is assumed to be 45 degrees. Where quarry walls are steeper,

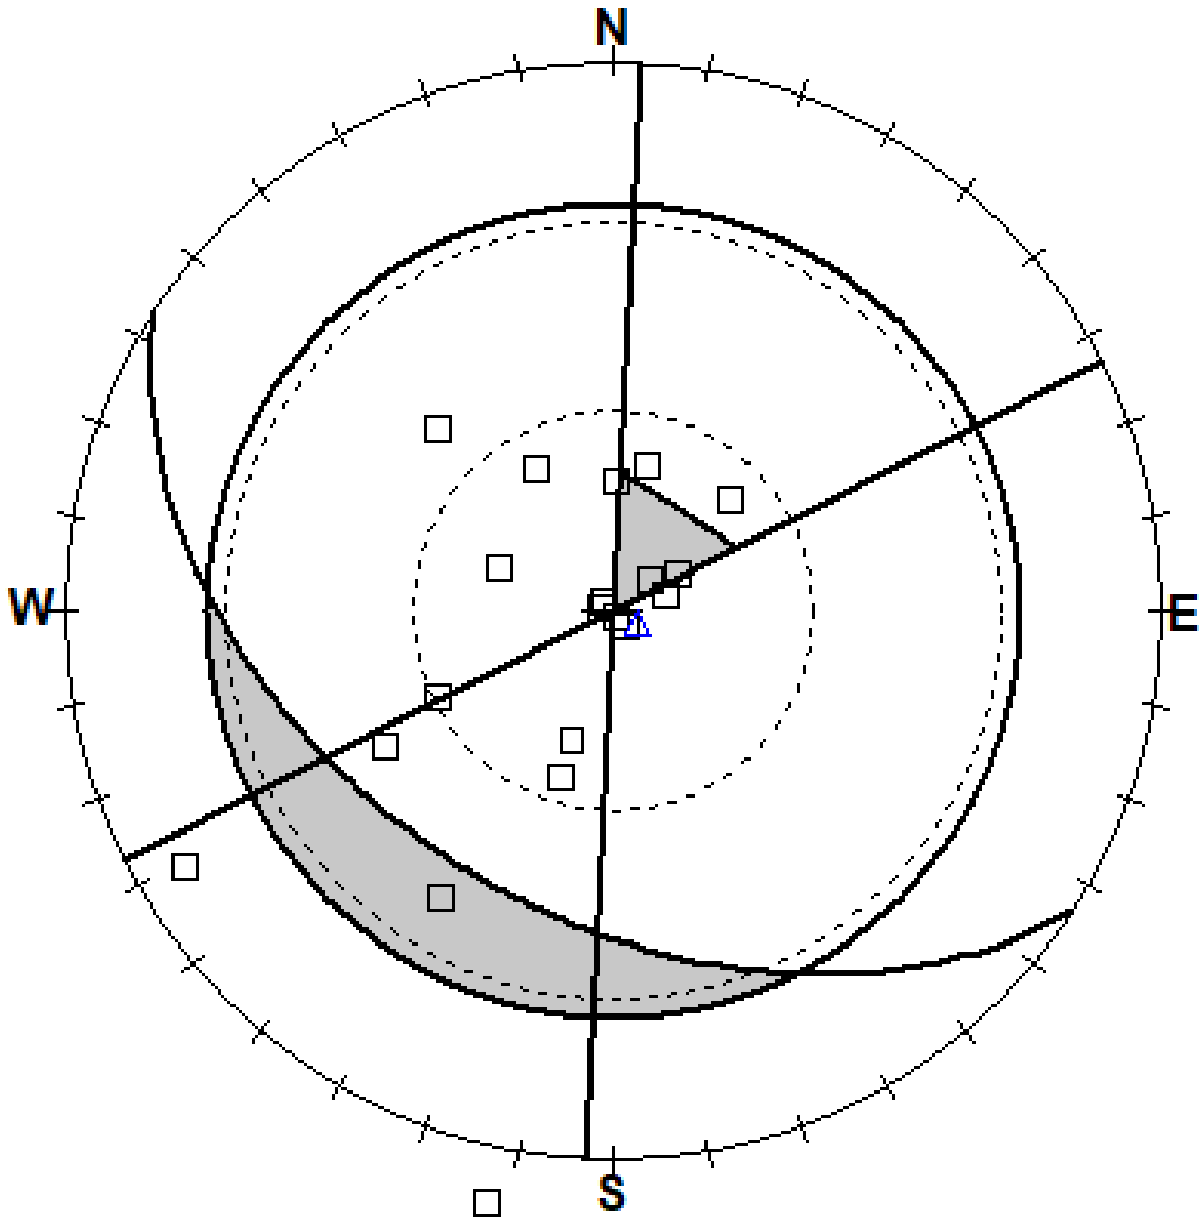
**Figure 16 - Stereonet Plot – Northeast Reclamation Slope
Granite Quarry - BLM Area (NE-BLM)**

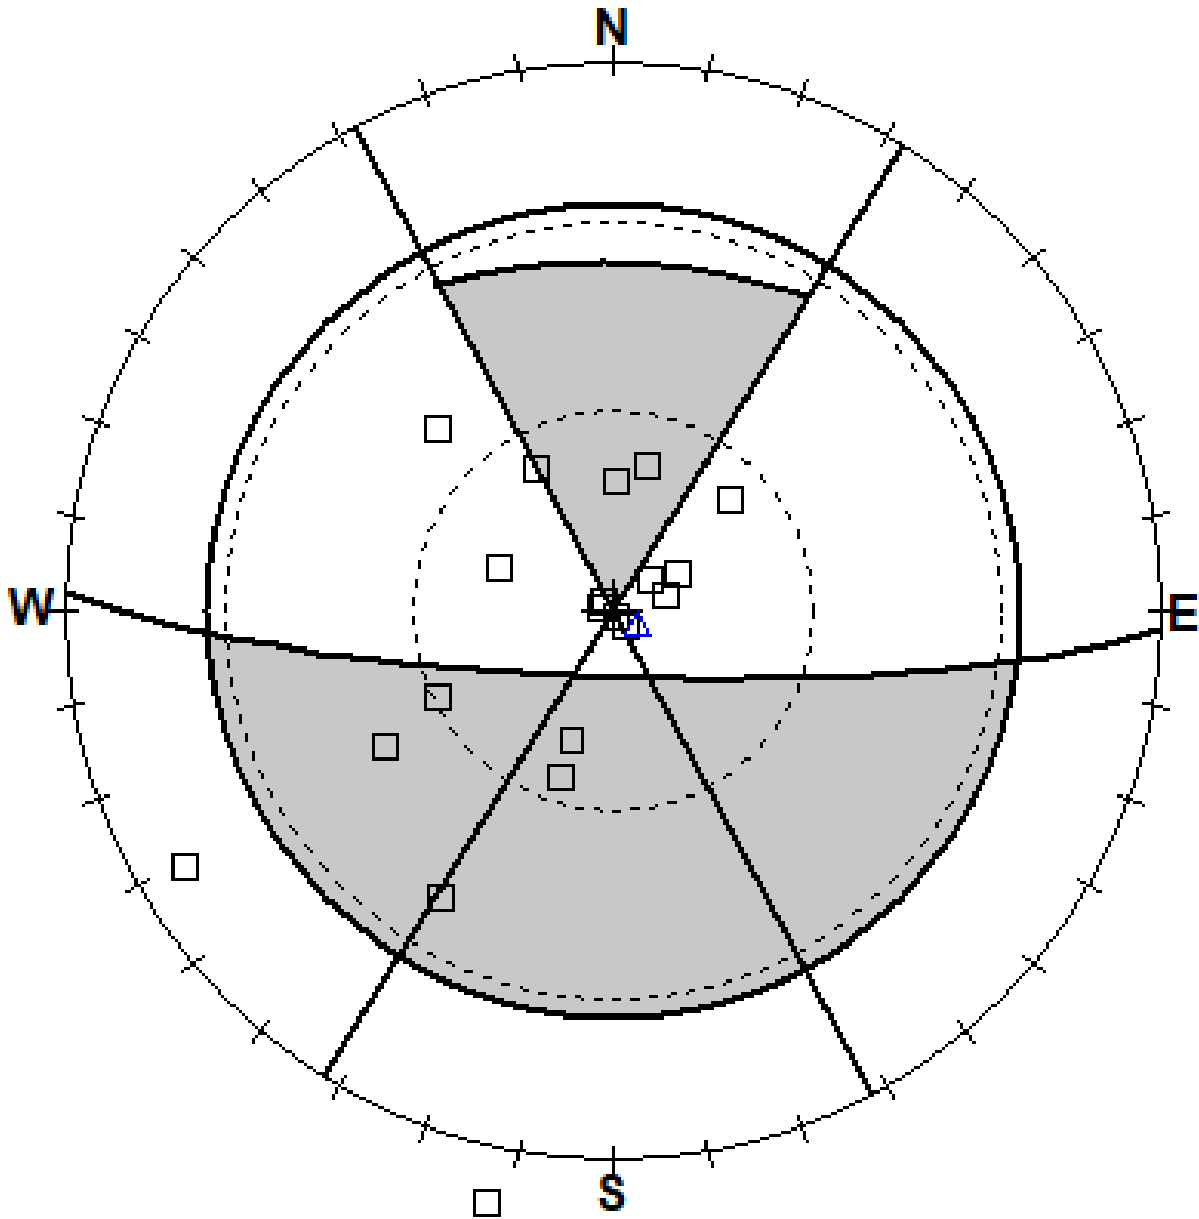
**Figure 17 - Stereonet Plot – North Highwall
Granite Quarry - BLM Area (N-BLM)**
Front Range Aggregates, LLC
Parkdale Quarry
Fremont County, Colorado
DRMS Mining Permit M1997-054

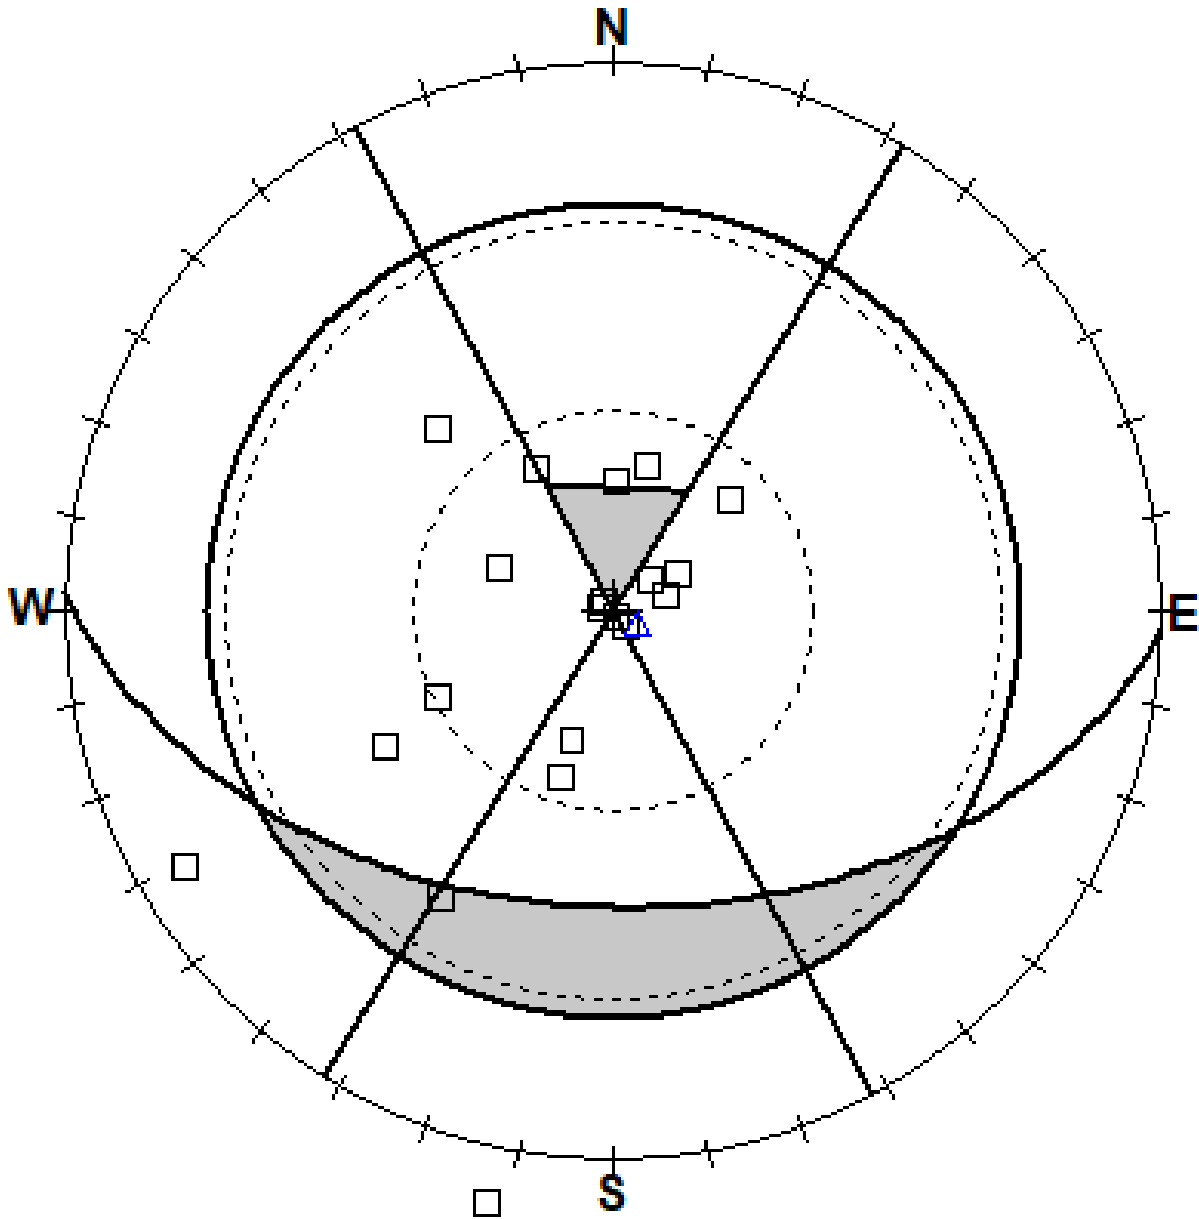
**Figure 18 - Stereonet Plot – North Reclamation Slope
Granite Quarry - BLM Area (N-BLM)**

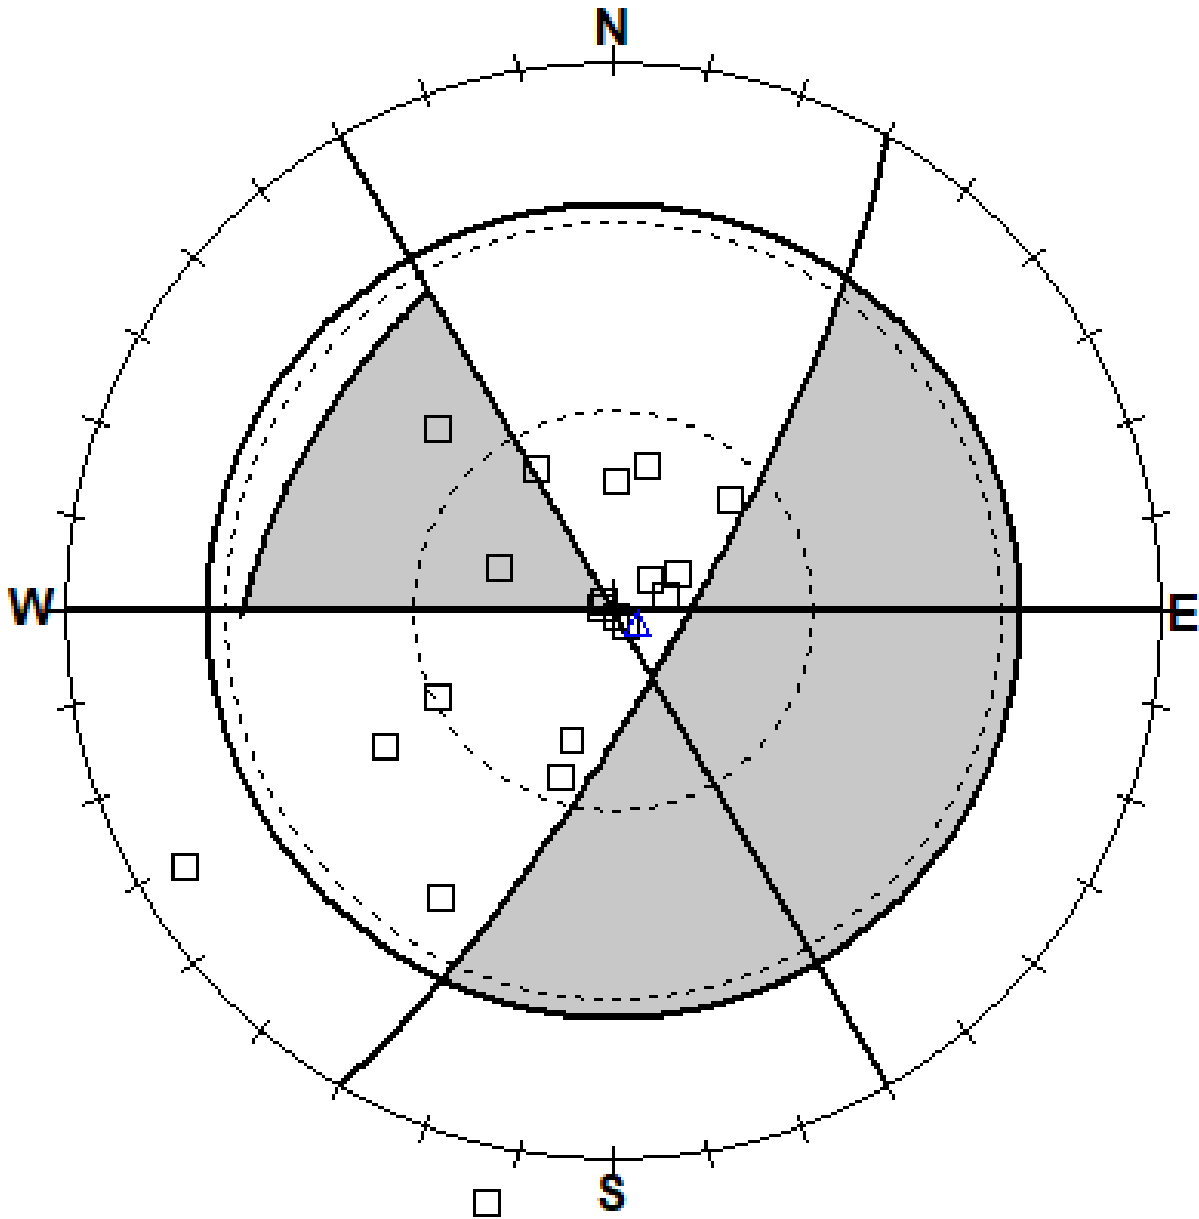
**Figure 19 - Stereonet Plot – Northwest Highwall
Granite Quarry - BLM Area (NW-BLM)**

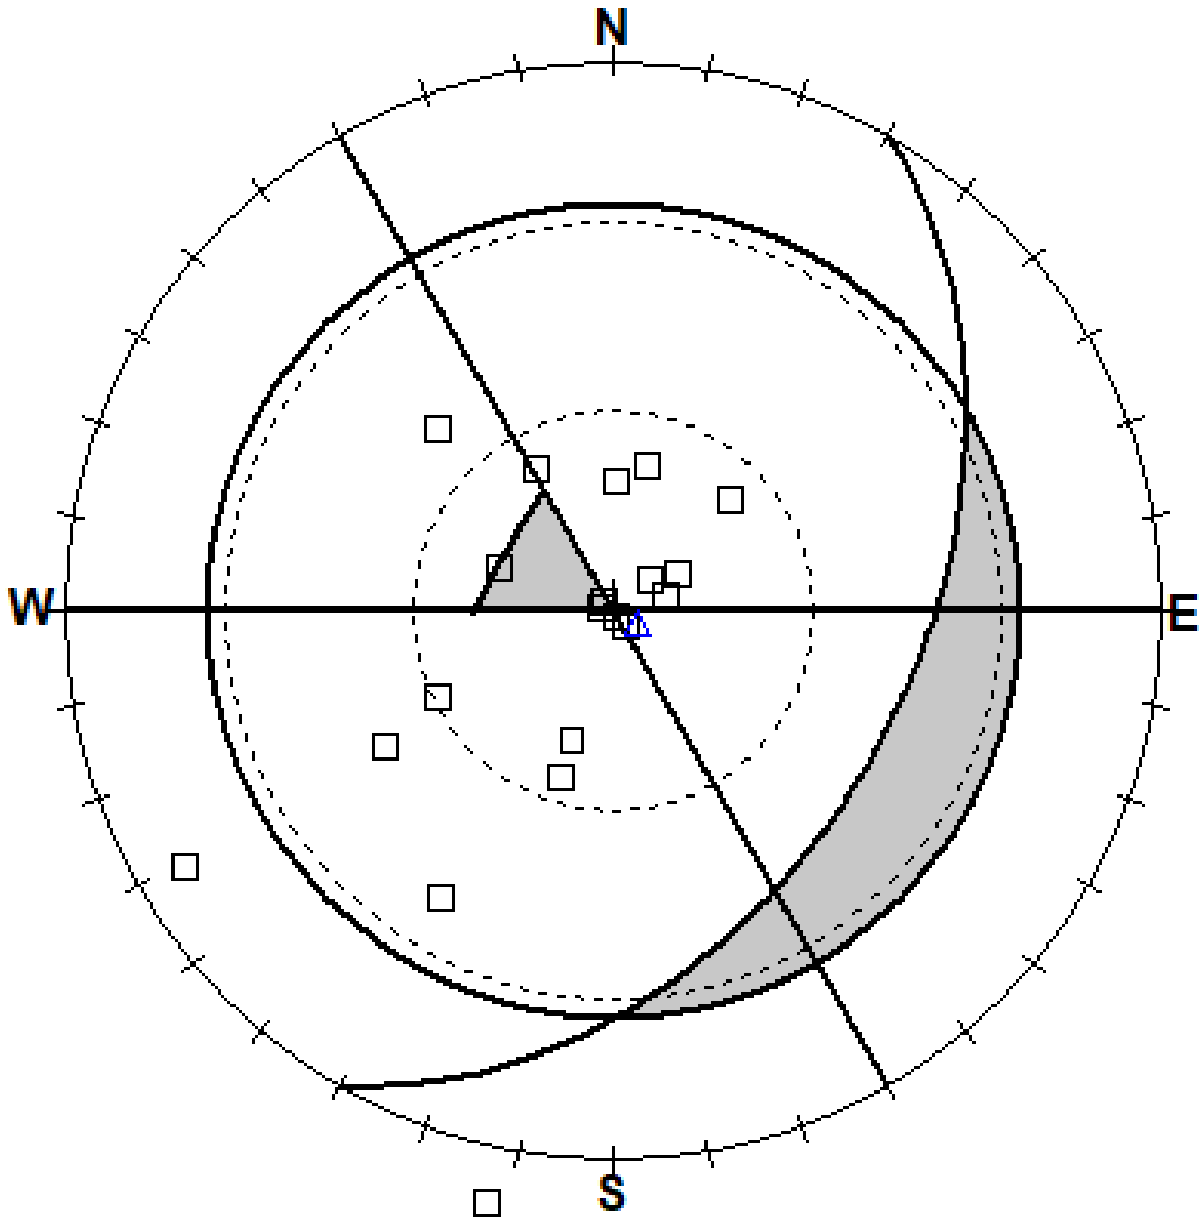
**Figure 20 - Stereonet Plot – Northwest Reclamation Slope
Granite Quarry - BLM Area (NW-BLM)**

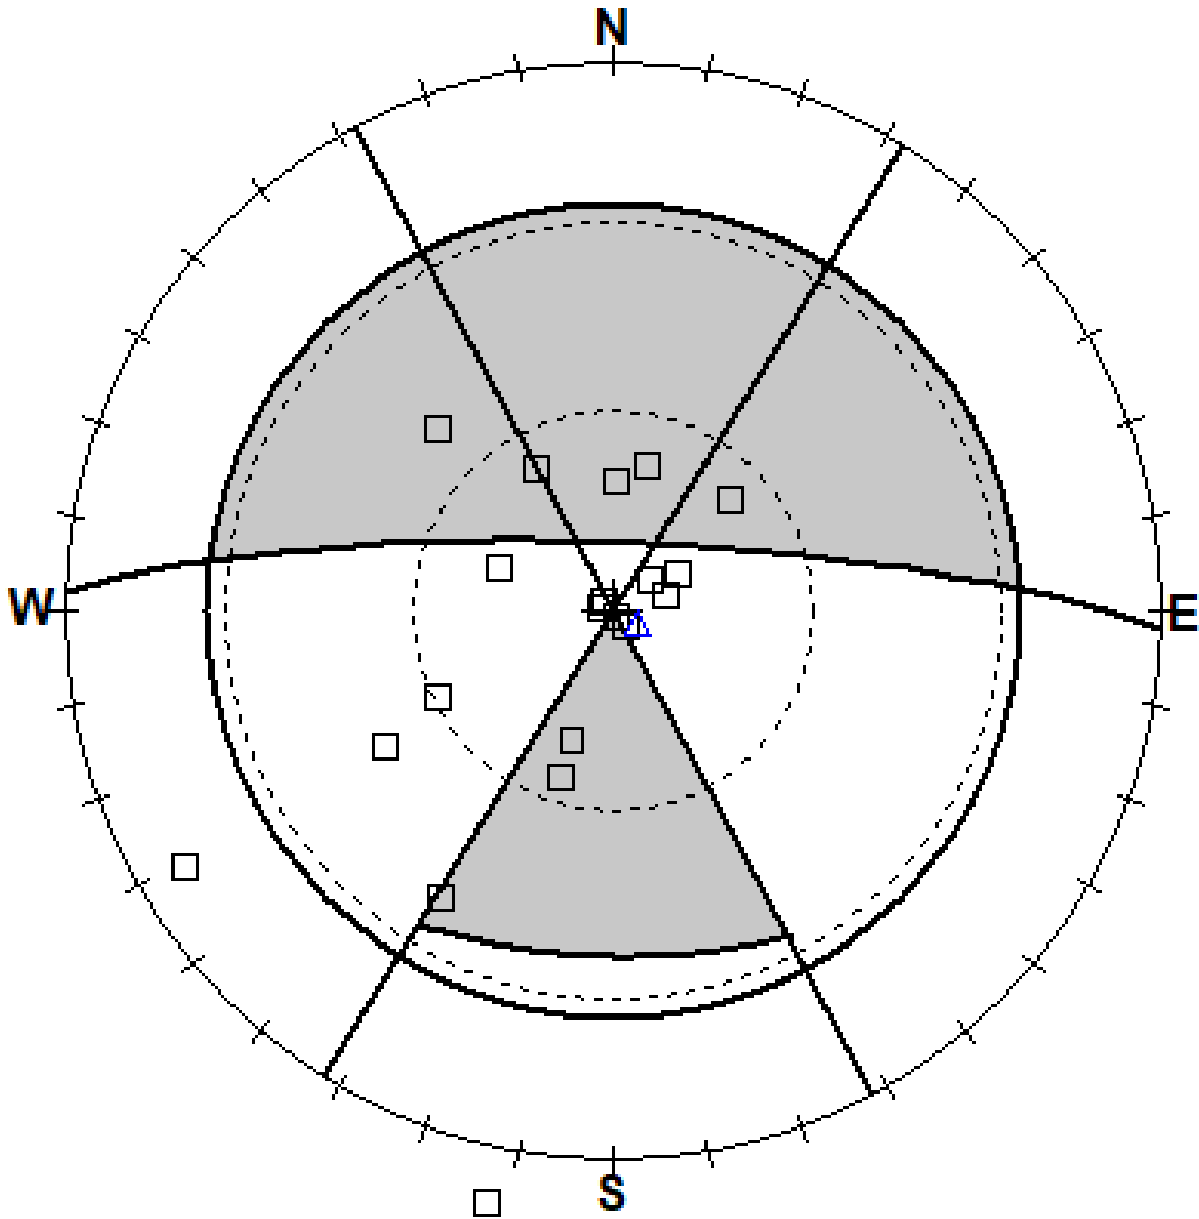
**Figure 21 - Stereonet Plot – South-central Highwall
Granite Quarry - BLM Area (SC-BLM)**

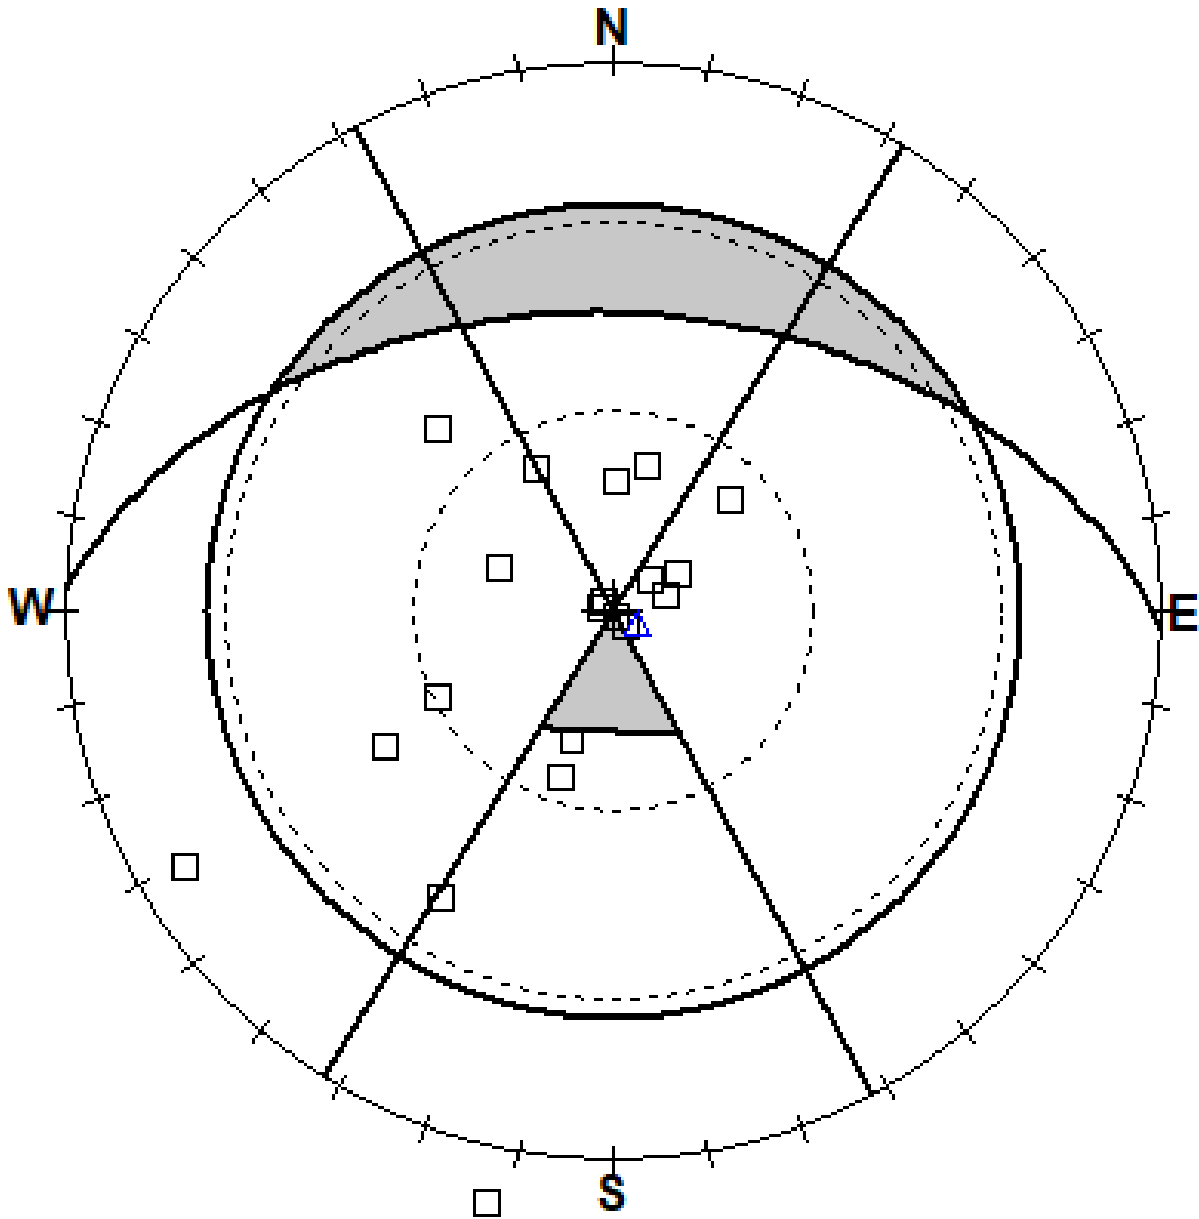
**Figure 22 - Stereonet Plot – South-central Reclamation Slope
Granite Quarry - BLM Area (SC-BLM)**

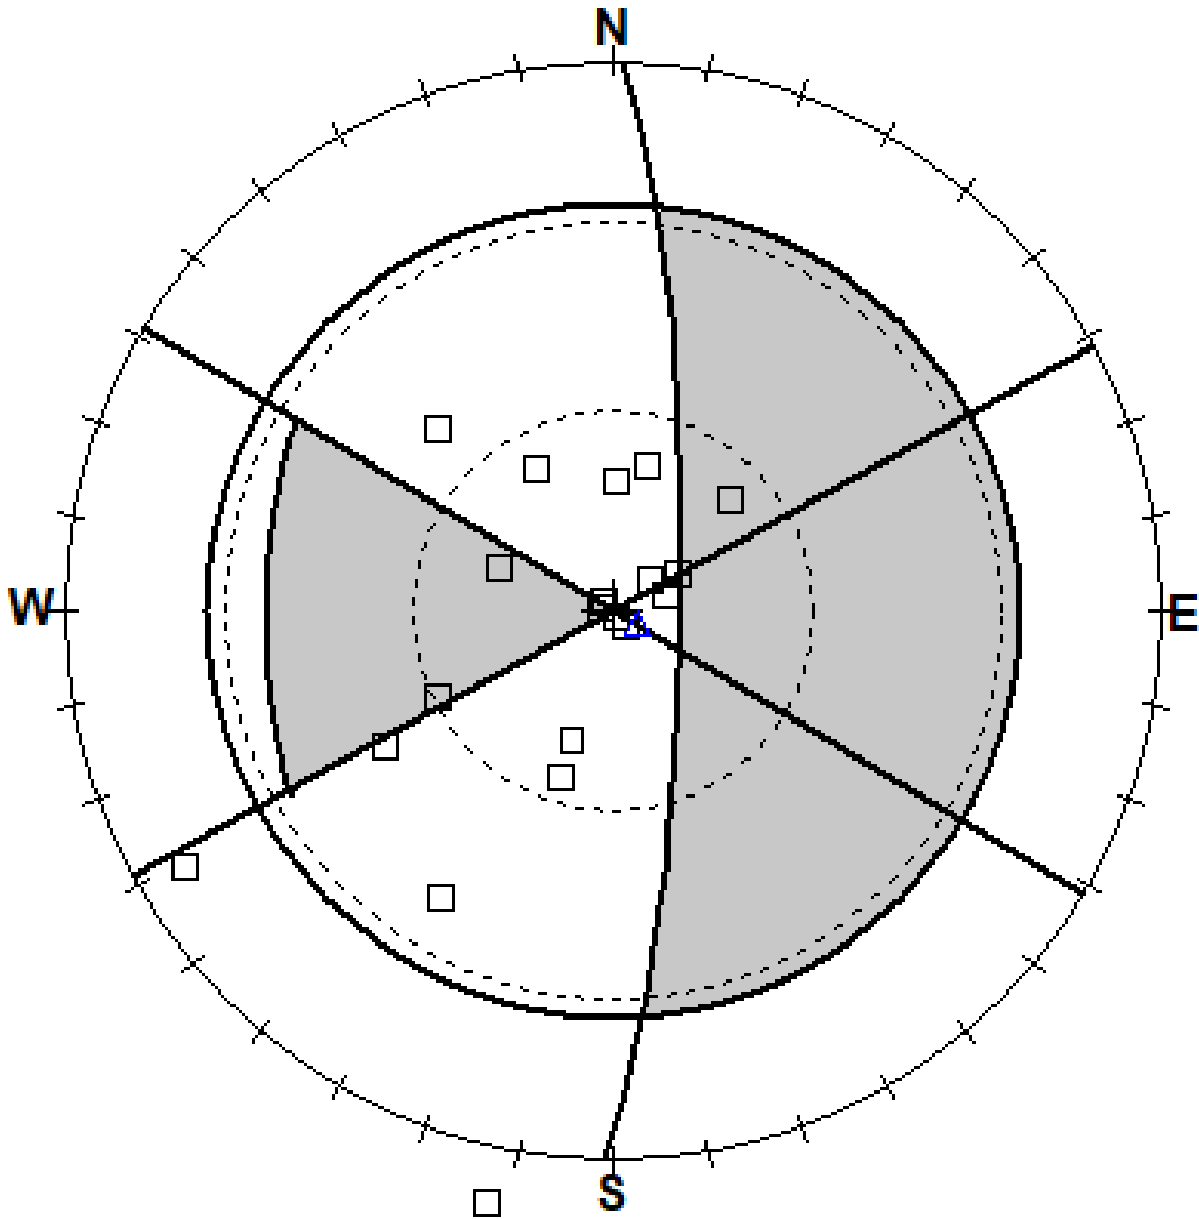
**Figure 23 - Stereonet Plot – Southwest Highwall
Granite Quarry - BLM Area (SW-BLM)**

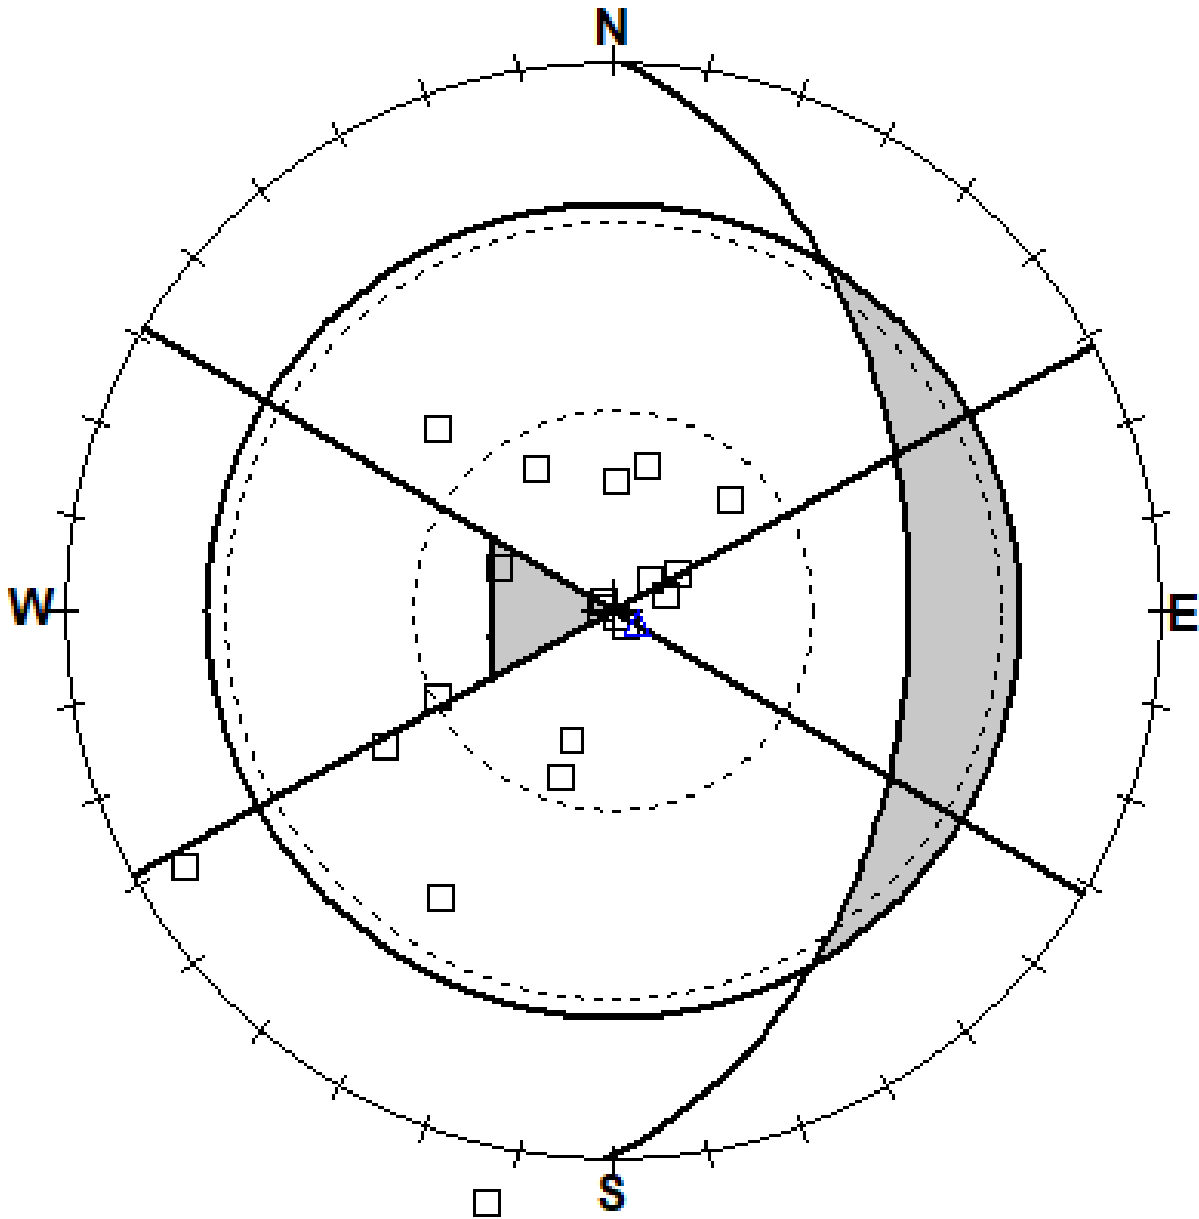
**Figure 24 - Stereonet Plot – Southwest Reclamation Slope
Granite Quarry - BLM Area (SW-BLM)**

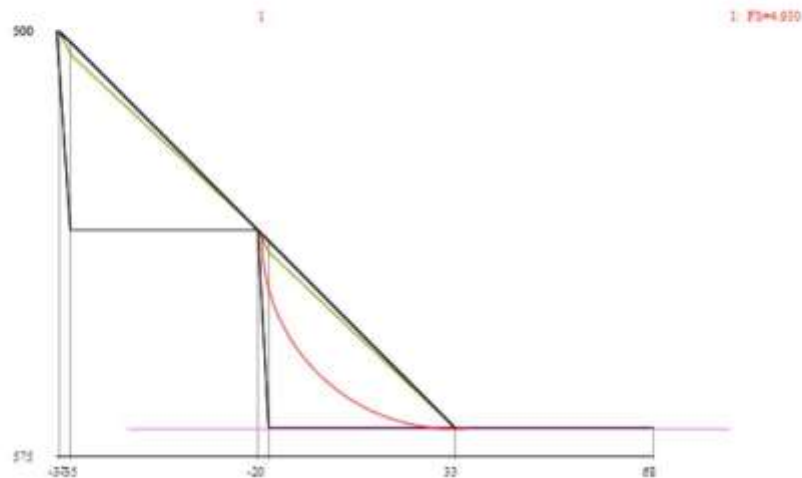
Method:	<input checked="" type="radio"/> Bishop Modified	<input type="radio"/> Ordinary Method of Slices
Seismic Coefficient:	.8 (unitless)	
Seismic Option:	<input checked="" type="radio"/> 1	<input type="radio"/> 2
*) optional

**Figure 27 - Reclamation Soil Fill Slope
Seismic Stability Failure Analysis Model**

Reclamation Slopes: Reclamation bench fill slopes were modeled assuming that a slope failure in a reclamation fill slope is constrained by mining benches in rock with a bench height of 35 feet, a bench face angle of 80 degrees, a horizontal bench width of approximately 30 feet, and a soil slope face angle of 45 degrees. As shown in Figure 27, the modeled failure plane assumed a worst-case scenario for a bench fill with failure initiated at the base of the fill and extending to the head of the fill. The calculated factor of safety for the seismic condition was found to be 4.930 indicating that reclamation slopes are stable. The slope was not modeled for the static condition since the seismic factor of safety exceeded 1.5. The finding that reclamation slopes are stable is consistent with four years of observation of fill slopes at the Parkdale Quarry and over 20 years of observation of similarly constructed fill slopes at the Martin Marietta Specification Aggregates Quarry in Golden, Colorado, where no stability-related failures of reclamation slopes have been observed though slopes are subject to accelerations in excess of 0.08g due to blasting on adjacent mining benches. To date, the failures observed on the existing reclamation slopes are generally caused by erosion. Rare raveling of saturated soils in areas generally less than 1,000 square feet have been observed in unvegetated or thinly vegetated areas after heavy rainfall events, but the raveling does not affect the overall stability of the slopes.

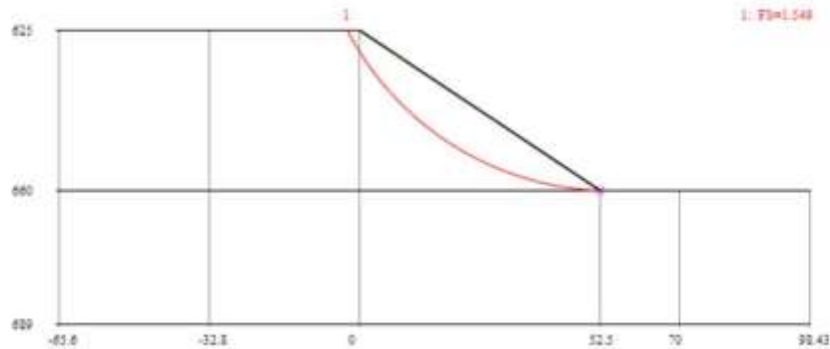
**Figure 28A – Overburden Stockpile Maximum Slope
Static Stability Failure Analysis Model**

Overburden Stockpile Slopes: Overburden stockpile slopes were modeled to determine the maximum slope angle for a 35-foot tall stockpile that meets the minimum factor of safety requirements for the site. As shown in Figures 28A and 28B, the modeled failure plane assumed a worst-case scenario with failure initiated at the base of the fill and extending to the head of the fill. Based on the modeling, stockpile slopes of 1.5H to 1V or flatter will have a static factor of safety of 1.55 or greater and a seismic factor of safety of 1.34 or greater.

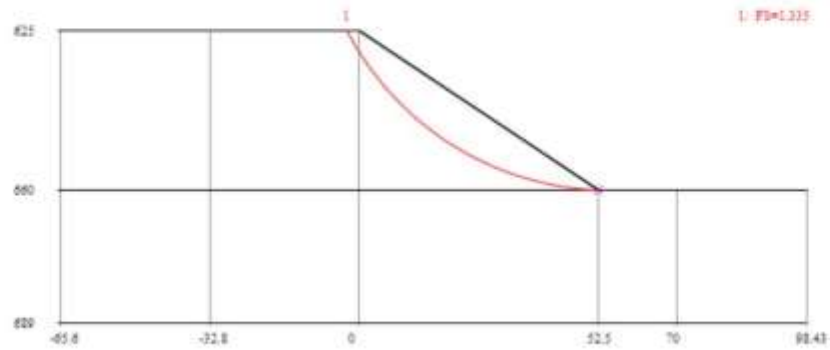
Method:	<input checked="" type="radio"/> Bishop Modified	<input type="radio"/> Ordinary Method of Slices
Seismic Coefficient:	<input type="text" value="08"/> (unitless)	
Seismic Option:	<input checked="" type="radio"/> 1	<input type="radio"/> 2
*) optional

**Figure 28B – Overburden Stockpile Maximum Slope
Seismic Stability Failure Analysis Model**
Front Range Aggregates, LLC
Parkdale Quarry
Fremont County, Colorado
DRMS Mining Permit M1997-054

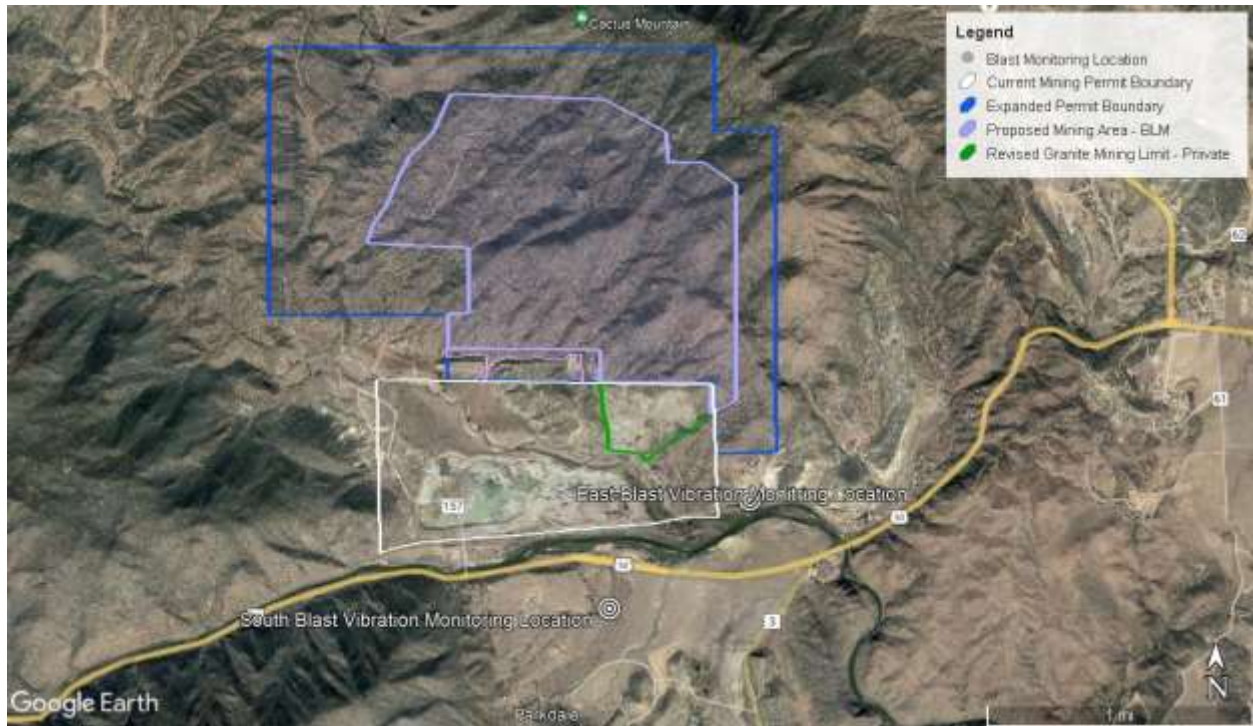
Figure 29 – Map Showing Parkdale Quarry Blast Monitor Locations

Regulatory limits have been set for ground vibration, expressed as peak particle velocity (PPV) to control potential damage to offsite structures due to blasting. Blasts are monitored to verify that these limits are not exceeded. Each blast at the Parkdale Quarry is monitored through a combination of a drone equipped with a video camera and a pair of seismic monitoring stations located at the Parkdale Quarry property boundary between the mining area and the residences closest to the quarry at the locations shown on Figure 29. The two seismic monitors are monitored by VibraTech, a third-party consultant. Vibra-Tech recorded the results of 181 blasts between January 11, 2018 and November 1, 2021. To date, no blast has exceeded allowable PPV limits. The blasting limits established for the site as per Martin Marietta company policy are as follows:

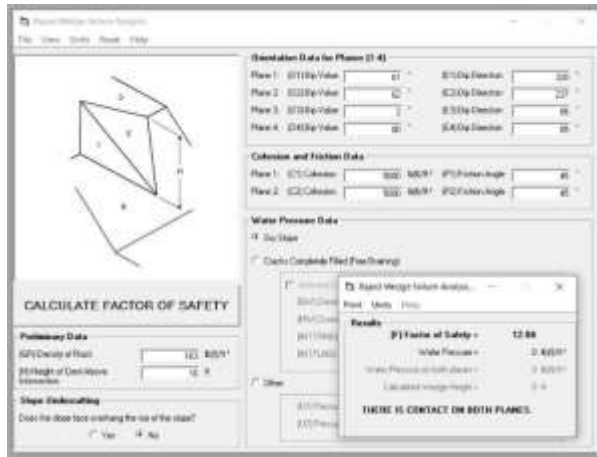
Joint Sets 1, 2

West Slope – Private Land

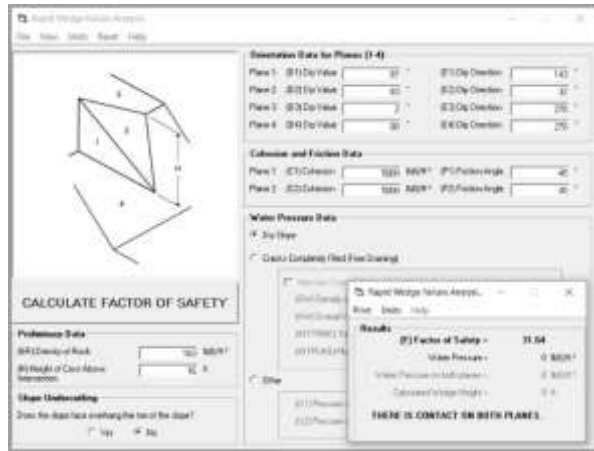
Joint Sets 2, 5

East Slope – BLM Land

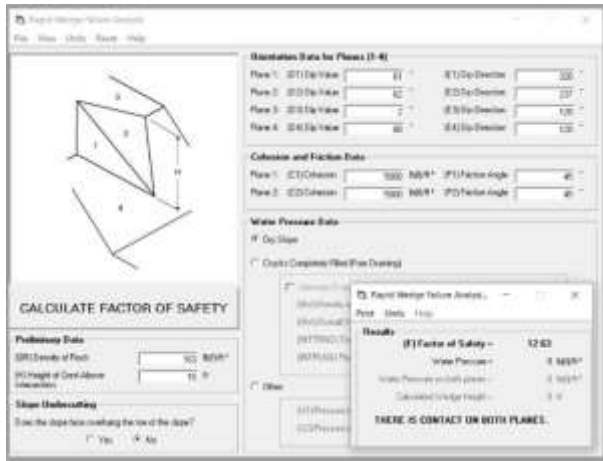
Joint Sets 1, 2

Northwest Slope – BLM Land

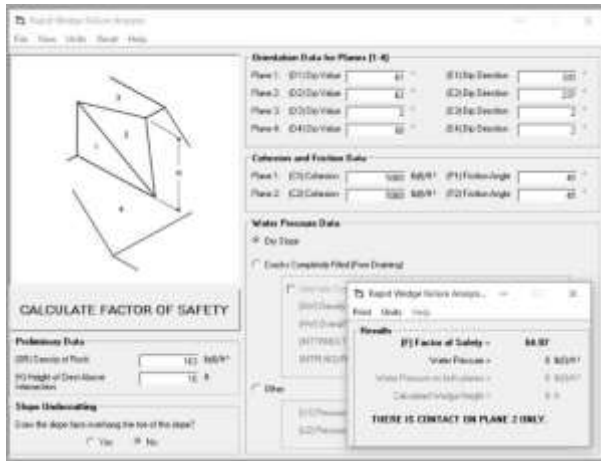
Joint Sets 1, 2

South-central Slope – BLM Land

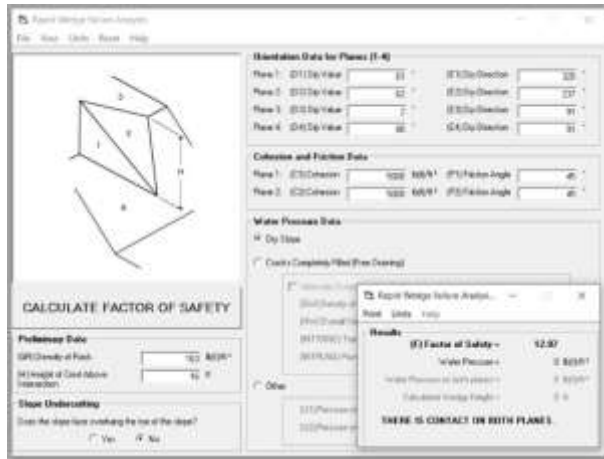
Joint Sets 1, 2

Southwest Slope – BLM Land

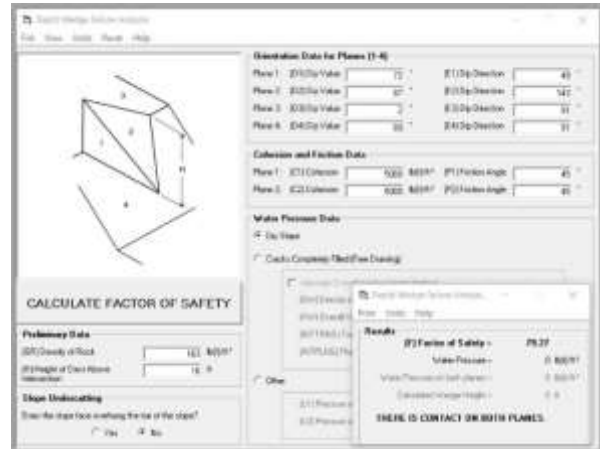
Joint Sets 2, 5

CONTACT IS LOST ON BOTH PLANES. THE WEDGE FLUATS AS A RESULT OF WATER PRESSURE ACTING ON PLANES 1 AND 2.

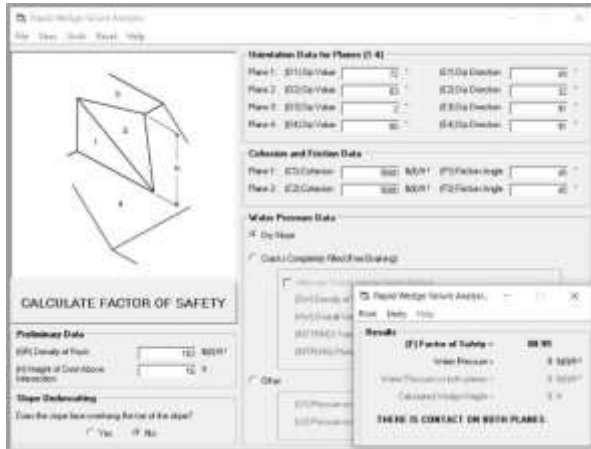
Joint Sets 3, 4

THERE IS CONTACT ON BOTH PLANES.
