**RE: Young Ranch Resource Quarry, File No. M-2021-009, 112 Construction Materials Reclamation Permit Application, Adequacy Review No. 3**

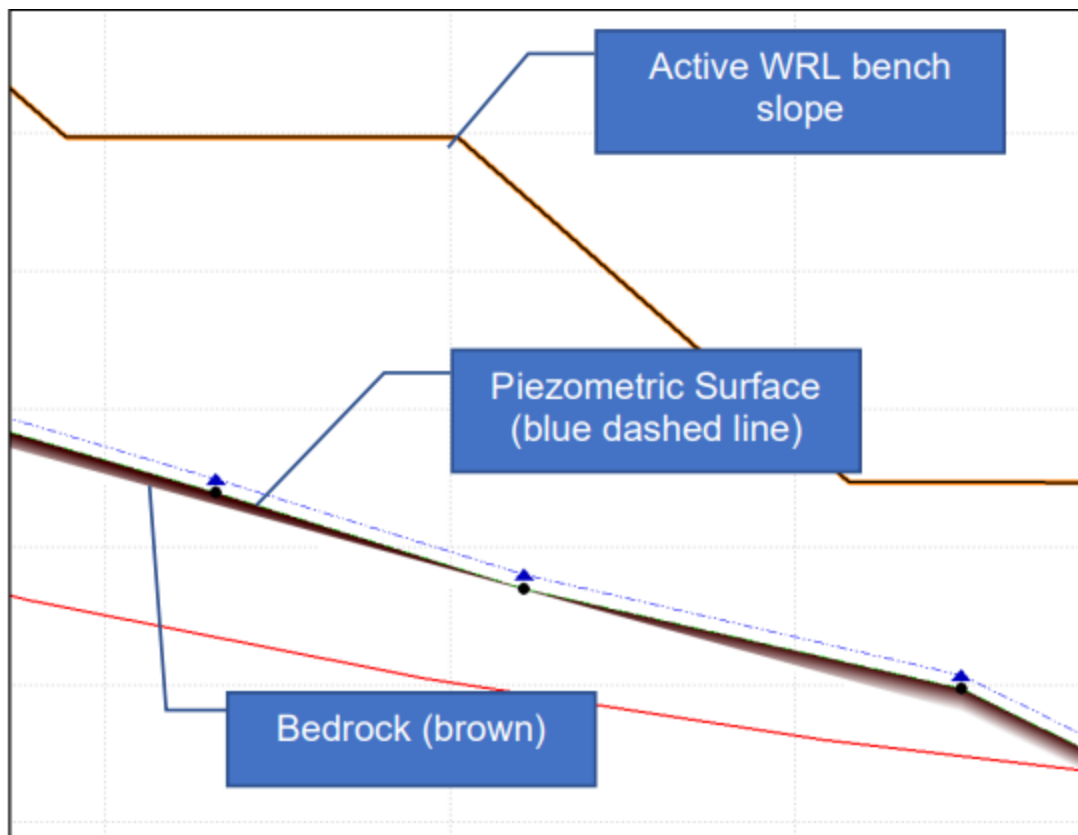
**YR:** In the Slope Stability Exhibit, Impact of Surface Water Infiltration subsection of Exhibit 6.5, the presence of groundwater is discussed. All slope stability analyses assume a piezometric surface immediately within the soil profile of the natural ground. Due to the scale of the WRL sections, this piezometric surface can be difficult to see in the GALENA outputs. An example of the piezometric surface from a zoom window in GALENA is shown in Figure 1 for reference.

**Figure 1. Screenshot of Active WRL Model from GALENA.**

This piezometric surface represents groundwater that would produce the seep identified in the August 4, 2021 site visit.

Language has been added to the Slope Stability Exhibit, Impact of Surface Water Infiltration subsection to emphasize that this piezometric surface is how the groundwater in the area is accounted for in the slope stability analysis.
