MINERALS PROGRAM INSPECTION REPORT
PHONE: (303) 866-3567

MINE NAME: Gleason Pit	MINE/PROSPECTING ID#: M-1983-159	MINERAL: Sand and gravel	COUNTY: Montrose
INSPECTION TYPE: Monitoring	INSPECTOR(S): Dustin Czapla	INSP. DATE: June 23, 2022	INSP. TIME: 13:30
OPERATOR: S & S Aggregate, Inc	OPERATOR REPRESENTATIVE: None	TYPE OF OPERATION: 112c - Construction Regular Operation	
REASON FOR INSPECTION: Normal I&E Program	BOND CALCULATION TYPE: Complete Bond	BOND AMOUNT: \$30,965.00	
DATE OF COMPLAINT: NA	POST INSP. CONTACTS: None	JOINT INSP. AGENCY: None	
WEATHER: Clear	INSPECTOR'S SIGNATURE:

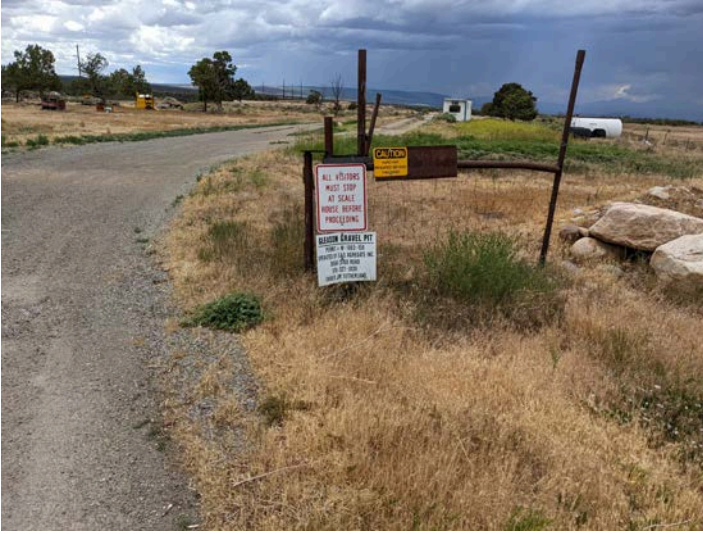
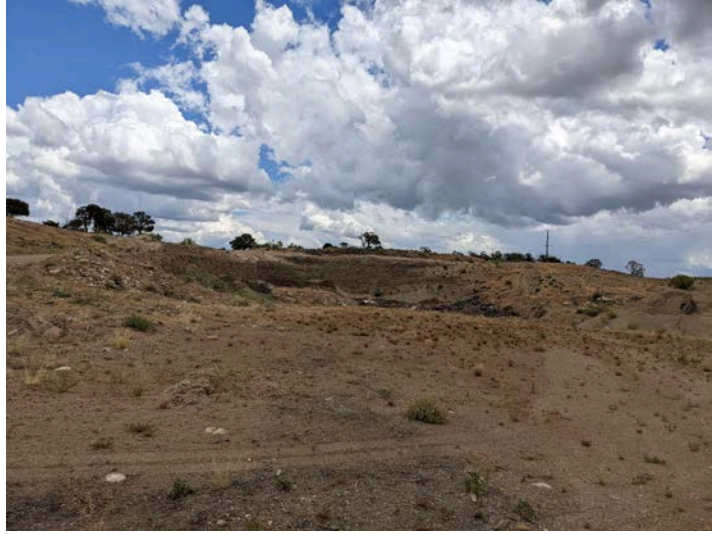
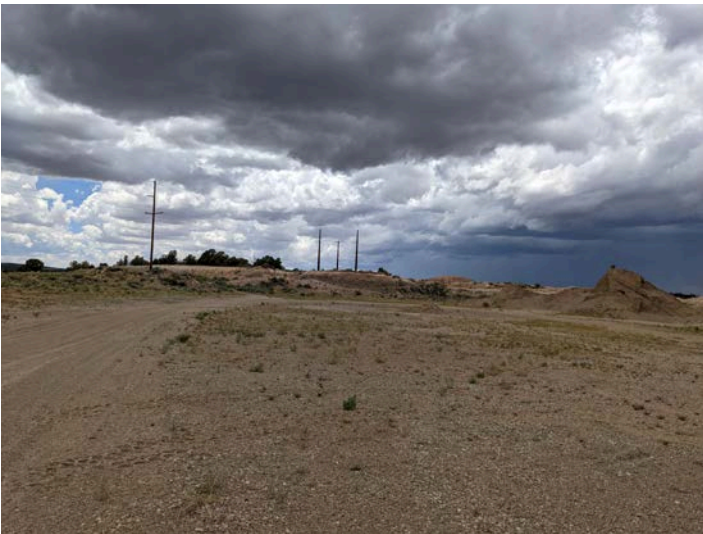
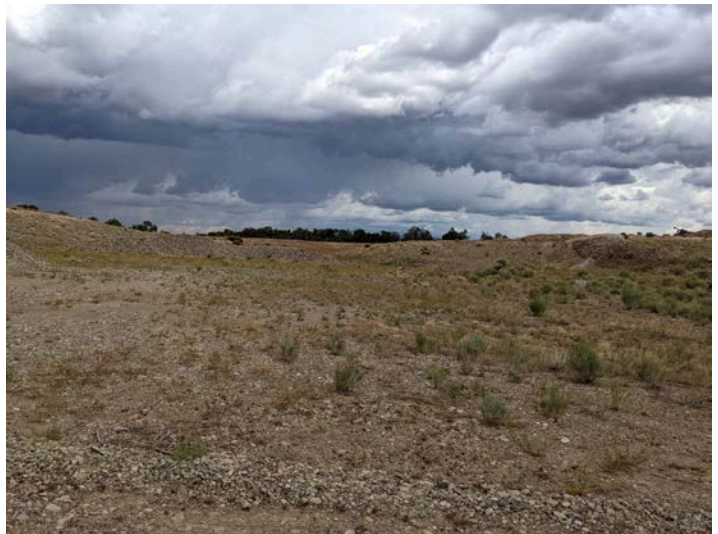
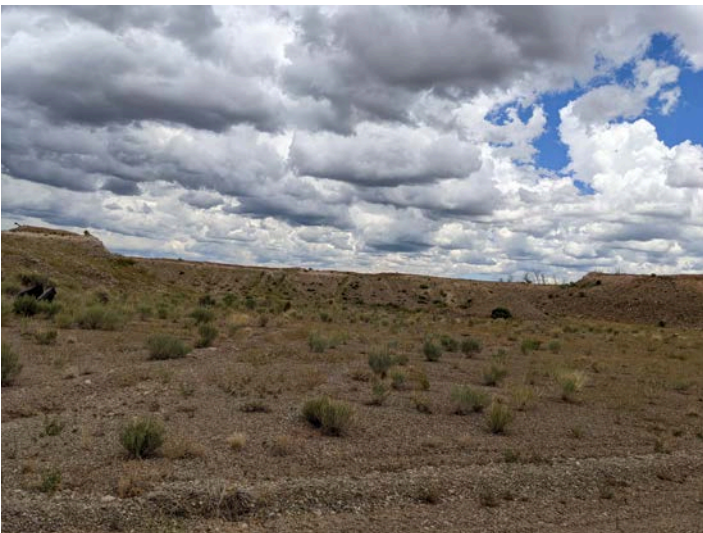
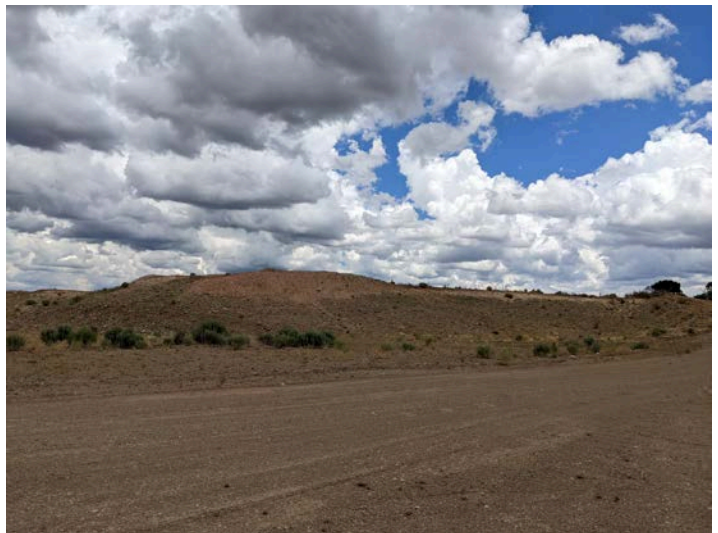
No evidence of any recent mining activity was observed. Conditions at the site appear relatively unchanged from the Division's last inspection, which took place on May 1, 2019. A scale and scalehouse are located near the site entrance. Various equipment and refuse are stored in the area south of the scale. The existing highwalls were left at random grades, from near vertical to 3H:1V. A near vertical highwall exists on the south side of the access road in the east side of the pit. Highwalls around the power poles are approximately 0.5H:1V. Except for a section of 0.5H:1V slope in the central part of the north pit wall, the west and north slopes are graded from 2H:1V to 3H:1V.

This inspection was conducted as part of the Division of Reclamation, Mining and Safety's (Division) normal monitoring program. A representative for the Operator was not present. Photographs are included with this report in order to illustrate some of the conditions observed.
