MINERALS PROGRAM INSPECTION REPORT
PHONE: (303) 866-3567

MINE NAME: Gallegos Pit	MINE/PROSPECTING ID#: M-1983-164	MINERAL: Sand and gravel	COUNTY: Conejos
INSPECTION TYPE: Monitoring	INSPECTOR(S): Clayton Wein	INSP. DATE: August 9, 2022	INSP. TIME: 10:10
OPERATOR: Conejos County	OPERATOR REPRESENTATIVE: Don Martinez	TYPE OF OPERATION: 112c - Construction Regular Operation	
REASON FOR INSPECTION: Normal I&E Program	BOND CALCULATION TYPE: None	BOND AMOUNT: \$0.00	
DATE OF COMPLAINT: NA	POST INSP. CONTACTS: None	JOINT INSP. AGENCY: None	
WEATHER: Clear	INSPECTOR'S SIGNATURE:

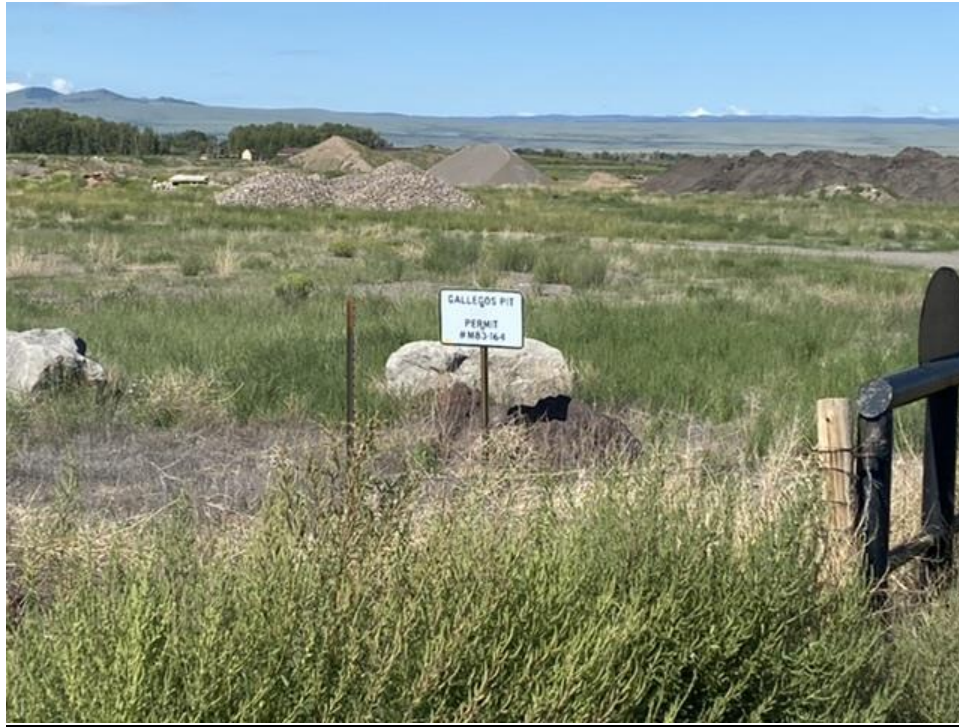
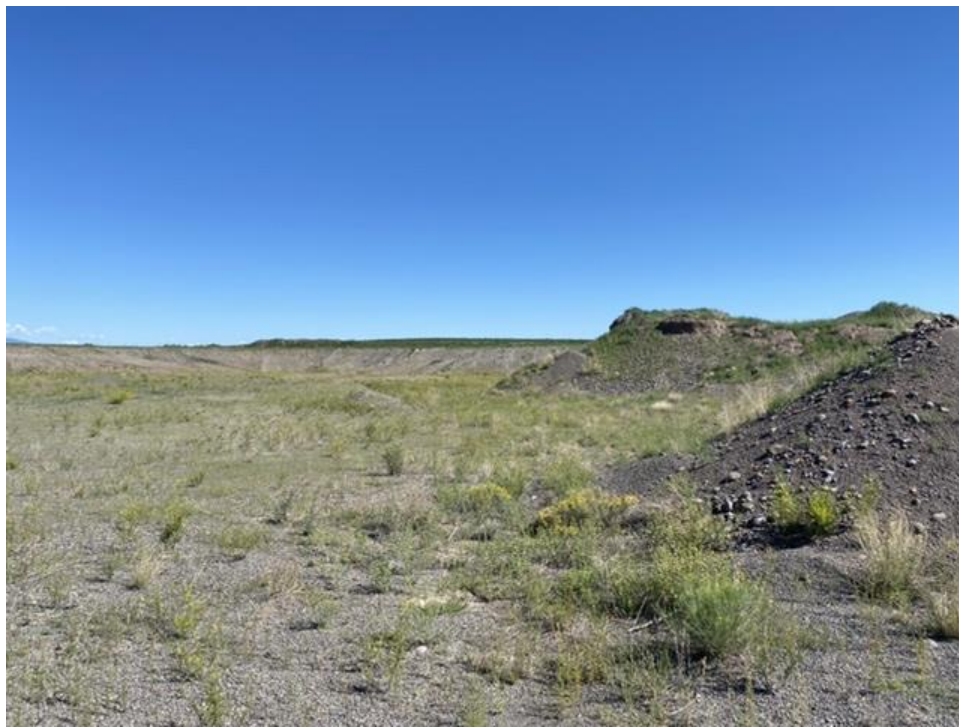
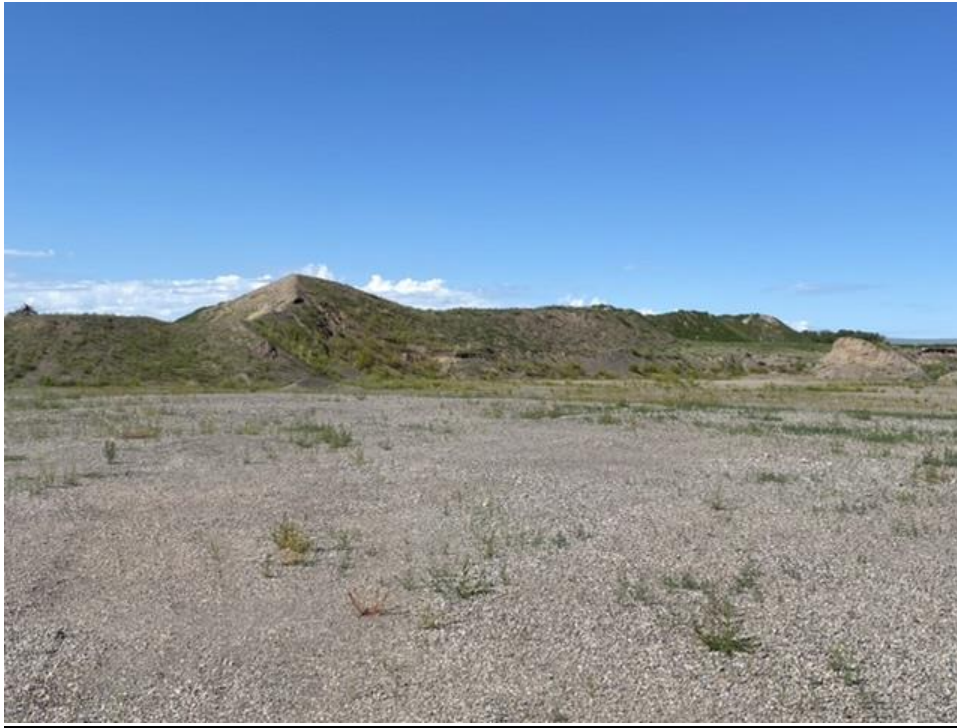
PHOTOGRAPHS

The highwalls were stable during the inspection. The slopes of the highwalls ranged from 1:1 to 3:1. The depth of the pit was at about 15 feet. Stockpiles of crushed material were located on the pit floor. There was no equipment located on site. No fuel or other hydrocarbons were located at the mine site. No erosional features were observed. The Division noted no off-site impacts from the mining operation.

Topsoil piles at the site were stable with vegetative cover. There were no indications of erosional features. No loss of topsoil resource was observed.

This report documents the observations made during a normal monitoring inspection of the Gallegos Pit conducted on August 9, 2022. The inspection was completed by Clayton Wein of the Colorado Division of Reclamation, Mining and Safety (the Division). Don Martinez represented the operator (Conejos County) during the inspection. The weather was clear with a temperature of 70 degrees F. The ground conditions were dry. The Gallegos pit is a 112c operation with approximately 65 permitted acres. The mine site is located approximately 0.75 miles south of Romeo, Colorado and is accessed from Highway 285. As per Rule 4.1.2(2), the division does not hold a bond for the site. Please see the attached photos for a visual reference of the site conditions during the inspection.
