MINERALS PROGRAM INSPECTION REPORT
PHONE: (303) 866-3567

MINE NAME: Hubbs Pit	MINE/PROSPECTING ID#: M-1987-088	MINERAL: Sand and gravel	COUNTY: La Plata
INSPECTION TYPE: Monitoring	INSPECTOR(S): Dustin Czapla	INSP. DATE: August 16, 2022	INSP. TIME: 16:00
OPERATOR: Hubbs III, LLC	OPERATOR REPRESENTATIVE: Barbara Hubbs	TYPE OF OPERATION: 112c - Construction Regular Operation	
REASON FOR INSPECTION: Normal I&E Program	BOND CALCULATION TYPE: Complete Bond	BOND AMOUNT: \$59,905.00	
DATE OF COMPLAINT: NA	POST INSP. CONTACTS: None	JOINT INSP. AGENCY: None	
WEATHER: Clear	INSPECTOR'S SIGNATURE:

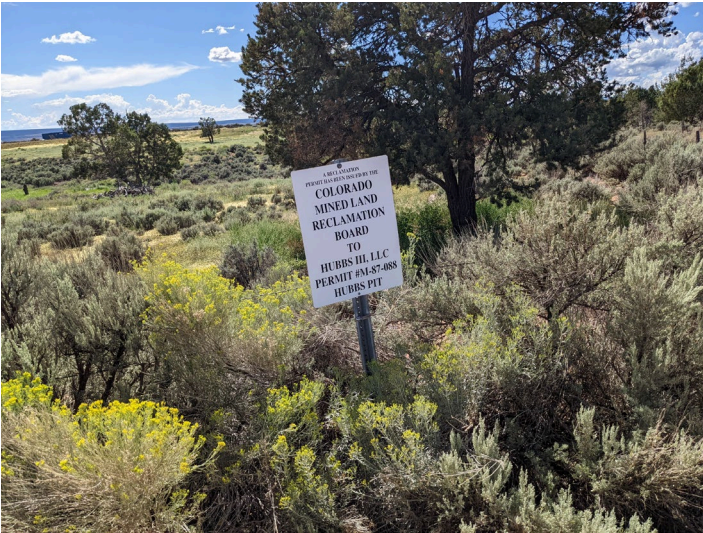
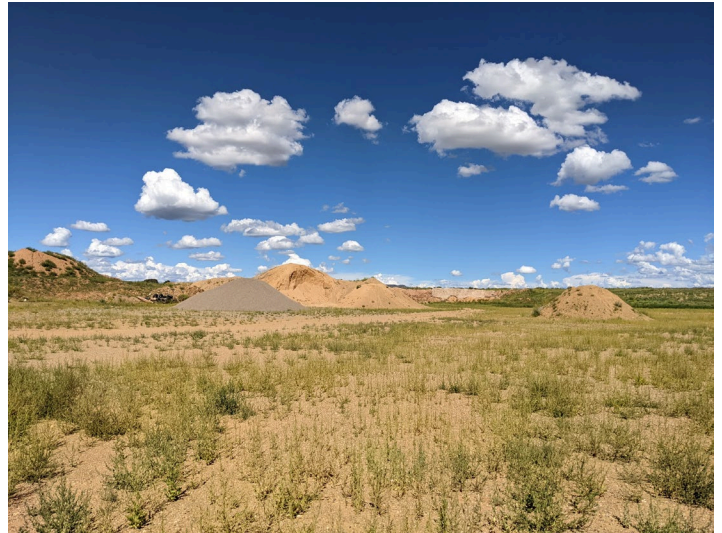
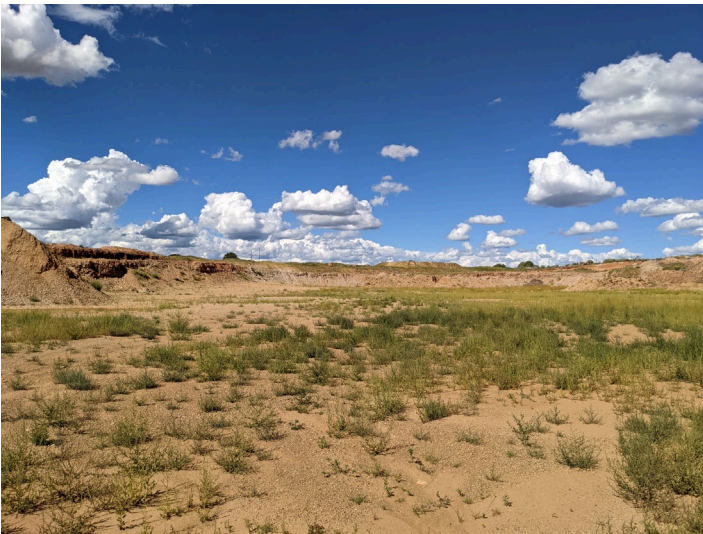
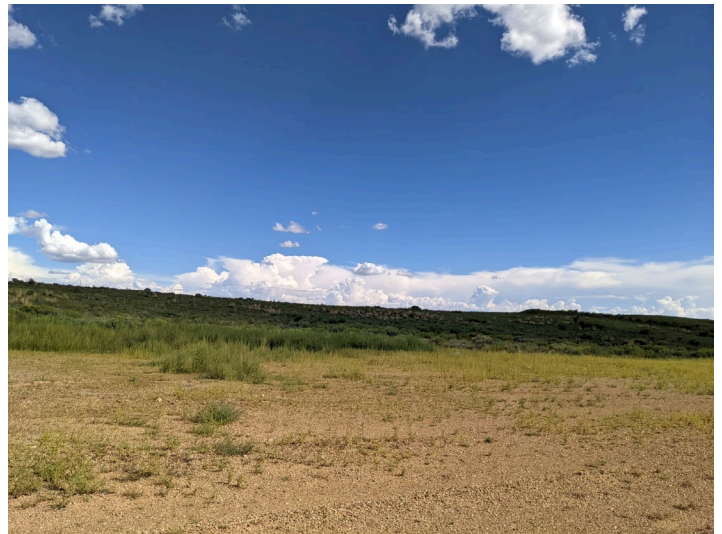
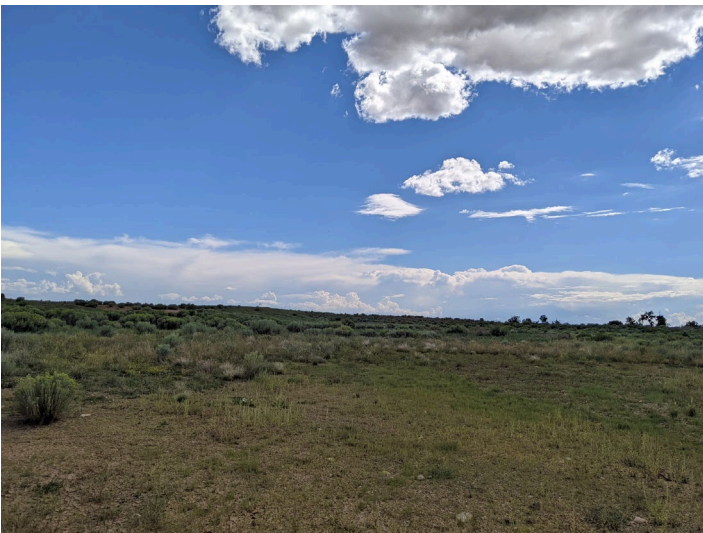
This inspection was conducted as part of the Division of Reclamation, Mining and Safety's (Division) normal monitoring program. Barbara Hubbs, representing the Operator, was present during this inspection. Photographs are included with this report in order to illustrate conditions observed.

Adequate mine identification signage was noted at the entrance to the site.

The site undergoes contemporaneous reclamation as the mining activity progresses. At this time the southern section of Phase 2 as well as the southern and eastern sections of Phase 3 have been reclaimed. Phase 1 is currently being used as the stockpiling and staging area. The reclaimed areas have been sloped to approximately a 3H: 1V or less and appear stable. The vegetation throughout the reclaimed areas is adequate in both density and diversity. Noxious weed infestations were not noted.
