TR-103 - Corrective Action Response to Comments

**Re: Permit No. M-1980-244;Cripple Creek & Victor Gold Mining Company; Cresson
Project; TR-103 Non-Compliance Corrective Action Response to Comments**

Subject: Stability Analysis of an Upset Condition around the Booster Pump

VLf2 Slope Stability At Booster Pump

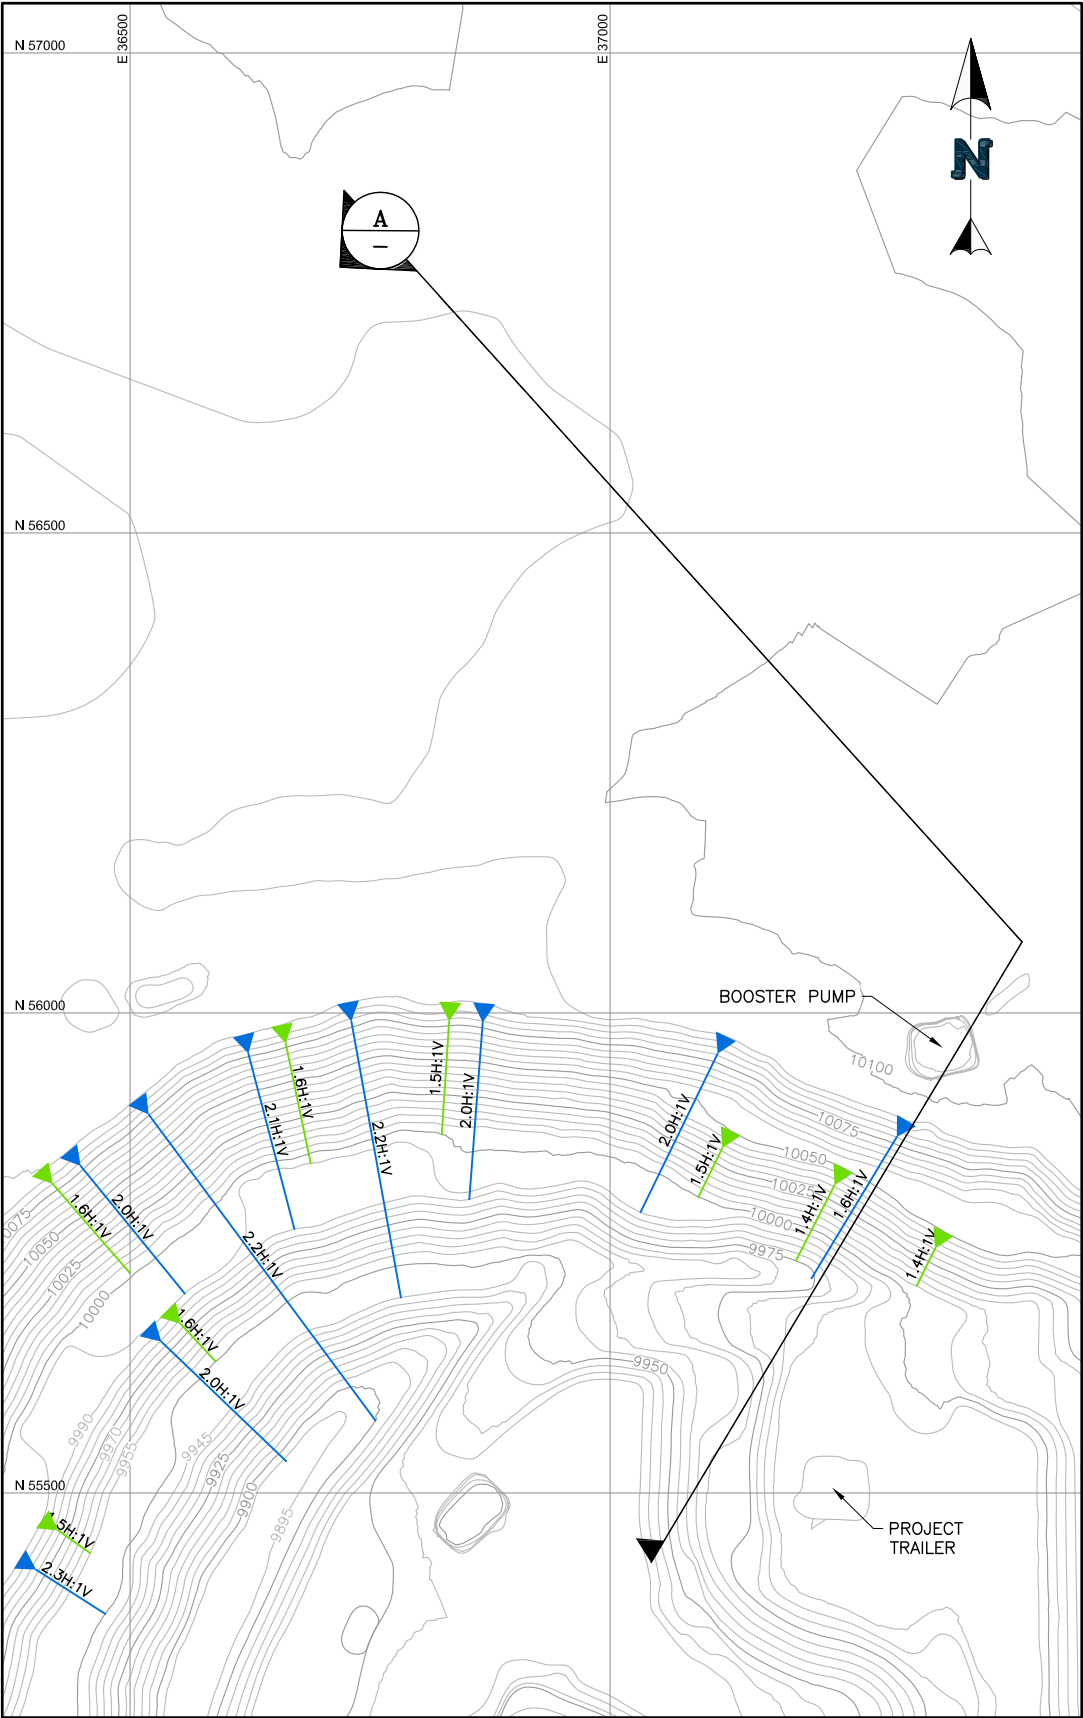
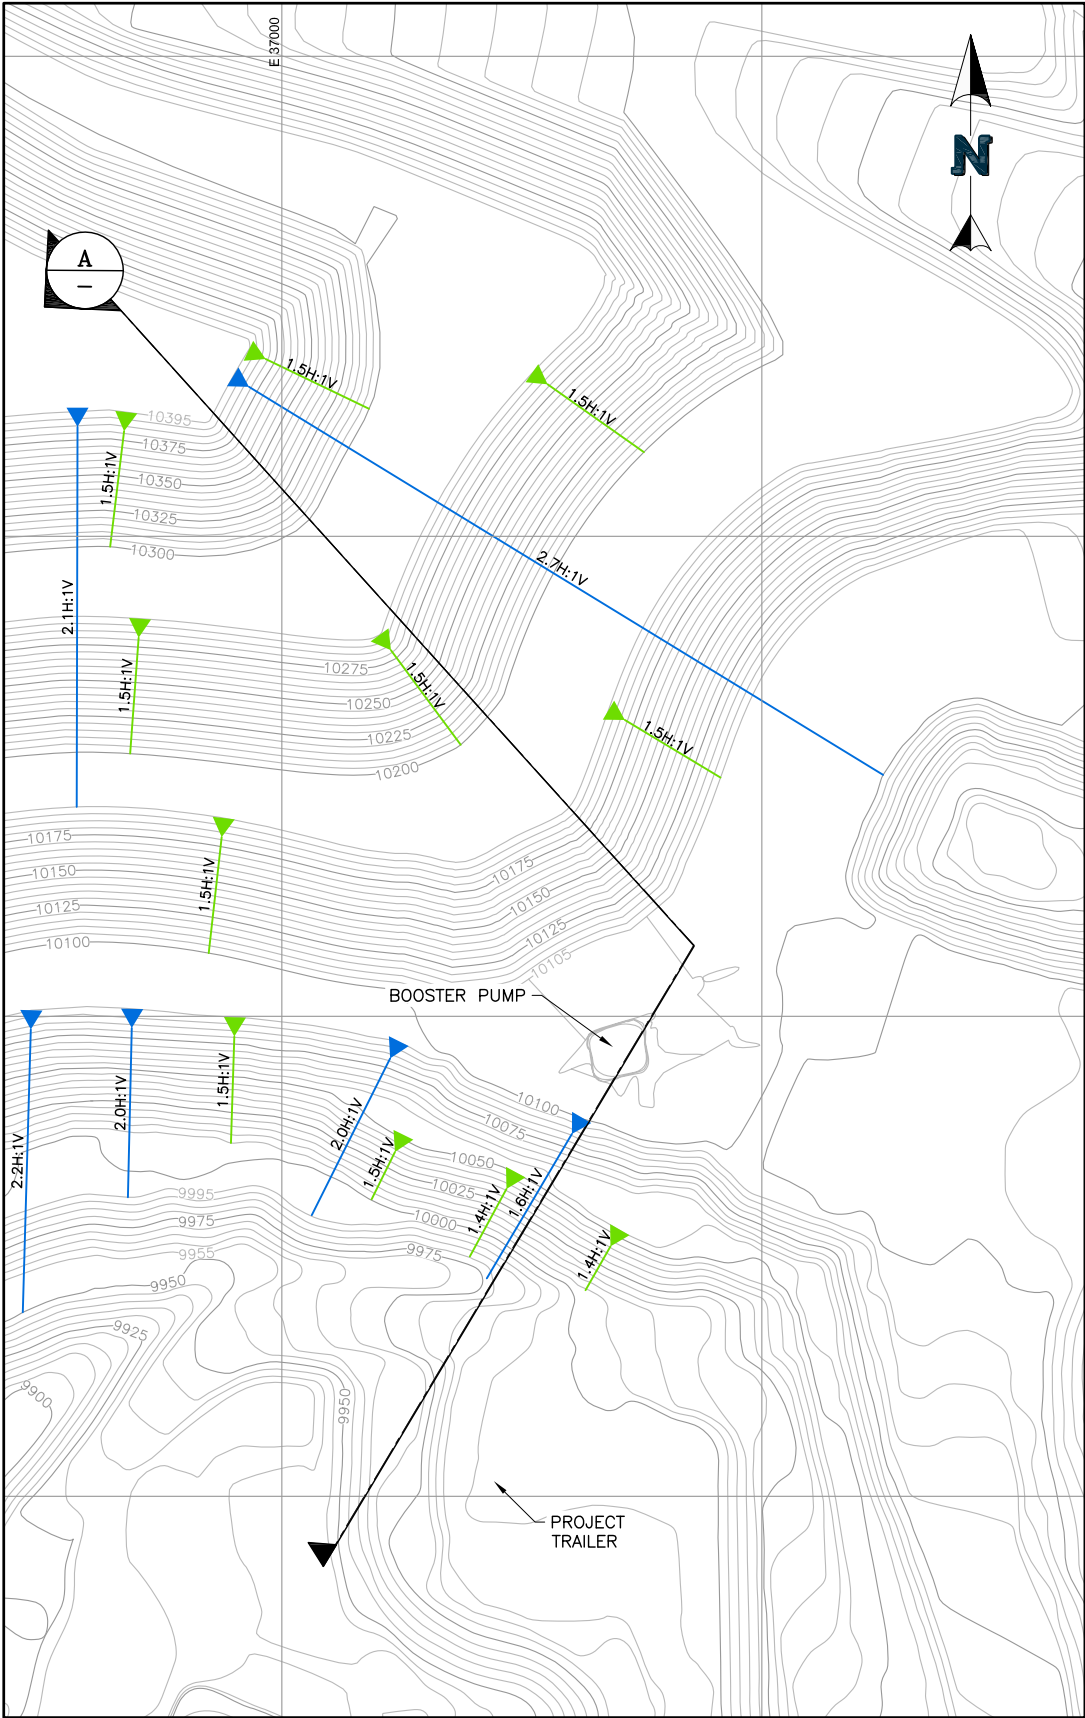
NewFields		CLIENT CRIPPLE CREEK & VICTOR GOLD MINING COMPANY	
PROJECT		CRESSON PROJECT, PERIMT NO. M-1980-244; TR-103 NON-COMPLIANCE CORRECTIVE ACTION RESPONSE REGARDING VLF2	
TITLE		VLF2 SLOPE STABILITY AT BOOSTER PUMP	
		FILENAME 0106.054.001F	
		FIGURE NO. 1	REVISION A

REFERENCE:
MARCH 2, 2022 TOPOGRAPHY WAS RECEIVED BY NEWFIELDS
ON APRIL 28,2022 IN A FILE CALLED "VLF2_3-2-22.DXF"
2029 TOPOGRAPHY WAS RECEIVED BY NEWFIELDS ON
AUGUST 5, 2022 IN A FILE CALLED "Final
Topo-VL2-20211201.DXF"

Figure 1 shows the current heap configuration and the future heap configuration. The Booster Pump is sited on the 11000' bench of VLF2, north of the Mill. The downhill heap slope near the pumps was over steepened to an overall slope of 1.6H:1V to facilitate the construction of the Booster Pump and associated infrastructure. The pump is in line with a 24-inch diameter pipeline which has the flow capacity of 16,000 gallons per minute (gpm). Based on our understanding of the current and future leaching plan in the vicinity of the booster pumps is that the slopes below the booster pump were leached prior to the installation of the pumps and there are no plans to leach the slope below the booster station in the future.

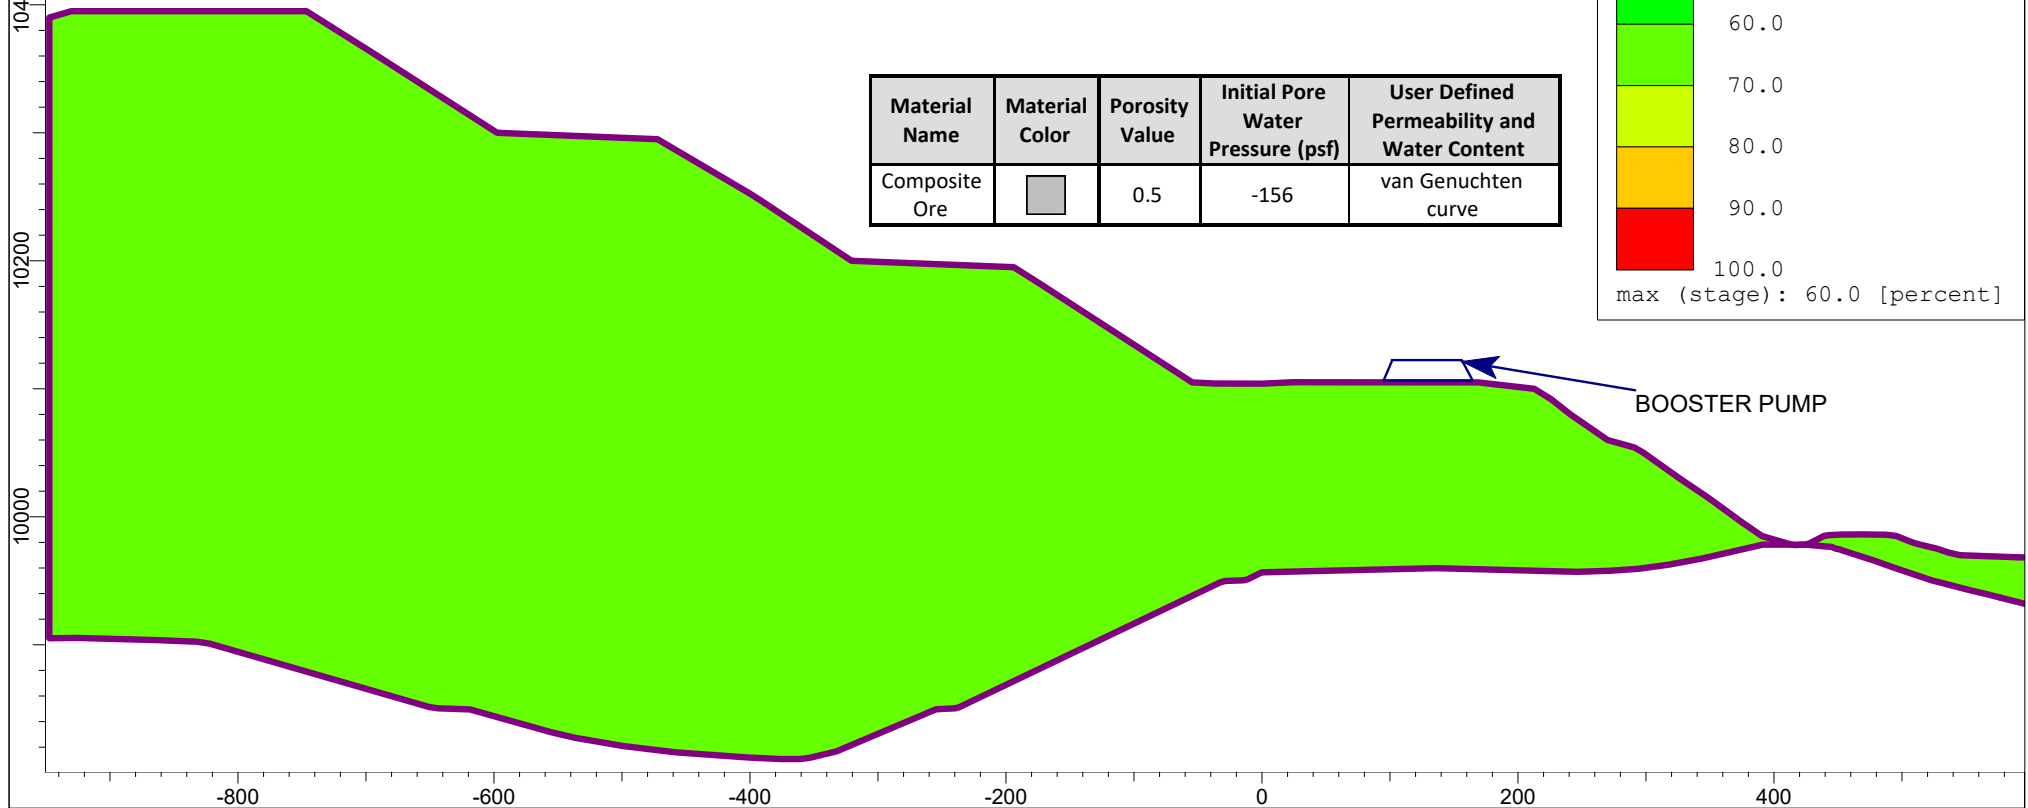
0.5	-156	van Genuchten curve

Seepage Analysis of a Breach in Process Solution Pipe - Initial Conditions

Output graphics for initial conditions (presented as degree of saturation) and at various timesteps over the 48-hour simulation are presented in [Attachment A](#).

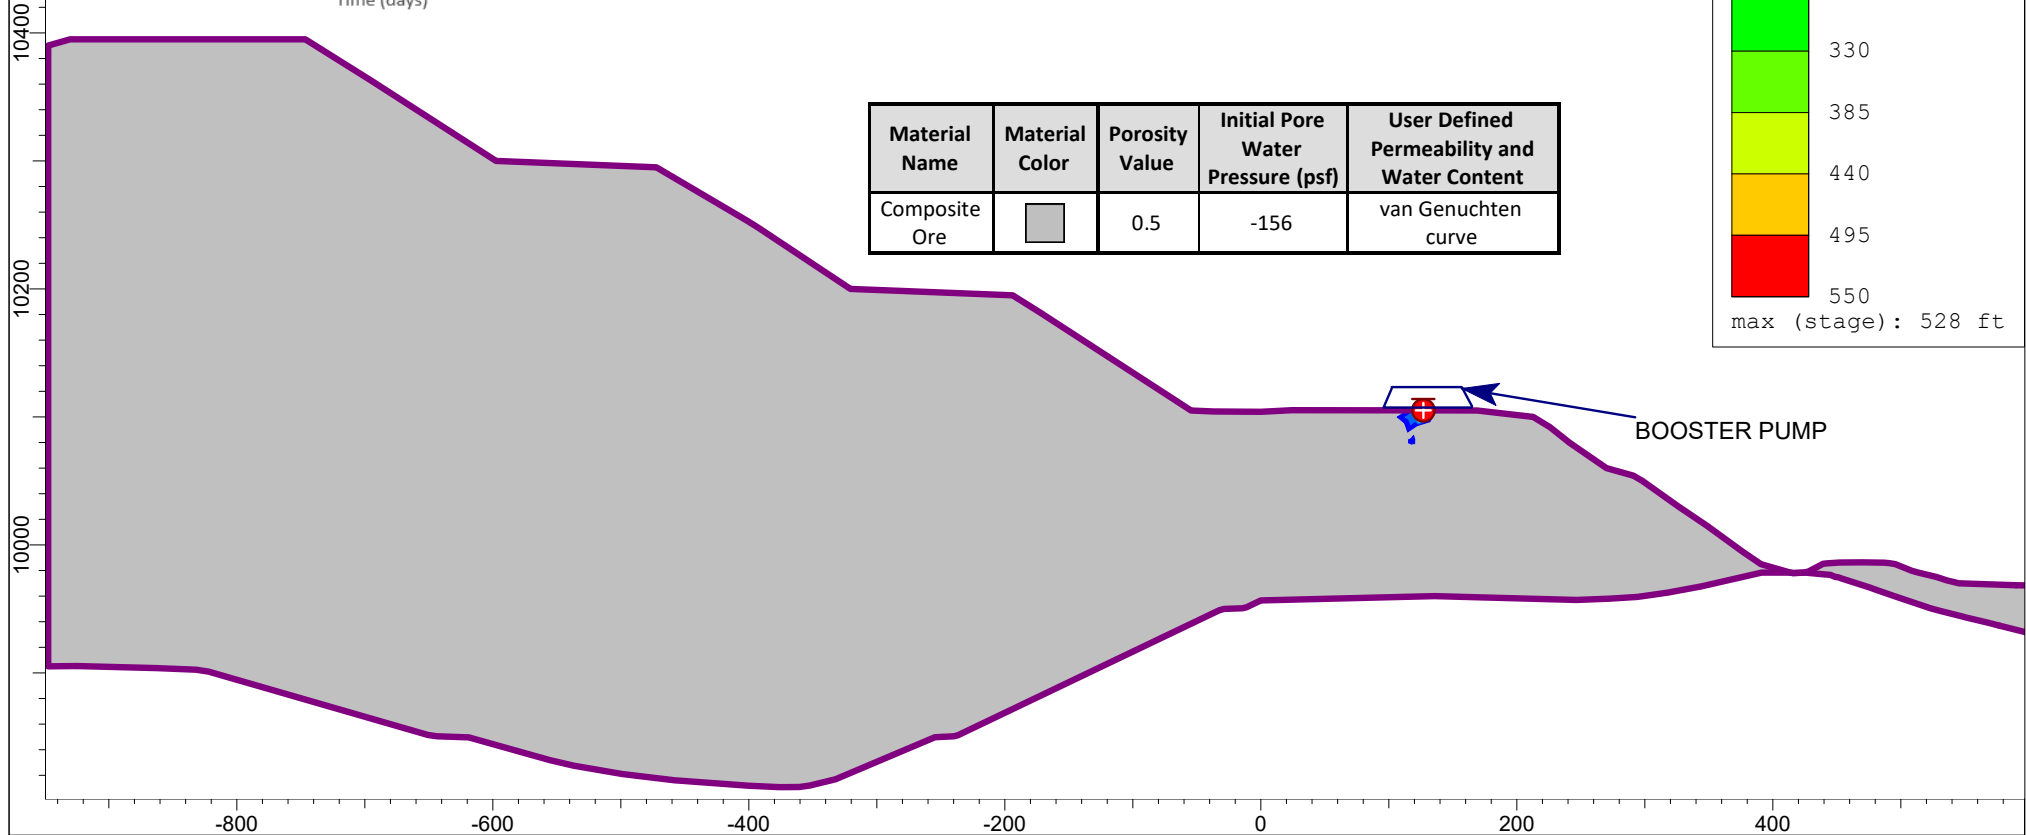
Seepage Analysis of a Breach in Process Solution Pipe - At Upset Condition

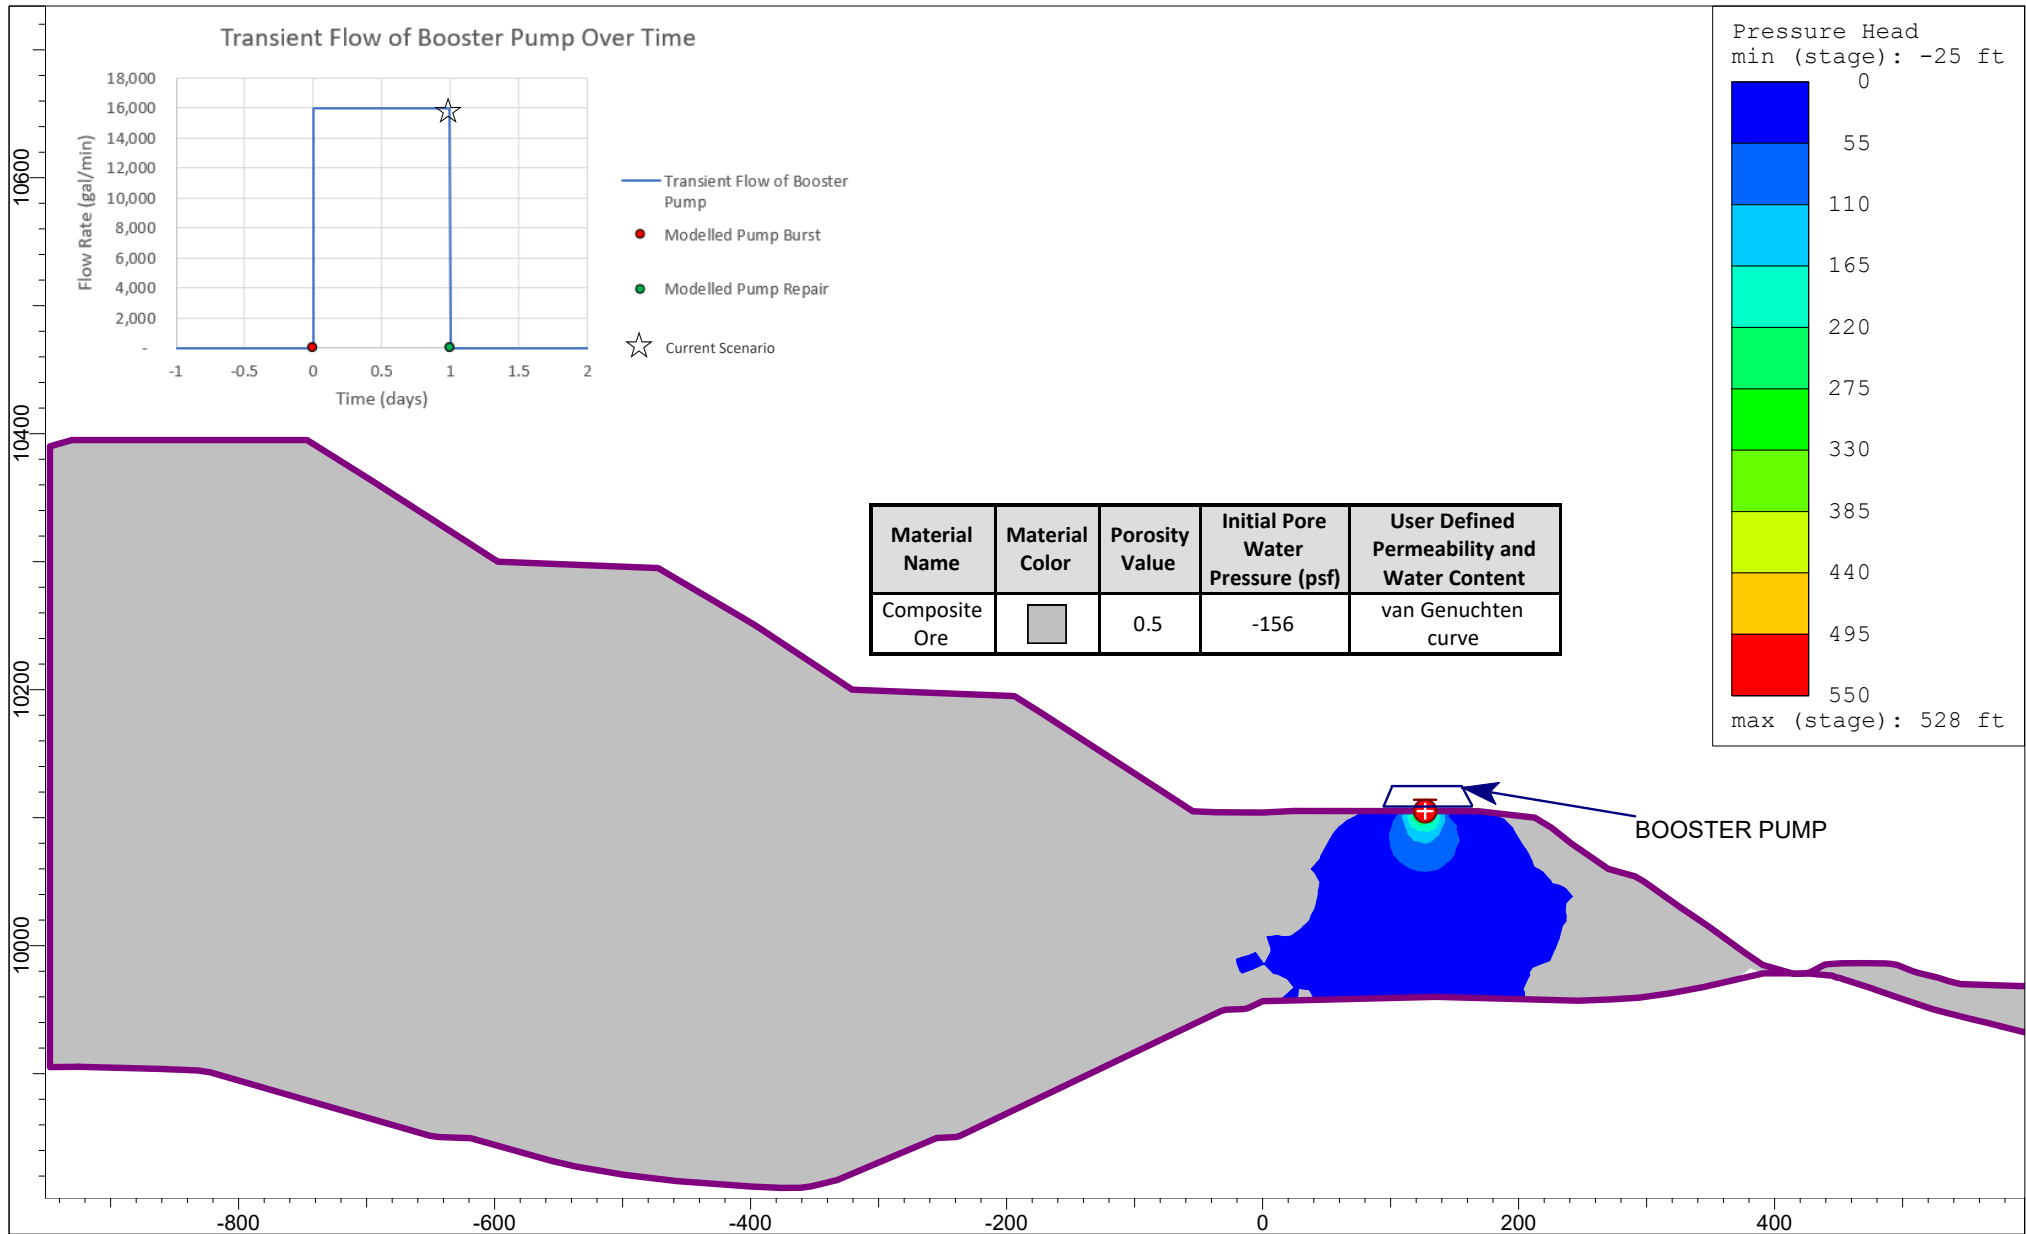
Seepage Analysis of a Breach in Process Solution Pipe - 24 Hours After Upset Condition, Immediately Before Repair

At the start of the upset condition a seepage plume develops in the facility subsurface and propagates down towards to the base liner. At 24 hours the plume is at the base of the liner and

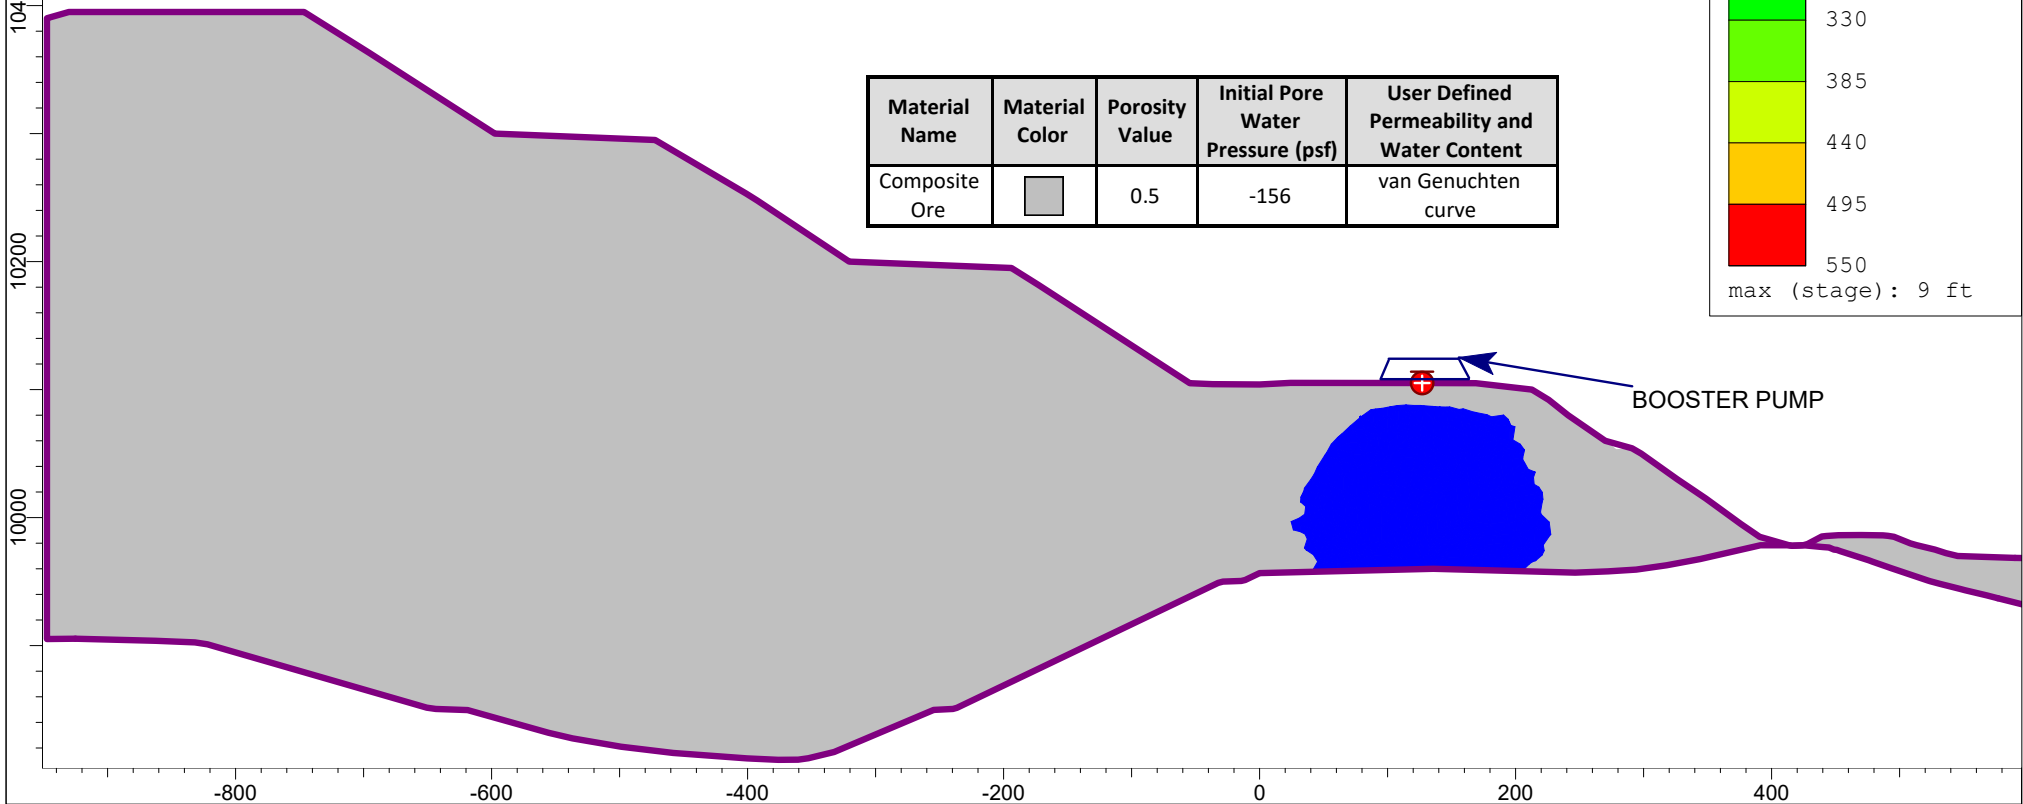
<i>Analysis Description</i> Seepage Analysis of a Breach in Process Solution Pipe - 24 Hours After Upset Condition, 1 Minute After Repair			
<i>Drawn By</i> FL	<i>Scale</i> 1:1800	<i>Company</i> Newmont	
<i>Date Printed</i> 9/1/2022	<i>File Name</i> Pipe Burst Model - Shut Off 24 hr.fez
