RE: M-1977-439 Technical Revision (TR-06) responses to Adequacy Review No. 1

MARTIN MARIETTA  
HOME OFFICE  
LARIMER COUNTY, COLORADO  
RECLAMATION PLAN

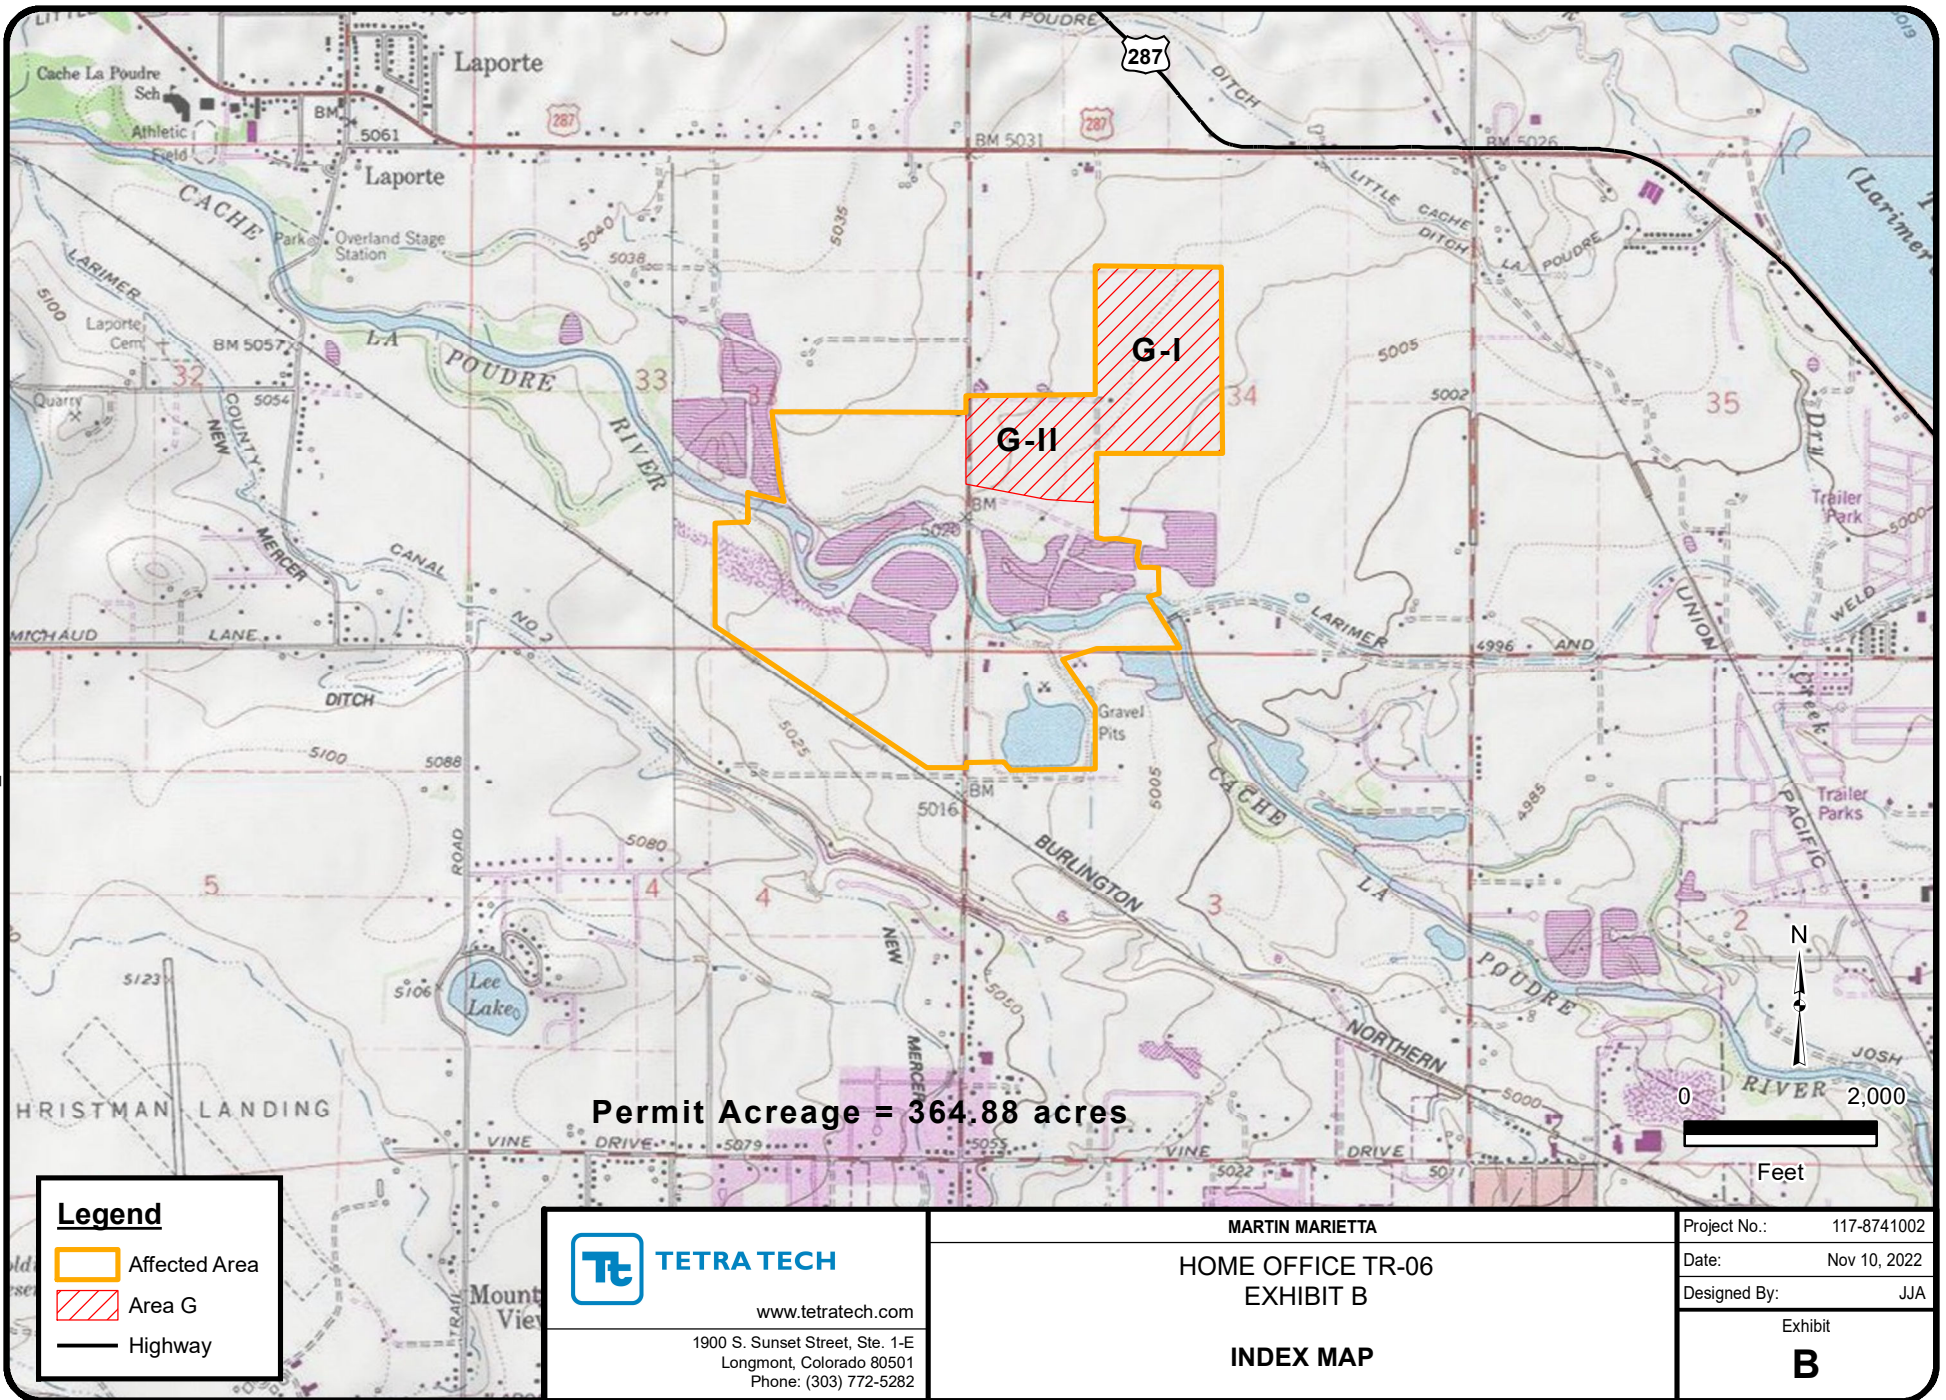
F1

WEST UNDERDRAIN (INSTALLED)  
NORTH UNDERDRAIN (INSTALLED)  
NORTH EXTENSION TO THE EAST (NORTH OF G-I AS PROPOSED W/TR-06)

The figure is a detailed engineering plan view of a mine site. It includes various boundary and feature lines such as the Mine Permit Boundary, Easement, Existing Contours, Wetland Buffer, Parcel Lines, Fence, Road Edge, Overhead Electric Line, Access Road, Underdrain, and Surface Drainage Ditch. A legend defines symbols for Topsoil (6"-8" and seed), previously approved areas (Pre-1973 disturbance, historical use not re-affecting or reclaiming, and commercial/industrial areas historically used for non-reclaimable purposes), and unlined pre-81 by DWR. A note specifies that structures in Area 1.2 and Y remain. The plan also features a North Arrow pointing up, a Scale Bar indicating 1 inch equals 200 feet, and a Certification statement signed by Julie Mikulas on 11/10/2022. On the right side, there are three colored lines representing installed underdrains: West Underdrain (blue), North Underdrain (green), and North Extension to the East (red). Below these lines is a table with project details: PROJ: 117-8741002, DESN: JJA, DRWN: JJA, CHKD: KKJ. At the bottom right, a large 'F1' label is present, and a note refers to Figure F3 General Plan for Stage G Preliminary Design.
