May Day Idaho Mine Complex

**Updated Surface and Groundwater  
Characterization-2017  
M-1981-185  
VOLUME 1**

*May Day Idaho  
Mine Complex*

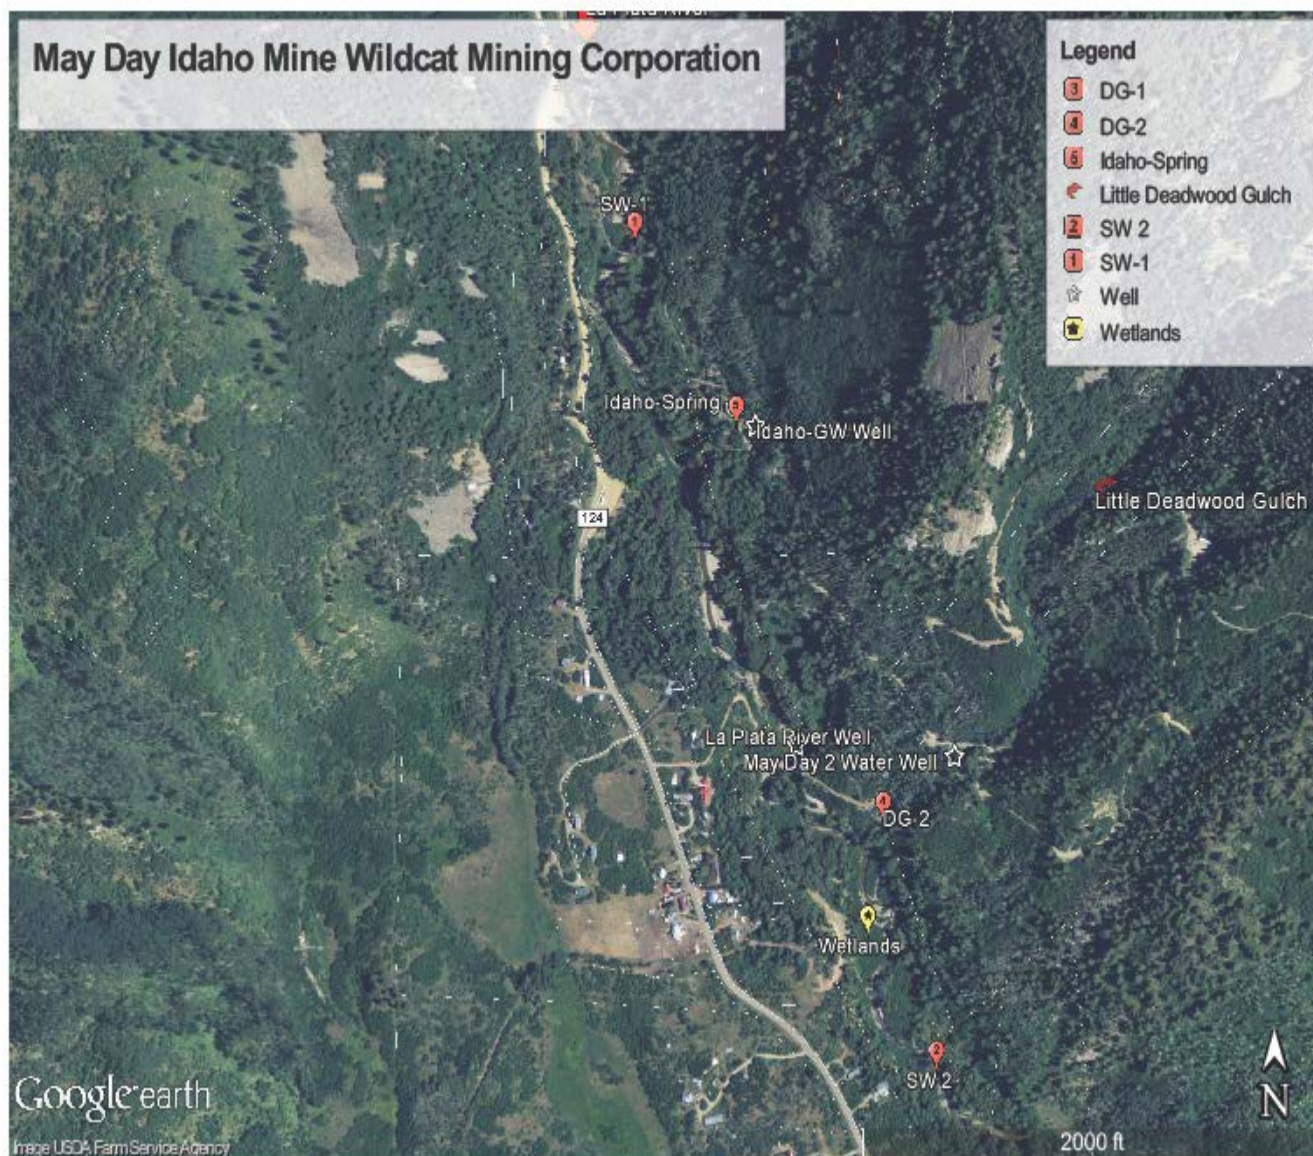
**Figure 6**

**Surface and Groundwater Monitoring Network  
Water May Day Idaho Mine Complex  
La Plata County, Colorado**
