**RE: Permit No. M-1980-244; Cripple Creek & Victor Gold Mining Company;
Cresson Project;** PoC Monitoring Well Drilling and Installation Report; Technical
Revision 129 (TR-129)

TECHNICAL MEMORANDUM

RE: **2023 Monitoring Wells – Poverty Gulch Monitoring Well (PGMW-5)**

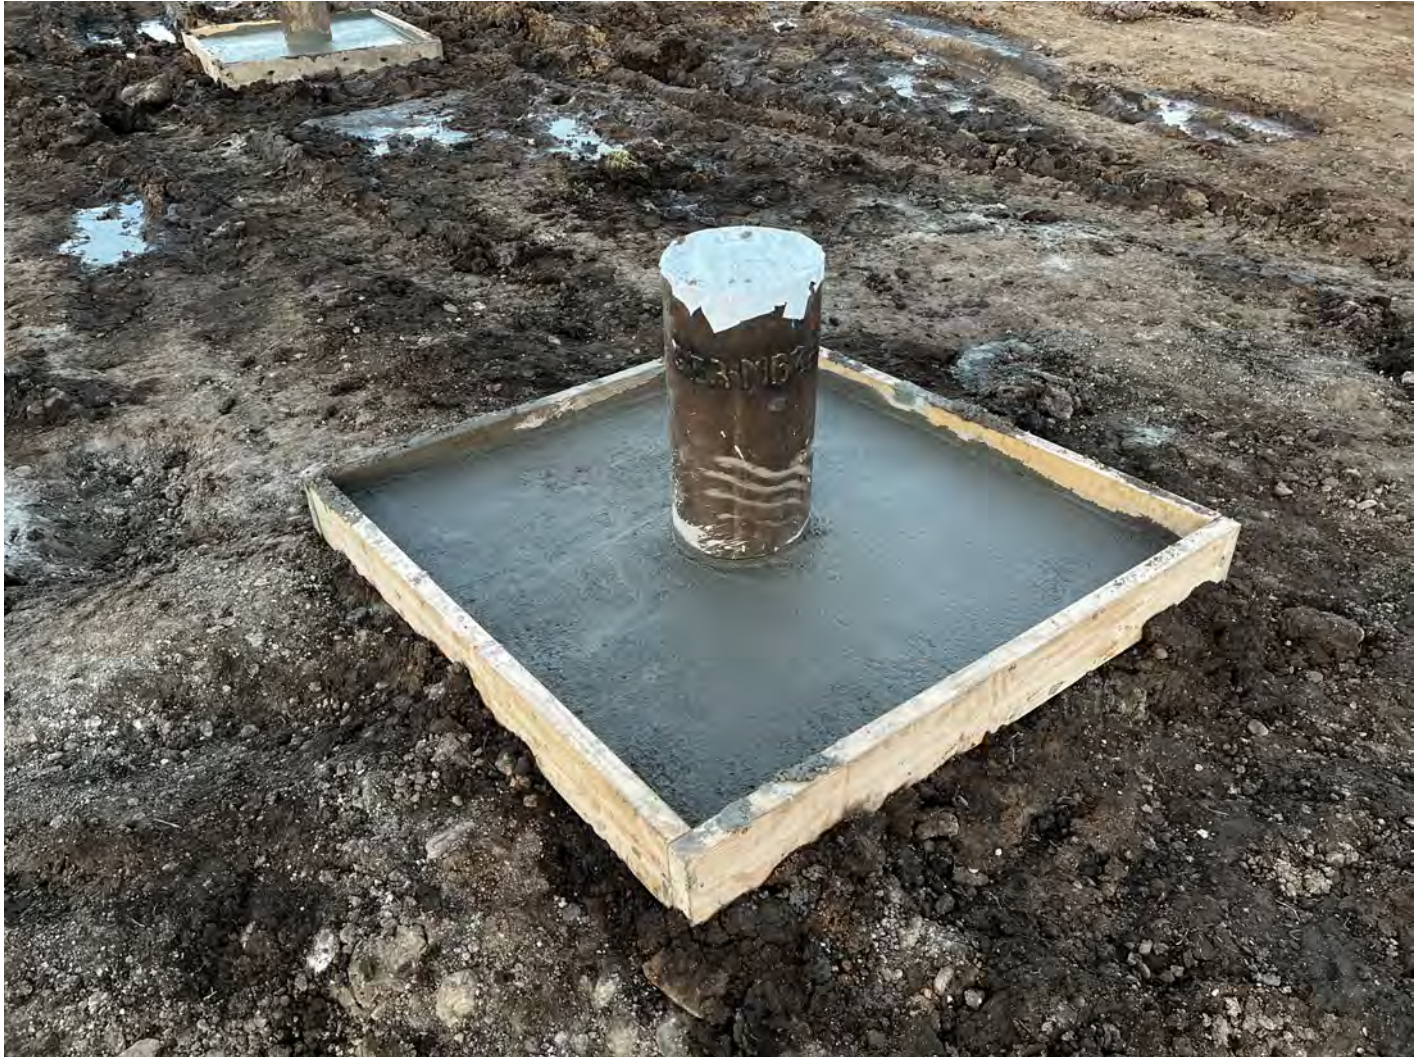
Figure 1 illustrates the location of the borehole. Figure 2 provides an as built of the completed monitoring well. Figure 3 provides a hydrogeologic log summarizing the geology, water detection, airlift and well construction. Figure 4 is a picture of the completed borehole well head.
