Adequacy Review, TR1, Everhart Pit, M-1997-081

RE: Statement for Exhibit G – No affected ground water pursuant to Rule 6.4.7 (1)

As requested, we investigated subsurface conditions at the Everhart Pit site located on Siloam Road in Pueblo, Colorado (Fig. 1). Our purpose was to determine the depth and thickness of the gravel deposit and evaluate the possibility that mining of the gravel could expose the groundwater.

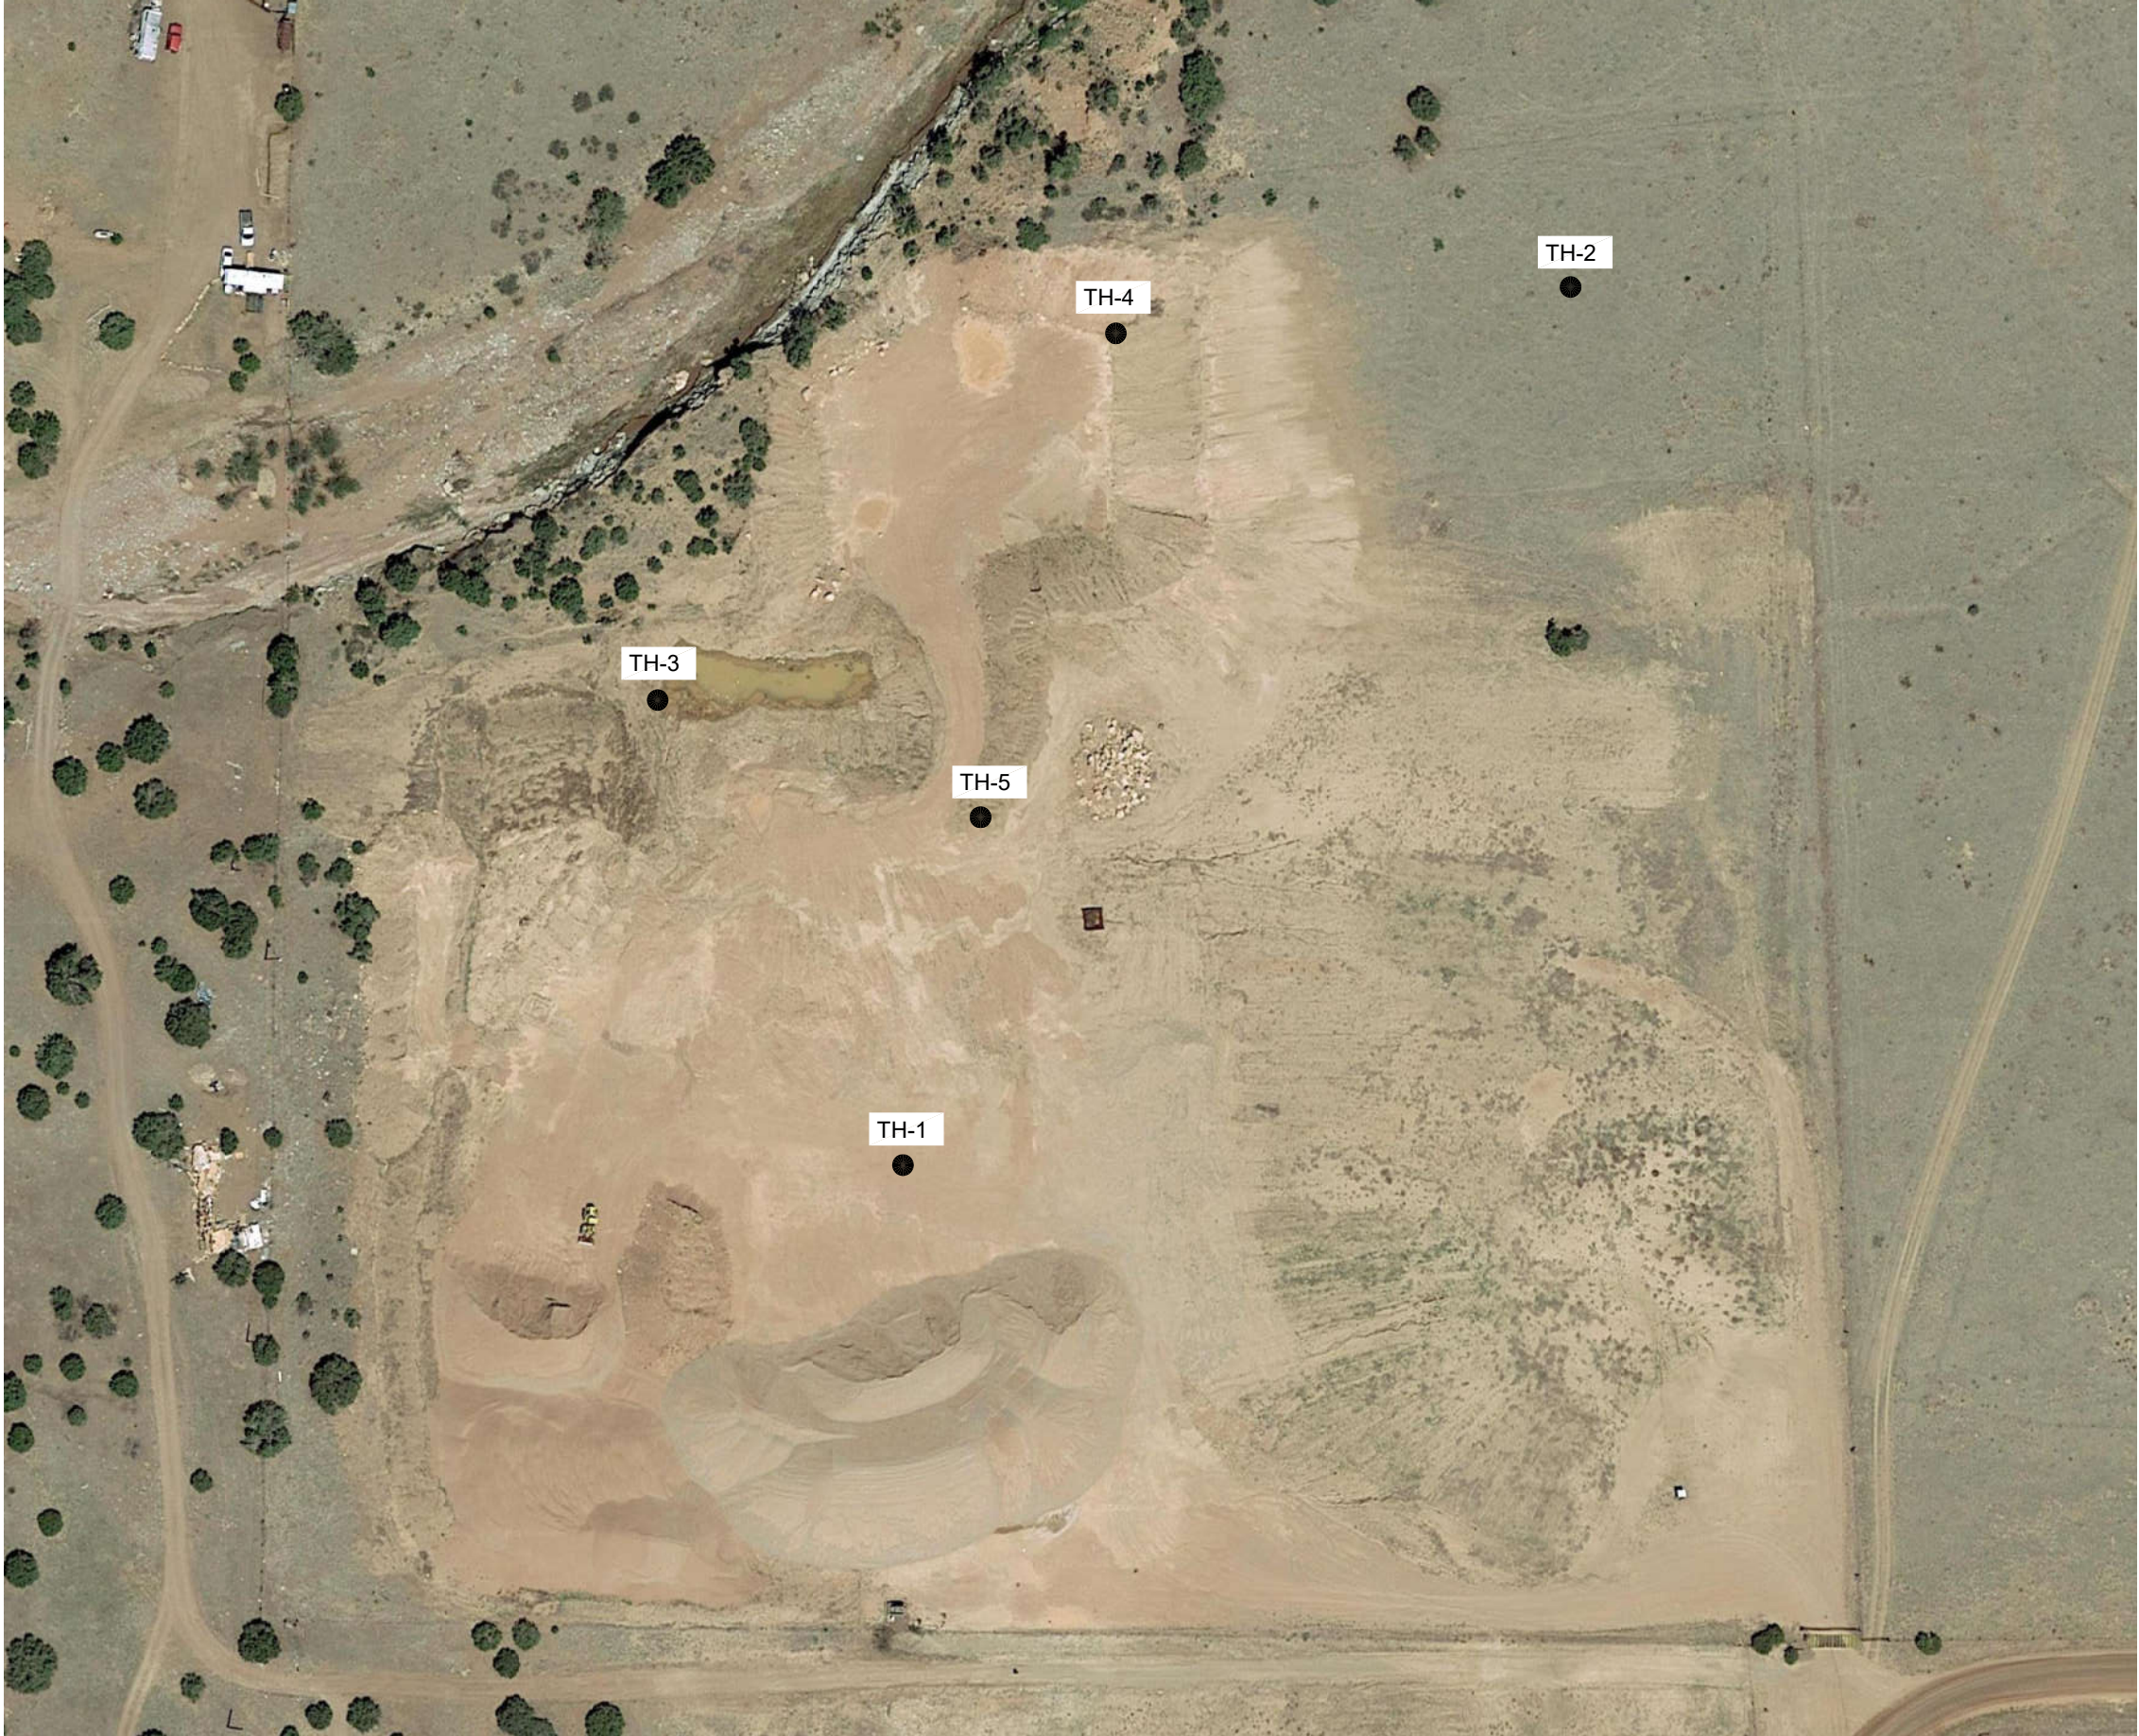
FIG. 1

LEGEND:
TH-1 ● APPROXIMATE LOCATION OF EXPLORATORY BORING.

Location of
Exploratory
Borings

Subsurface conditions were explored by drilling five exploratory borings within the Everhart Pit (Fig. 1). The borings were advanced to depths between 15.5 and 39 feet using a 4-inch diameter, continuous-flight auger and a truck-mounted drill rig. Practical auger drilling refusal was encountered on very hard bedrock at depths of 15.5 feet, 39 feet, and 16 feet in TH-1, TH-2, and TH-5, respectively. Our field representative observed drilling, logged the conditions encountered in the borings, and obtained samples. Graphical logs of the borings, including the results of field penetration resistance tests and some laboratory test data, are presented in the Summary Logs of Exploratory Borings (Fig. 2).

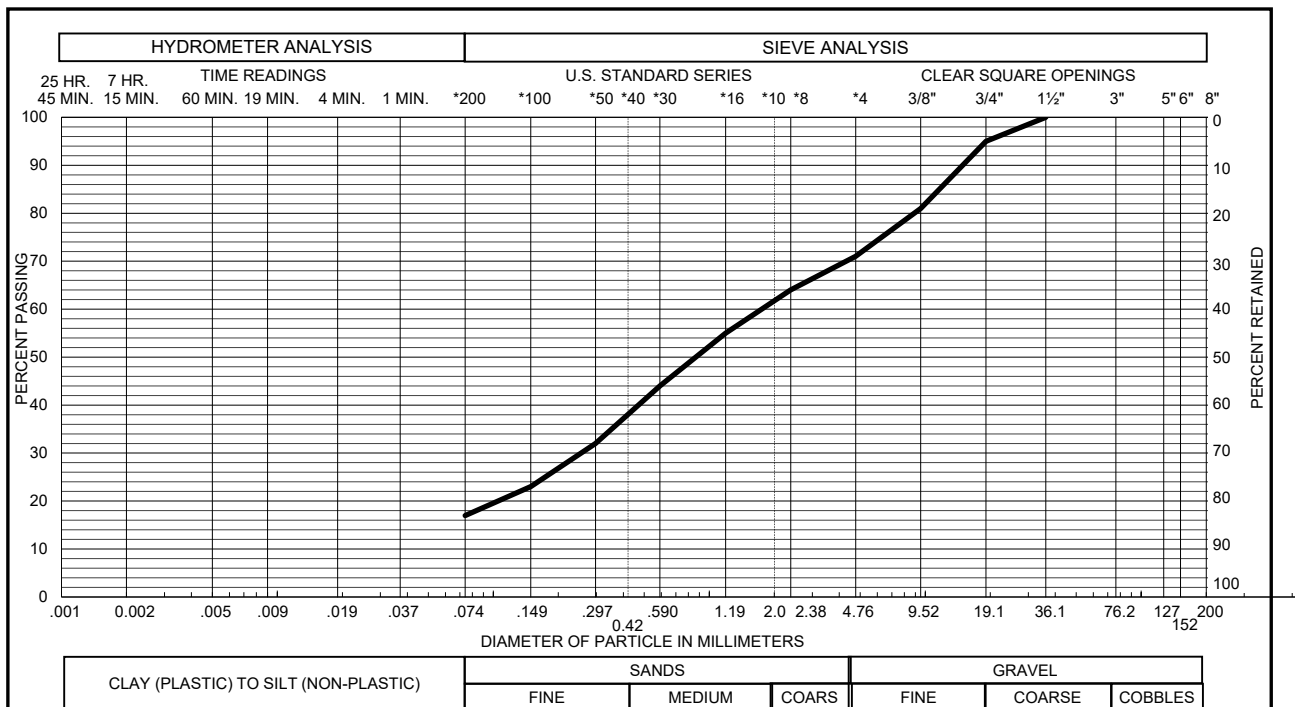
Sample of SAND, SILTY, GRAVELLY (SM) GRAVEL 29 % SAND 54 %
From TH - 1 AT 4-9 FEET SILT & CLAY 17 % LIQUID LIMIT _____
PLASTICITY INDEX _____

Soil samples obtained during drilling were returned to our laboratory and visually classified. Laboratory testing was then assigned and included moisture content and gradation. Results of the laboratory tests are presented in Figs. 3 through 8 and are summarized in Table 1.

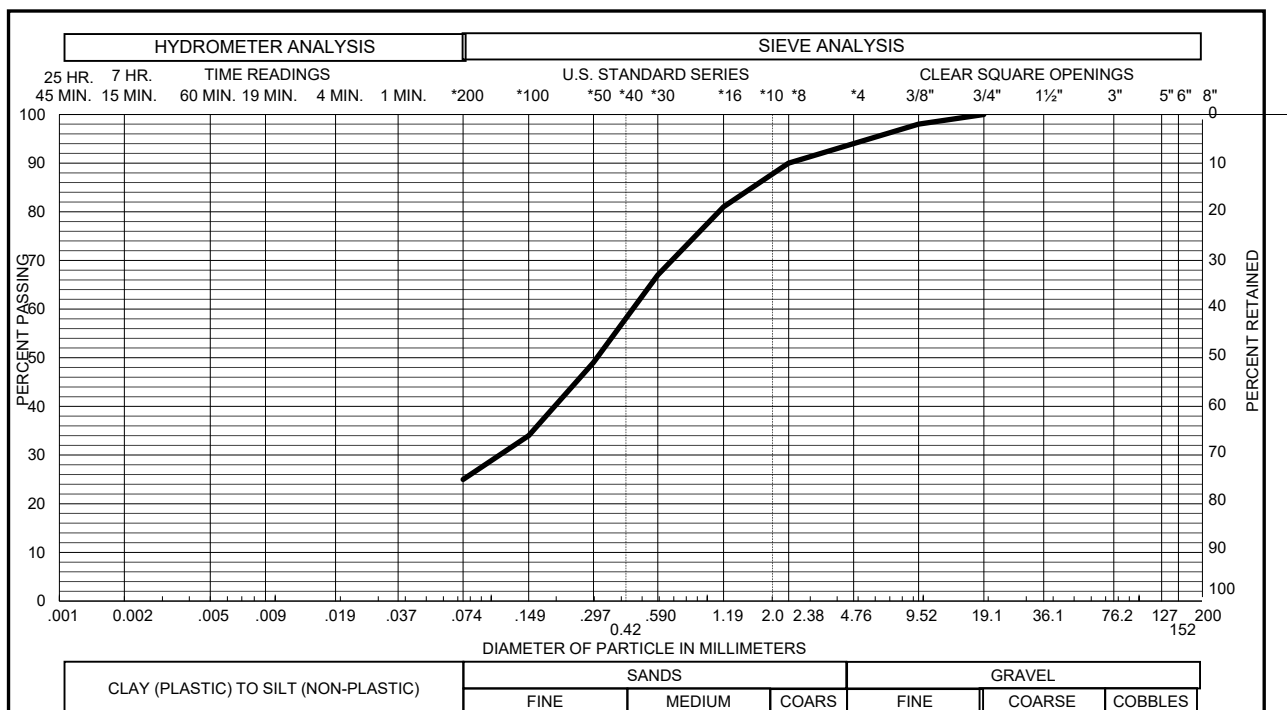
Sample of SAND, SILTY, SLIGHTLY GRAVELLY (SM) GRAVEL 6 % SAND 69 %
From TH - 2 AT 20-24 FEET SILT & CLAY 25 % LIQUID LIMIT _____
PLASTICITY INDEX _____

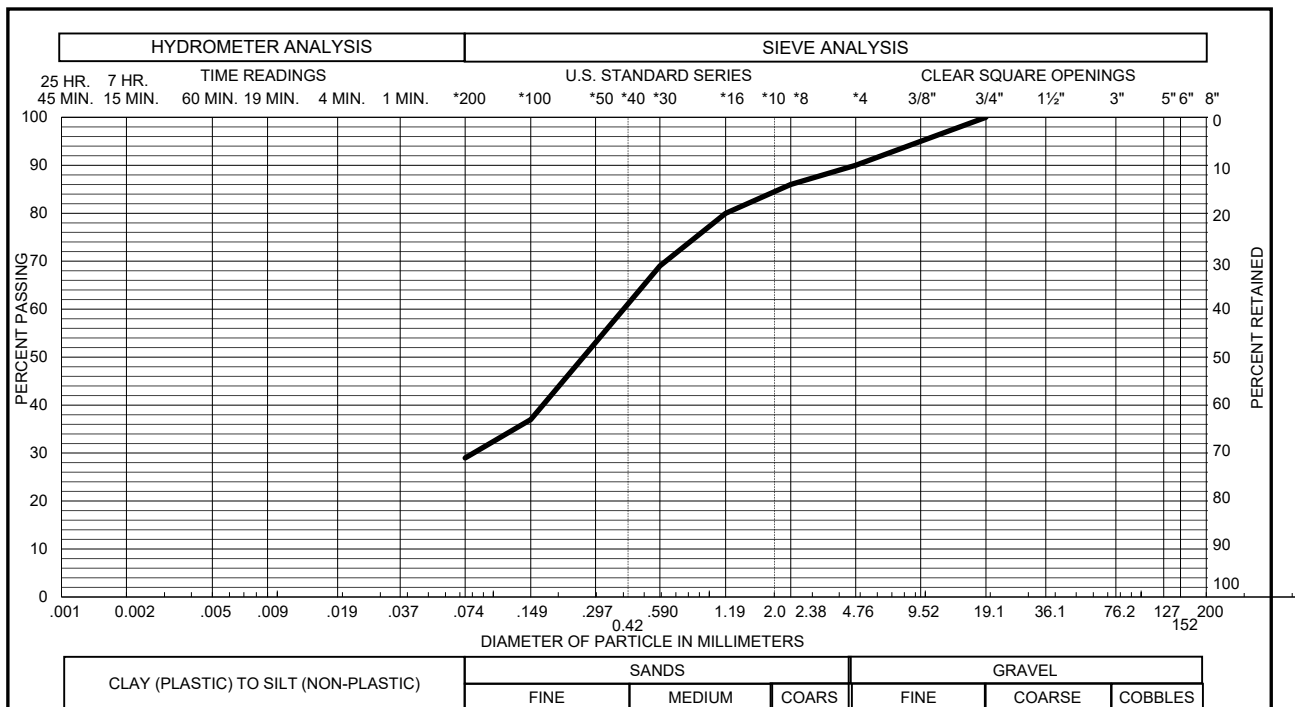
Sample of SAND, SILTY, SLIGHTLY GRAVELLY (SM) GRAVEL 10 % SAND 61 %
From TH - 2 AT 24-29 FEET SILT & CLAY 29 % LIQUID LIMIT
PLASTICITY INDEX

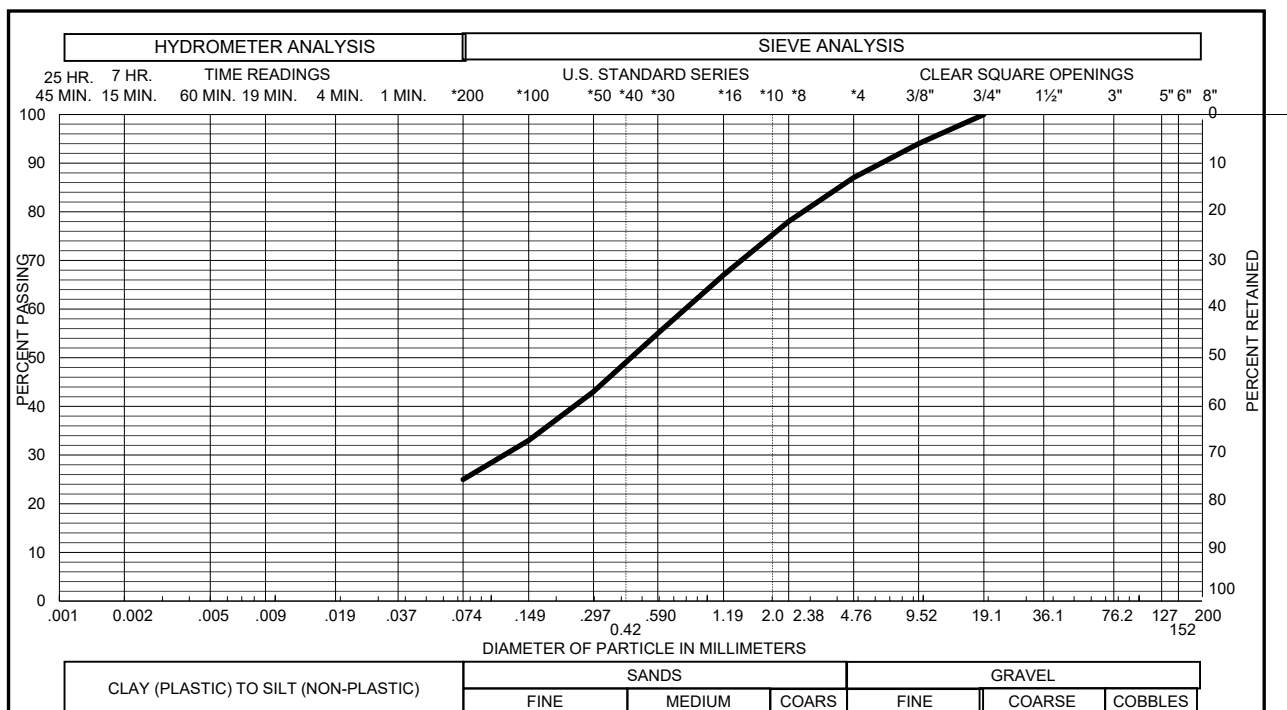
Sample of SAND, SILTY, GRAVELLY (SM) GRAVEL 13 % SAND 62 %
From TH - 3 AT 0-9 FEET SILT & CLAY 25 % LIQUID LIMIT
PLASTICITY INDEX

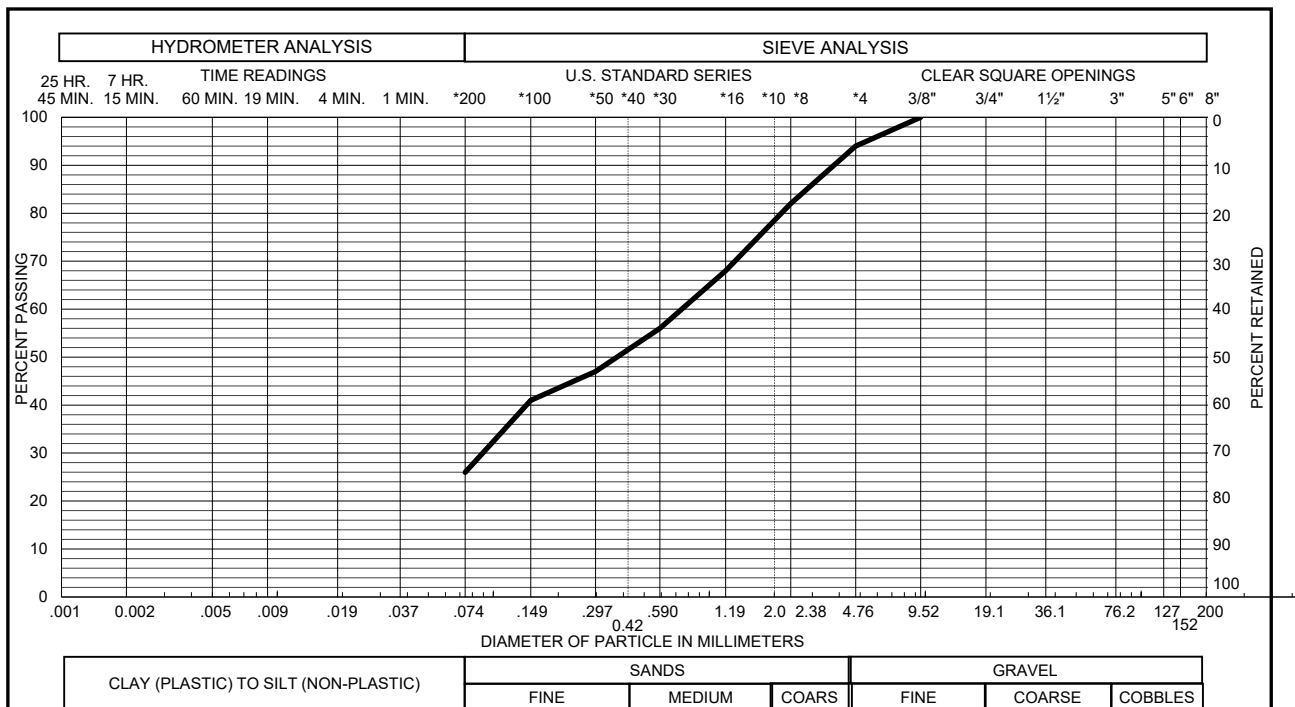
Sample of SAND, VERY SILTY, SLIGHTLY GRAVELLY (SM) GRAVEL 6 % SAND 68 %
From TH - 3 AT 14-19 FEET SILT & CLAY 26 % LIQUID LIMIT _____
PLASTICITY INDEX _____

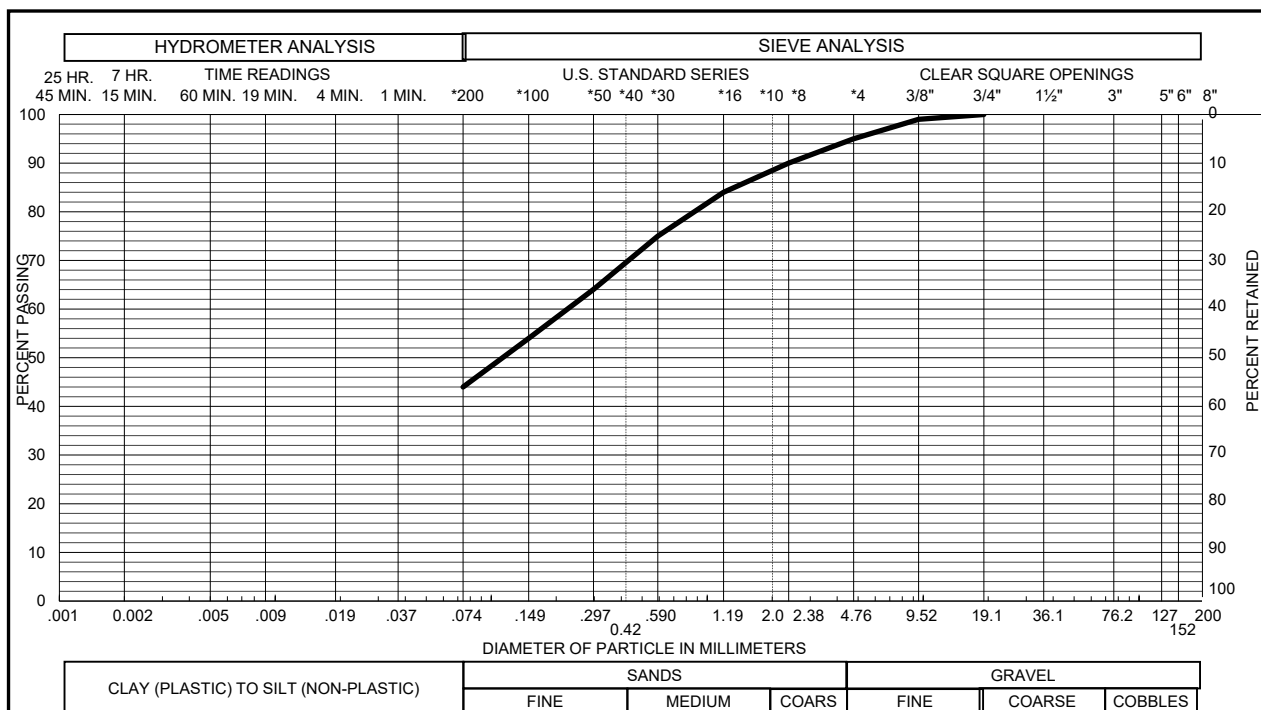
Sample of SAND, VERY CLAYEY, SLIGHTLY GRAVELLY (SC) GRAVEL 5 % SAND 51 %
From TH - 4 AT 0-9 FEET SILT & CLAY 44 % LIQUID LIMIT _____
PLASTICITY INDEX _____

The Everhart Pit contains silty sand with varying amounts of gravel, and clayey sand with varying amounts of gravel extending to depths of 12 to 31 feet. The sand soils were very loose to very dense based on the results of field penetration resistance tests. Five samples of the silty sand soils tested in our laboratory contained 17 to 36 percent silt and clay-sized particles (passing the No. 200 sieve), and up to 19 percent gravel sized particles (passing the 3-inch sieve and retained on the No. 4 sieve). One sample of the clayey sand soils tested in our laboratory contained 44 percent silt and clay-sized particles and 5 percent gravel.
