Figure 2
Castle Concrete Aggregates - Pueblo East Pit - Monitoring Wells
Depth to Ground Water
Phase 1 Area

Figure 4
Castle Concrete Aggregates- Pueblo East Pit - Monitoring Wells
Depth to Ground Water
Phase 7 Area

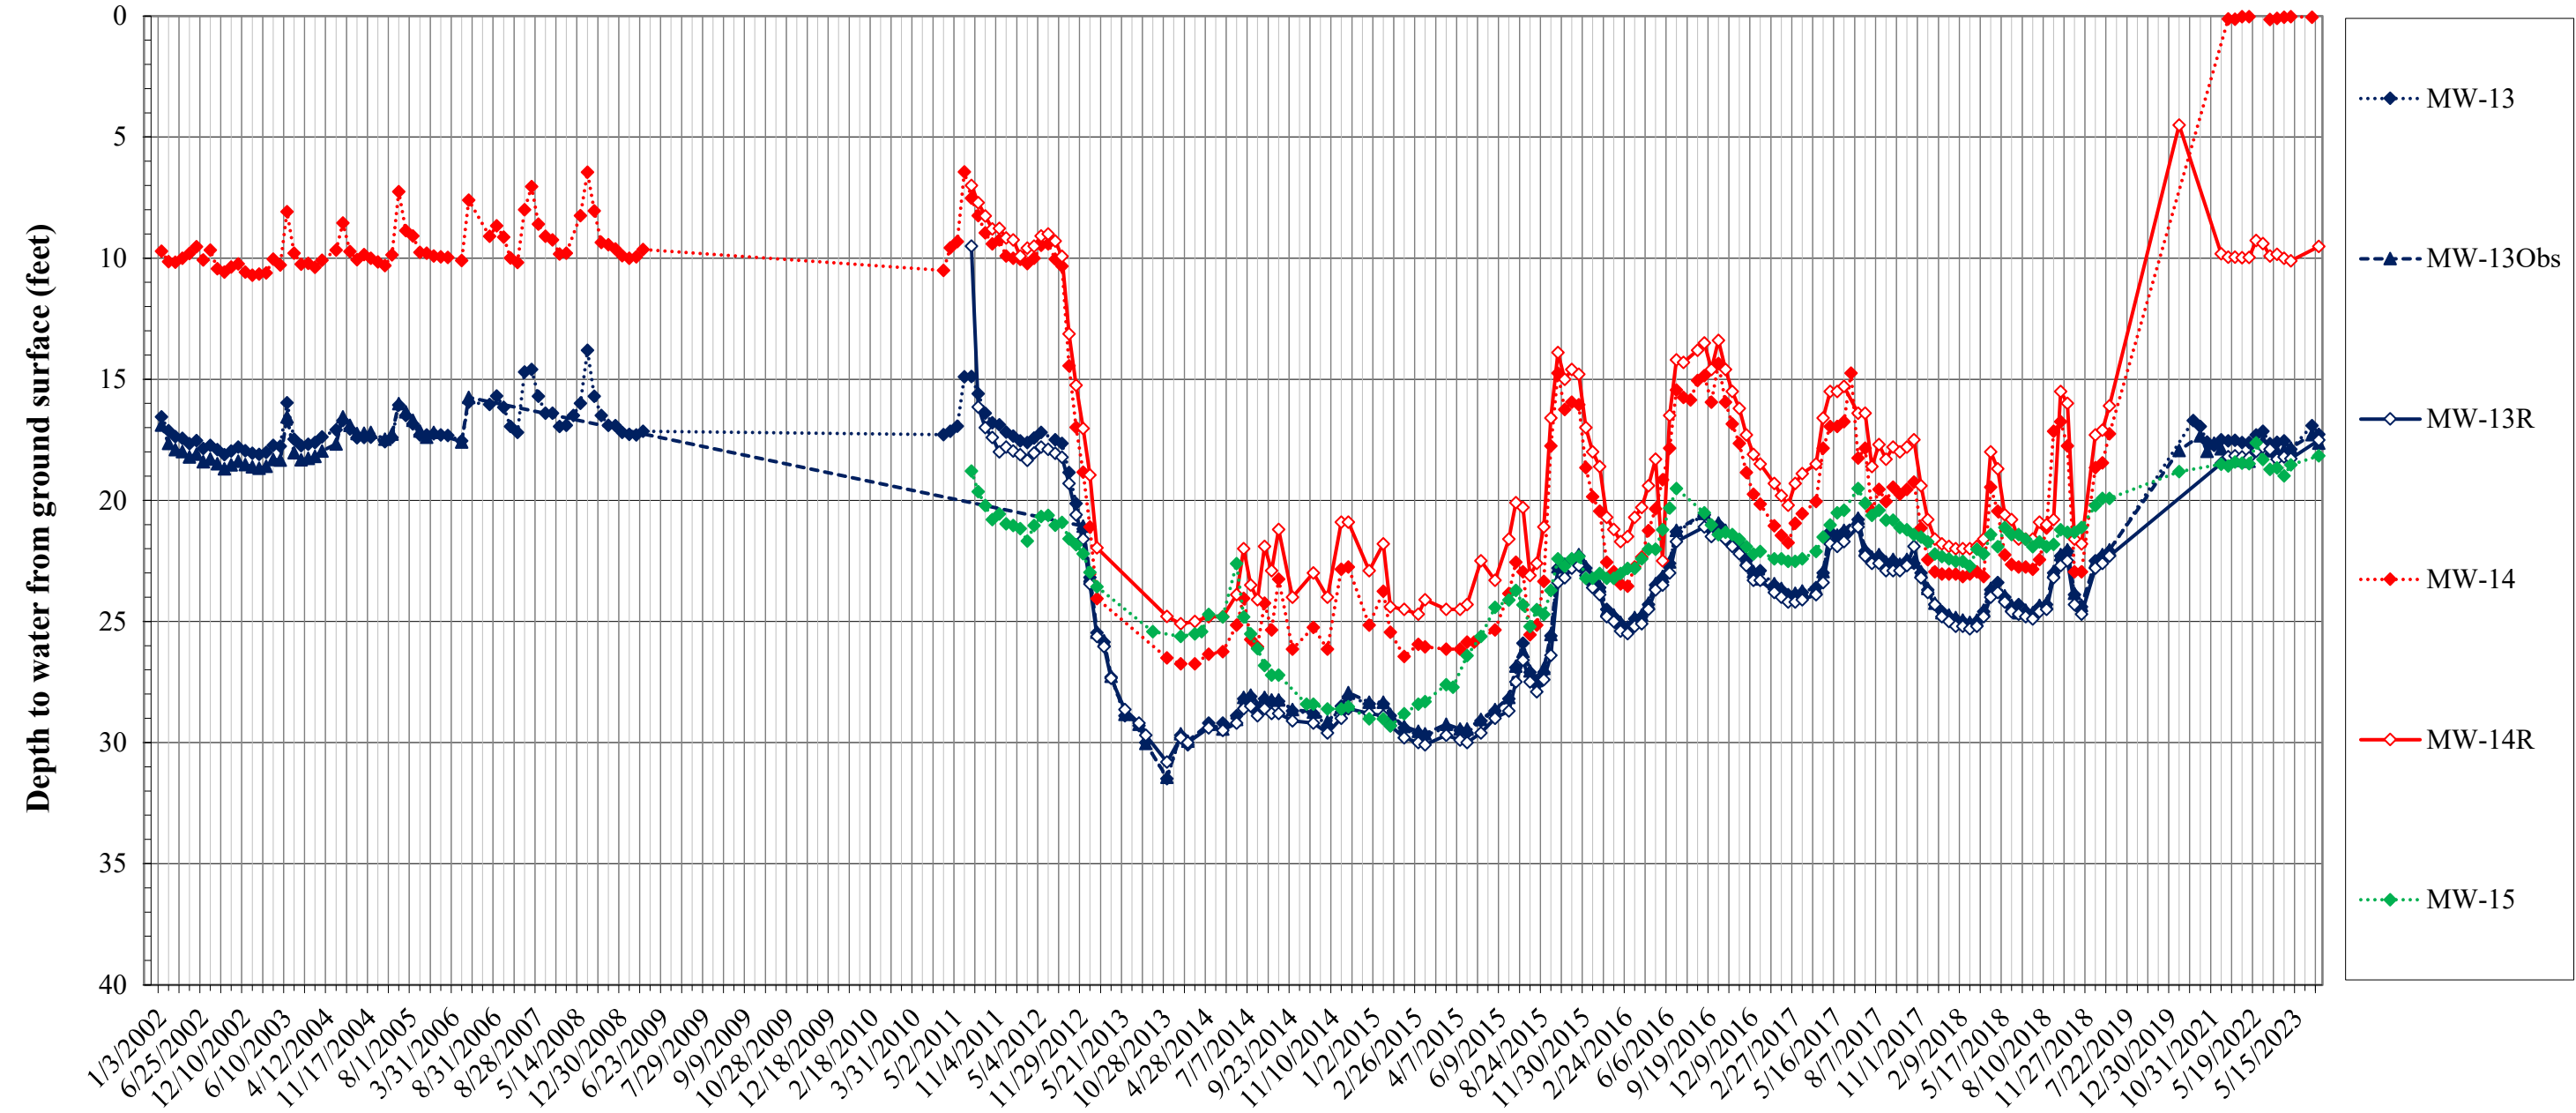
- Increase in depth to water starting in late 2012 due to beginning of dewatering operations at Phase 7.
- Gradual decrease in depth to water from late 2015 to April 2019 present due to reduction in the footprint of the dewatered area. Significant decrease in depth to ground water as of March 2021 due to cessation of dewatering activities at Phase 7 pit in October 2020.
