RE: Additional Information Required and Issuance of Corrective Action, Grassy Valley Groundwater and Surface Water Monitoring Report September 2023; Permit No. M-1980-244

Cripple Creek and Victor Gold Mining Company (CC&V) received the Division of Reclamation, Mining, and Safety's (DRMS) *Additional Information Required and Issuance of Corrective Action, Grassy Valley Groundwater and Surface Water Monitoring Report September 2023; Permit No. M-1980-244*. CC&V has reviewed the additional information required and corrective actions issued in the letter dated November 22, 2023 from DRMS and has prepared the following responses for each comment. The DRMS comment (*in italics*) and CC&V's corresponding response (**in bold**) is presented below.

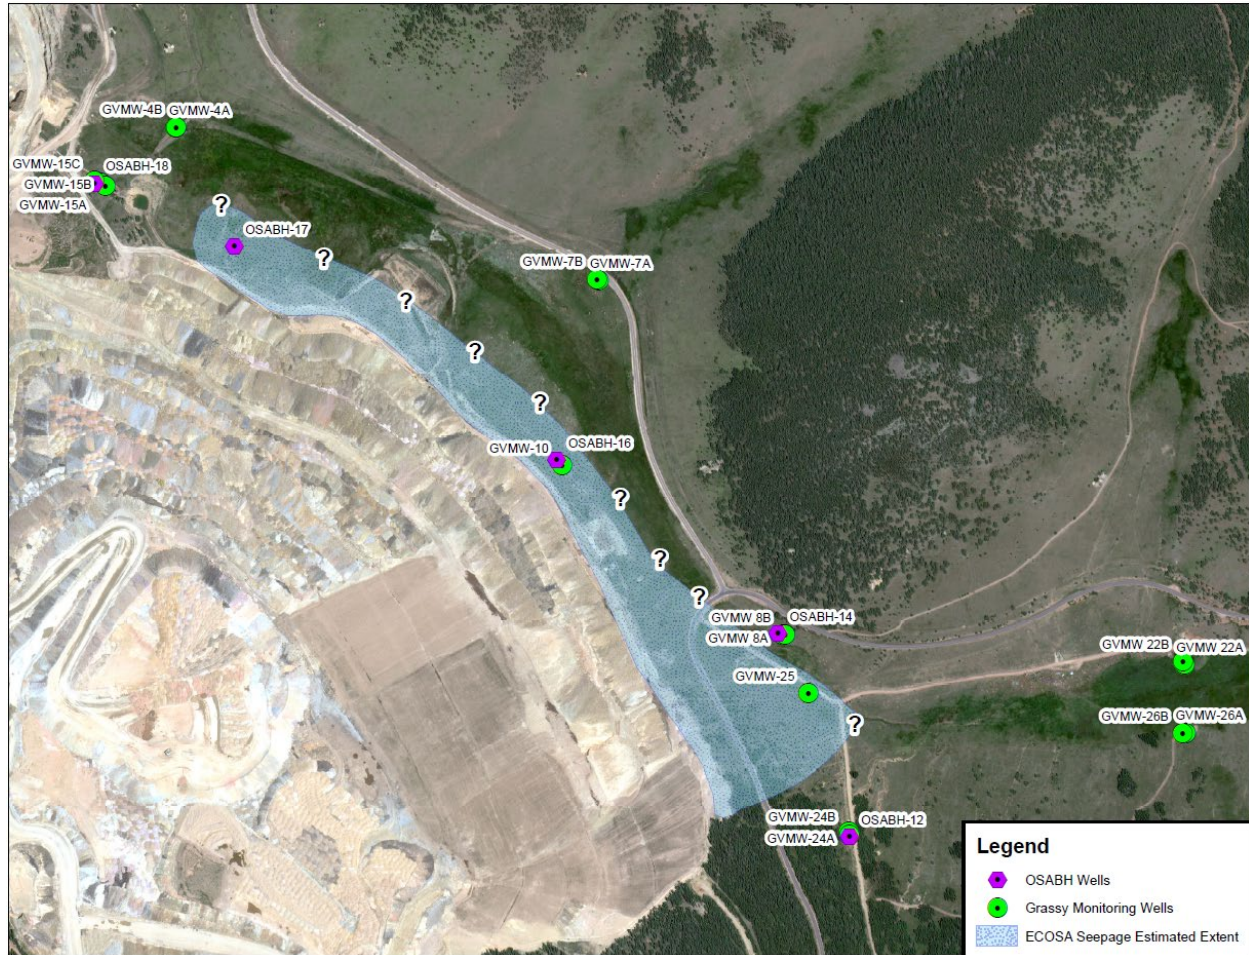
Attachment 1

- Question marks (?) indicate uncertainty with whether or how far beyond the potentially impacted wells seepage may extend

Based on water quality data, CC&V hypothesizes that potential seepage of mine impacted water from ECOSA has been observed at groundwater monitoring wells GVMW-25 & OSABH-17 on the ECOSA (southwest) side of the thalweg of Grassy Valley. It is uncertain whether or how far beyond these wells the seepage may extend, but there is no indication of seepage observed on the opposite (northeast) side of the thalweg as seen from water quality data at monitoring
