**Construction Materials Regular (112) Operation
Reclamation Permit Application**

**Butala Construction Co.
Salida, Colorado**

**November 2023
Revised 1/24/2024**

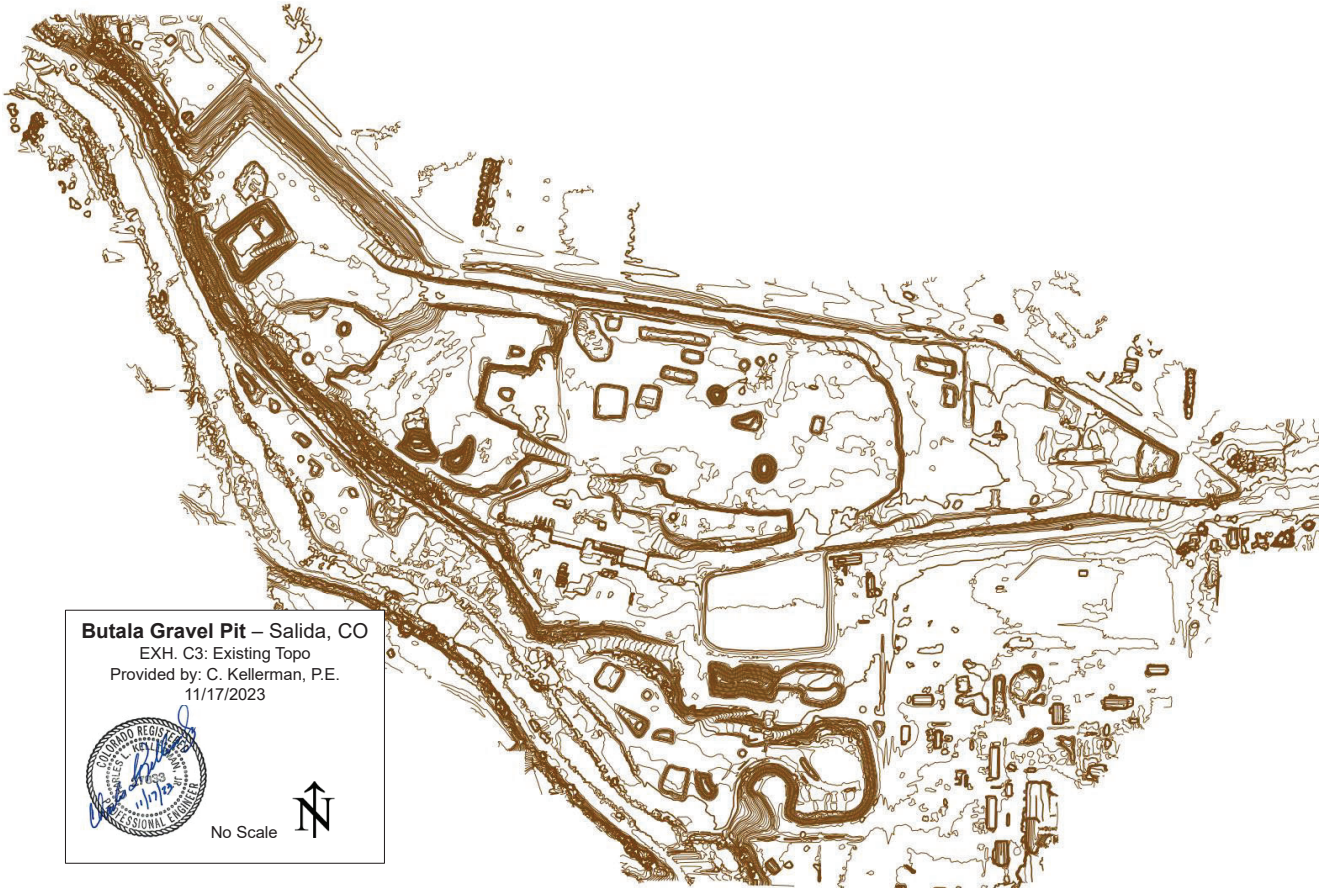
Butala Gravel Pit – Salida, CO
EXH. C3: Existing Topo
Provided by: C. Kellerman, P.E.
11/17/2023

LIDAR contour schematic, August 2023. Note: the entire property drains towards the Arkansas River (lower left).

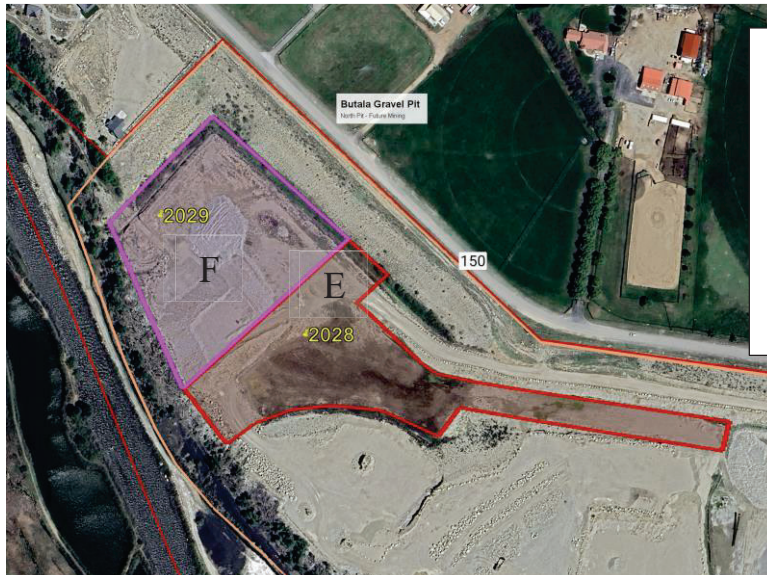
EXH. D2: North Pit Mining Plan

Previously, two pits have been excavated to approximately 25 feet by first removing 1-3 feet of overburden, then proceeding across the pits with high, side wall excavation. The North pit has been fully mined to the first 25-foot level with a pit floor of approximately 10 acres. The South pit is currently nearing completion of the first 25-foot level and will have a pit floor of approximately 23 acres.
