Re: Resolution of Groundwater Comments, M-1980-183

encl: Brannan (Scott Legg) letter, February 8, 2024, Quarterly Groundwater Monitoring Results
Civil Resources (Brad Hagen) letter, February 13, 2024, Groundwater Mounding East of Pit 29

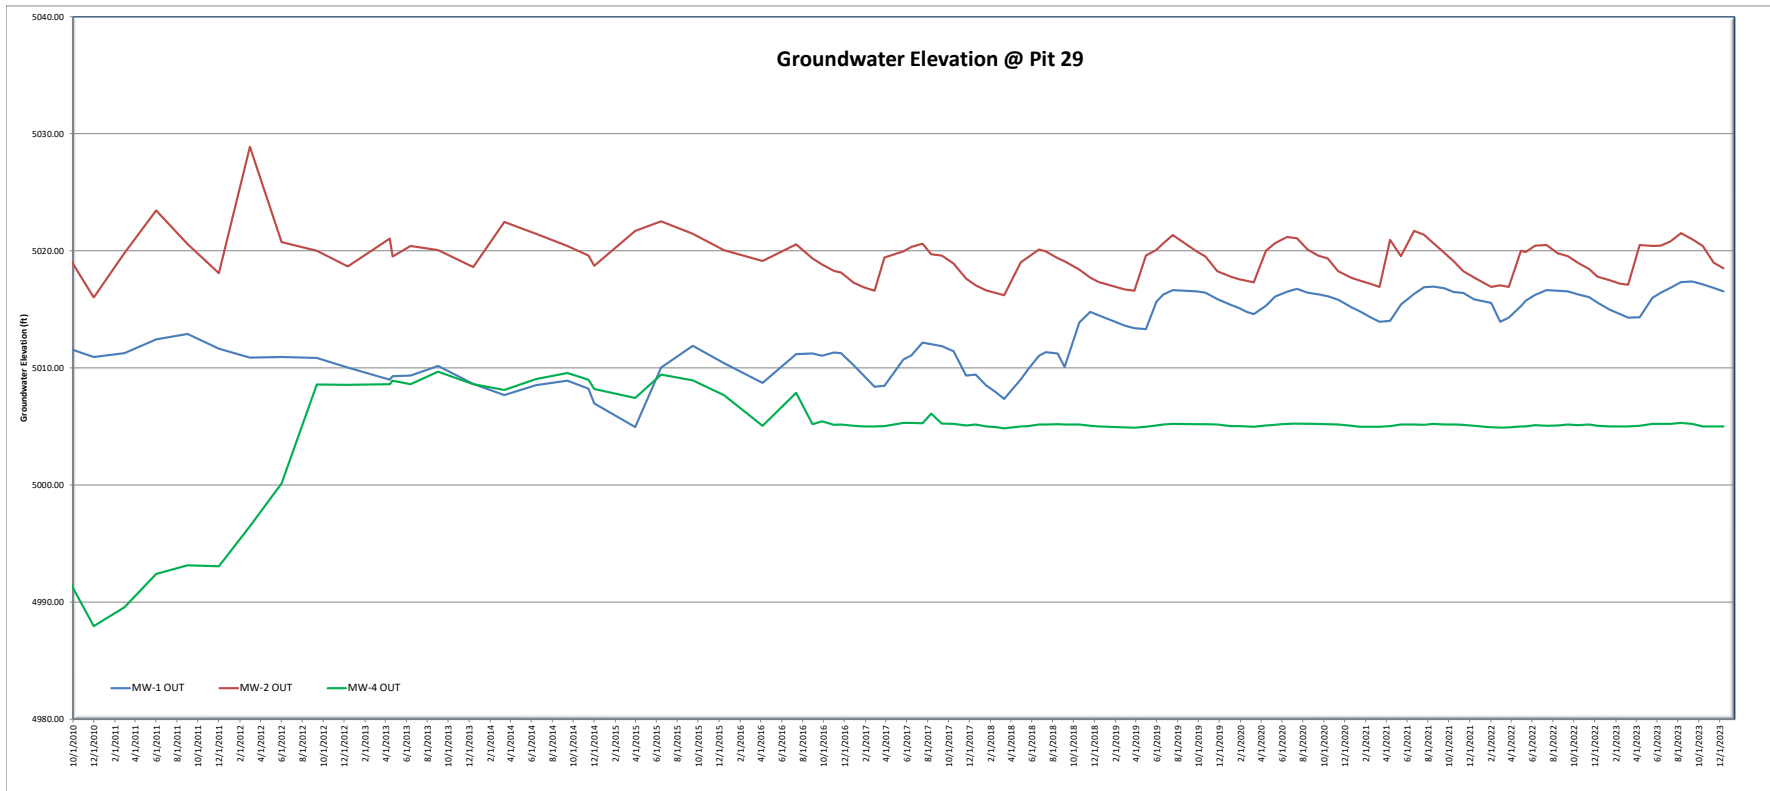
Attachment B

Graph of Groundwater Elevations

*Missing data from 11/12/2012 for MW-1 & MW-2 has been interpolated to provide graphical continuity.

Stated concisely, data from MW-1 since the slurry wall repair in 2019, at the cited east side permit boundary, illustrates a rebounding effect from artificially depressed groundwater levels. For further explanation, enclosed is a supplementary engineering/hydrogeology letter from Civil Resources, LLC.

The hydrologic balance is being kept in check by the French drain, as verified by the readings from MW-4. There have not been any offsite impacts associated with hydrologic balance issues observed since the French drain was installed. MW-2 groundwater levels appear to be similar to previous years and are currently exhibiting seasonal fluctuations. MW-1 groundwater levels are exhibiting seasonal fluctuations. The groundwater levels in MW-1 have remained within a steady range since early 2019.

- c. Brannan’s impact on the local groundwater balance became negligible when the water levels recovered following repair of the slurry wall and ceasing pumping of the groundwater in 2019. The documented groundwater levels recovered following the slurry wall repair and have been stable over the last several years with water levels fluctuating seasonally within natural variability. Refer to Brannan’s letter latest Quarterly monitoring results.
