| PROJECT | | VLF3 PHASE 3 STAGE A.2 | |
| TITLE | LEAK DETECTION TRENCH 2<br>AS-BUILT PLAN AND PROFILE | | FILENAME |

| TITLE | LEAK DETECTION TRENCH 1<br>AS-BUILT PLAN AND PROFILE | | FILENAME |

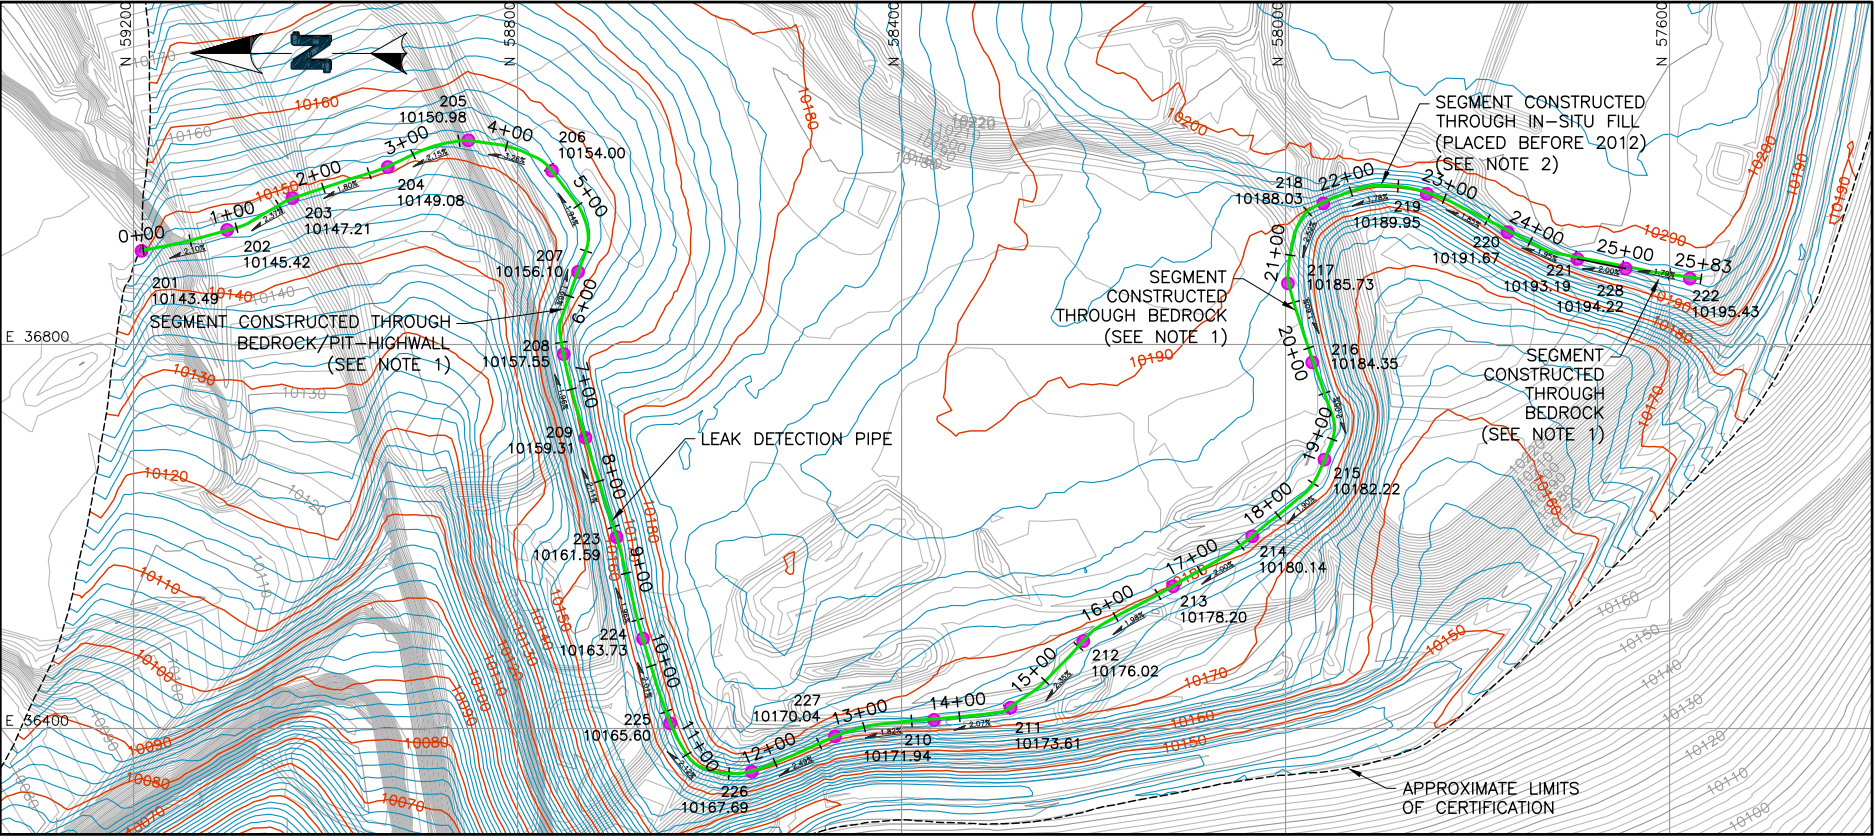
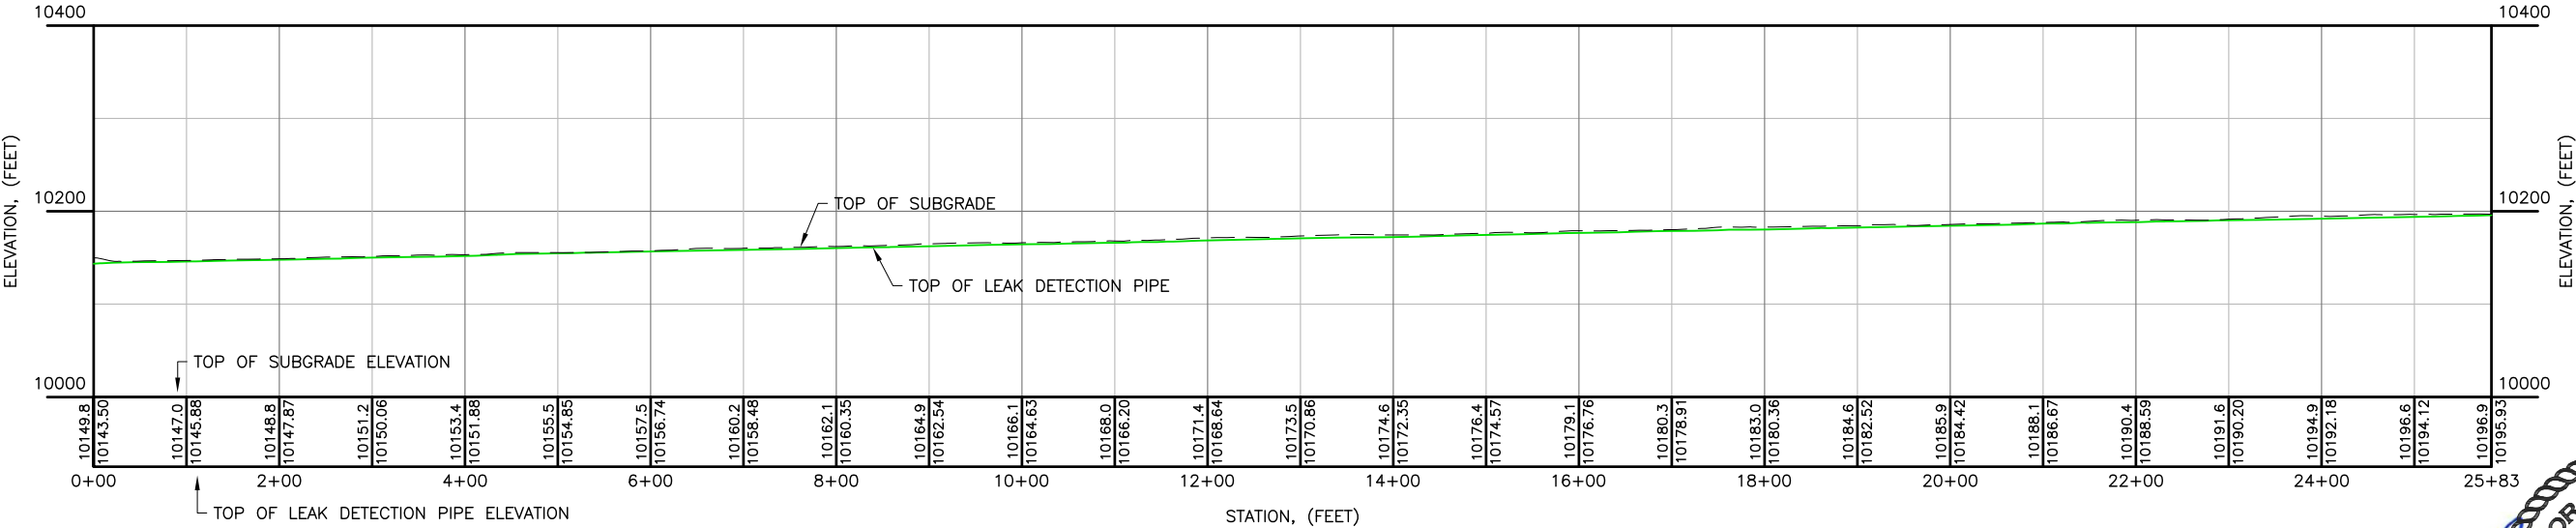
| | | 6 | 1 |

- NOTES:**
1. SEGMENT CONSTRUCTED THROUGH BEDROCK/PIT-HIGHWALL. METHODS NECESSARY FOR FURTHER EXCAVATION, SUCH AS BLASTING, WOULD BE LESS PRECISE AND ULTIMATELY DETRIMENTAL TO THE PROJECT. SETTLEMENT IN THESE AREAS IS UNLIKELY.
  2. SEGMENT CONSTRUCTED THROUGH IN-SITU FILL PLACED BEFORE 2012. SETTLEMENT IN THESE AREAS IS UNLIKELY.
  3. OVERALL SLOPE OF UPPER LEAK DETECTION TRENCH IS 2.06%.
