### Pit 29 Groundwater

Attached you will find Brannan's response to ongoing questions concerning groundwater levels at the eastern boundary of Pit 29 (M-1980-183).

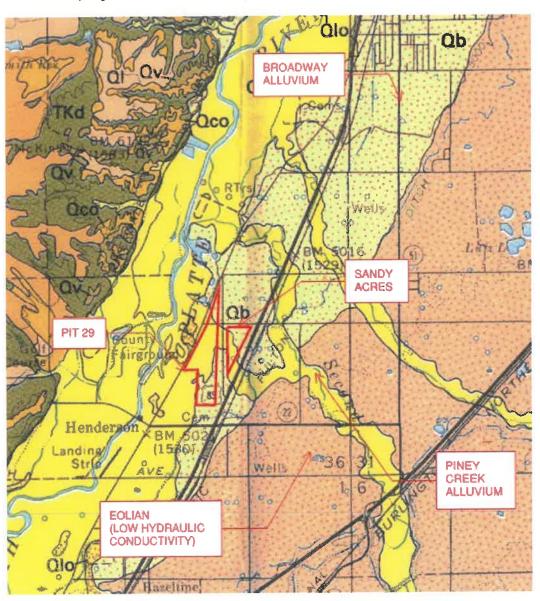
As shown in the geologic map below (Trimble 1979), the Pit 29 slurry wall was constructed to within 800 feet of the low conductivity eolian deposits to the east of Highway 85. This may have decreased the amount of flow to the northeast essentially putting the eastern side of the Site including the Sandy Acres Site in the groundwater shadow. The groundwater shadow in conjunction with evaporation from the unlined Sandy Acres Site would account for the drop in groundwater elevation during this period.

- Filling of Sandy Acres Site (2015 to 2018): From March 2015 to September 2015, groundwater elevation then rose approximately 7 feet to 5011.9 feet or 2.3 feet below historic. This coincides with the filling of Sandy Acres with low permeability fill. As shown in the USGS geologic map (Trimble 1979) above, the location of the Sandy Acres Site is located in what was likely a channel of the Second Creek drainage consisting of Piney Creek Alluvium and Broadway alluvium, both with relatively high hydraulic conductivity. Filling in this historic stream bed with low permeability material potentially cut off flow to the north causing the observed mounding and abrupt rise in groundwater elevation. Even considering this rise in groundwater elevation, groundwater elevation at MW-1 OUT is consistently lower than the 1980 groundwater elevation during this time period.

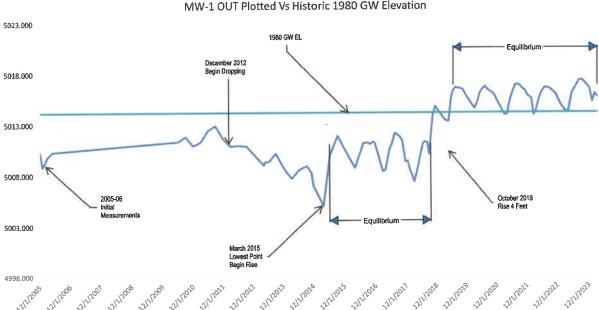
- Post Slurry Wall Repair (2018 to current): Groundwater elevation then remained at levels that would be expected from seasonal variability until October 2018 when groundwater rose approximately 4 feet in one month to 5013.8 feet or 0.4 feet below historic. Since October 2018, groundwater has remained relatively consistent ranging from 5013.3 feet (0.9 feet below historic) to 5017.4 (3.2 feet above historic). The graph below shows the changes in groundwater elevation at MW-1 OUT in relation to the 1980 water elevation.

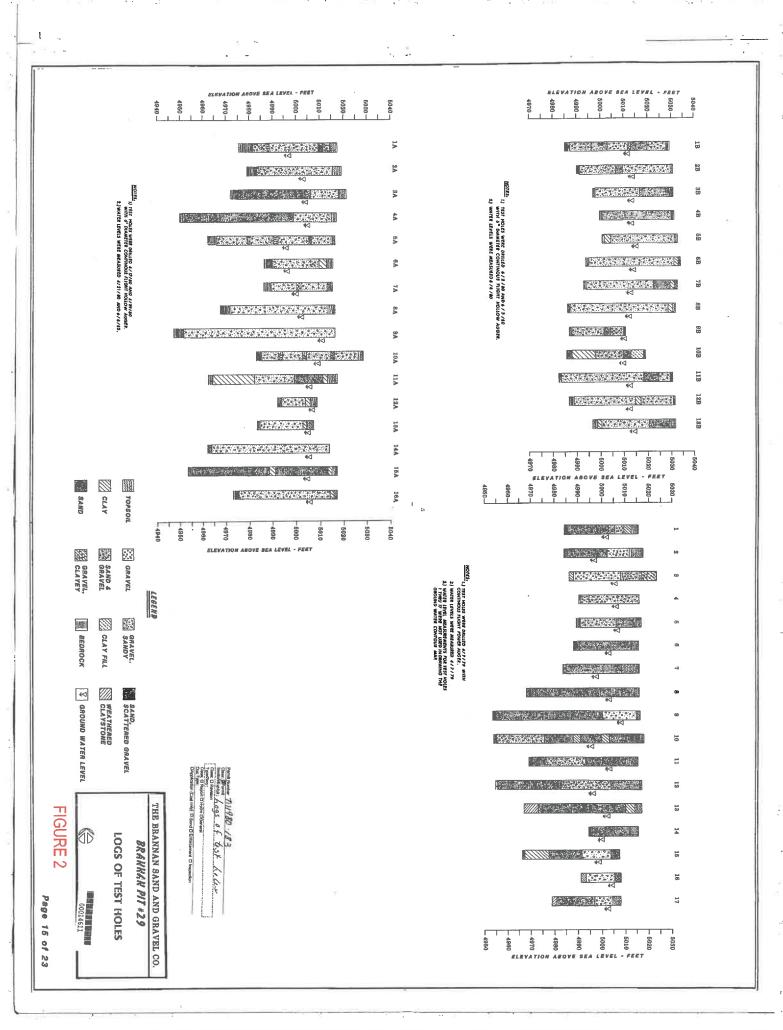
FIGURE 1

After further review of the DRMS permit record, CR identified a report completed by Blatchley Associates Inc. which presented pre-mining groundwater levels at the proposed Pit 29 Site. The investigation included forty six (46) test holes drilled to bedrock at the site on: April 7, April 17, May 29, June 2, and June 3 1980. The groundwater measurements were taken from twenty-six (26) of these test holes 3 to 6 days after drilling (April 21 for holes drilled April 17 and June 6 for test holes drilled May 29, June 2, and June 3) and were used to generate the presented groundwater contours. Obtaining water levels multiple days after drilling would allow the water table to recover from any disturbance from the drilling process and provide reliable groundwater elevation data. The seventeen (17) test holes not used in the groundwater level analysis had water levels taken on the same day as drilling and were considered less reliable. Figure 1 shows the locations of the test holes and corresponding groundwater level data and Figure 2 depicts the drill logs.

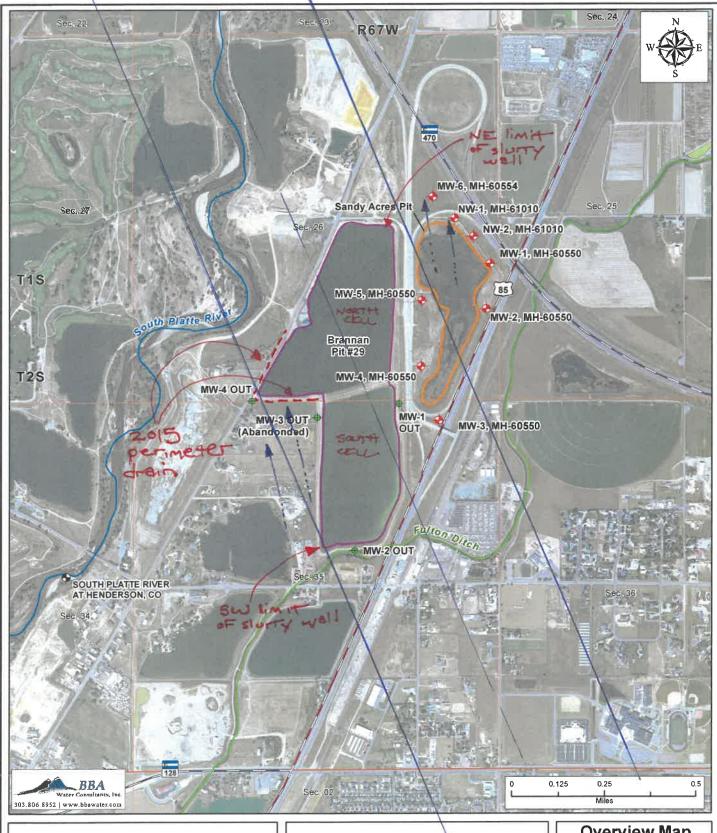
### Figure 1 E-470 Sandy Acres Pit Monitoring Well Locations

Date: 2/8/2024 | Job No. 9607.00 Aerial Photo Date: 8/3/2019 NAIP-USDA Data Source: CDSS, CDOT, USGS, BLM

- Observed Mounding: E-470 Acknowledges that groundwater mounding is primarily observed on its south boundary which directly infers that the groundwater flow is from that direction. Similarly, groundwater mounding caused by Pit 29 has been observed to occur on its south boundary. Regardless, the Pit 29 mounding was either previously mitigated or determined to have no deleterious effects on adjacent properties to its south.
