**Re: Permit No. M-1980-244; Cripple Creek & Victor Gold Mining Company; Cresson Project;**  
**Technical Revision 144 – Adequacy Review Response**

# Seepage Collection Design Memorandum

Newmont ECOSA Seepage Mitigation

# EAST CRESSON OVERBURDEN STORAGE AREA (ECOSA) SEEP MANAGEMENT

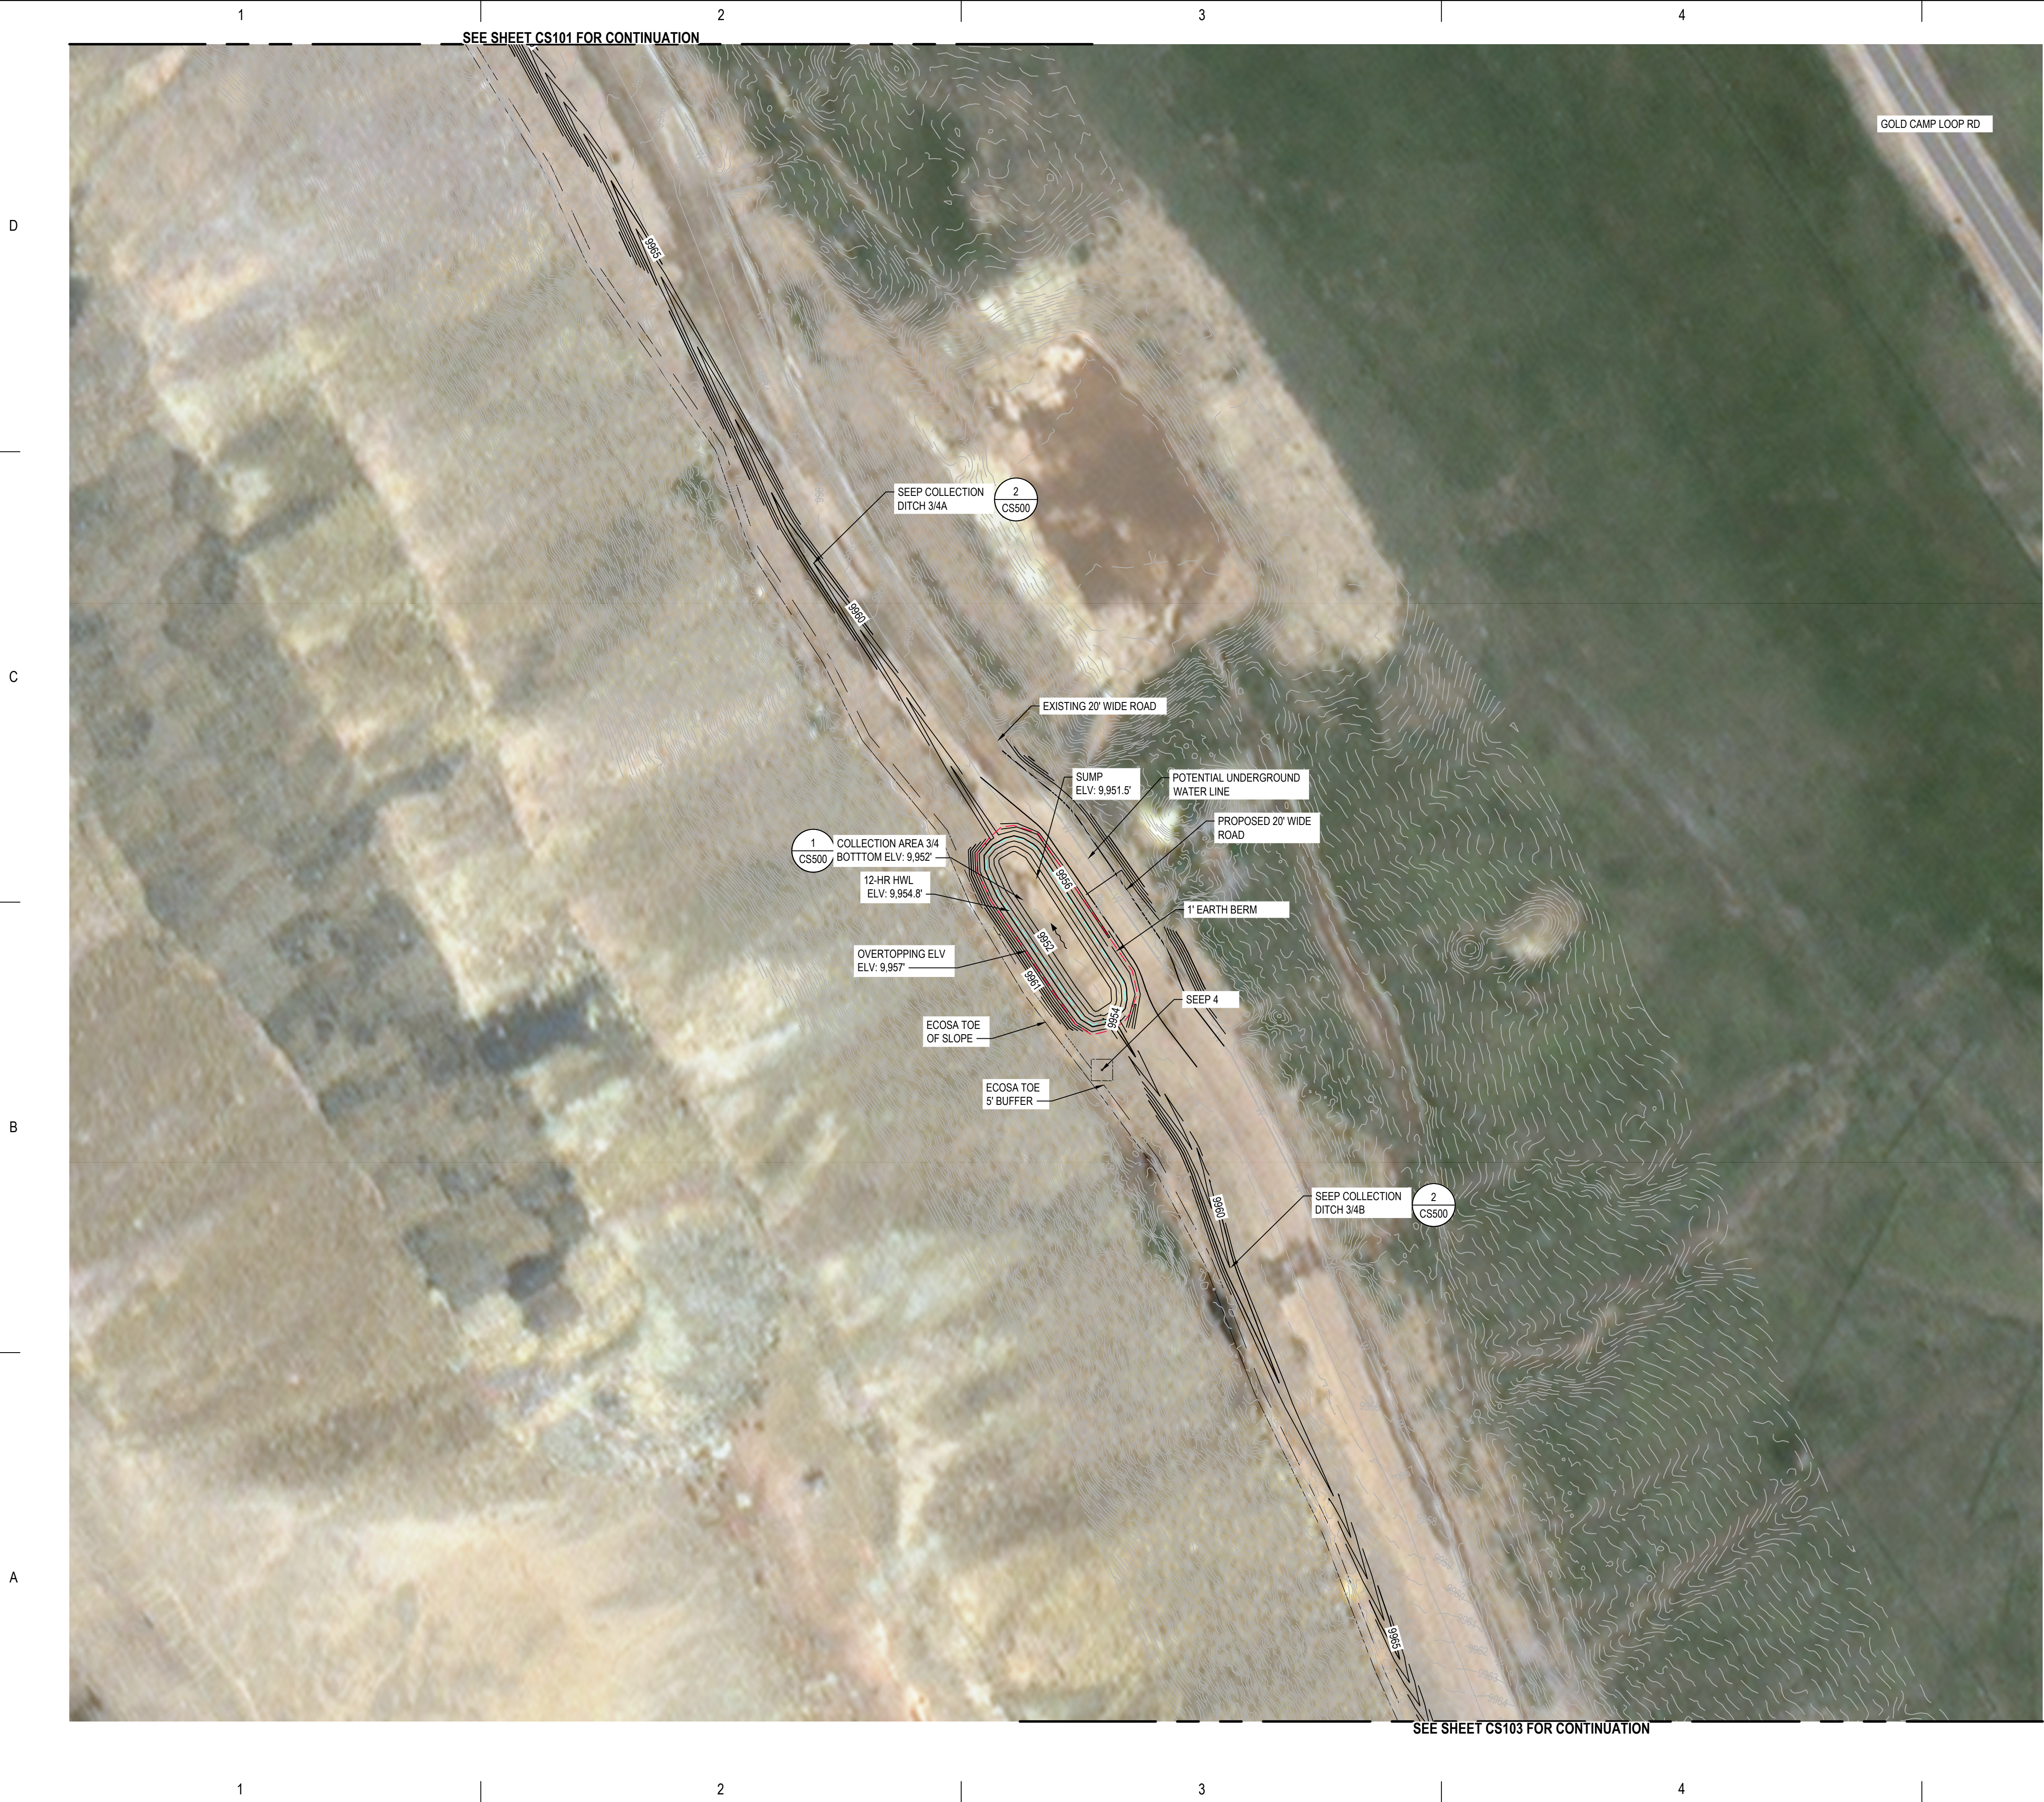
- GENERAL NOTES:**
- 1. SEE SHEET CS300 AND CS301 FOR SEEP COLLECTION DITCH 3/4A PROFILE.
  - 2. SEE SHEET CS302 FOR SEEP COLLECTION DITCH 3/4B PROFILE.
  - 3. CONSTRUCT COLLECTION AREA WITH SLOPED BOTTOM TO FACILITATE PUMPING TO THE ELEVATIONS PROVIDED.
- LINER NOTES:**
- 1. REMOVE ALL VEGETATION AND STUBBLE FROM AREAS TO BE LINED.
  - 2. EXCAVATE ALL EXISTING AREAS TO NATIVE CLAY LAYER. ALL SURFACES TO BE LINED SHALL BE FREE OF ALL SHARP STONES, ROCKS LARGER THAN 3/4 INCHES IN ANY DIMENSION, AND OTHER OBJECTS WHICH MAY DAMAGE THE LINER.
  - 3. ALL EARTH MATERIALS SHALL BE APPROVED BY THE ENGINEER.
  - 4. PROVIDE ANCHOR TRENCHES AT PERIMETER OF LINING AS SHOWN ON DRAWINGS OR RECOMMENDED BY LINER MANUFACTURER AND APPROVED BY ENGINEER.

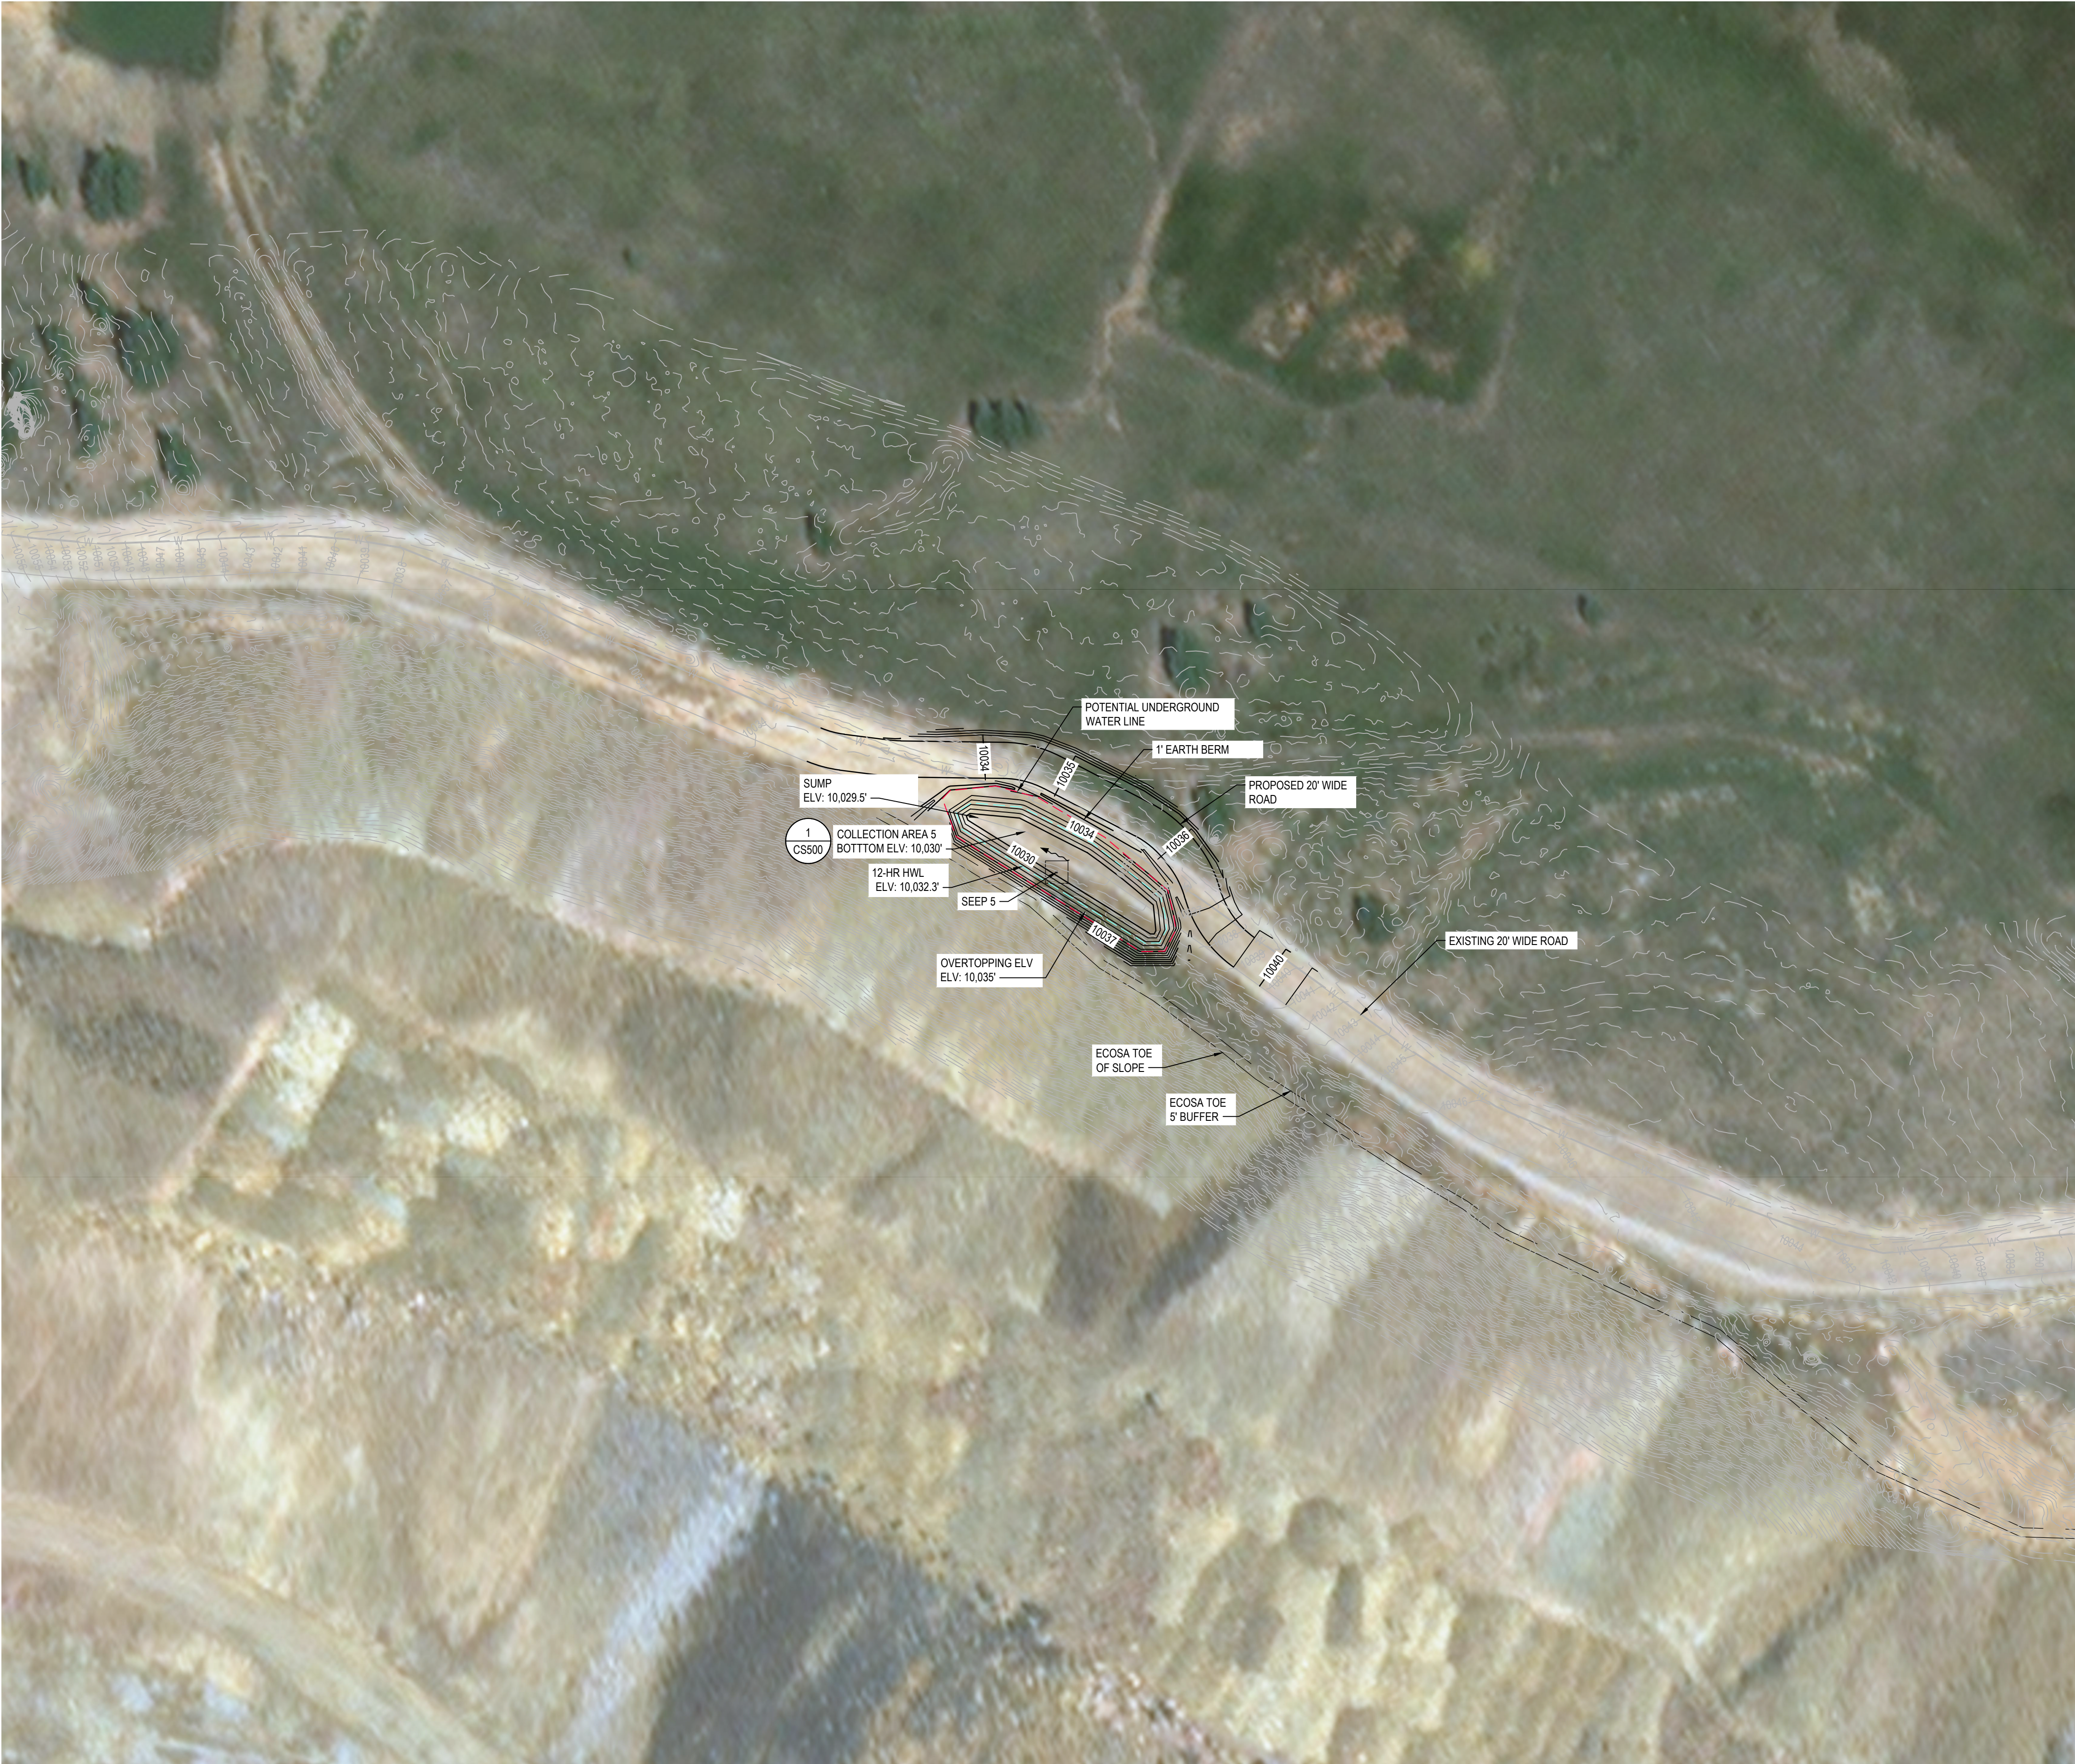
1. CONSTRUCT COLLECTION AREA WITH SLOPED BOTTOM TO FACILITATE PUMPING TO THE ELEVATIONS PROVIDED.
