EXHIBIT E
Reclamation Plan

3.0 RECLAMATION PLAN

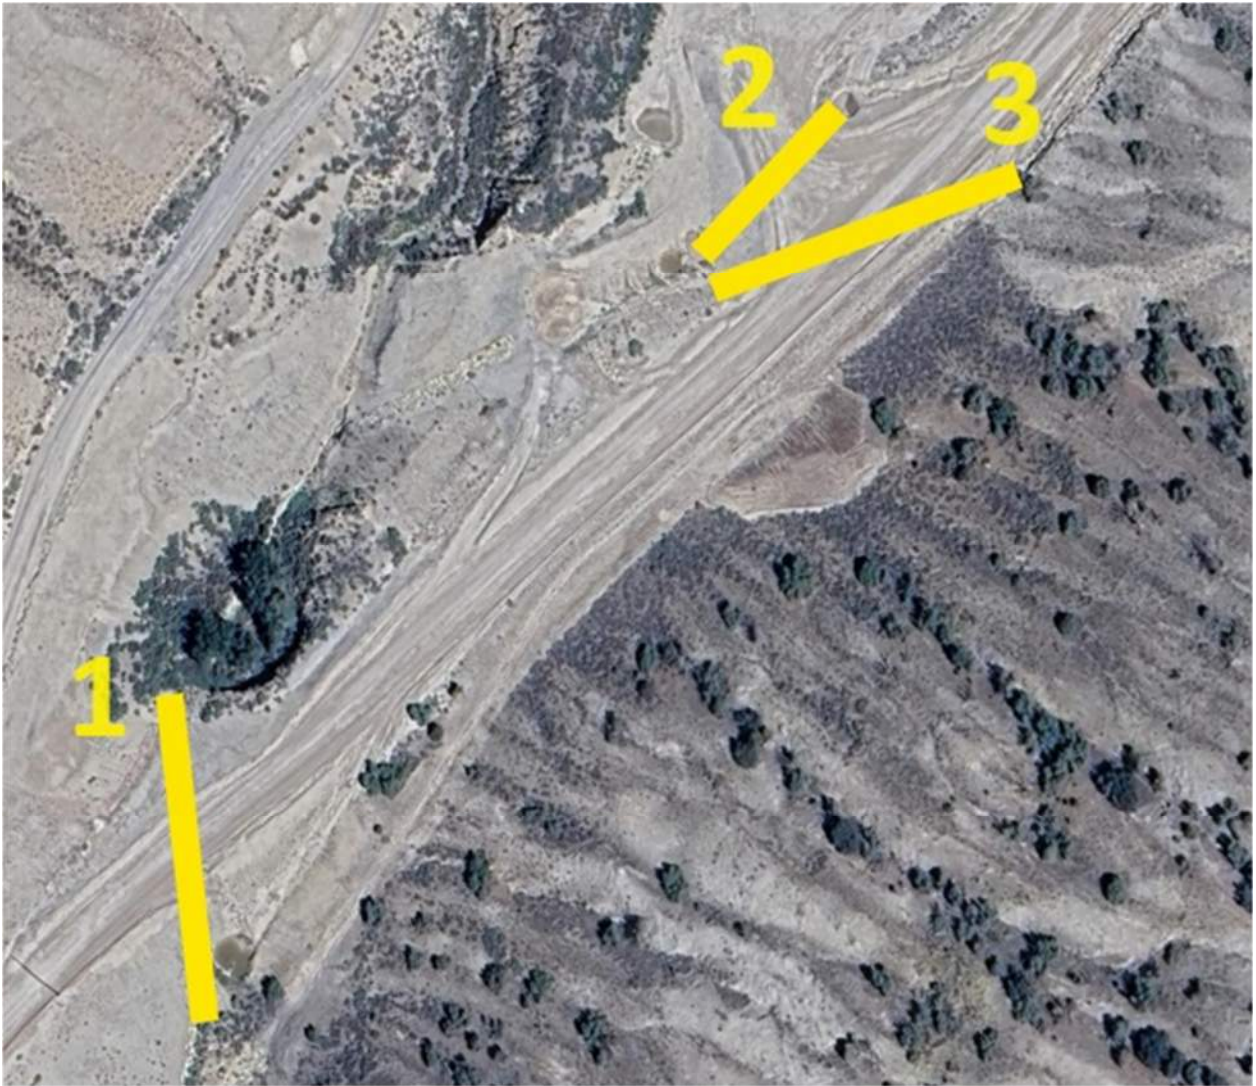
Figure 3.1. Locations of culverts 1, 2, and 3

Dry creek beds at the Mine rarely flow (only during isolated major storms). Following cessation of mining activities, culverts (constructed to convey flows under road fills during storm events) would be removed and road fill excavated to reestablish native drainage channels. As necessary, based on the conditions encountered during culvert removal, natural channels would be constructed with rock vortex weirs or isolated sections of riprap lining to prevent erosion.

Block Heater Breaker	Electrical panel box with wood frame cover	4.5 × 7.5	6-inch thick reinforced concrete (wire reinforcement)
Truck Shed	Metal Canopy	12 × 16, pad 12 × 30 × 12, shed	6-inch thick reinforced concrete (wire reinforcement)
Culvert 1	Corrugated steel pipe	320 (l) × 5 (d)	N/A
Culvert 2	Corrugated steel pipe	232 (l) × 3 (d)	N/A
Culvert 3	Corrugated steel pipe	142 (l) × 2 (d)	N/A
Culvert 4	Corrugated steel pipe	440 (l) × 5 (d)	N/A
Culvert 5	Corrugated steel pipe	284 (l) × 3 (d)	N/A
Culvert 6	Corrugated steel pipe	252 (l) × 3 (d)	N/A
Culvert 7	Corrugated steel pipe	143 (l) × 3 (d)	N/A
Culvert 8	Corrugated steel pipe	260 (l) × 3 (d)	N/A
Conexes (4)	Mobile Storage Boxes	8 × 40 × 12	N/A
Conex	Mobile Storage Box	8 × 20 × 12	N/A

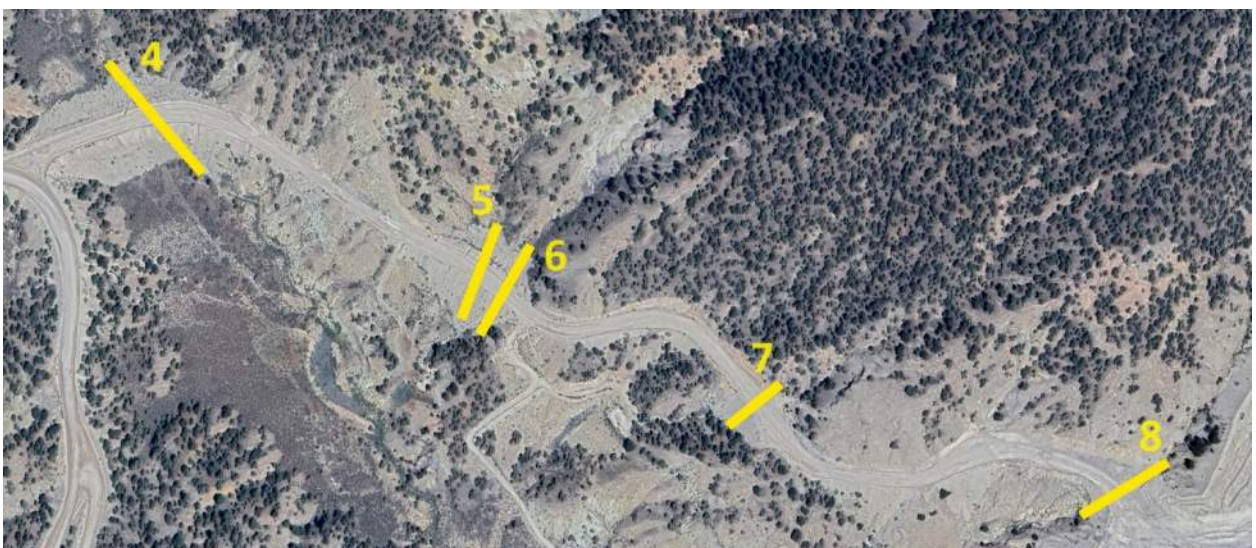
Figure 3.2. Locations of culverts 4, 5, 6, 7, and 8
