**Re: Tailings Delivery Line (TDL) Leak – Climax Mine Permit No. M-1977-493**

# Attachment 1 – Location Map

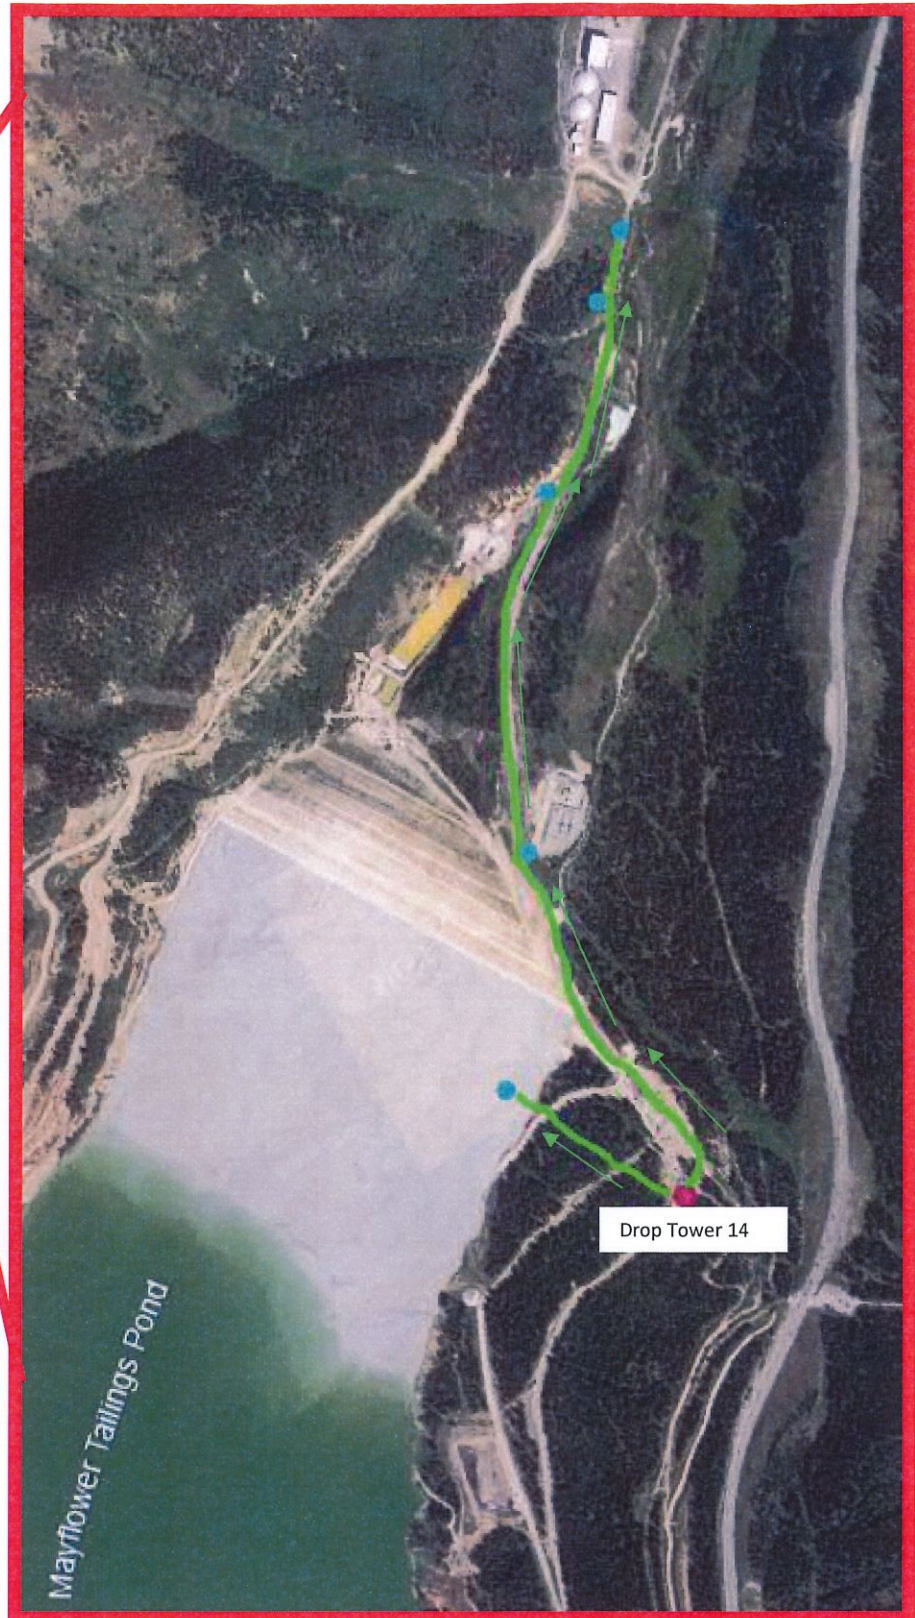
Drop Tower 14 (Pink Dot) overflowed and spilled tailings material that followed pathways (Green Lines) and ultimately ponded and froze at five locations (Blue Dots). All spill material was contained on the roadway and has been recovered and hauled back for deposition in Mayflower TSF.

Attachment 1 depicts the location of Drop Tower 14, the spill pathways, and the farthest locations the spill traveled.
