RE: M1973007SG, TR-11 Adequacy Review #1 - Holcim Response

Holcim has completed our response to your Adequacy Review #1 for TR-11 at the Daniels Sand Pit 2 Facility. The responses to your questions are in order below. Please let us know if you have any questions. We look forward to the DRMS's review and approval of this Technical Revision.

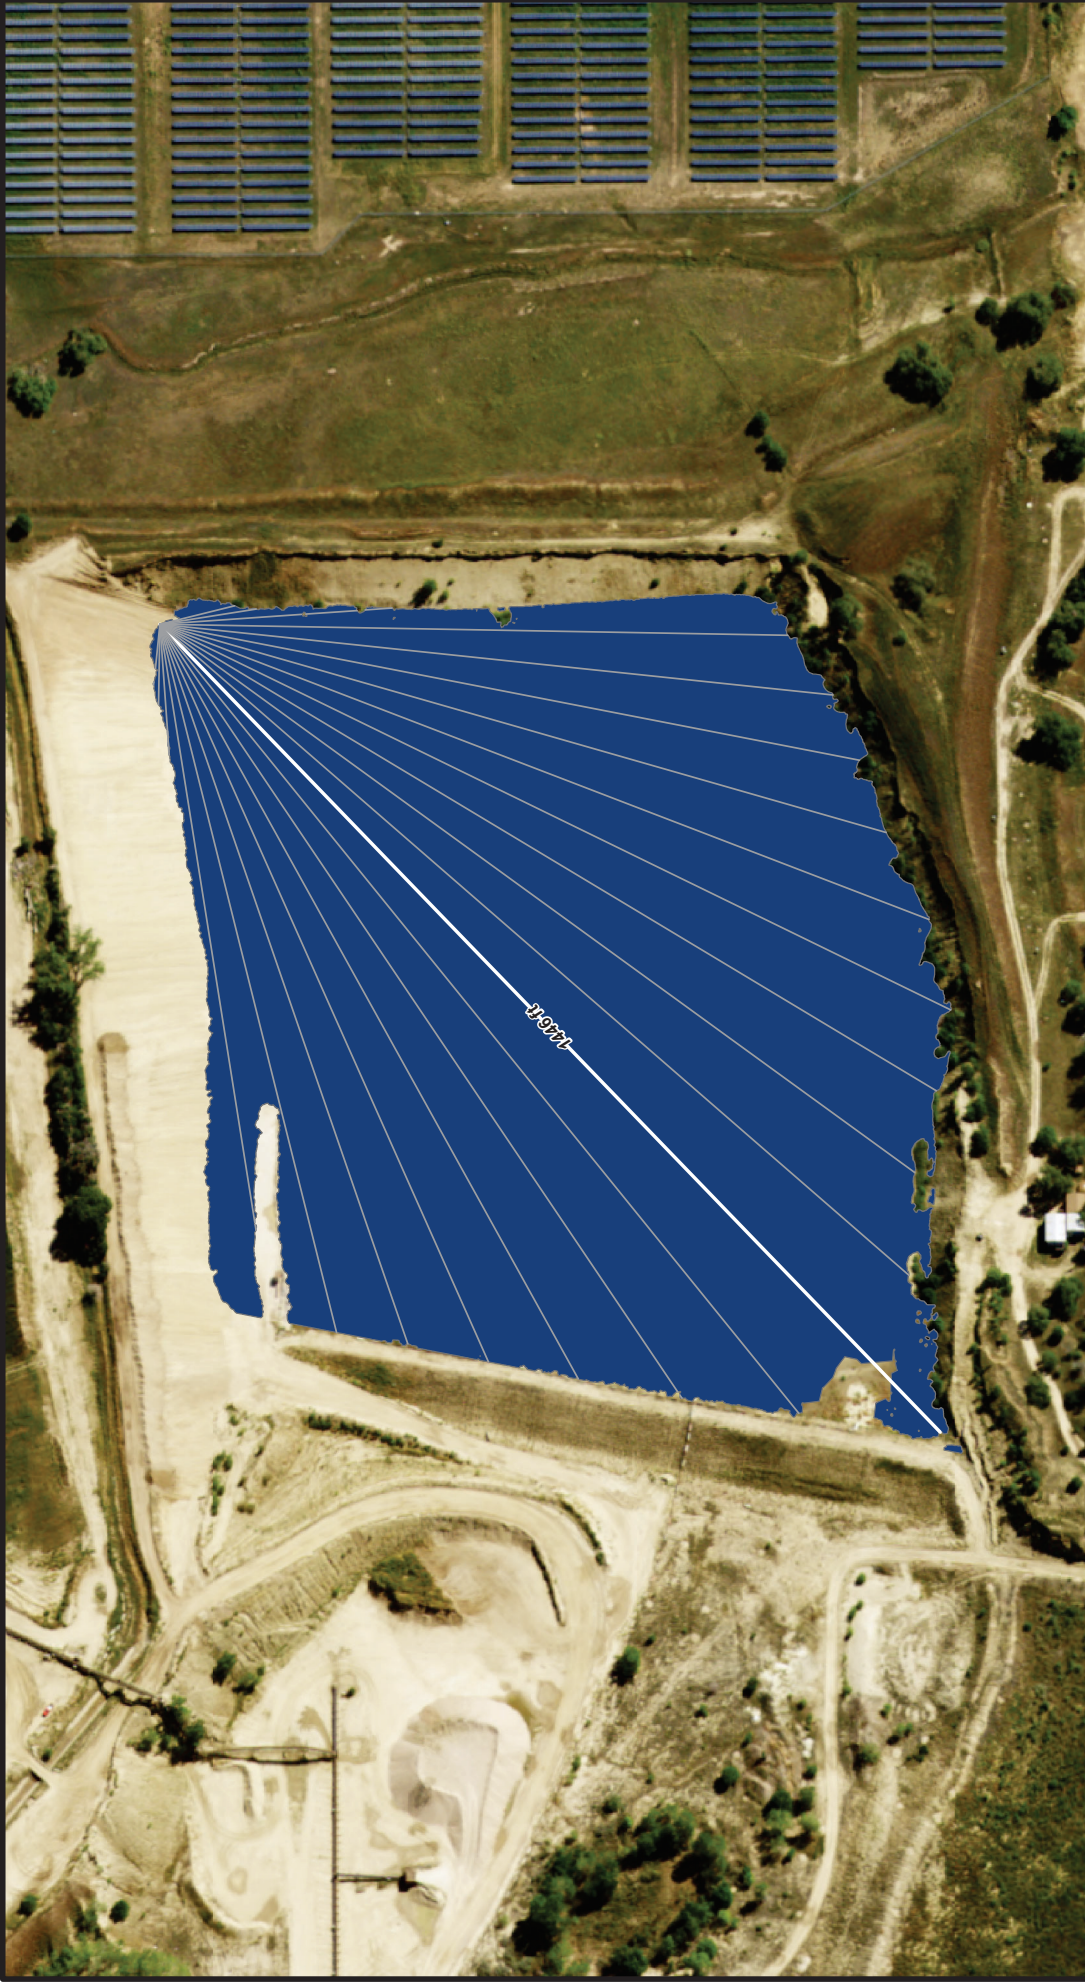
Fig. 4

1. Highwater 3ft freeboard surface derived from site topo. Data represents hypothetical model conditions. Site conditions may change over time, accuracy is not guaranteed. Map should not be used for measurement.

WAVE RUN OFF SCHEMATIC:
"SITE TOPO" HIGHWATER - 3FT
FREEBOARD CONDITIONS

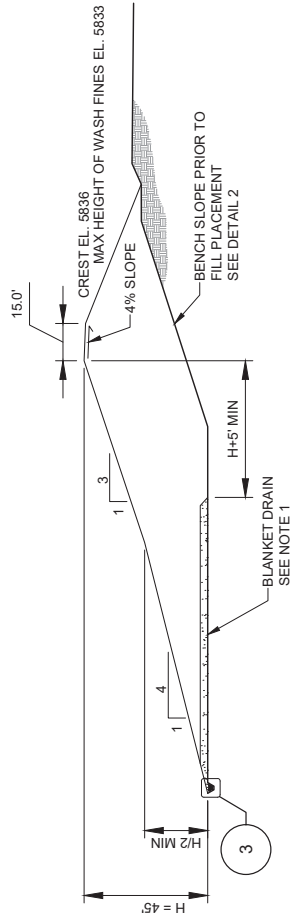
1 MAXIMUM SECTION A-A'

- NOTES:**
1. SEE SPECIFICATION SECTION 31.00.00 EARTHWORK FOR BLANKET DRAIN AND TOE DRAIN GRAIN SIZE DISTRIBUTION REQUIREMENTS.
 2. CONSTRUCT BENCHES FOR NEW FILL PLACED AGAINST EXISTING SLOPES.
 3. BENCHES TO BE CUT AS CONSTRUCTION PROGRESSES. BENCHES SHALL NOT REMAIN UNSUPPORTED FOR MORE THAN 12 HOURS.
 4. PRIOR TO PLACEMENT OF FILL, ORIGINAL GROUND SURFACE SHALL BE SCARIFIED WITH A DISC OR SIMILAR EQUIPMENT AND MOISTURE CONTROLLED TO FACILITATE BONDING WITH NEW FILL.
