**Re: Permit No. M-1980-244; Cripple Creek & Victor Gold Mining Company; Cresson Project;  
Technical Revision 147 – Adequacy Review No. 1 Response**

ECOSA - Cripple Creek and Victor Gold  
Mine, Teller County, Colorado

# Aquifer Testing Report

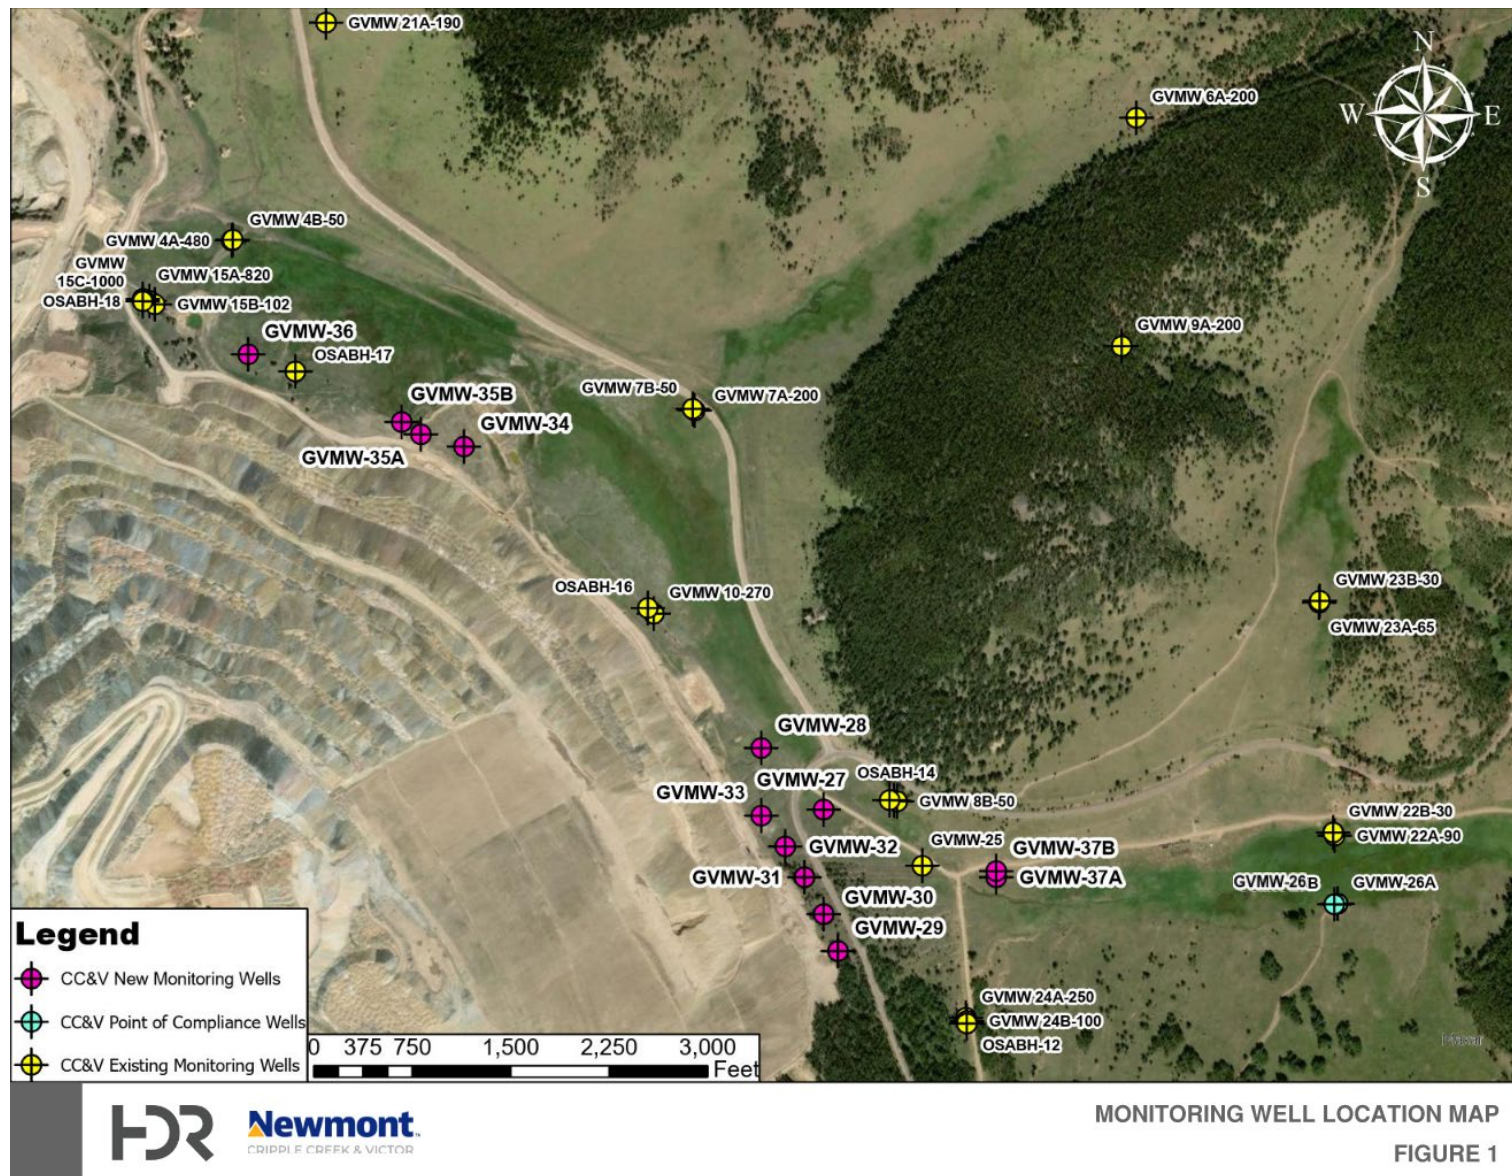
### Figure 1. ECOSA/Grassy Valley Monitoring Well Location Map

In July and August 2024, 13 groundwater monitoring wells (GVMW-27, GVMW-28, GVMW-29, GVMW-30, GVMW-31, GVMW-32, GVMW-33, GVMW-34, GVMW-35A, GVMW-35B, GVMW-36, GVMW-37A, and GVMW-37B) were installed as part of Phase I of the ECOSA Seepage Mitigation Design Project (**Table 1** and **Figure 1**) (HDR, 2024). The colluvium encountered during installation of the new monitoring wells was found to be dry in some locations (GVMW-29, GVMW-31, GVMW-32), except where groundwater was identified directly above competent bedrock (GVMW-28, GVMW-30, GVMW-33, GVMW-34, GVMW-35B, GVMW-36). Groundwater was also identified in monitoring wells installed in the weathered bedrock (GVMW-27, GVMW-37B). GVMW-35A and GVMW-37A were installed as deep bedrock wells and were screened in fractured, competent bedrock (HDR, 2024).

GVMW-27 and GVMW-28 were installed closer to the thalweg of Grassy Valley to better characterize groundwater flow paths for the potential downgradient migration of seepage. GVMW-29, GVMW-30, GVMW-31, GVMW-32, and GVMW-33 were installed in a northwest-southeast trending line within the observed shallow low resistivity zone in the southeastern portion of the ECOSA. GVMW-34, GVMW-35A, and GVMW-35B were installed within the observed shallow low resistivity zone in the northwestern portion of the ECOSA. GVMW-35A and GVMW-35B were installed near one another to intersect both the shallow and deep low resistivity zones observed at that location. GVMW-36 was installed at an additional small, shallow resistivity zone. GVMW-37A and GVMW-37B were installed downgradient of GVMW-25 to address Division concerns about low resistivity areas identified in the 2023 Golder Report at the PB23-01 location. Additionally, this location provides an observation point to monitor water quality downgradient of GVMW-25. The monitoring wells were constructed in a manner that allows for pump installation and conversion to interception wells, if necessary.

1. **Figure 1 of the Aquifer Testing Report incorrectly identifies GVMW-27B as a Point of Compliance. Please update the figure to accurately reflect the Points of Compliance.**

*Figure 1 within the Aquifer Testing Report has been revised and is included within Attachment 1.*

(**Figure 1**) showed groundwater flows from 10 to 70 gpm. From 110 to 245 feet bgs, the groundwater flow ranged from 10 to 25 gpm. From 300 to 440 feet bgs, the groundwater flow ranged from 60 to 70 gpm (White, 1997).

The southeast portion of Grassy Valley consists of Valley Fill colluvium and overburden material from 0 to 20 feet bgs (Ligocki, 1998). The underlying bedrock consists of porphyritic phonolite. At GVMW-8A (**Figure 1**), there was a medium-grained aphanitic dike from 20 to 30 feet bgs. From 85 to 140 feet bgs, the geologic logs show weak sericite and potassic alteration and 2 to 3% pyrite. From 105 to 110 feet bgs and 150 to 225 feet bgs, trace amounts of fluorite were found. From 205 to 250 feet bgs, the logs indicated groundwater occurring within the fractured bedrock. At 200 feet bgs, groundwater flow was 5 gpm (Ligocki, 1998).
