Lyons Quarry –  
Catchment Basin O&M  
Plan (Draft)

# Lyons Quarry Reclamation Project Operation and Maintenance (O&M) Plan

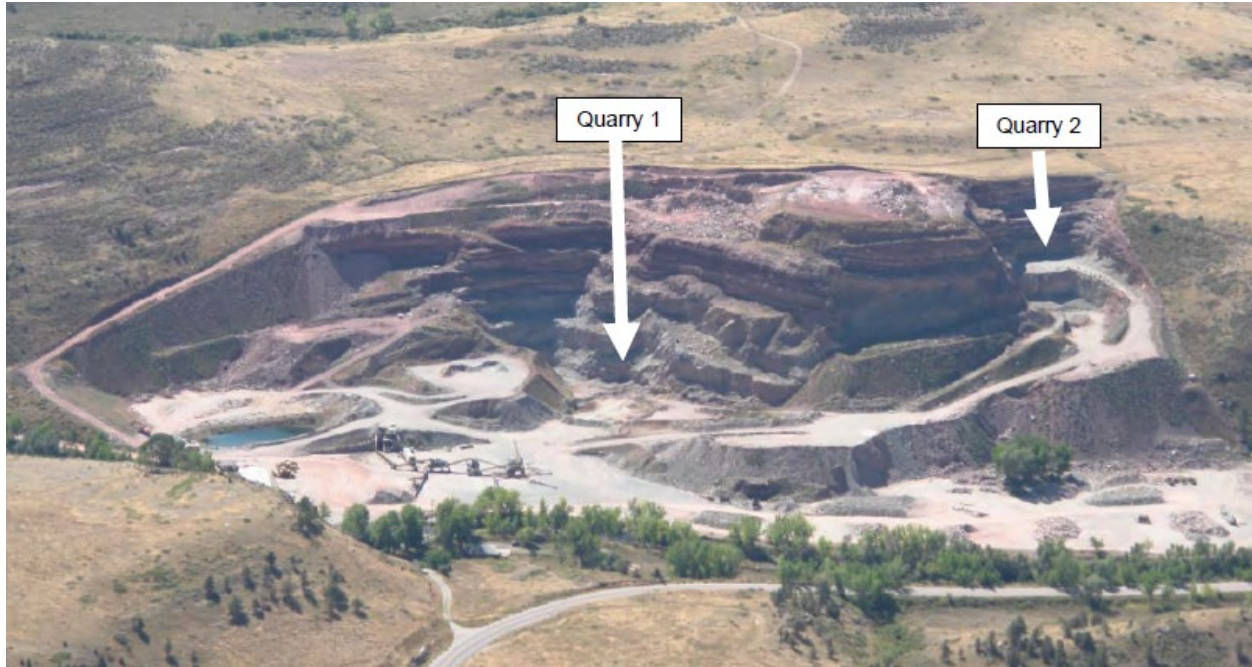
*Figure 1 - Lyons Quarry Pit Configuration prior to Reclamation*

Reclamation for Lyons Quarry was proposed to occur in two Phases. Phase 1 included all areas above the historic 100-year floodplain area such as the Quarry #1 pit in the center of the site, Quarry #2 in the southwest corner of the site (Figure 1 below), associated fill areas as well as the high wall and crest (top) of the quarry to the south. Phase 2 included the toe of the mining area and the floodplain north to South St. Vrain Creek with some areas across South St. Vrain to be restored. The east and west boundaries of the mine permit are the approximate extents of reclamation for the floodplain. A draft of this O&M Plan was provided as an attachment for Technical Revision 05 (TR-05) of the mining permit in 2021. This updated draft may be revised again before the completion of the Phase 1 and Phase 2 reclamation plan activities. Completed reclamation is expected to occur when the vegetation of the site has reached acceptable criteria for establishment and no erosion issues exist.

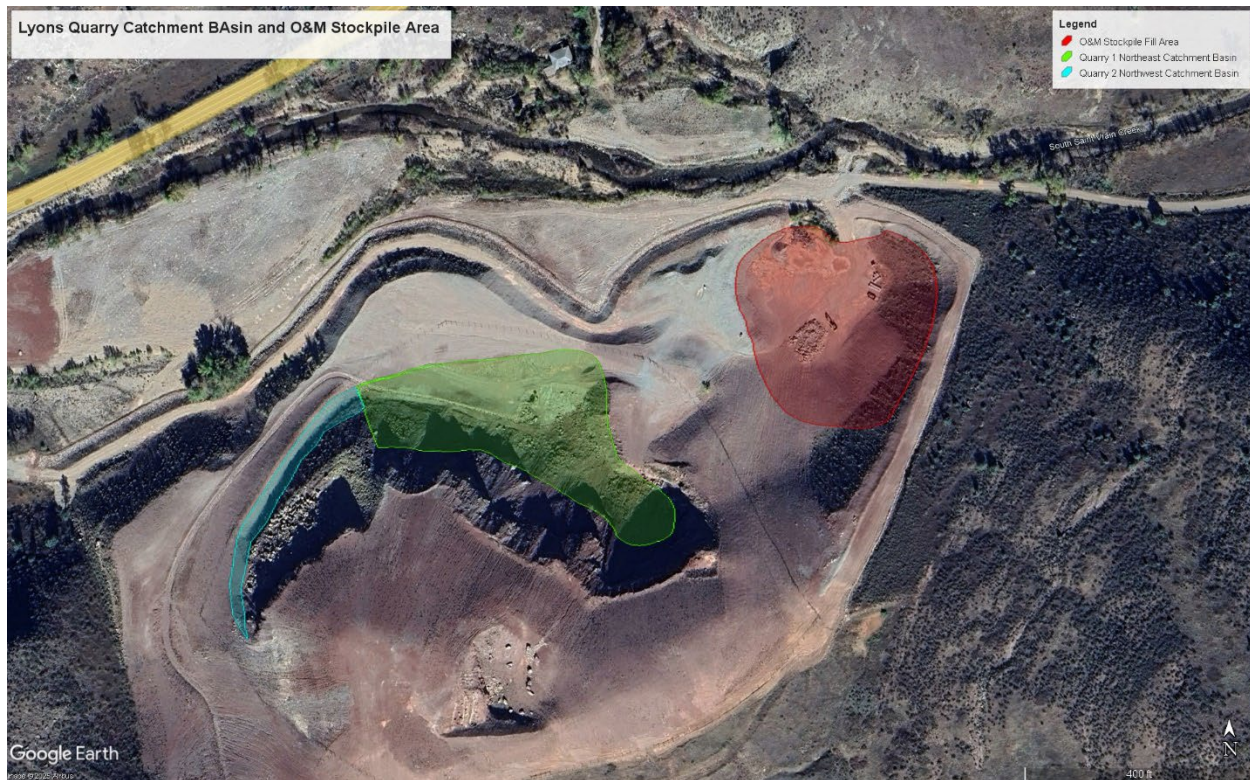
Figure 2 – Lyons Quarry Catchment Basin and O&M Stockpile Area

The catchment basins (shown in Figure 2 below) were designed to provide the necessary runout area to capture 100% of potential rockfall from the sandstone and dacite slopes that would remain exposed along the northwest and northeast-facing slopes of Lyons Quarry. Refer to Sections 3.1, 3.2, and Attachment F of the Technical Revision #6 for the geotechnical modeling that was performed on both of these areas following blasting and the drone photogrammetric survey. The constructed berm across the opening at the base of the northeast Quarry 1 highwall along with the natural topography creates a catchment basin that will have an adequate factor of safety to capture dacite and sandstone rockfall from even the highest sections of the northeast-facing highwall. The evaluation of the northwest-facing highwall in Quarry 2 has been almost completely backfilled by blast material such that only the upper most portion is still exposed. This section was left in place to provide valuable nesting habitat or avian species per BCPOS request. No seasonal modifications or adjustments are anticipated outside of monitoring for erosion or buildup of rockfall material or sedimentation within the catchment basins at the base of both highwalls. Once vegetation has been established on the restored slopes, monitoring and maintenance of weed species will be needed.

Material removed from the catchment basins shall be transported to the designated stockpile area (Figure 2) located where remnant materials (logs, rock, gravels) from the reclamation work are currently stockpiled. This area is outside of the historic 100-year floodplain and is proposed to have 20,000-40,000 CY capacity before the lower section of the basin area is filled. Fill could continue above the basin area at a 3H:1V grade to the south and east, providing additional capacity as needed.
