Re: GCC Energy, LLC, King I Mine CDRMS Permit # C-1981-035

March 2025 Complete Inspection Maintenance Items #3 - Proposed Plan

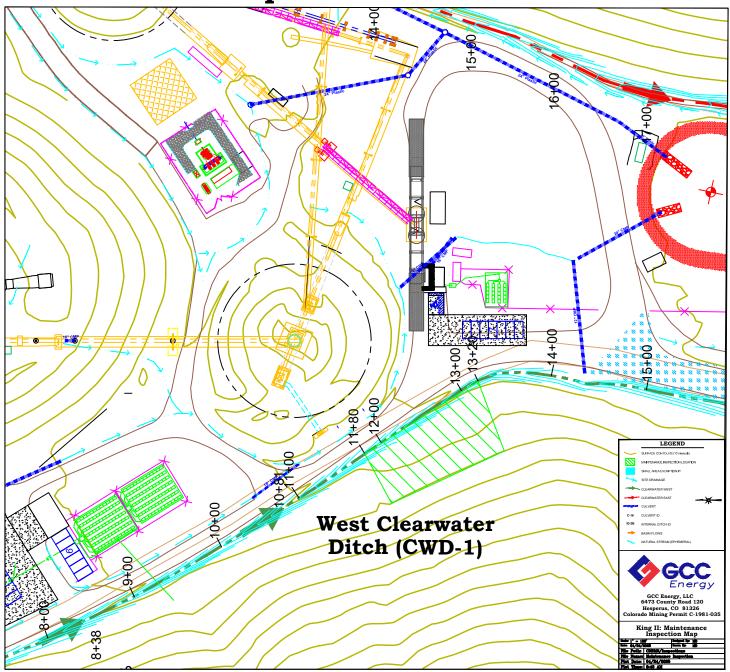
Inspection Location

Location: Hillside (Station 11+80 to 13+20) Maintenance Inspection Report

To formally define the area identified in the March Complete Inspection, GCCE specifies the affected zone as located between CWD-1A station points 11+80 and 13+20. These points will be clearly marked to support the following steps outlining the measures that will be implemented to mitigate coal dust accumulations, protect CWD-1A, and identify the source of the issue while minimizing additional disturbance.

Silt fencing will be installed on the hillside, along station points 11+80 to 13+20 of the CWD-1A. This measure aims to prevent any runoff from depositing fines into CWD-1A.
