RE: M-2000-016 Additional Information Required

M-2000-016 Riverbend Monitoring Wells

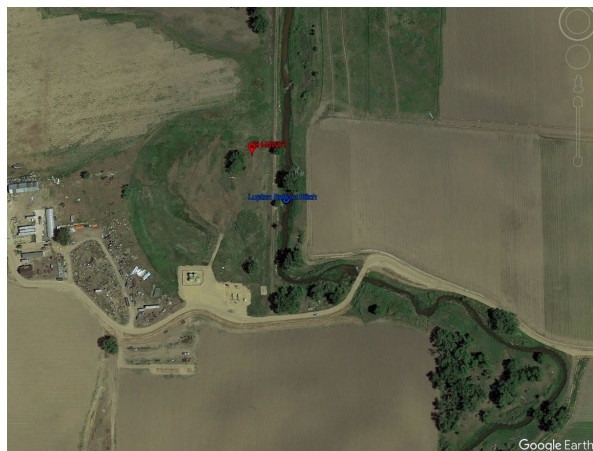
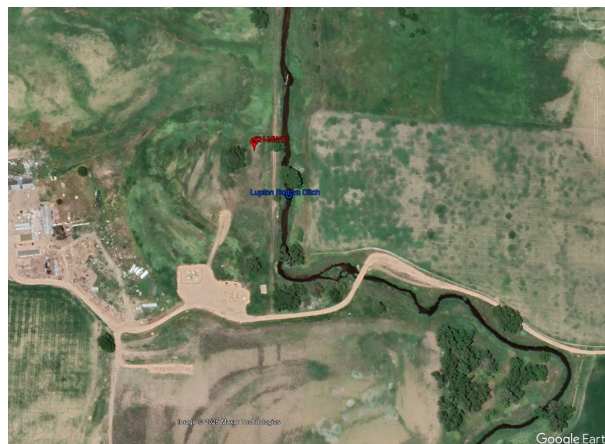
The well sits west of the Lupton Bottom Ditch in an area that we have not mined. From aerial photos in 2018 when the area was still farmed and 2022 after farming had ceased, it appears that there is an old oxbow and a possible explanation could be that well is influenced by when the ditch is running.
