MINERALS PROGRAM INSPECTION REPORT
PHONE: (303) 866-3567

MINE NAME: Hollenbeck Pit	MINE/PROSPECTING ID#: M-1985-023	MINERAL: Sand and gravel	COUNTY: Gunnison
INSPECTION TYPE: Monitoring	WEATHER: Clear	INSP. DATE: April 29, 2025	INSP. TIME: 10:00
OPERATOR: Duane E. Hollenbeck	OPERATOR REPRESENTATIVE: None	TYPE OF OPERATION: 110c - Construction Limited Impact	
REASON FOR INSPECTION: Normal I&E Program	BOND CALCULATION TYPE: Complete Bond	BOND AMOUNT: \$19,029.00	
DATE OF COMPLAINT: NA	POST INSP. CONTACTS: None	JOINT INSP. AGENCY: None	
INSPECTOR(S): Dustin Czapla	INSPECTOR'S SIGNATURE:

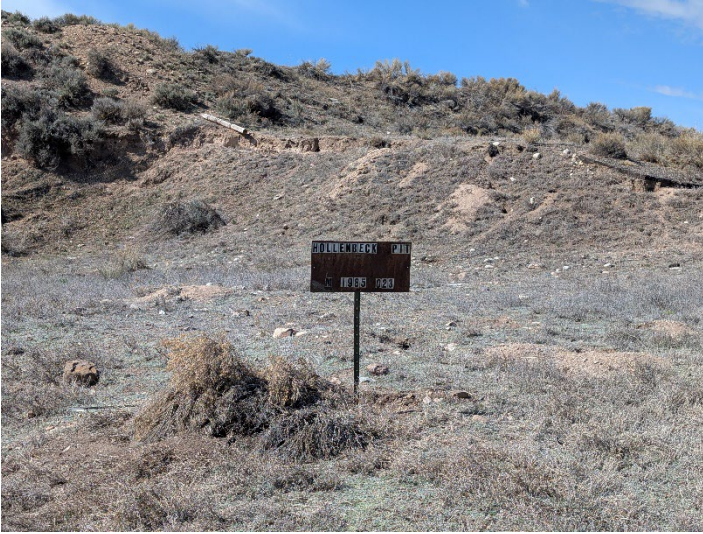
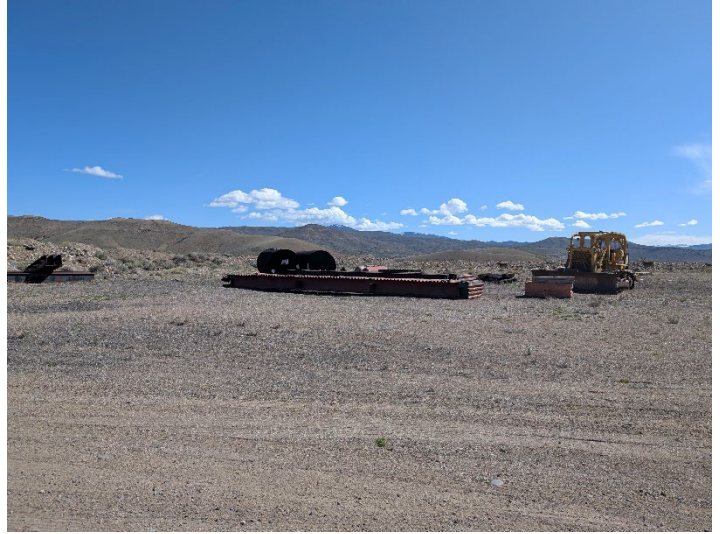
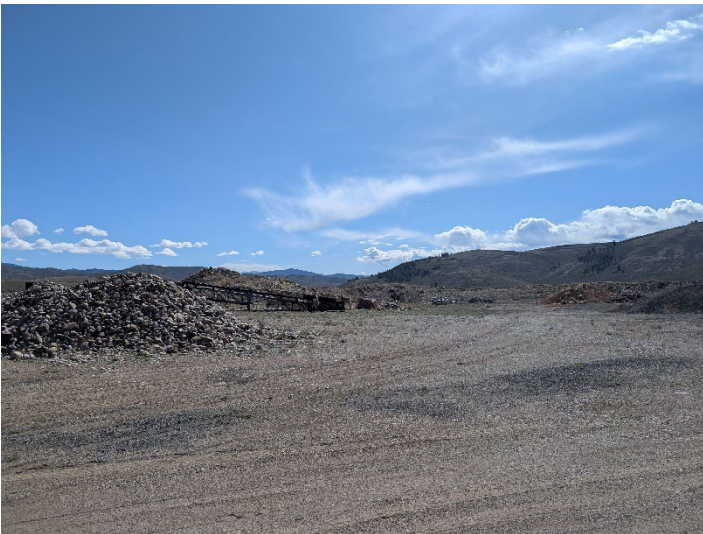
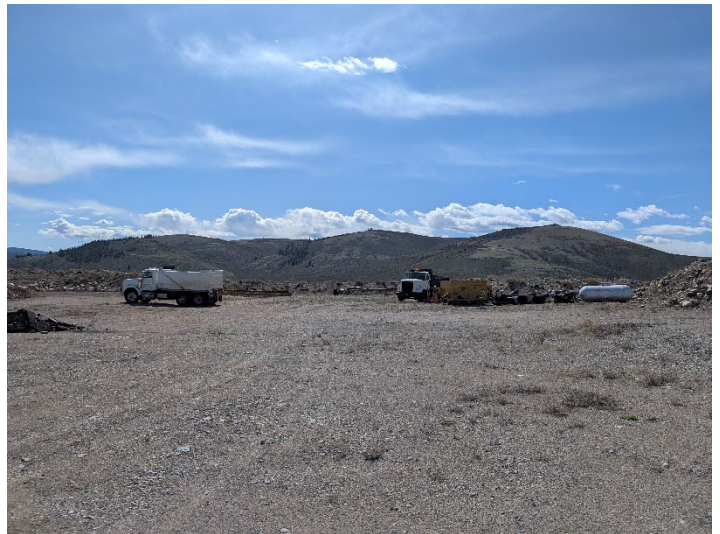
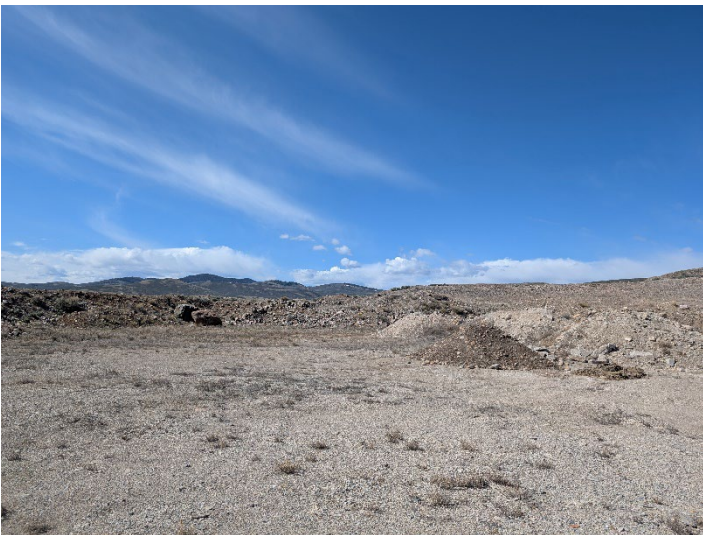
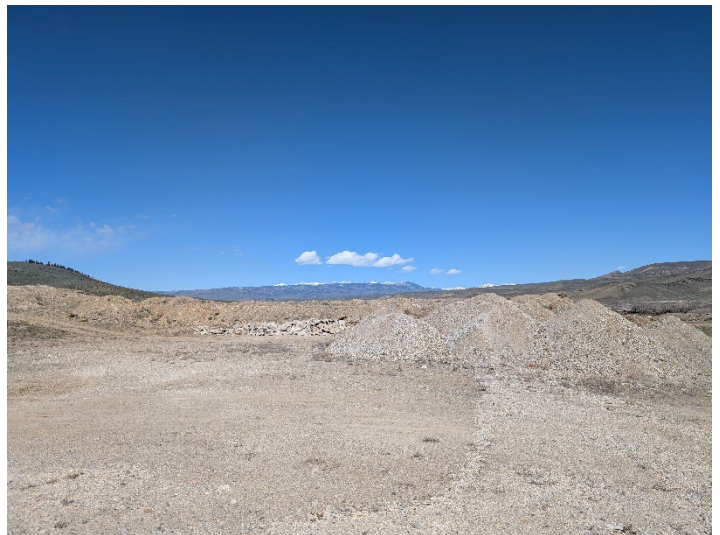
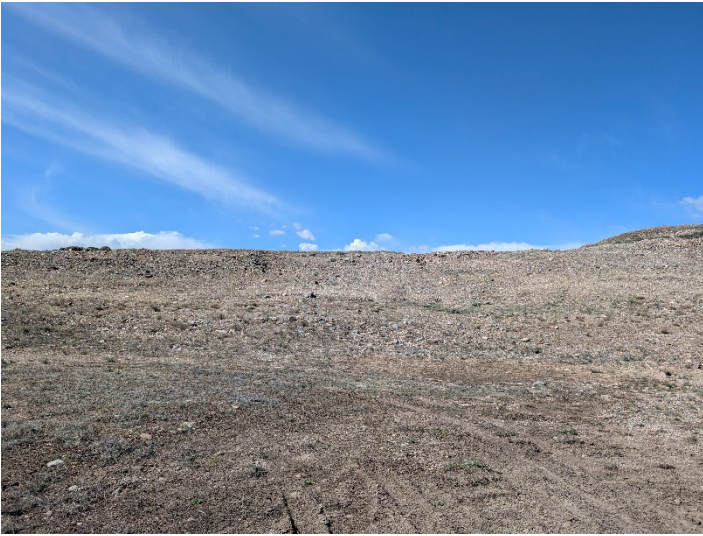
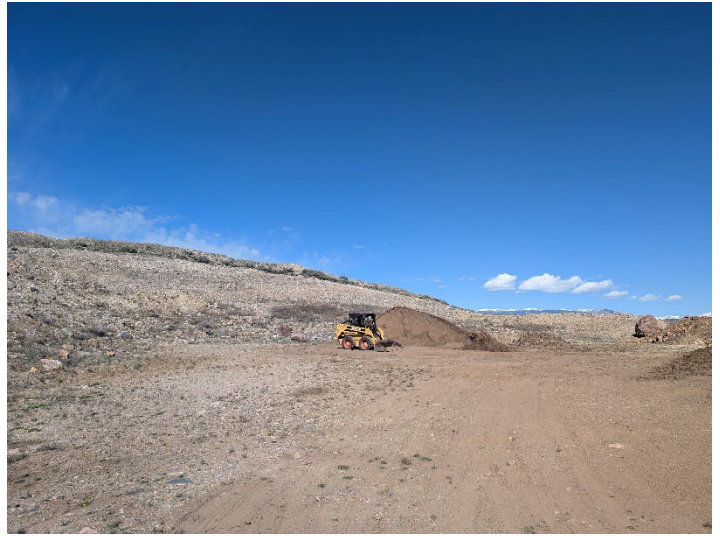
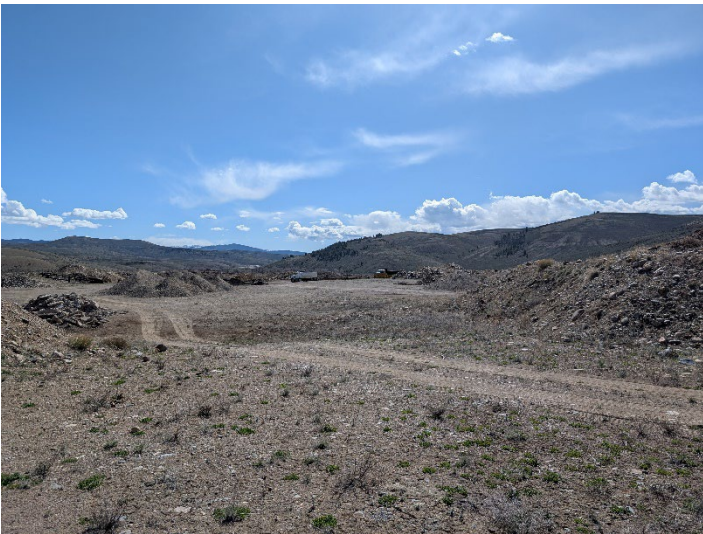
This inspection was conducted as part of the Division of Reclamation, Mining and Safety's (Division) normal monitoring program. A representative for the operator was not present. Photographs are included with this report in order to illustrate some of the conditions observed.

Nearly all of the 9.9 permitted acres have been disturbed by the operation. The highwall on the west side of the pit is approximately 15-20 feet high, spanning approximately 800 linear feet. Most of the highwall has been reduced to 2-3H:1V. Topsoil has not been replaced on the highwall yet. A berm, 3-4 feet in height, surrounds the pit on the north, east and south sides. The pit floor holds various construction material stockpiles and construction equipment.
