MINERALS PROGRAM INSPECTION REPORT
PHONE: (303) 866-3567

MINE NAME: Crader Gravel Pit	MINE/PROSPECTING ID#: M-1981-114	MINERAL: Sand and gravel	COUNTY: La Plata
INSPECTION TYPE: Monitoring	WEATHER: Clear	INSP. DATE: September 3, 2025	INSP. TIME: 08:45
OPERATOR: La Plata County	OPERATOR REPRESENTATIVE: Leslie Jakoby	TYPE OF OPERATION: 112c - Construction Regular Operation	
REASON FOR INSPECTION: Normal I&E Program	BOND CALCULATION TYPE: None	BOND AMOUNT: \$0.00	
DATE OF COMPLAINT: NA	POST INSP. CONTACTS: None	JOINT INSP. AGENCY: None	
INSPECTOR(S): Dustin Czapla	INSPECTOR'S SIGNATURE:

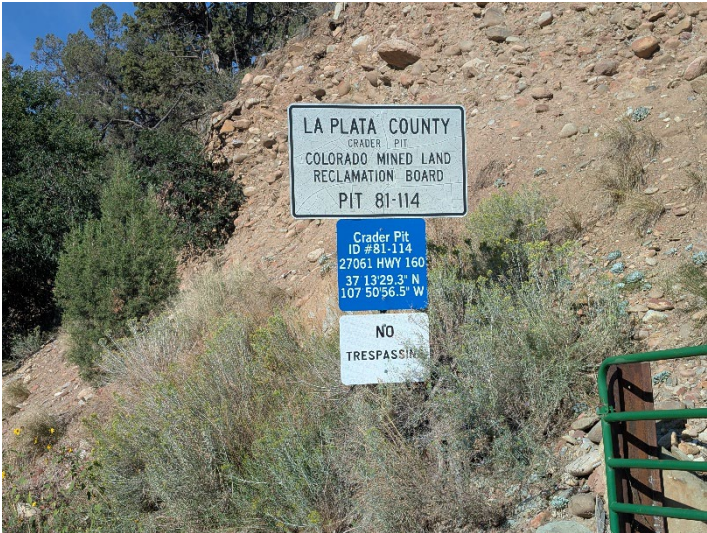
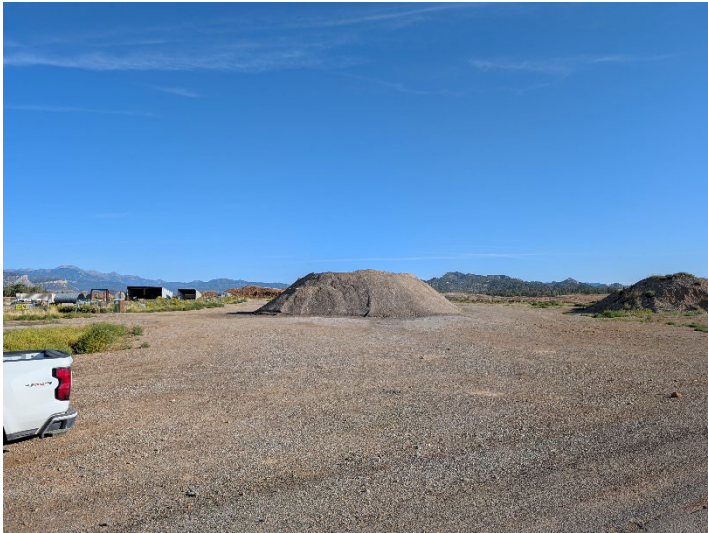
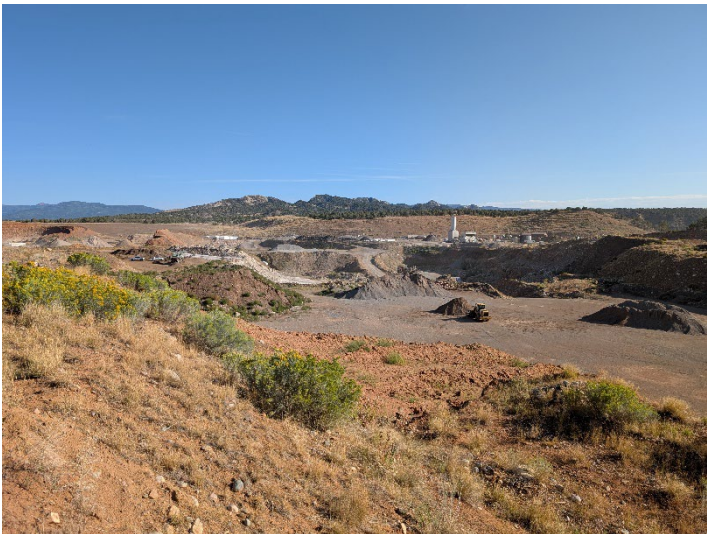
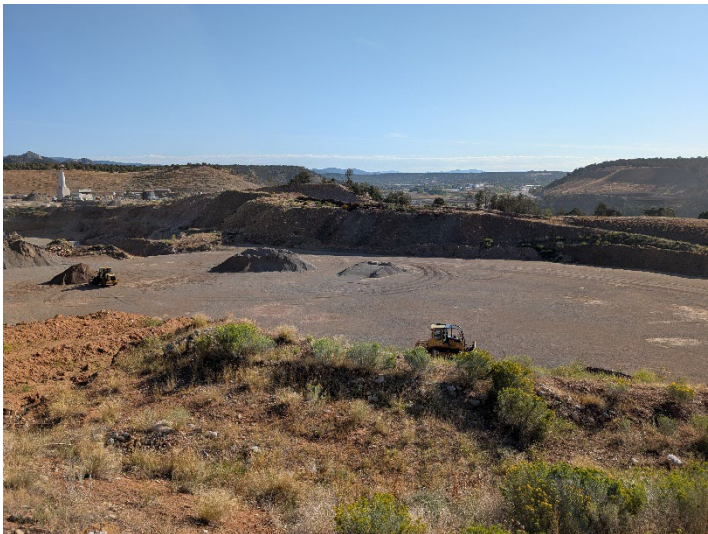
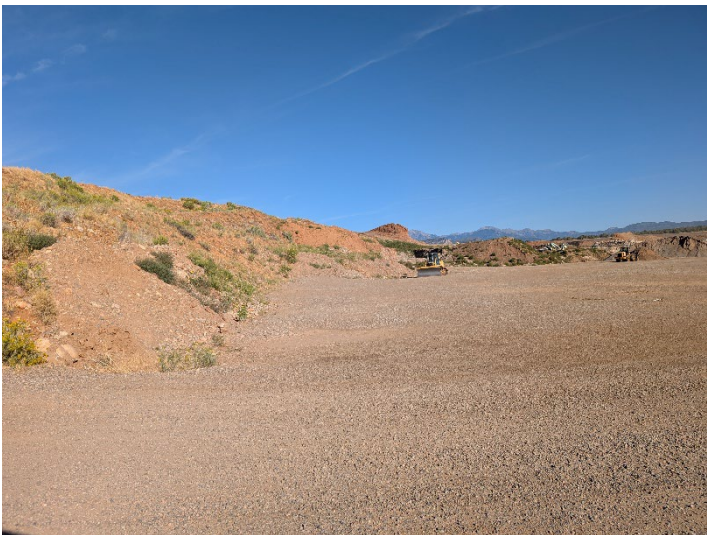
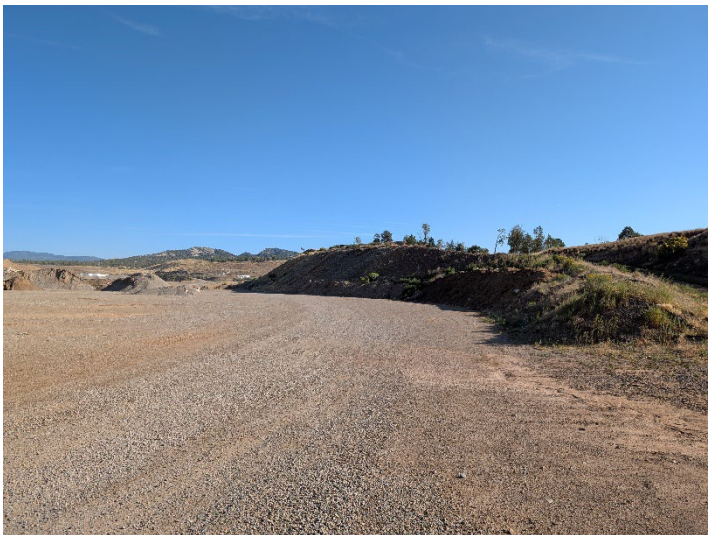
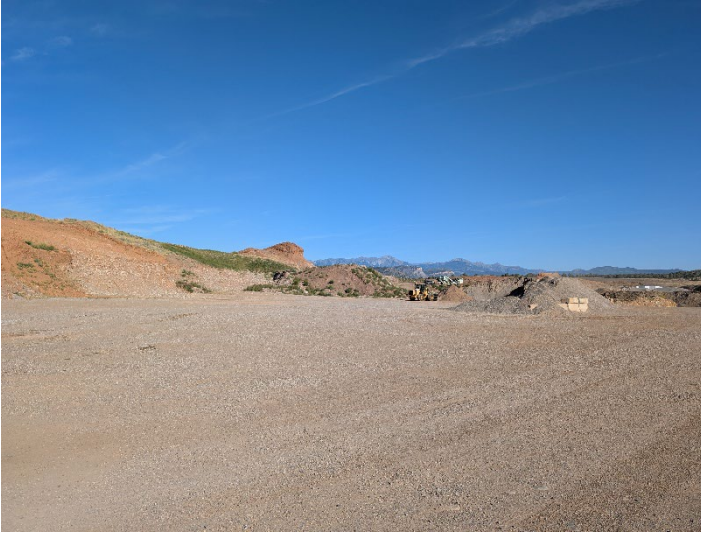
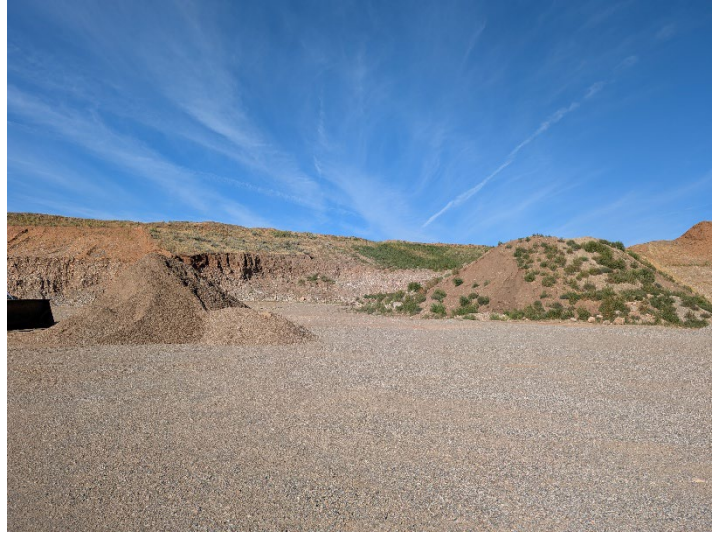
Mining is still occurring in the Phase 1 area. The pit walls are approximately 40 feet high with most of the slopes left between 1-2H:1V. No stability or erosional concerns were noted. Hauling was occurring during this inspection. Processed gravel stockpiles are located within the pit and above the pit in the east part of the Phase 2 and 3 areas.
