**MINERALS PROGRAM INSPECTION REPORT**  
**PHONE: (303) 866-3567**

| <b>MINE NAME:</b><br>Weaselskin | <b>MINE/PROSPECTING ID#:</b><br>M-1986-148 | <b>MINERAL:</b><br>Sand and gravel | <b>COUNTY:</b><br>La Plata |
| <b>INSPECTION TYPE:</b><br>Monitoring | <b>WEATHER:</b><br>Clear | <b>INSP. DATE:</b><br>October 28, 2025 | <b>INSP. TIME:</b><br>16:10 |

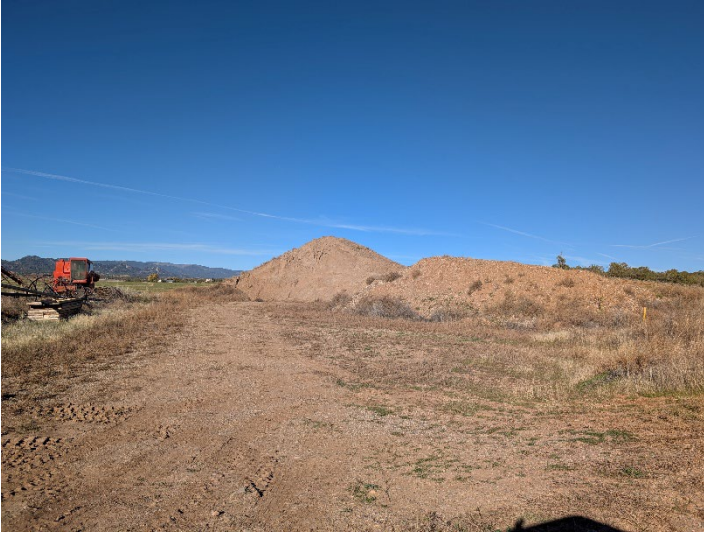
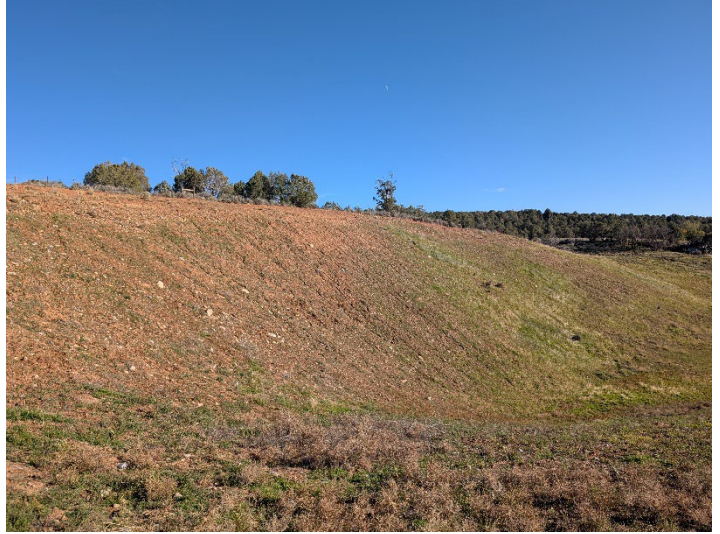
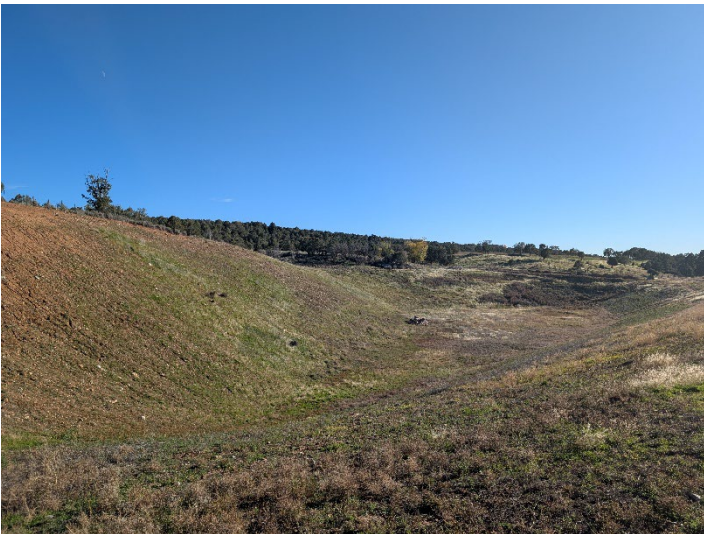
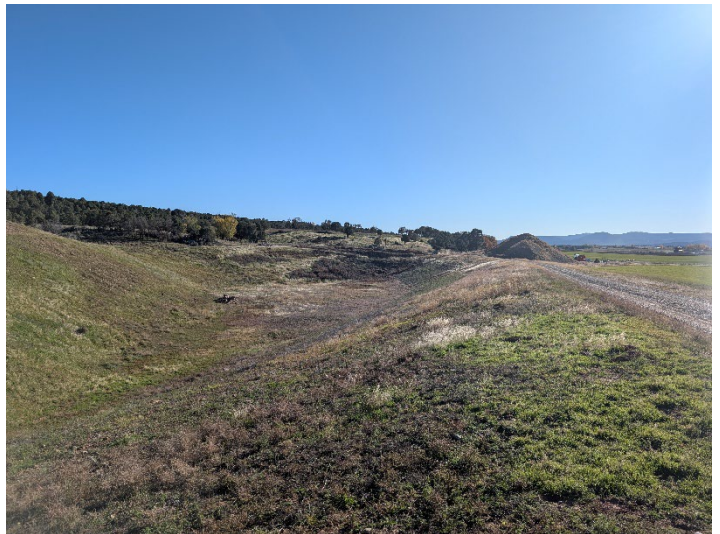
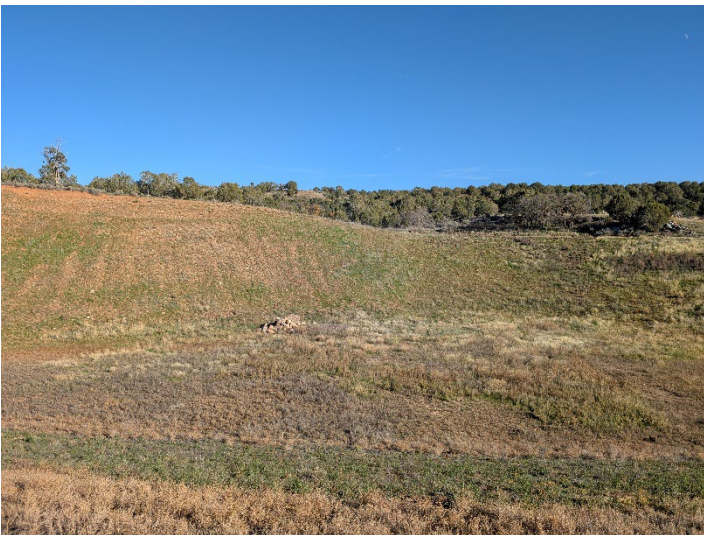
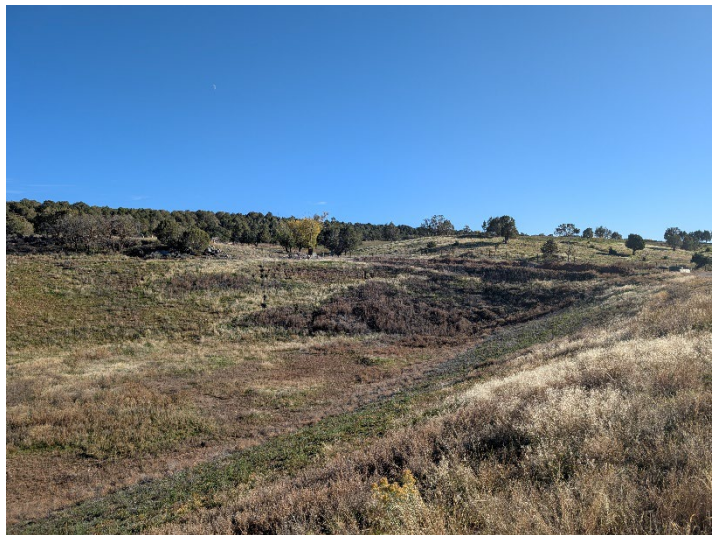
This inspection was conducted as part of the Division of Reclamation, Mining and Safety's (Division) normal monitoring program. A representative for the operator was not present. Photographs are included with this report to illustrate conditions observed.

The site is in final reclamation. The slopes have been graded to 2H:1V. The slopes appear stable. Vegetation on the slopes is becoming well established. Noxious weed infestations were not noted.
