## MEMORANDUM

**Re: SM-18 Mine Drainage Design Plan – Second General Stormwater  
Comments, Permit No. M-1978-116 / AM-02**

The Division of Reclamation, Mining and Safety (DRMS) engineering staff has reviewed the Response to Adequacy Review #2 for the SM-18 Mine prepared by Cotter Corporation and O'Connor Design Group, Inc., dated May 1, 2013. The following comments are posed to ensure adequate engineering analyses and design practices are implemented to eliminate or reduce to the extent practical the disturbance to the hydrologic balance expected by the mining operation with respect to water quality and quantity in accordance with Rules 3.1.6(1), 6.4.21(10) and 7.3.1. Please note, as this site is a designated mining operation (DMO), compliance with Rule 7.3.1 is applicable, thus requiring certified designs and specifications for engineered elements associated with the environmental protection plan (EPP). The original comment numbers have been retained for the purpose of tracking responses.

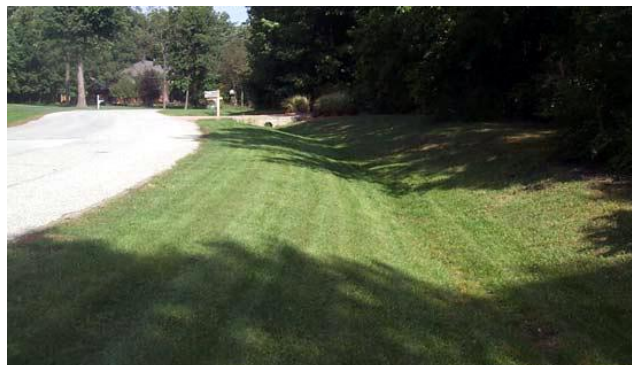
1. Page ESWMP-5, section 7.2. The response to this comment is adequate.
2. Page ESWMP-5, section 7.3. The narrative response to this comment is adequate. *{Note: The "Table 802C" has a hand drawn arrow pointing to "Grassed" Manning's n values. Grass lined channels as determined by Ven Te Chow do not exist naturally in arid regions (i.e., without irrigation). Below is an image of a typical grass-lined channel. None of the photos in Attachment 6 indicate a grass-lined channel exists on site}.*
