ECOSA Field Fit Ditches

Re: **Modification of ECOSA Underdrain System**

Scale	As shown	East Cresson Overburden Storage Area
Design:	A. Brown, P.E. 22-Feb-2012	PLATE 14
Drawing:	MLE2-Master-35-ECOSA.dwg	SEEPAGE MITIGATION TRENCH SYSTEM
File:	D:\...\1385_cri-mle2\4_Maps

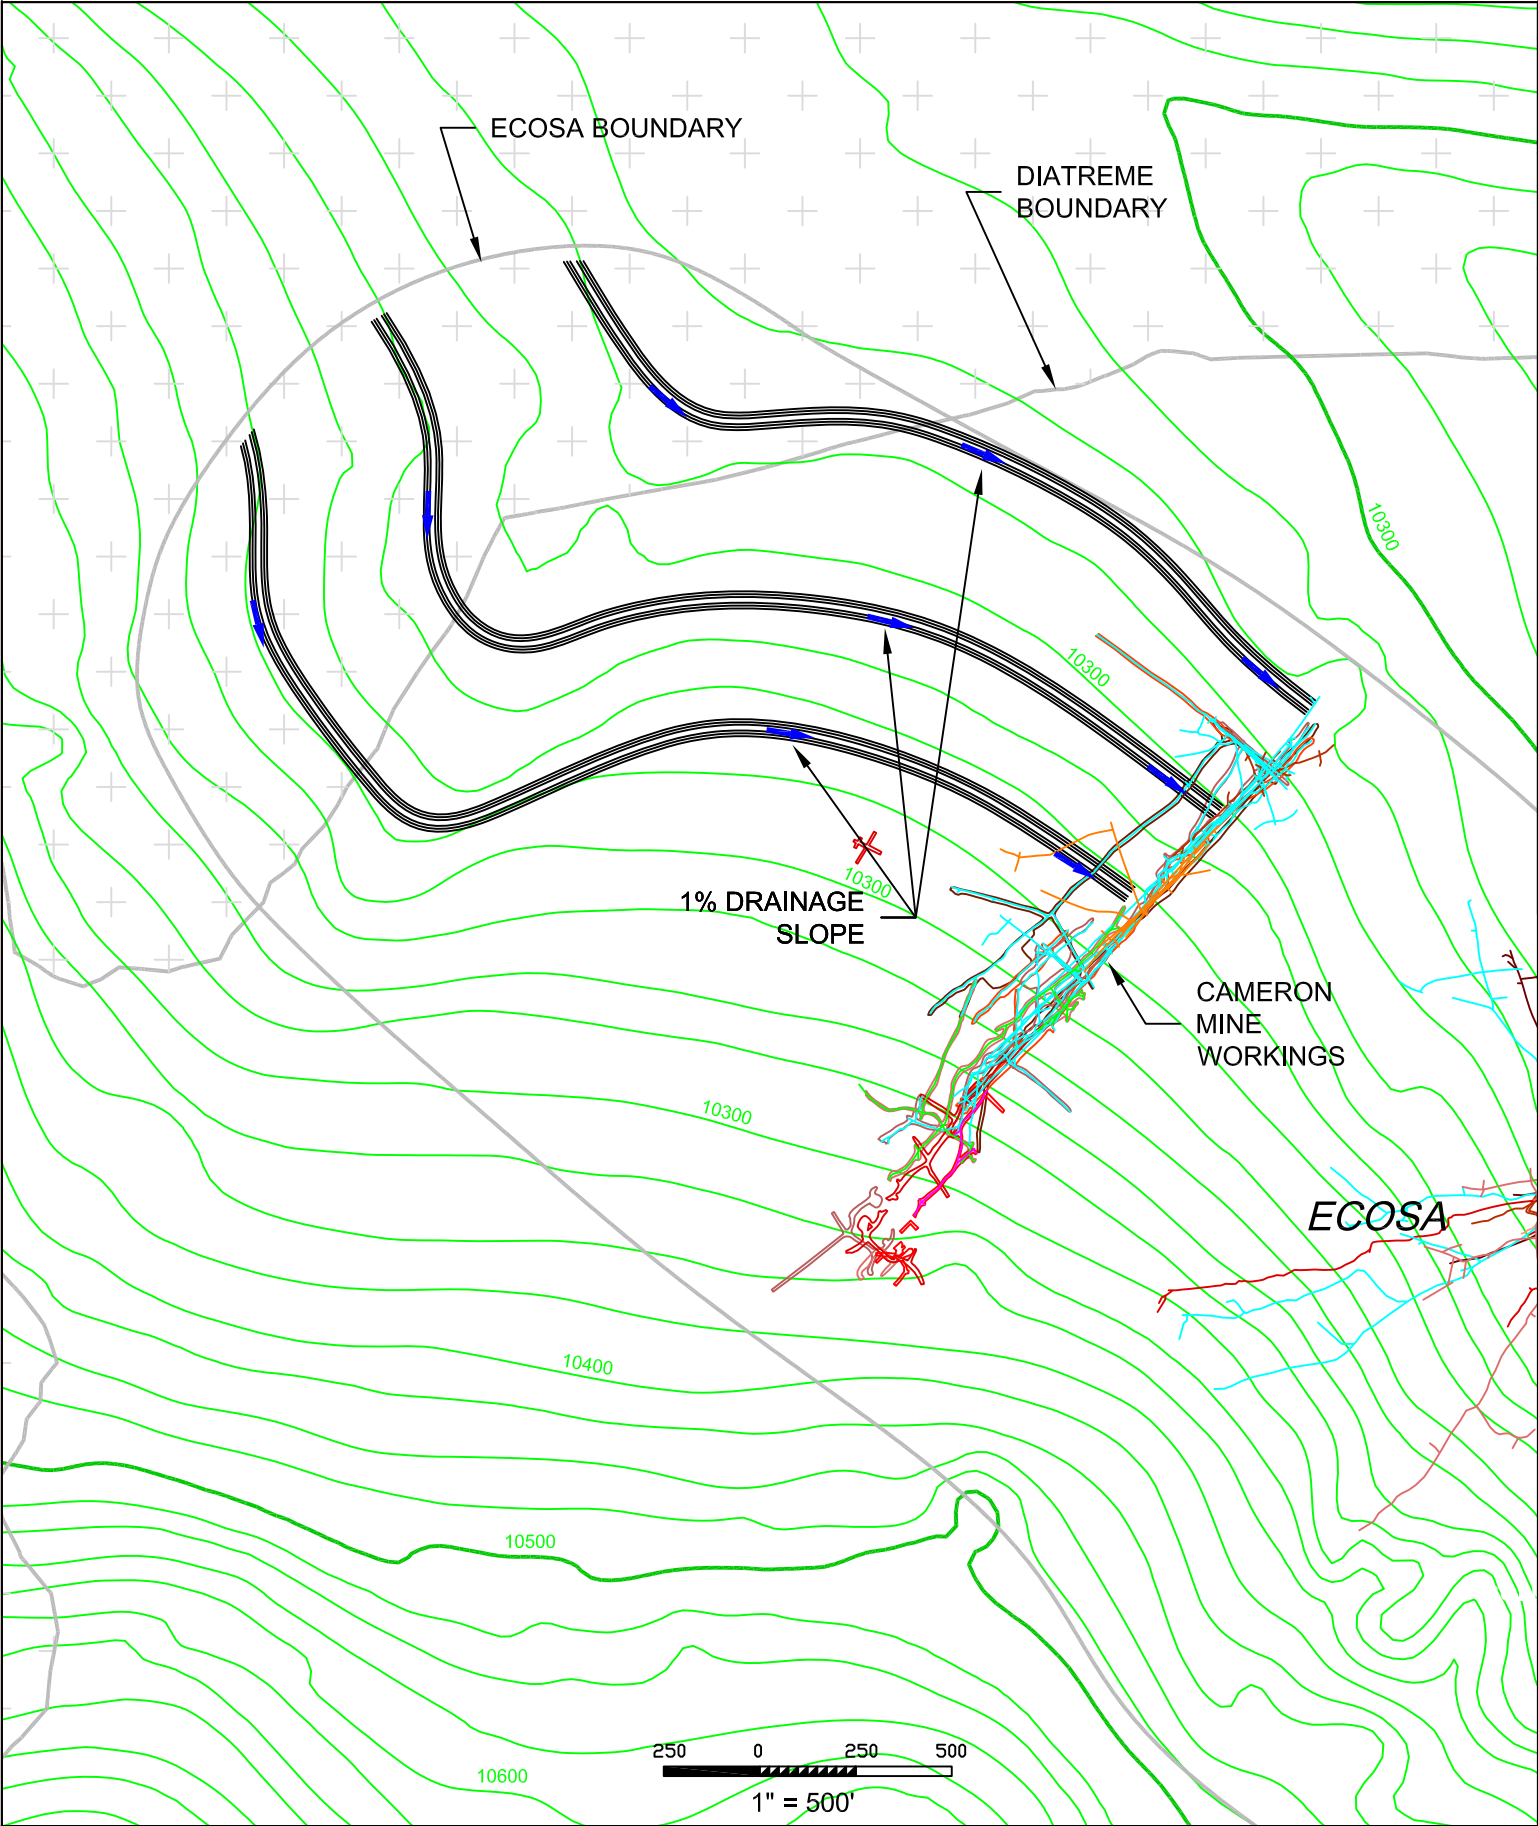
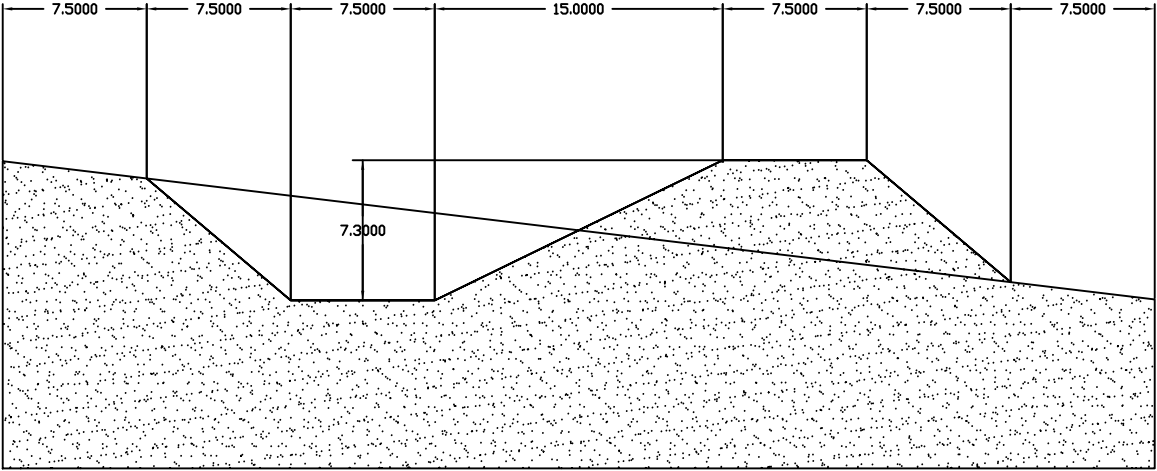
The original underdrain design was included in the Mine Life Extension Permit M-1980-244, and is shown in Plate 14 of the ECOSA design report (Attachment 1 to this letter). The design comprised three parallel 7.3 feet deep seepage mitigation trenches beneath the western half of the ECOSA, whose purpose was to conduct any seepage through the western portion of the ECOSA that overlies Precambrian rock to the east, for infiltration into areas underlain by the drained Tertiary volcanic diatremal rock.

TYPICAL DRAINAGE DITCH CROSS SECTION

1. Removal of seepage from the Precambrian area underneath ECOSA. The proposed mitigation trench alignment provides drainage from the same area as the original trench, with the same 1% eastward slope, so the drainage capability is unchanged.
2. Infiltration of any captured seepage water to the diatreme rock. The infiltration area of the base of the proposed mitigation trench and borrow area where it discharges that overlies the diatreme is 7,500 square feet in the trench, and up to 90,000 square feet in the borrow pit area. This infiltration area greatly exceeds the 15,000 square feet infiltration area in the original design.

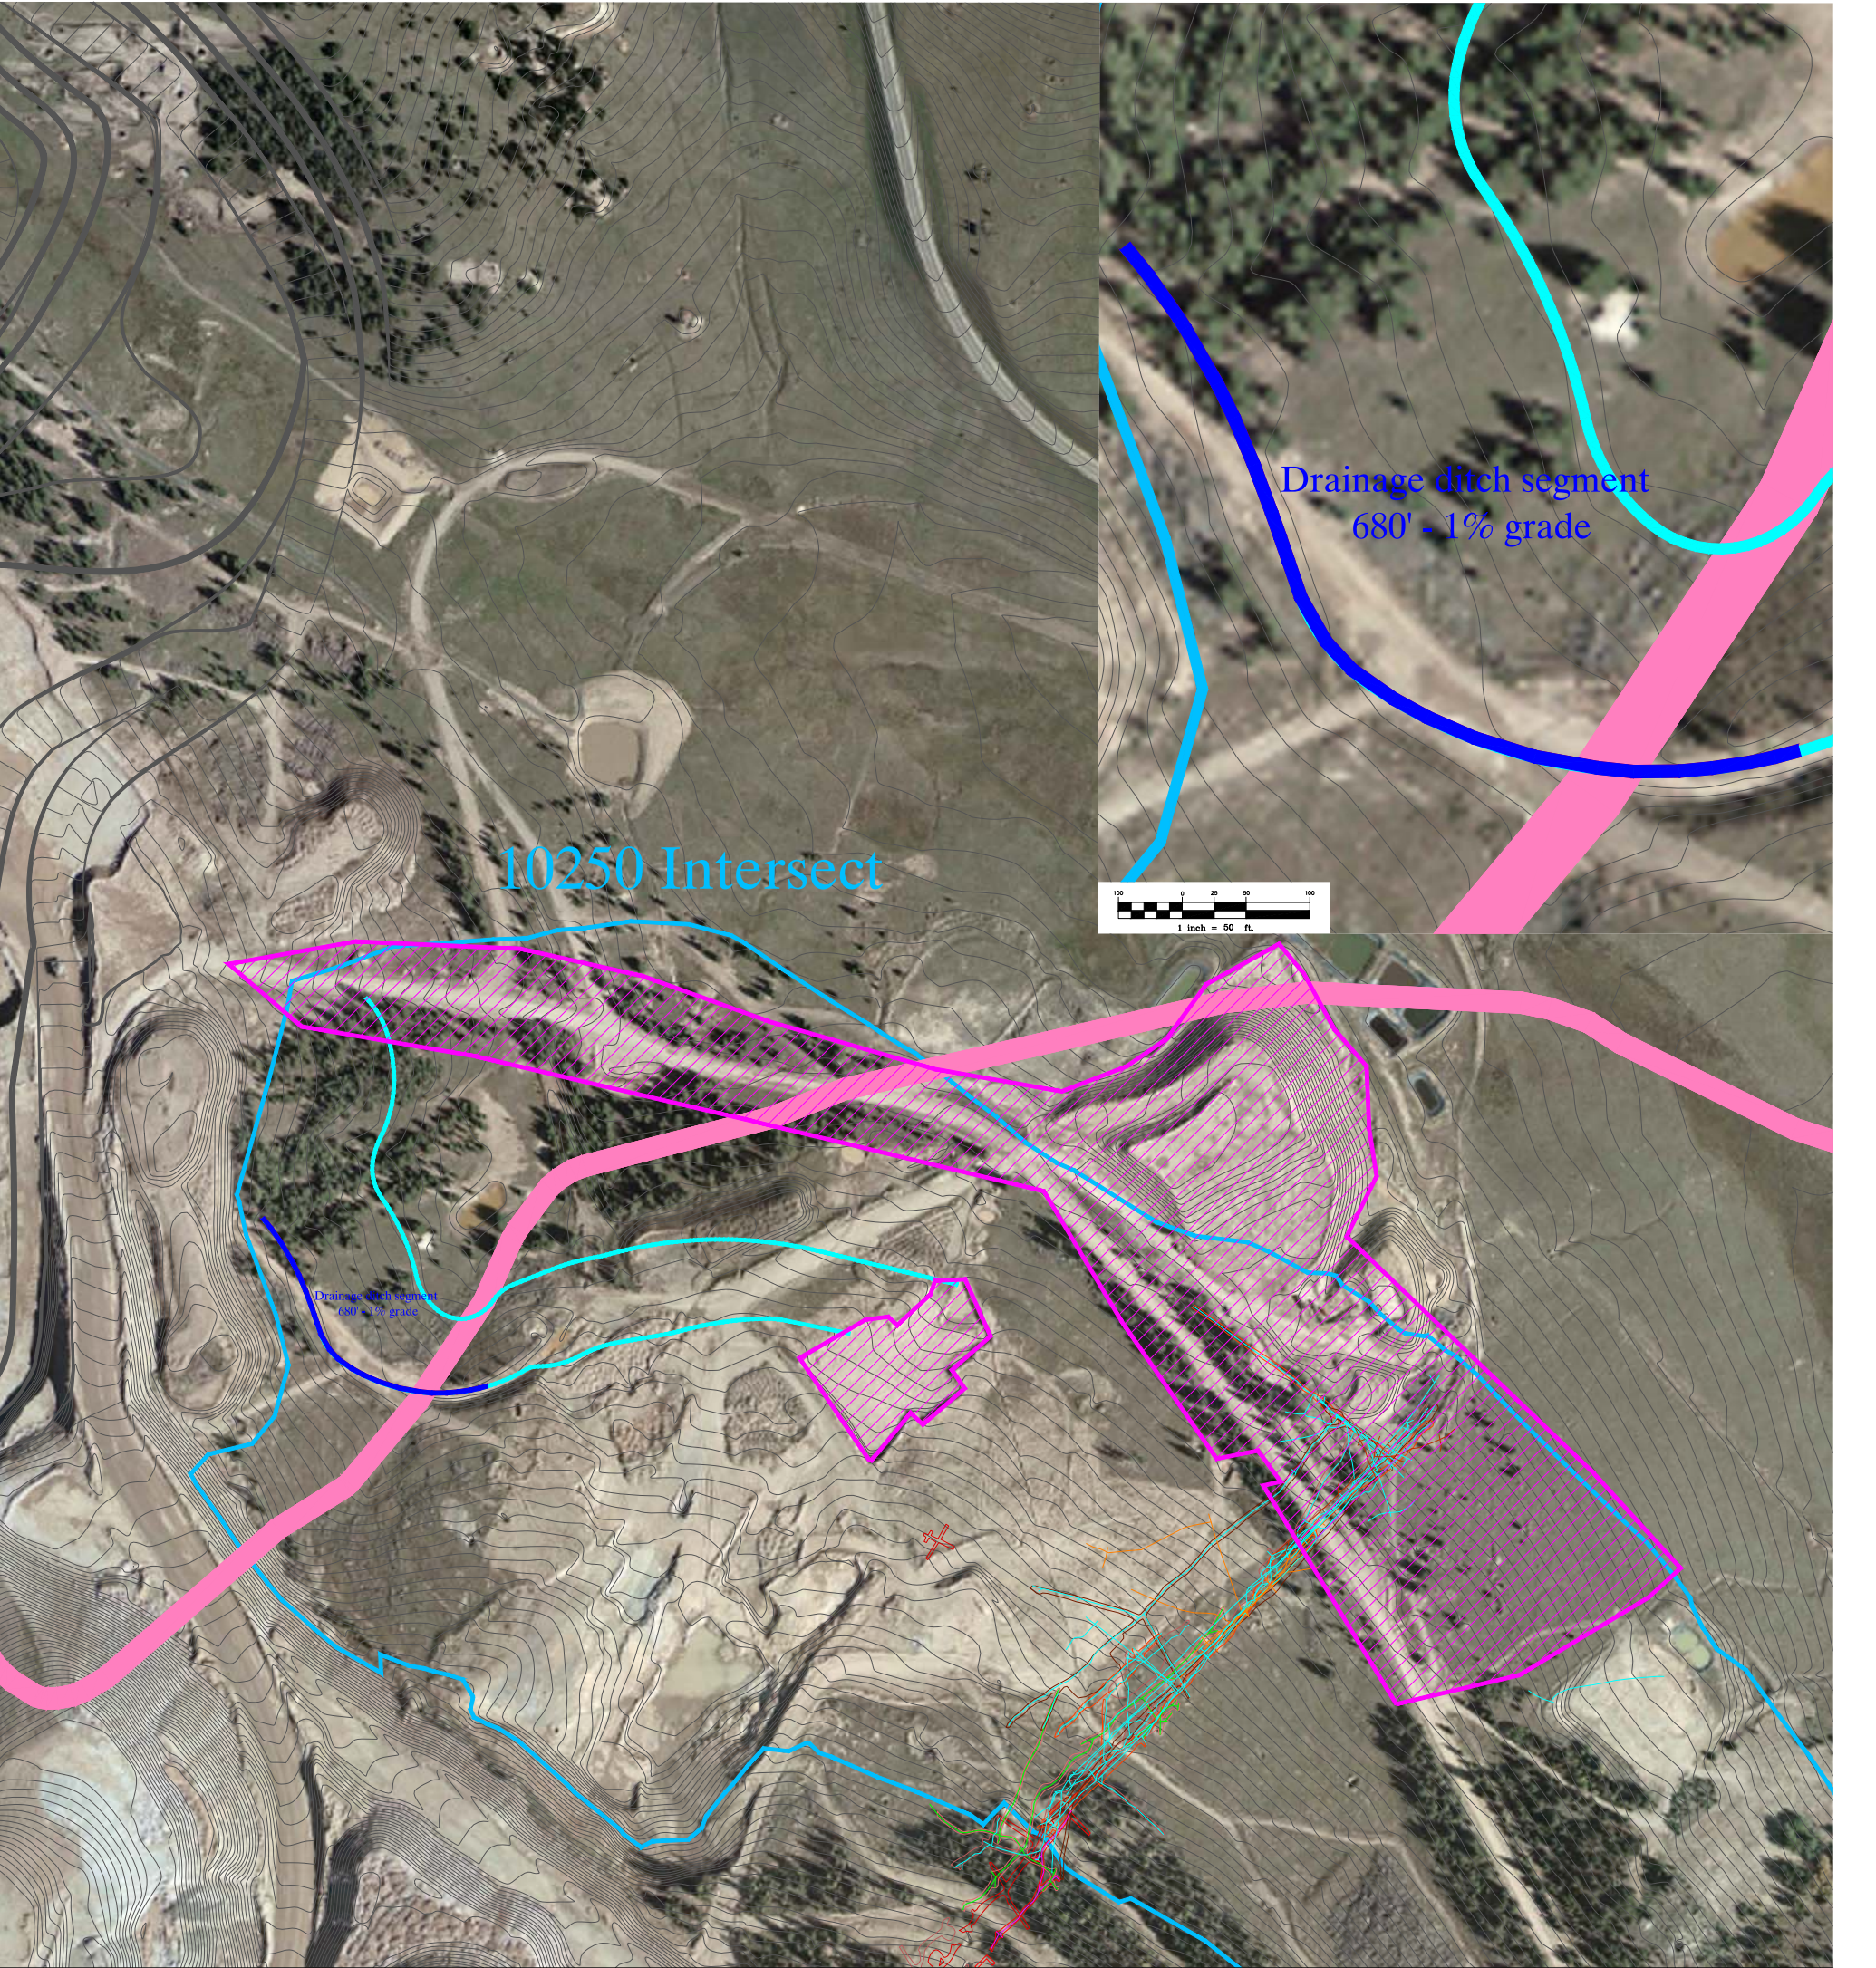
| | Proposed Ditch | | 5' Interval Contour Lines |
