COLORADO DAM SAFETY BRANCH

*2012 Irrigationist Symposium*  
*Dam Safety and Maintenance*

Loveland, CO

March 15, 2012

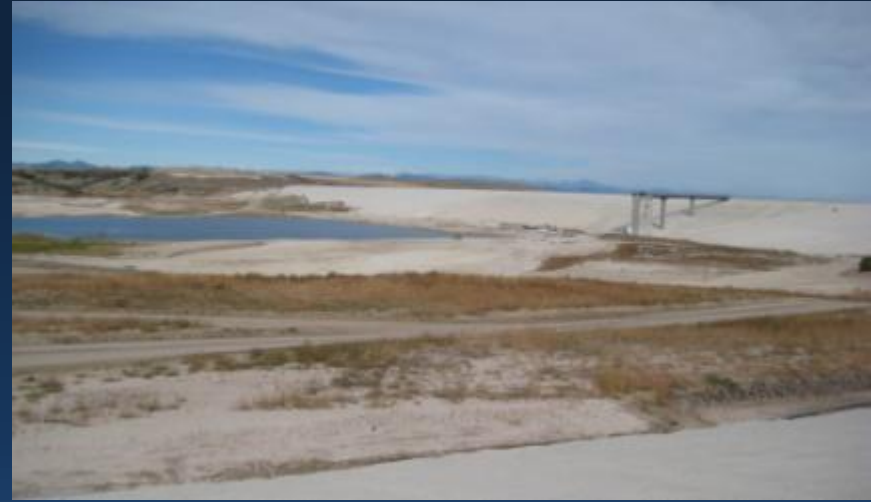
## ■ **Embankment Dams**

- Built of locally available soil and/or rock materials as a compacted mass
- Variable engineering properties

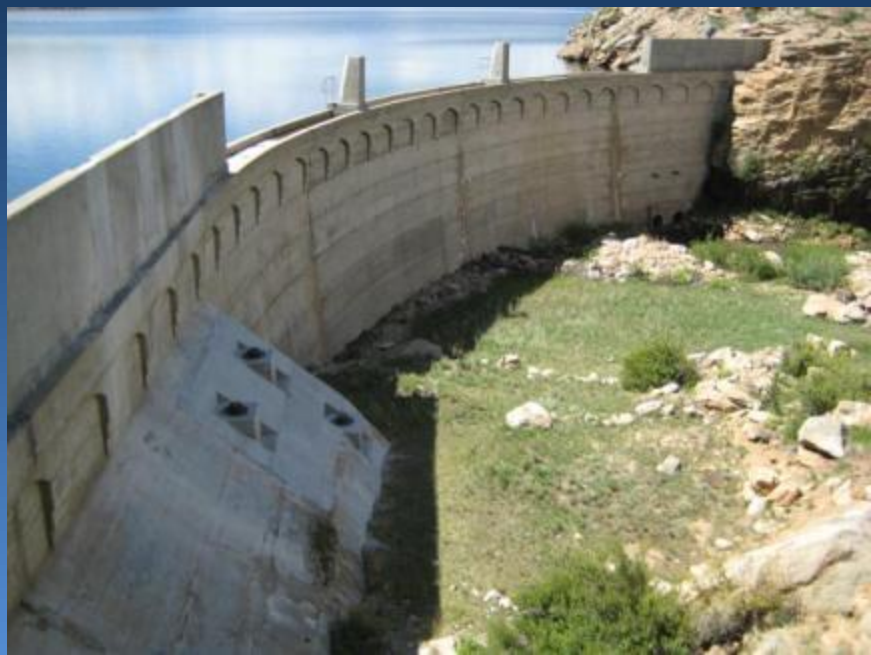
## ■ **Concrete Dams**

- Constructed of concrete, a rigid man-made structural material
- Controlled engineering properties

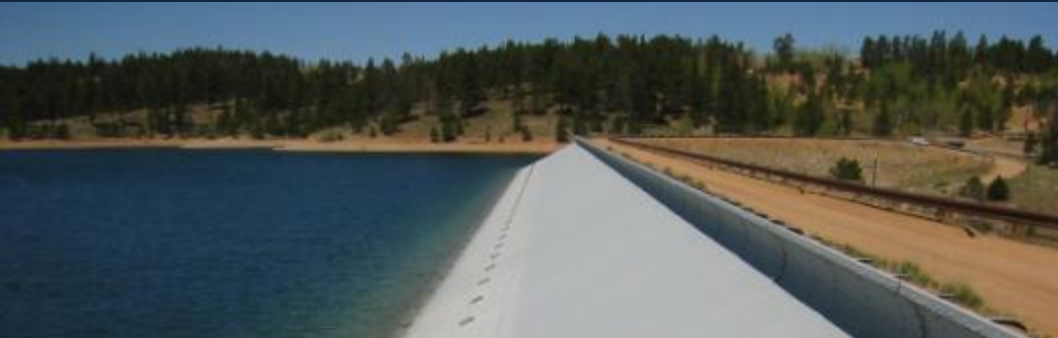
South Catamount

# *Embankment Dam Examples: Homogeneous with Upstream Barrier*

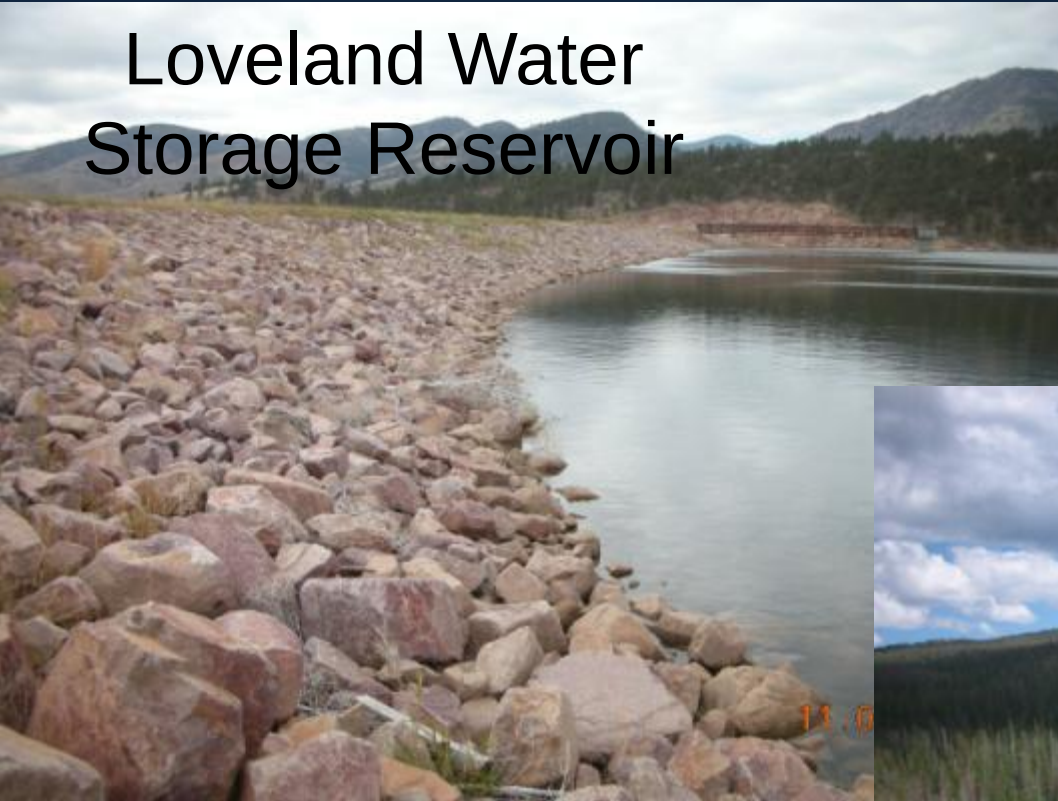
Loveland Water  
Storage Reservoir

# *Embankment Dam Example Pictures: Granular Shell w/ Finer Grained Core*

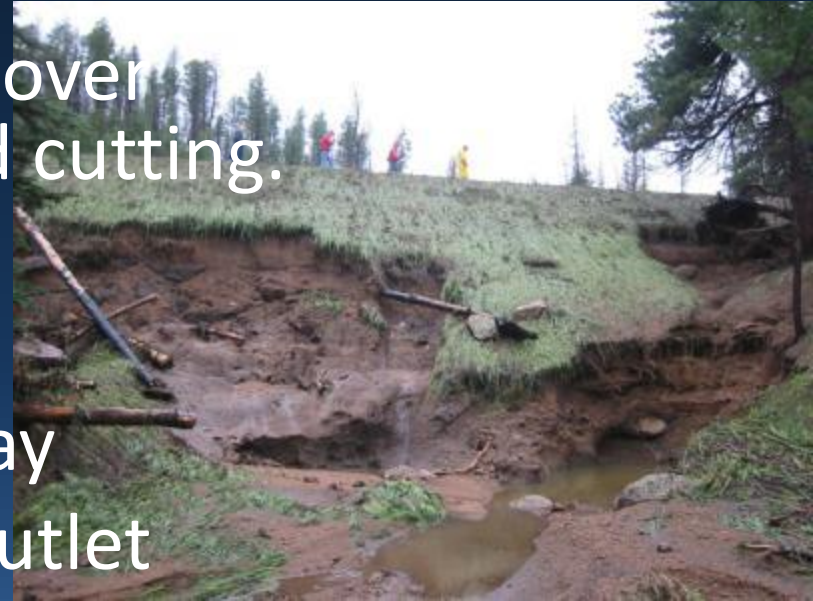
# Overtopping

Accounts for roughly  $\sim 1/2$  of all dam failures

- Uncontrolled flow of water over crest causes backward head cutting.

- Obstructed or inadequately designed emergency spillway
- Inoperable or inadequate outlet
- Settlement of crest causing loss of freeboard.

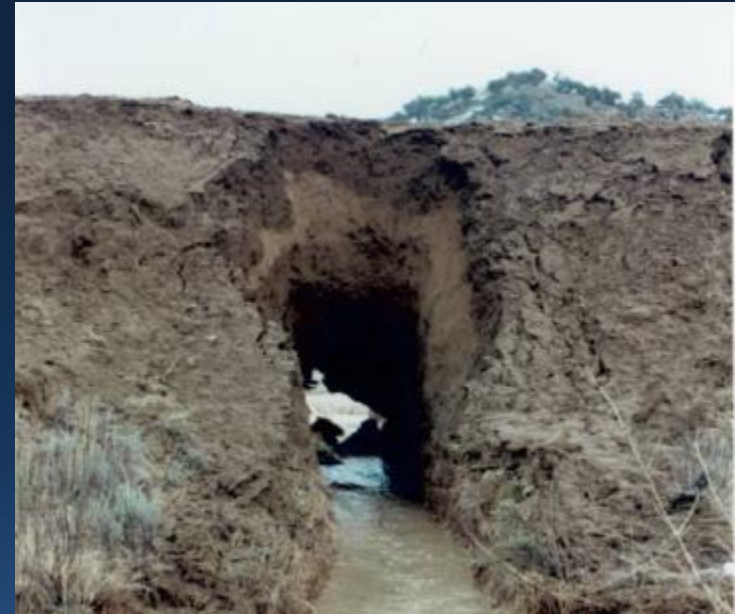
# Seepage Piping/Internal Erosion

Accounts for roughly  $\sim 1/2$  of all dam failures

- Uncontrolled movement of soil particles caused by flowing water and development of internal erosion by seepage

- Seepage along penetrations through the dam (ie: Conduit, rodent holes, cracks, etc.)
- Uncontrolled seepage through embankment and/or foundation

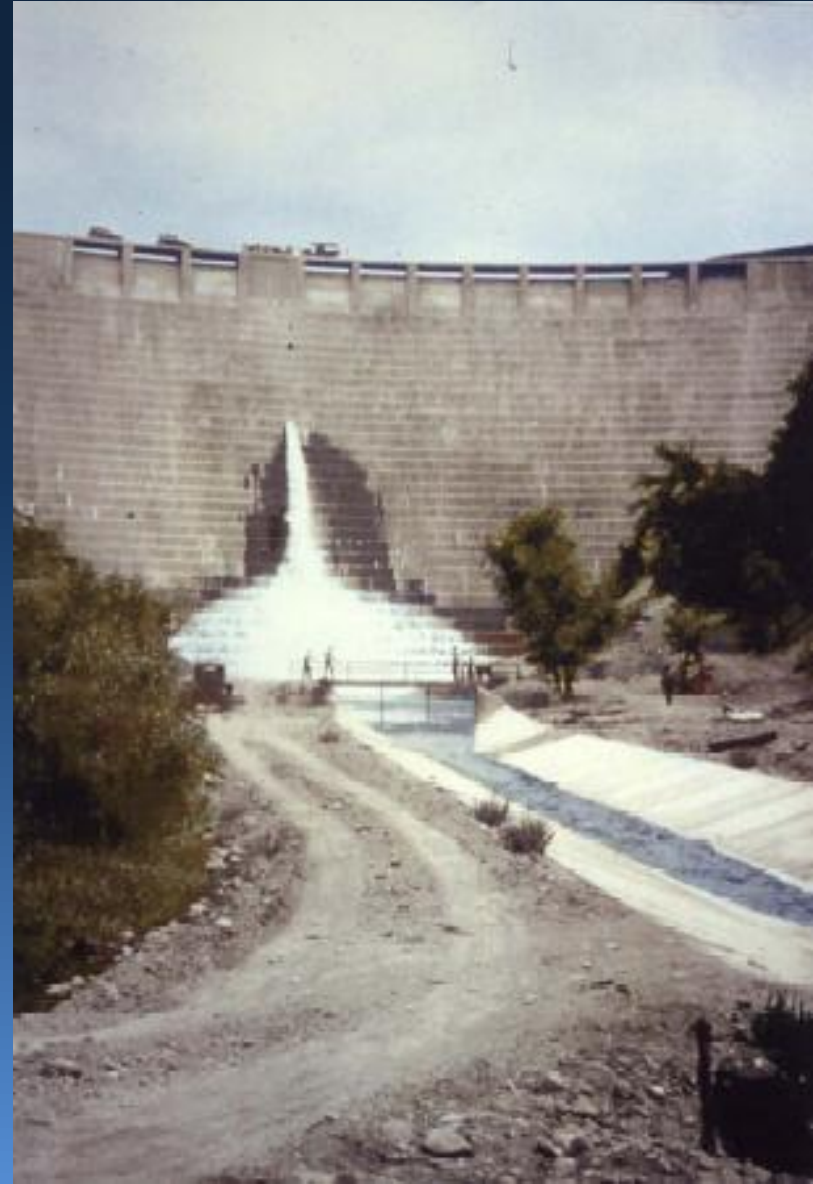
# *Dam Failure Mechanisms – Concrete Dams*

- Overtopping
  - Leading to structural failure of dam, abutments or foundation
- Drainage System Failure
  - Leading to uplift and sliding
- Foundation/Abutment Settlement
  - Leading to loss of support and excess deformation

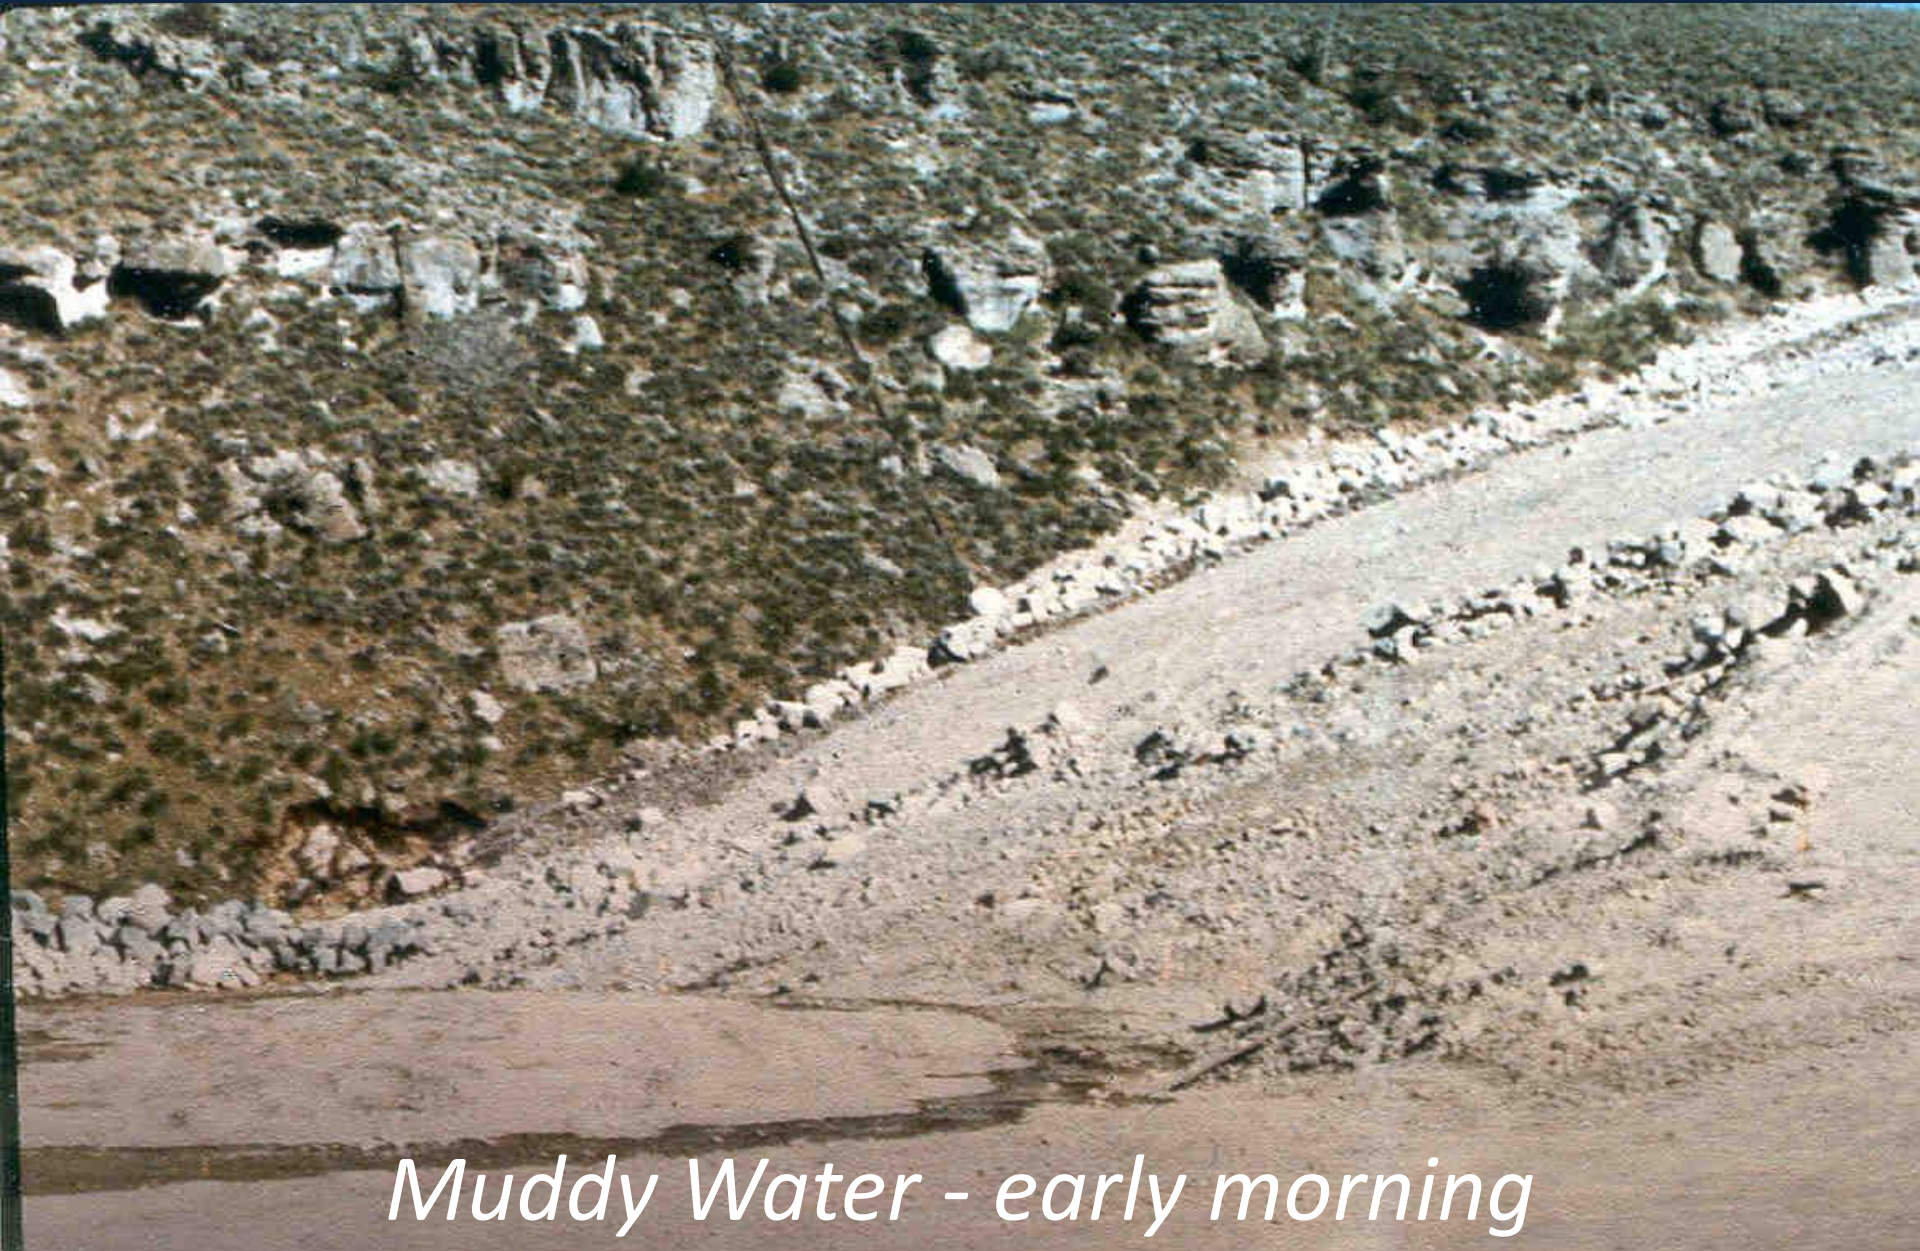
# *Piping/Internal Erosion*

*Muddy Water - early morning*

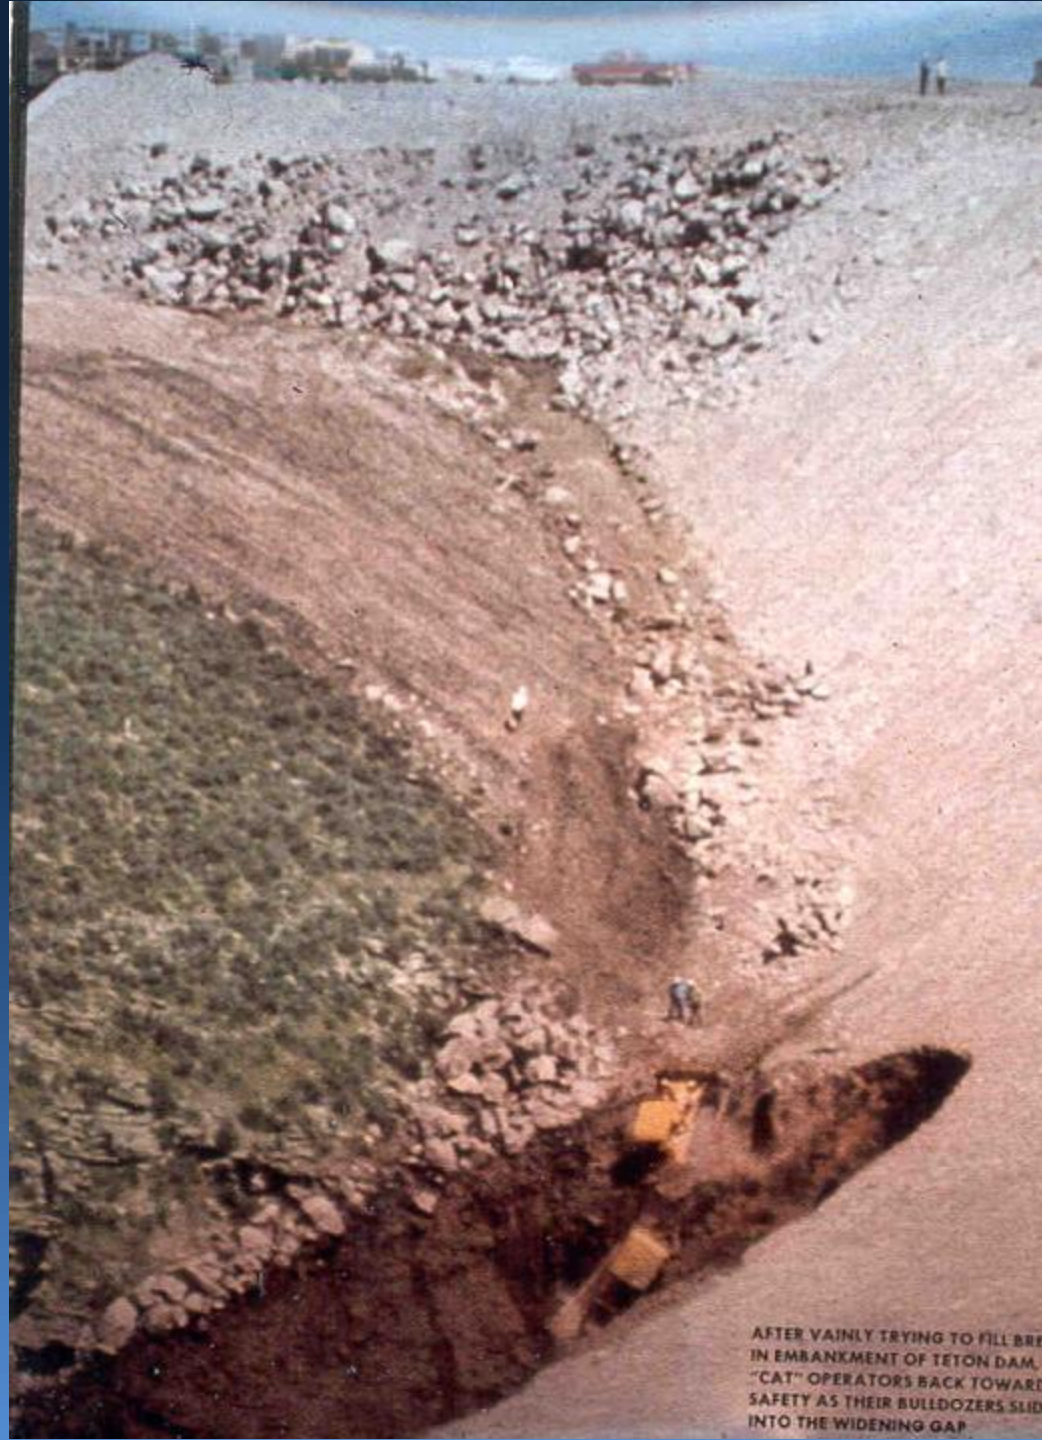
AFTER VAINLY TRYING TO FILL BREACH  
IN EMBANKMENT OF TETON DAM,  
"CAT" OPERATORS BACK TOWARD  
SAFETY AS THEIR BULLDOZERS SLID  
INTO THE WIDENING GAP

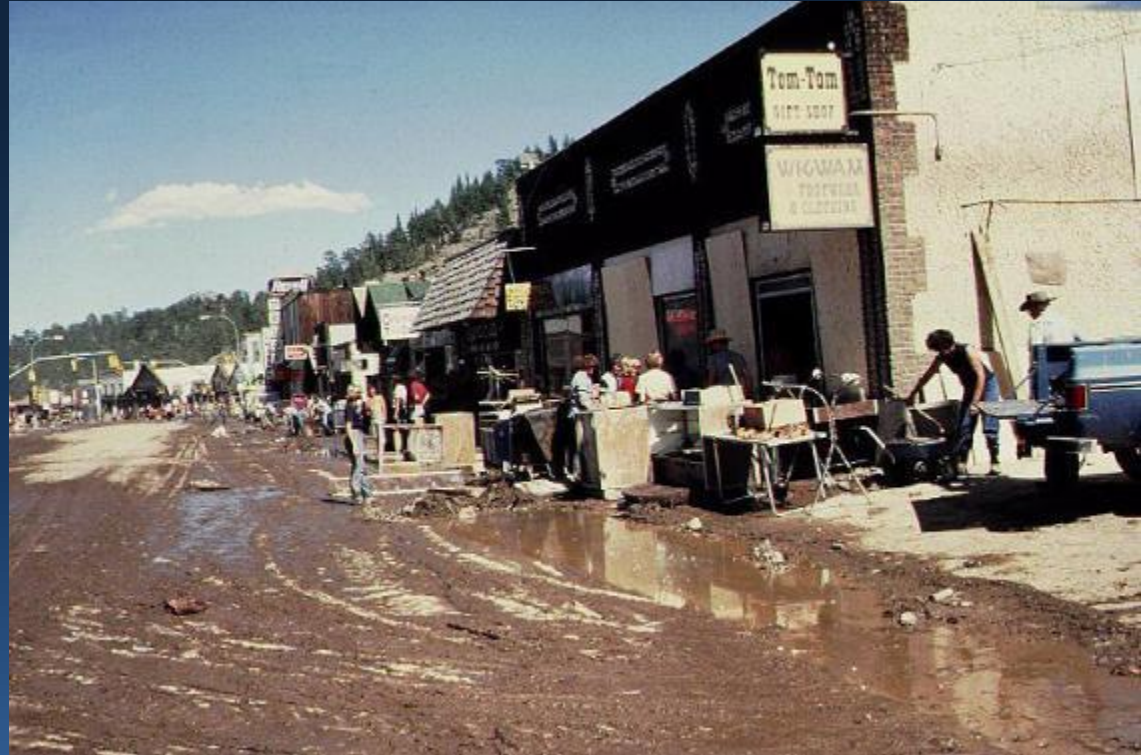
# Lawn Lake Dam

- Deterioration of lead caulking between upstream outlet works pipe and valve housing.
- Seepage around outlet pipe leading to piping and catastrophic failure.
- ***3 people killed.***

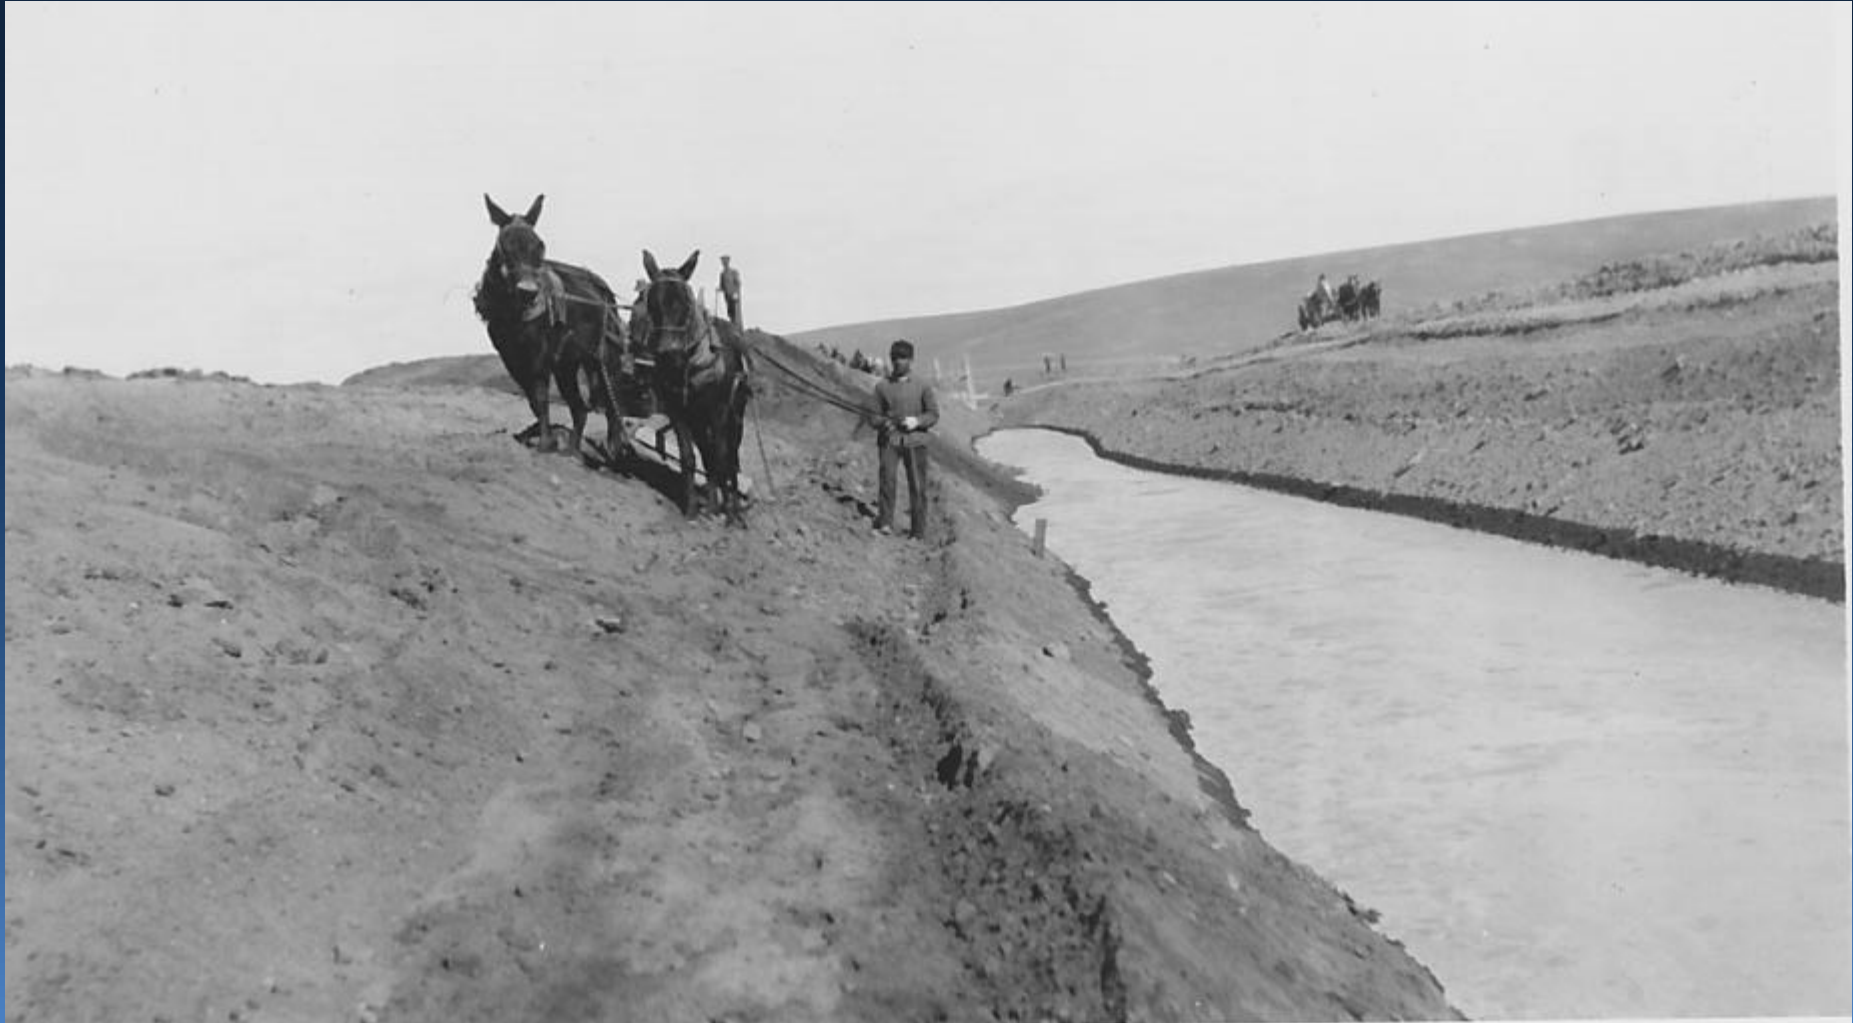
- Heavier Compaction equipment! Horses, puddle core. South Park Area, 1908.

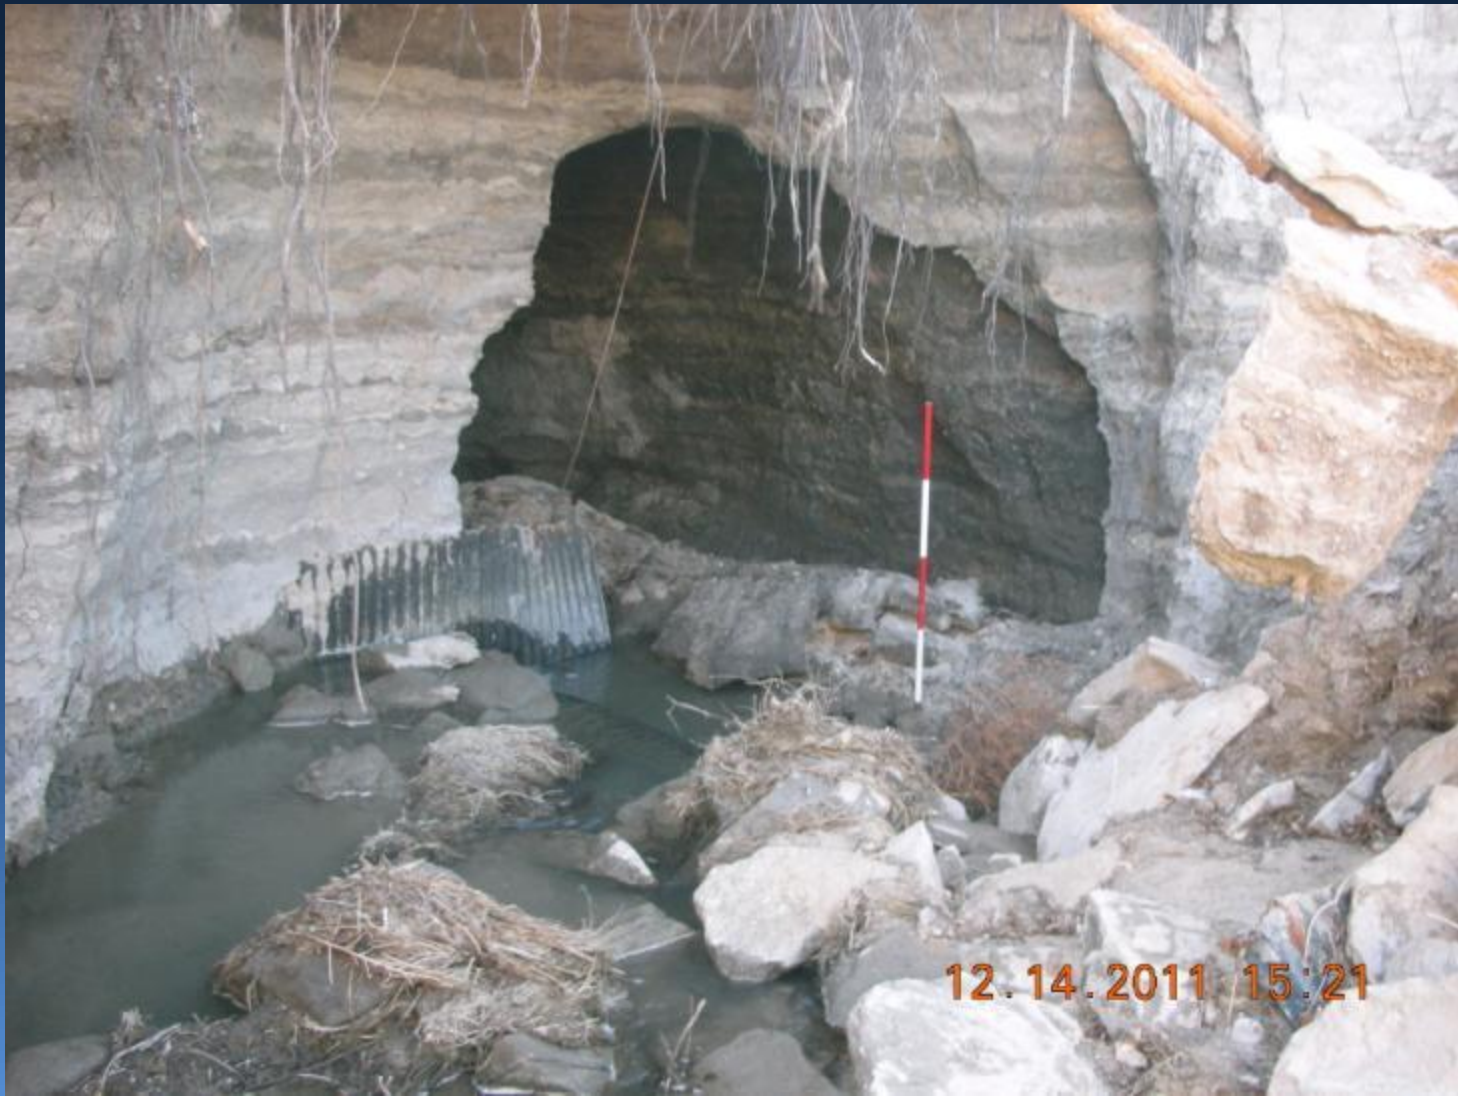
- Corrugated Metal Pipe (CMP) + Cutoff Collars! Many, (most?), small dams built before 1980's.

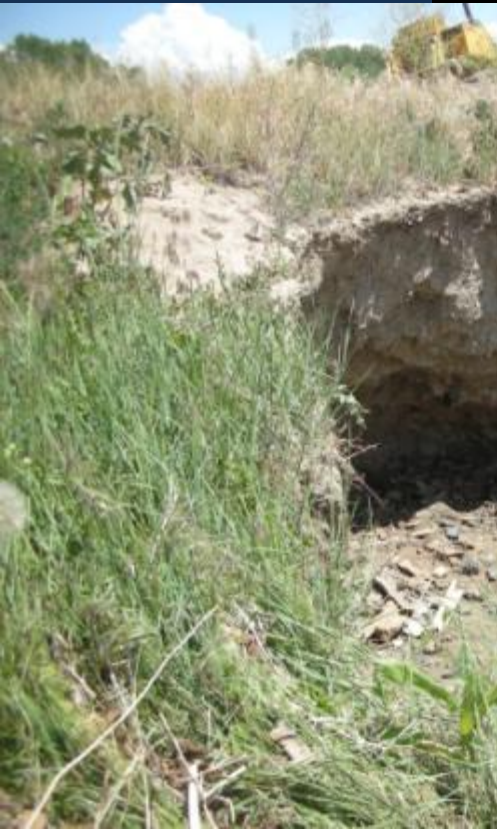
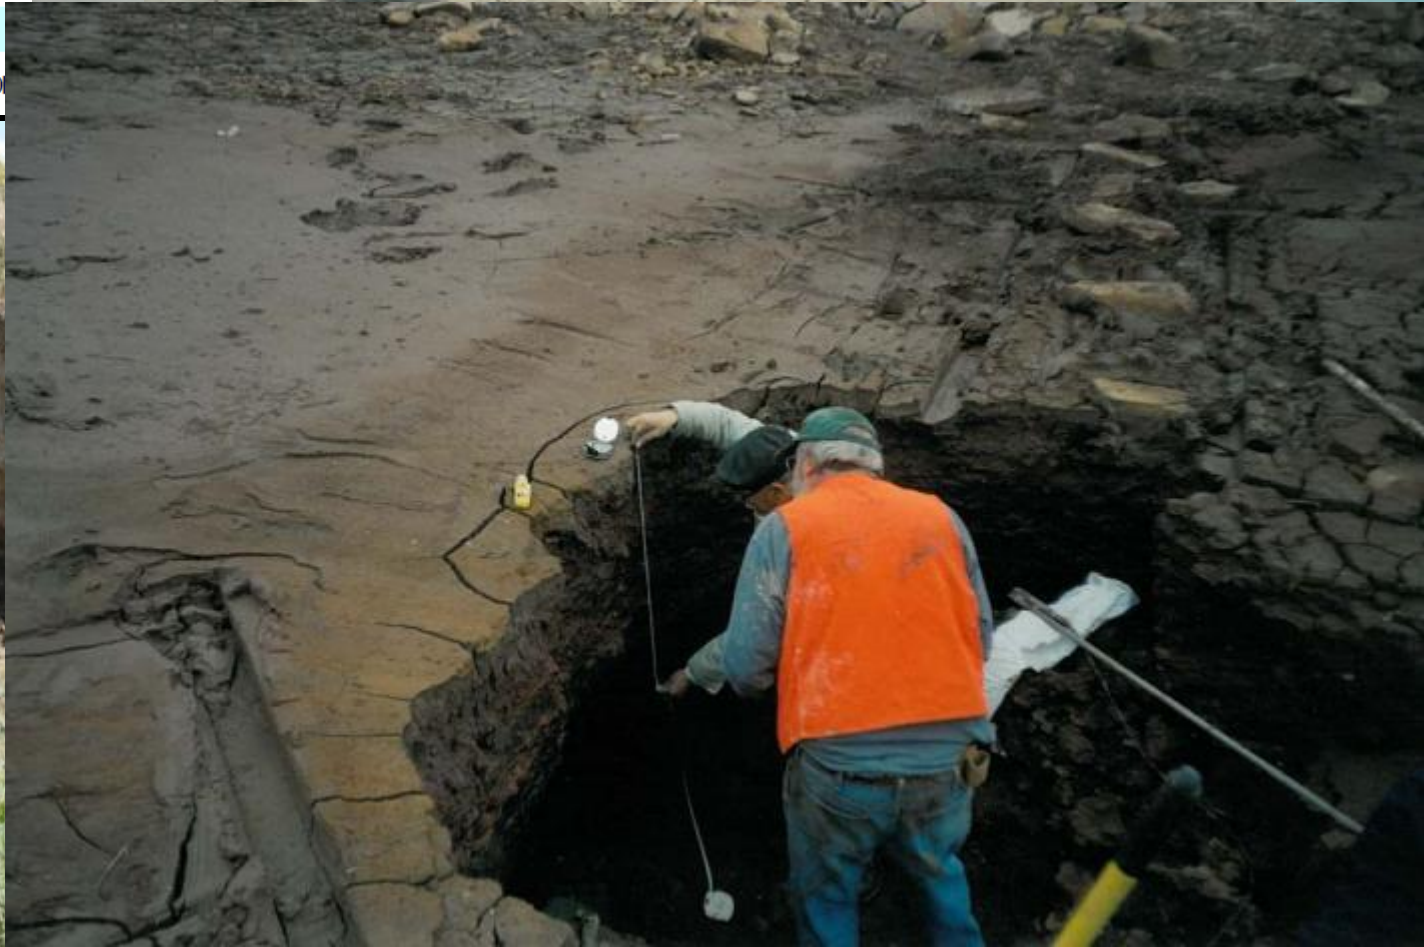
**PROBLEMS NOTED:** ☐ (0) NONE ☐ (1) RIPRAP - MISSING, SPARSE, DISPLACED, WEATHERED ☐ (2) WAVE EROSION - WITH SCARPS  
☐ (3) CRACKS WITH DISPLACEMENT ☐ (4) SINKHOLE ☐ (5) APPEARS TOO STEEP ☐ (6) DEPRESSIONS OR BULGES ☐ (7) SLIDES  
☐ (8) CONCRETE FACING - HOLES, CRACKS, [

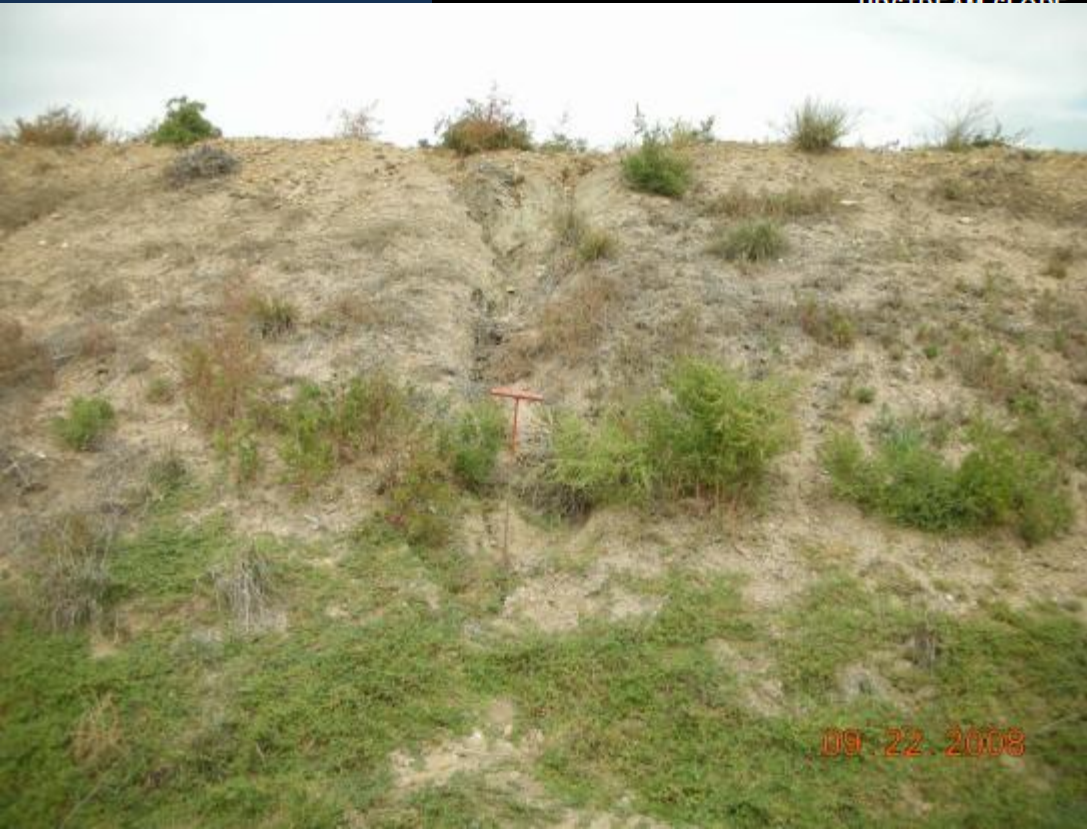
**PROBLEMS NOTED:** ☐ (10) NONE ☐ (11) RUTS OR PUDDLES ☐ (12) EROSION ☐ (13) CRACKS - WITH DISPLACEMENT ☐ (14) SINKHOLES  
☐ (15) NOT WIDE ENOUGH ☐ (16) LOW AREA ☐ (17) MISALIGNMENT ☐ (18) IMPROPER SURFACE DRAINAGE ☐ (19) OTHER

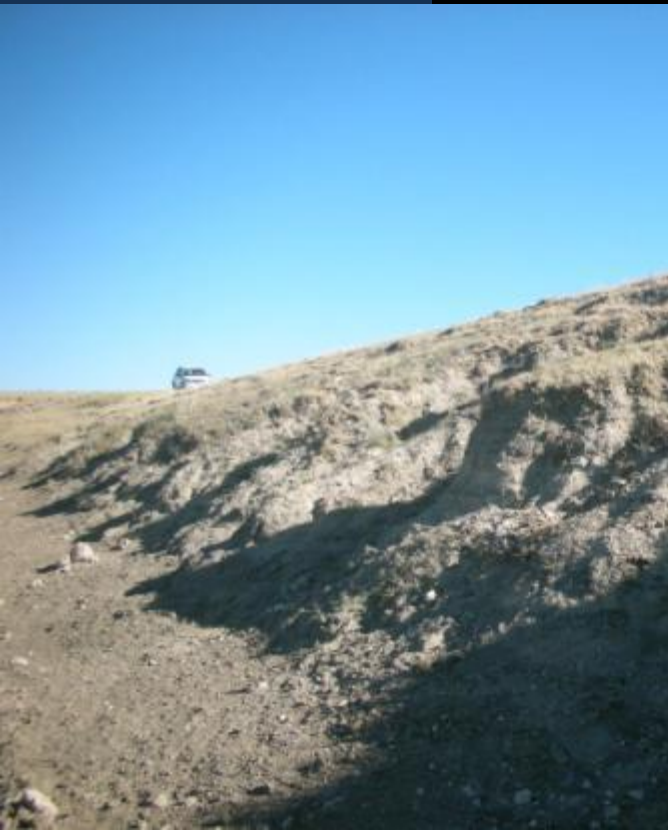
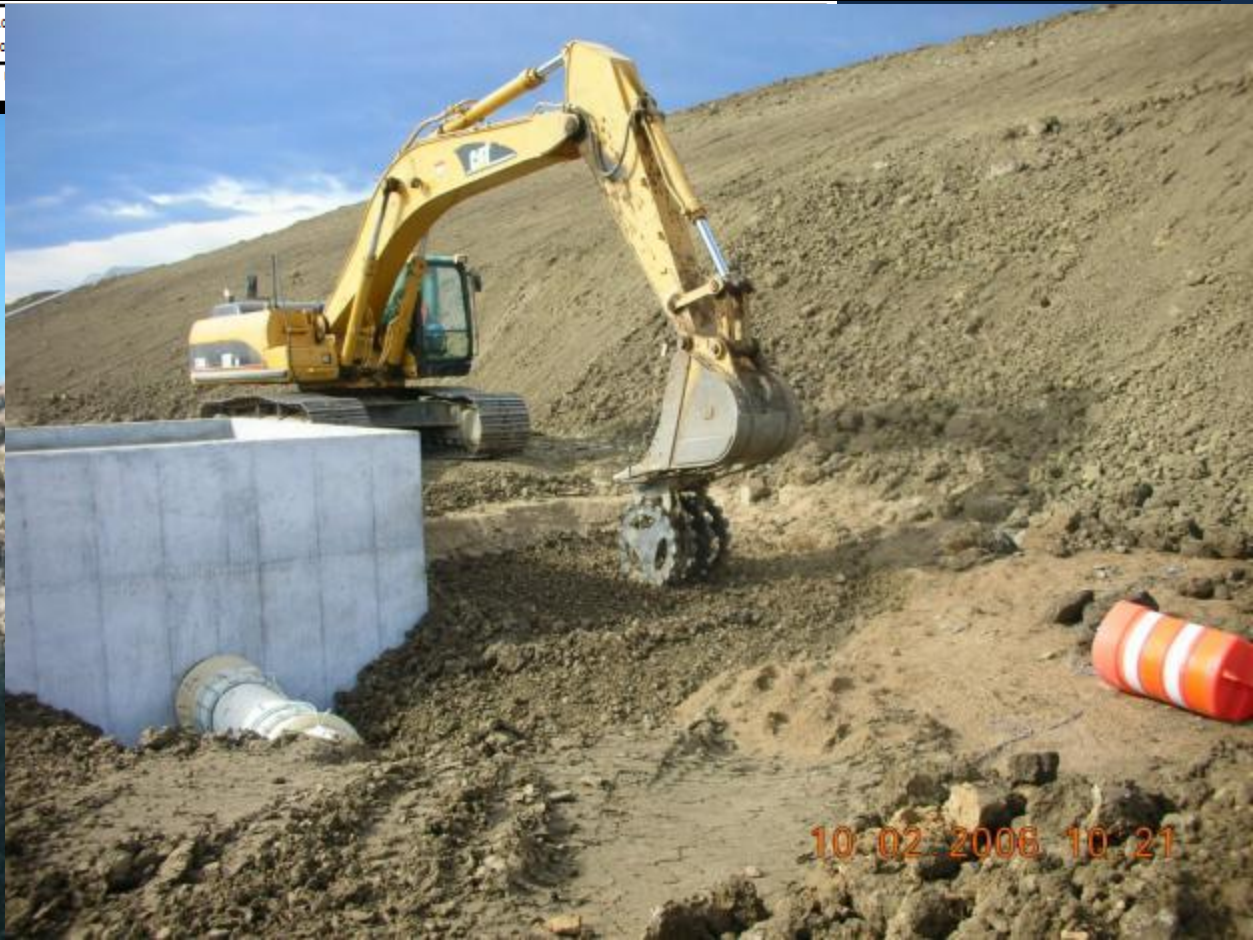
**PROBLEMS NOTED:** ☐ (20) NONE ☐ (21) LIVESTOCK DAMAGE ☐ (22) EROSION OR GULLIES ☐ (23) CRACKS - WITH DISPLACEMENT ☐ (24) SINKHOLE  
☐ (25) APPEARS TOO STEEP ☐ (26) DEPRESSIONS OR BULGES ☐ (27) SLIDE ☐ (28) SOFT AREAS ☐ (29) OTHER

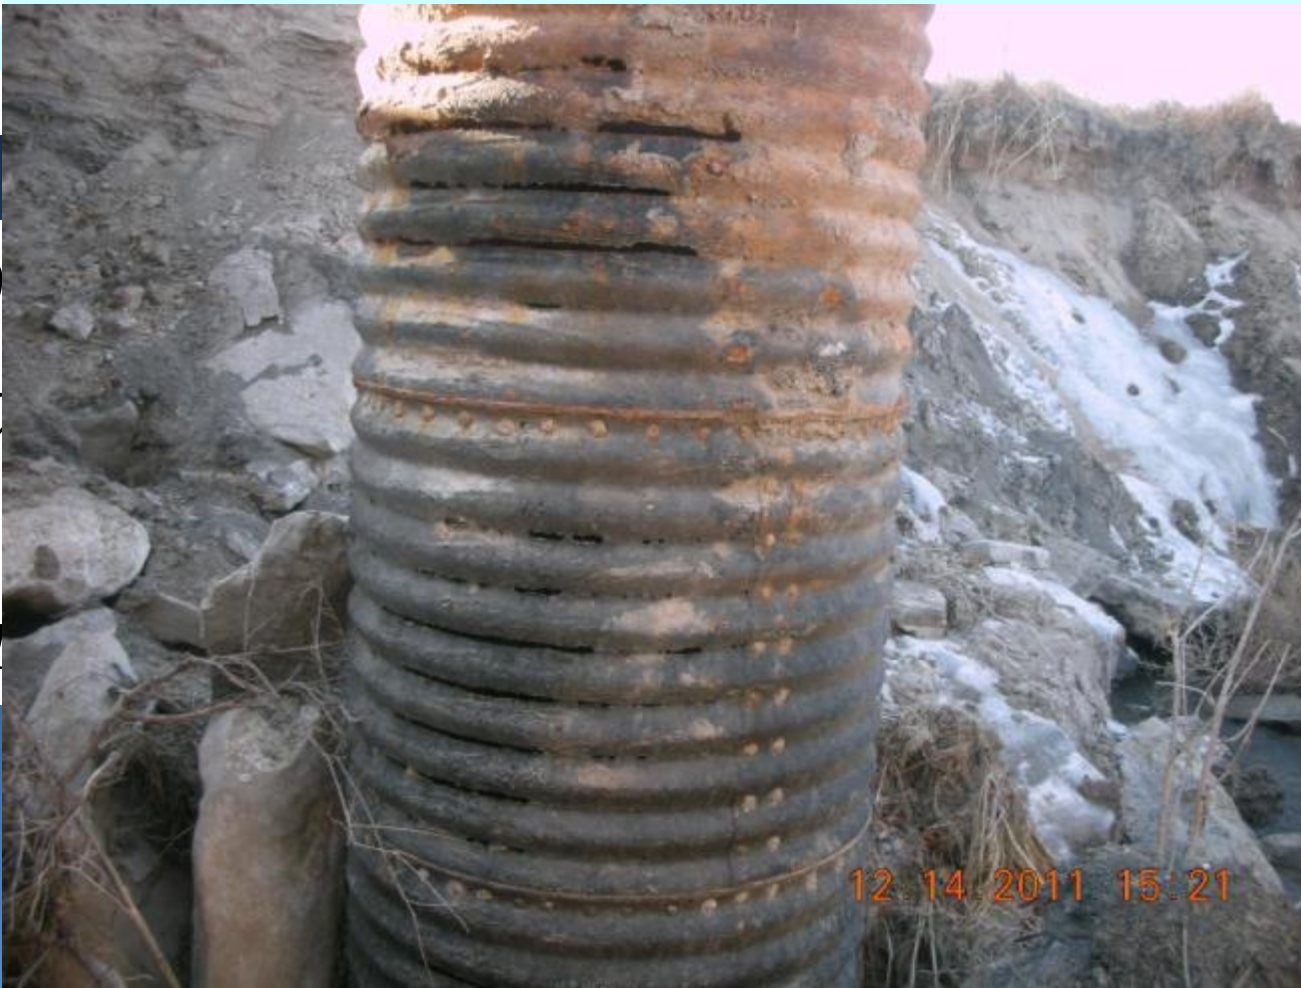
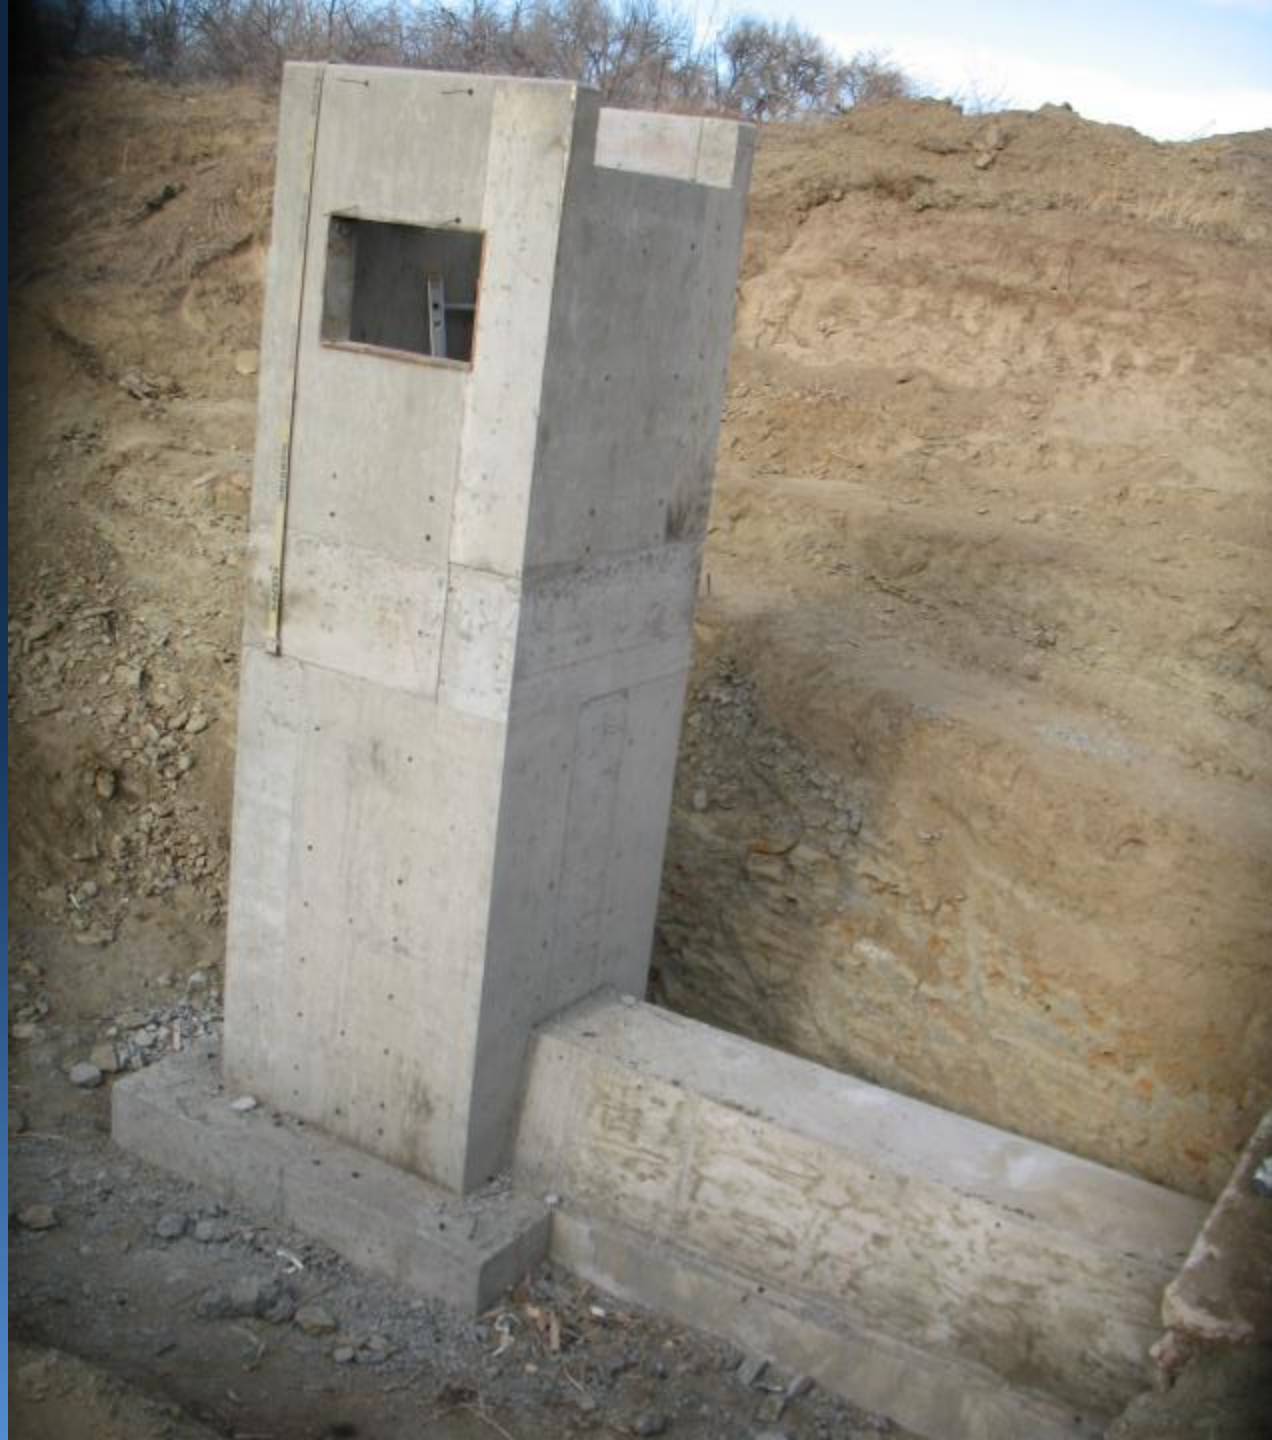
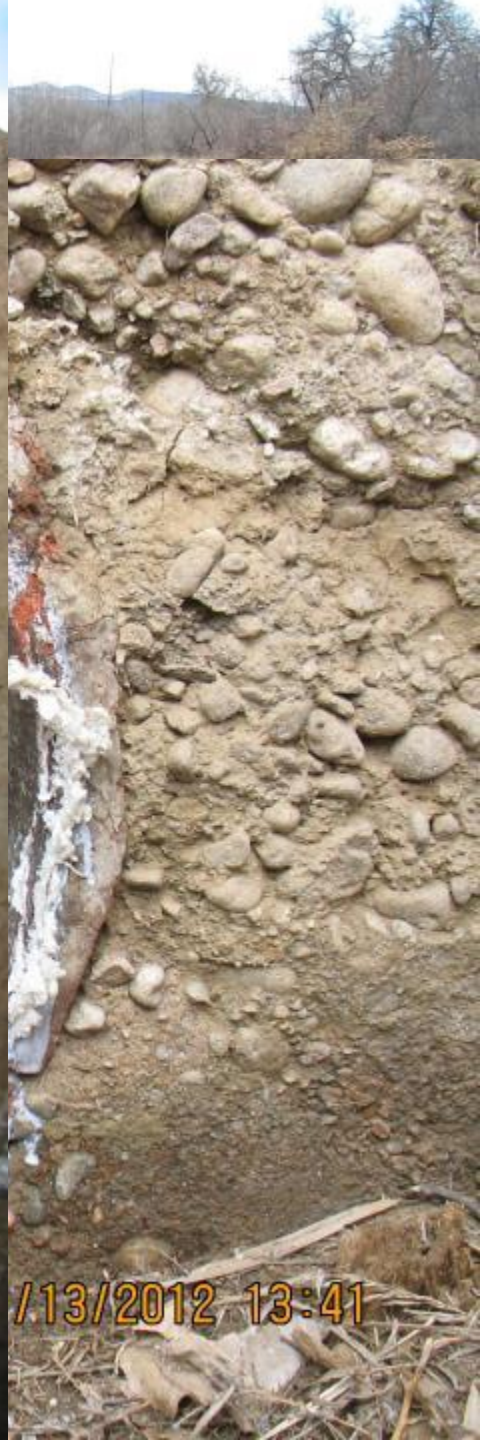
**PROBLEMS NOTED:** ☐ (40) NONE ☐ (41) NO OUTLET FOUND ☐ (42) POOR OPERATING ACCESS ☐ (43) INOPERABLE

☐ (44) **UPSTREAM** OR **DOWNSTREAM** STRUCTURE DETERIORATED ☐ (45) OUTLET OPERATED DURING INSPECTION ☐ YES ☐ NO

**INTERIOR INSPECTED** ☐ (120) NO ☐ (121) YES ☐ (46) CONDUIT **DETERIORATED** OR **COLLAPSED** ☐ (47) JOINTS DISPLACED ☐ (48) VALVE LEAKAGE

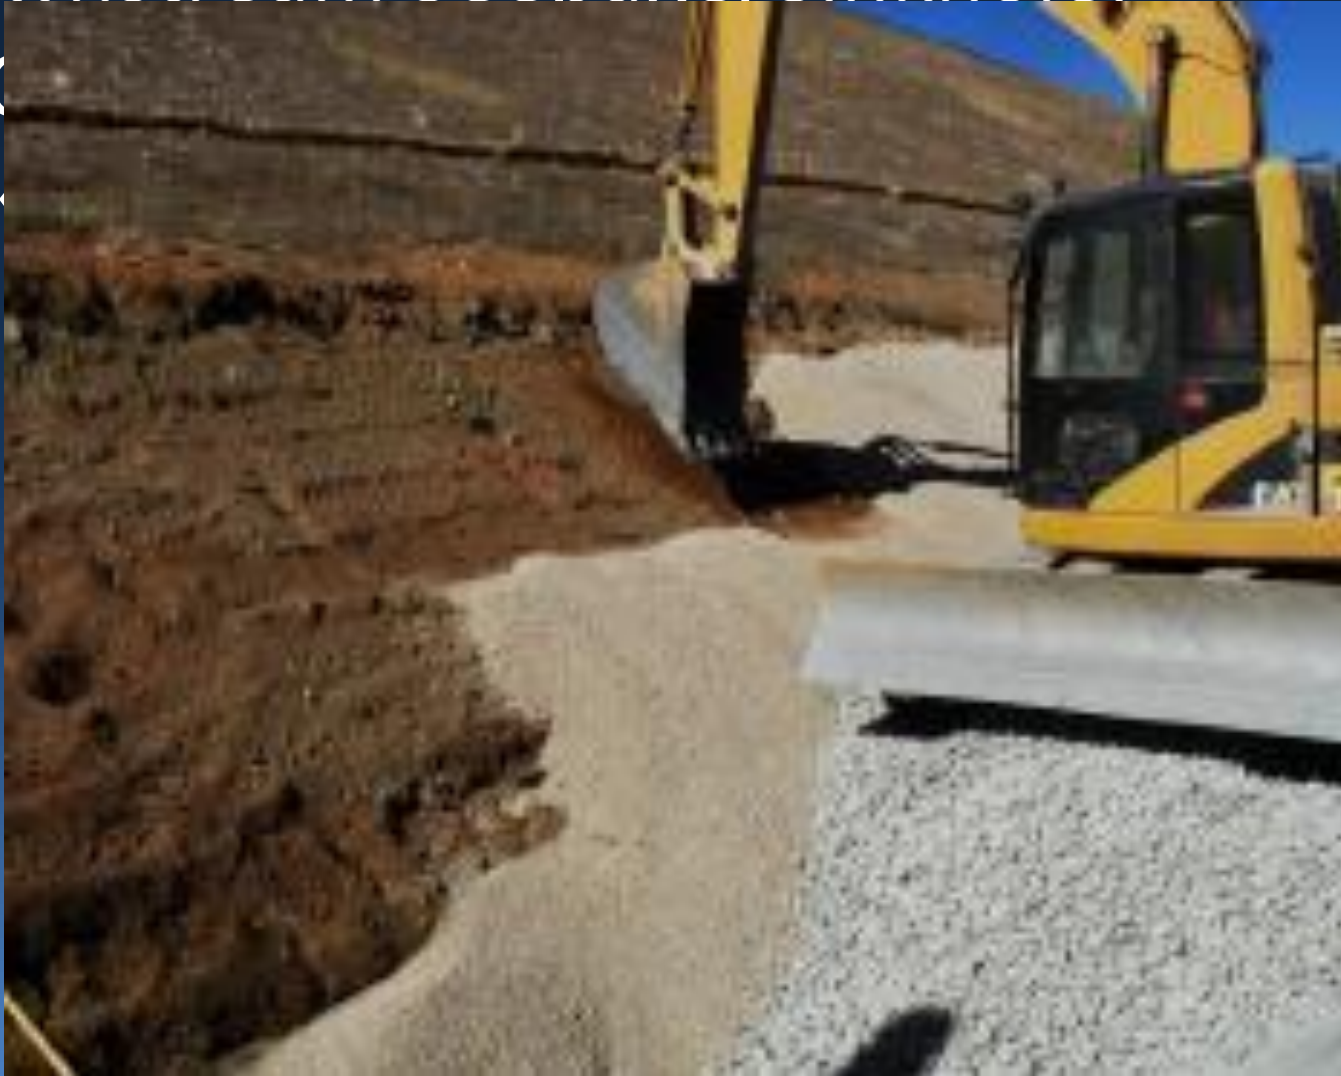
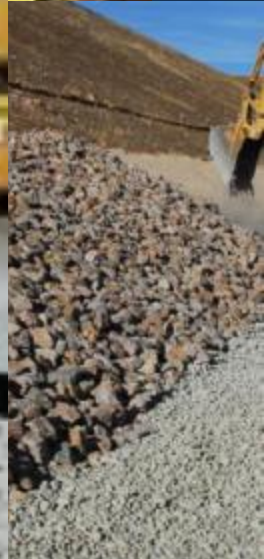
Photograph 6-5 - Filter material
