Colorado Watershed Restoration Program Application

Upper Ingram Gulch Restoration Project Fourmile Watershed Coalition

Ingram Gulch Upper Watershed Restoration and Stabilization Conceptual Design Report

Prepared By: AloTerra Restoration Services

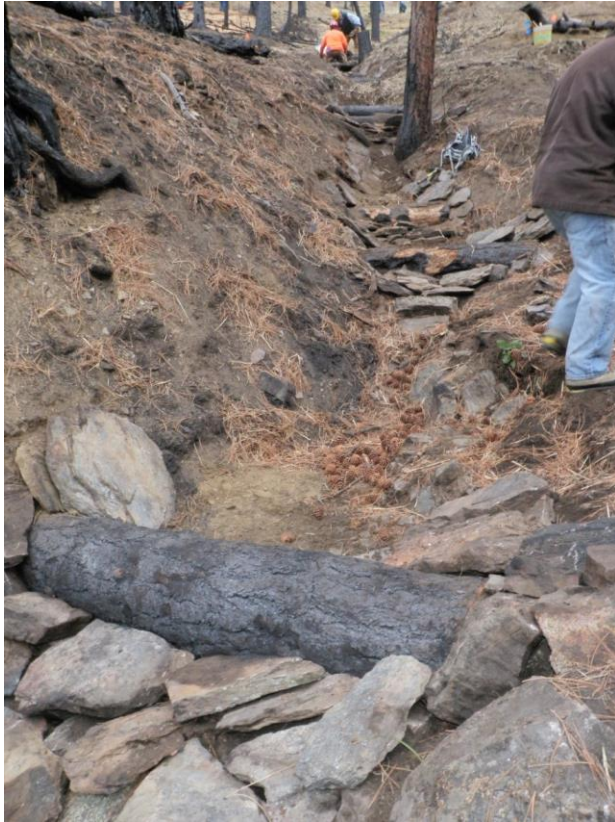
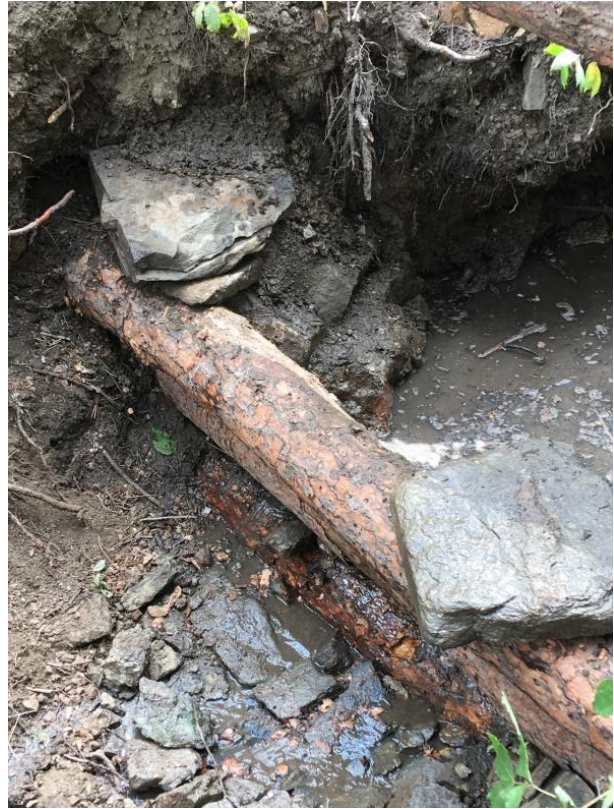
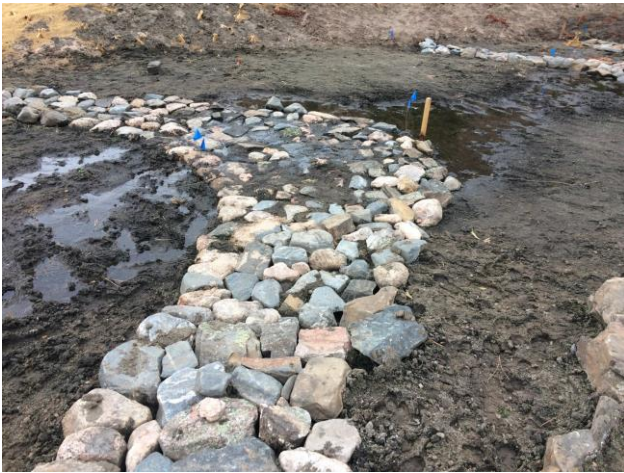
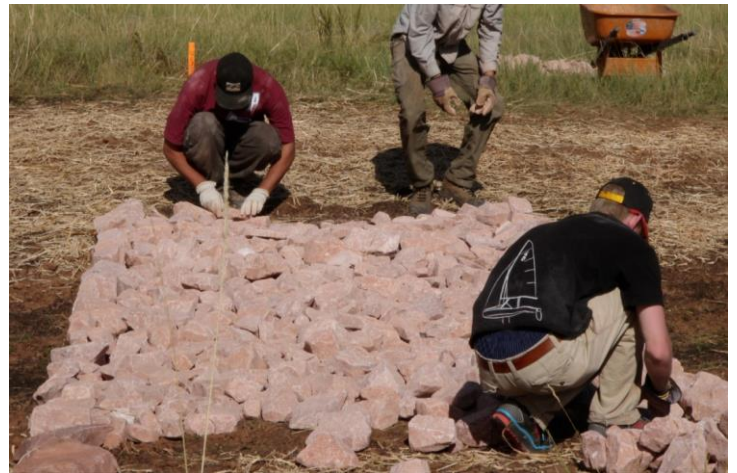
Figure 8. Photos of log-rock weirs (top left and top right), one-rock dams (bottom right), and media luna (bottom left) gulley treatments that are appropriate for prioritized gullies within the study area.

Figures 5-8 provide typical treatments for gulleys of the Ingram Gulch upper watershed. A refinement of treat typical details, locations, and priorities should be provided during a subsequent design phase.

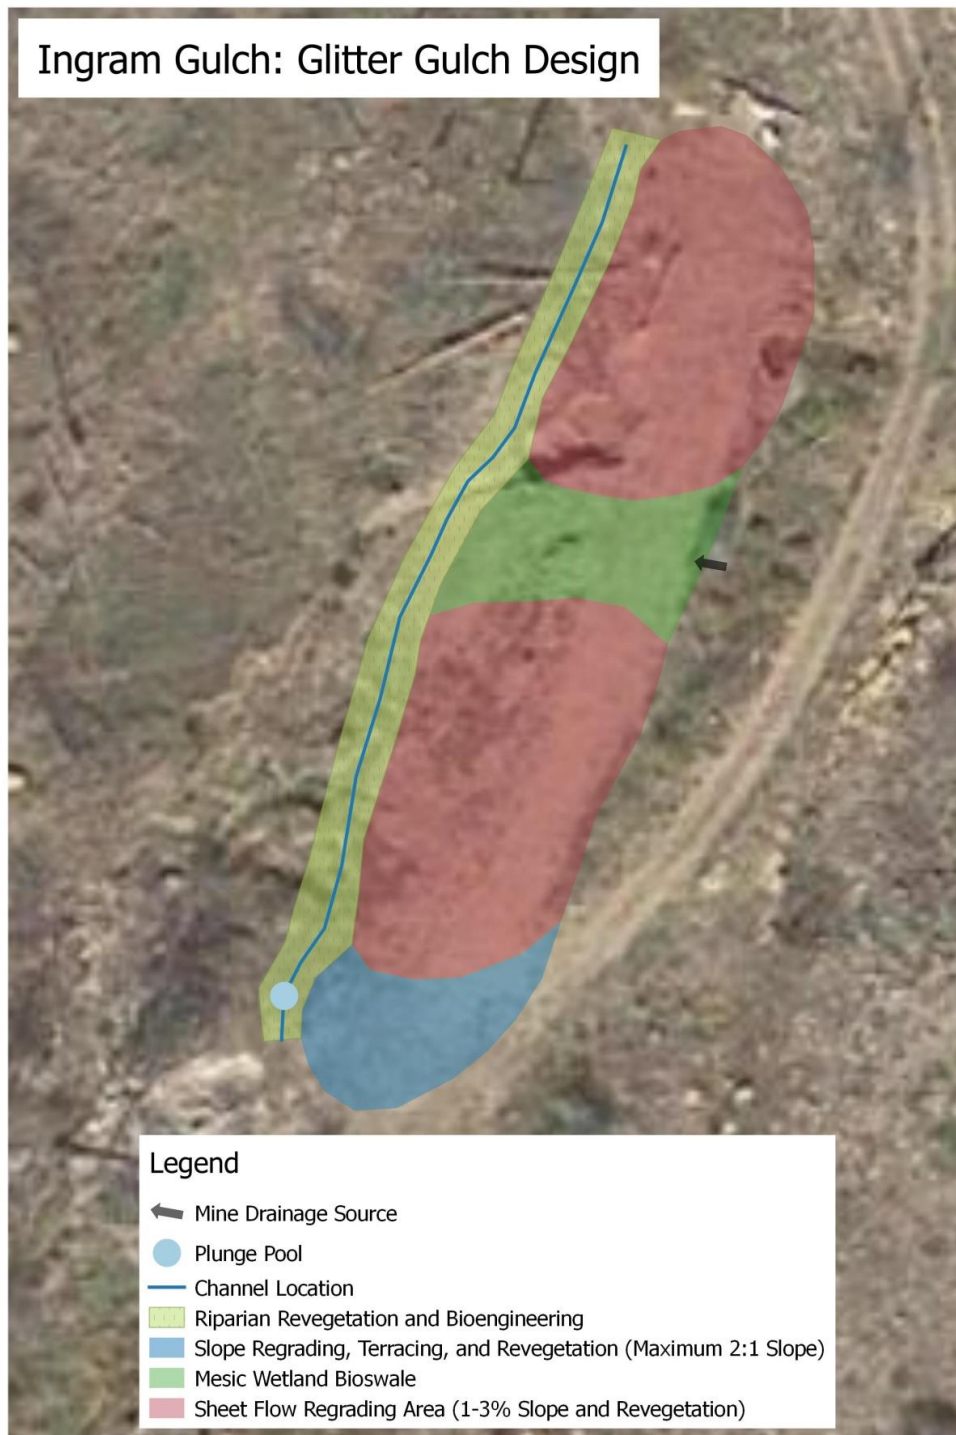
Figure 9. Conceptual design overview for shooting range area of Glitter Gulch.

Based on an informal assessment of the shooting area of Glitter Gulch, considering the proximity of a large denuded area adjacent to an intermittent stream, and significant geomorphic risk during high flow events, the conceptual design in Figure 9 is provided. Additional analysis is necessary during a subsequent design phase to better understand the site constraints and opportunities fully enough to inform treatments appropriate for the watershed health goals and existing conditions.

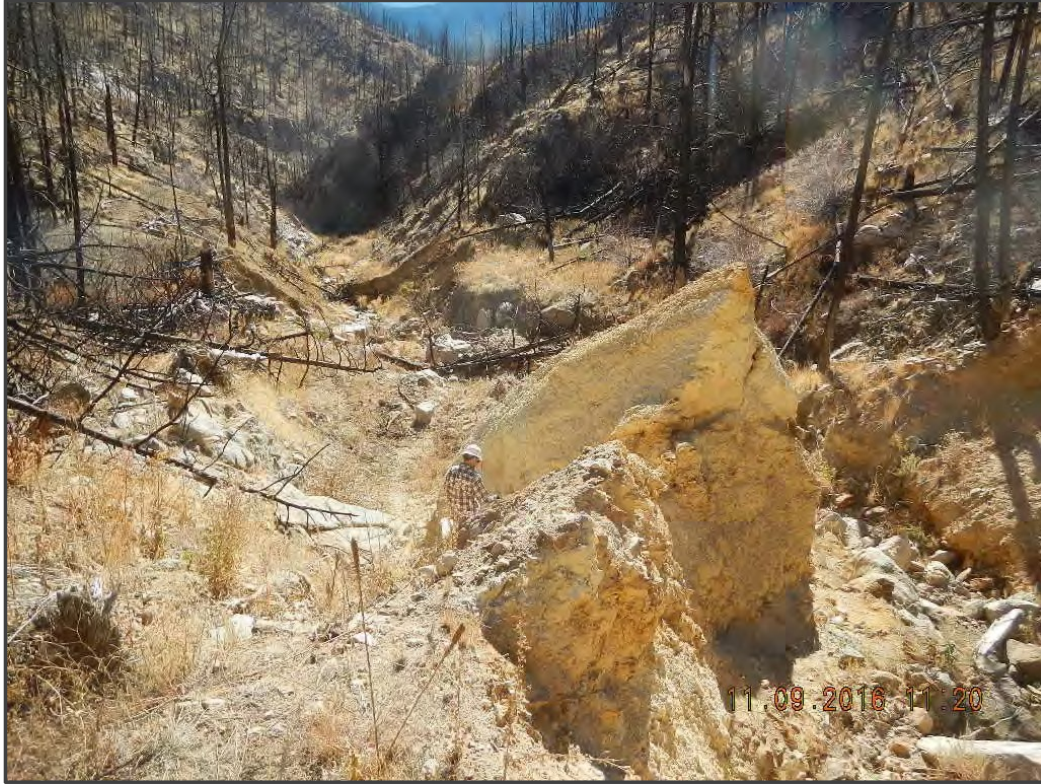
Mineral Point-SS33 Waste Pile Located Within Ingram Gulch Channel

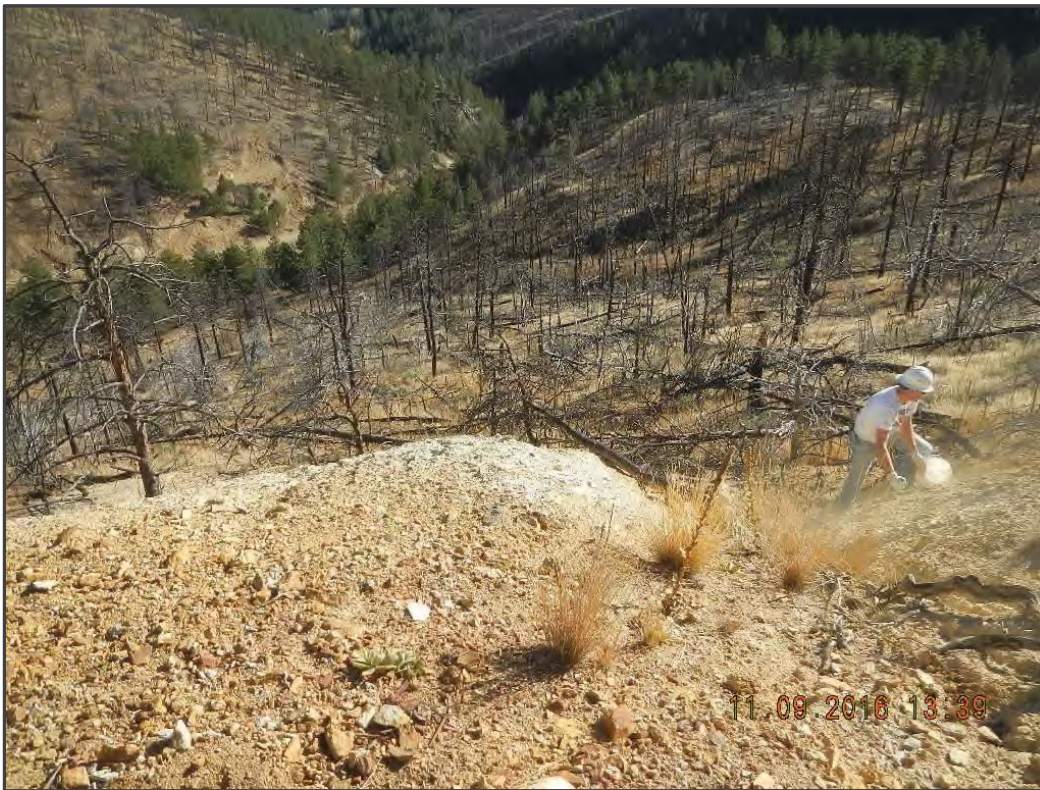
Fairfax-SS10 Waste Pile Located Outside of Ingram Gulch Channel
