# Yampa River Health Assessment Report

December 2017

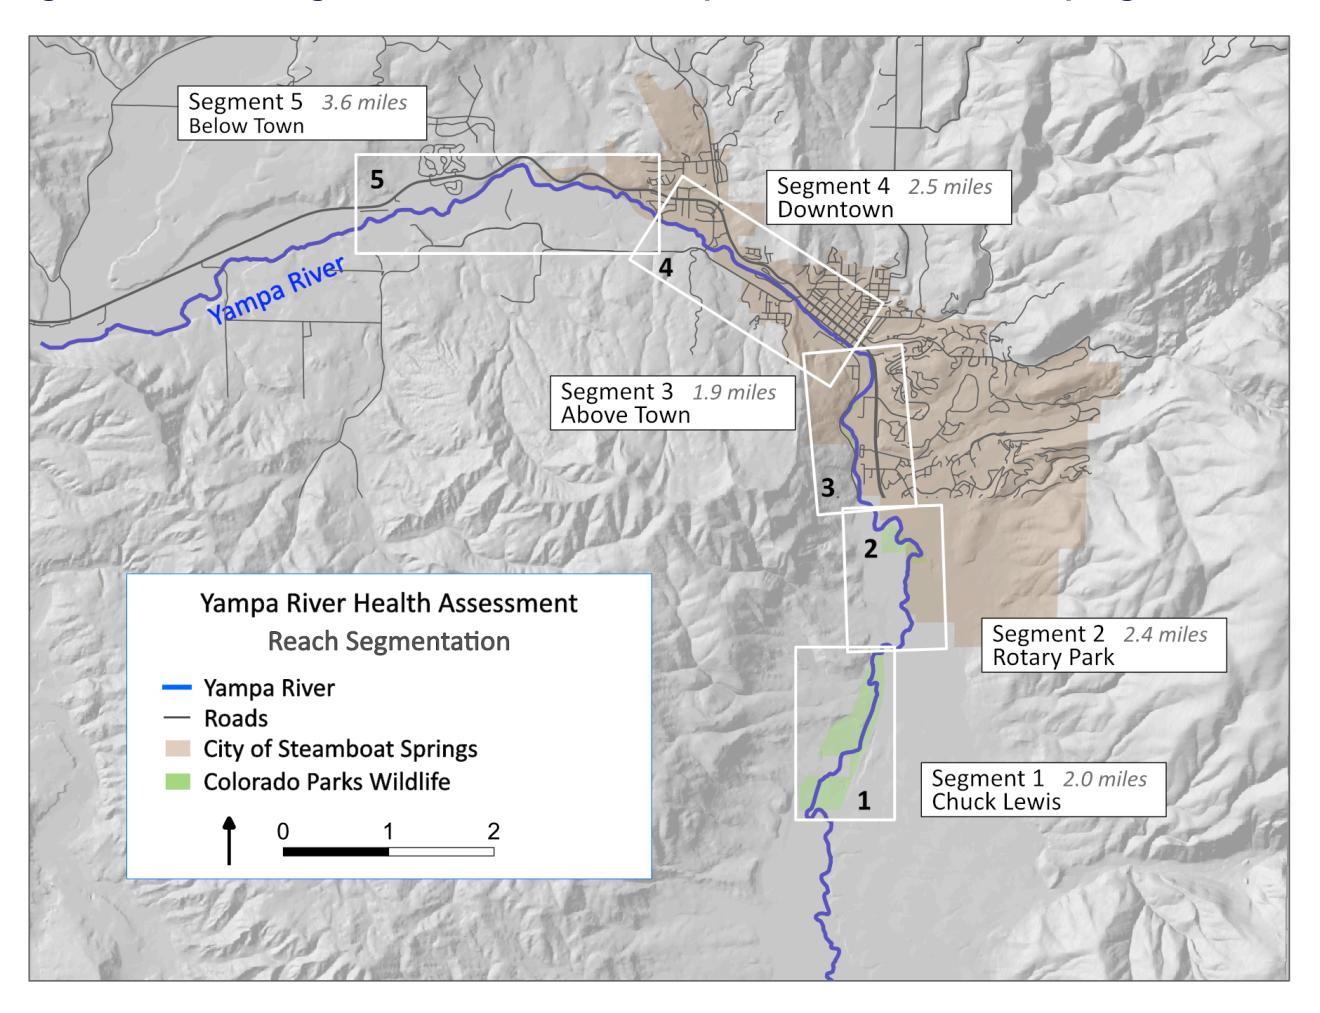
Figure 1. Five river segments assessed on the Yampa River near Steamboat Springs.

Chuck Lewis SWA Segment (~10,600 feet long, 5 assessment reaches). This segment is an unconfined, low-gradient river with valley slope about 0.21%. The Yampa River historically meandered and spread across a half-mile-wide native valley bottom in a sinuous and branching pattern, but is now largely confined to a single straighter channel bounded by artificial levees<sup>1</sup>, roads, railroad, and/or high banks. Most of the valley bottom and riparian area was converted for use as hay meadow and pastureland in the 1800s. Ranching is still a dominant land use today, though some of the river reaches and floodplain were converted again for use in aggregate mining during the late 1900s. Most of the mined areas have been restored as ponds, parks, and natural areas.

- 2. Rotary Park Segment (~12,800 feet long, 3 assessment reaches). Like the Chuck Lewis SWA, the Rotary Park segment historically had a half-mile-wide valley bottom and very low 0.23% gradient. The river's naturally unconfined branching and sinuous pattern is now a much straighter single-thread channel, but it is not as channelized or confined as the Chuck Lewis SWA. Most of the riparian zone was cleared in the 1800s, and agriculture is still an important land use on this segment, though a large portion is now managed as open space natural area. Urban development has been encroaching on the upper portions of the segment since the mid-1900s. River and floodplain form on the upper reaches were heavily impacted by aggregate mining in the late 1900s, especially near the confluence of Walton Creek. The City of Steamboat Springs constructed an infiltration gallery in the alluvial aquiver on this segment to augment drinking water supplies.

- 3. Above Town Segment (~10,000 feet long, 3 assessment reaches). The valley becomes markedly steeper on this segment, and floodplain width also begins to decrease. Valley slope is about 0.41% and mean natural bottom width is about 1,000 feet. The contributions of Walton Creek and Fish Creek considerably increase streamflows on this segment, especially during runoff. Urban development is the dominant land use, though significant portions of the riparian zone are preserved as parks or open space. For most of its length, this segment is bounded on one side or the other by railroad, road, trail, and/or flood-control levee structures.

- 4. **Through Town Segment** (~13,000 feet long, 4 assessment reaches). The segment of the Yampa River that flows through downtown Steamboat Springs is even steeper and more geologically confined than upstream segments. Channel slopes average about 0.56% and mean bottom width is about 500 feet. This river segment is straight, channelized, and confined on both sides for most of its length, but valley and floodplain widths begin to increase near the western end of town. The core area of Steamboat Springs is sited mostly on high uplands, terraces, and alluvial fans above the valley floor, although much of the riverside development is on artificial fill covering the historic floodplain. The rodeo grounds and parks on the west side of the river are constructed directly on the historical floodplain. The river is highly manipulated in this segment to accommodate streamside commercial development and transportation corridors. Numerous engineered in-stream structures were constructed over the last 20-30 years to improve trout habitat and recreational opportunities for whitewater enthusiasts. Spring Creek and Soda Creek enter the Yampa River in this segment and increase Yampa River streamflows during runoff. The tributaries provide only modest contributions of flow during other times of the year.

- 5. **Below Town Segment** (~19,000 feet long, 4 assessment reaches). Below town, the valley width increases to approximately 2,000 feet, and mean channel gradient falls to about 0.44%. The river's access to the large floodplain to the south of the river

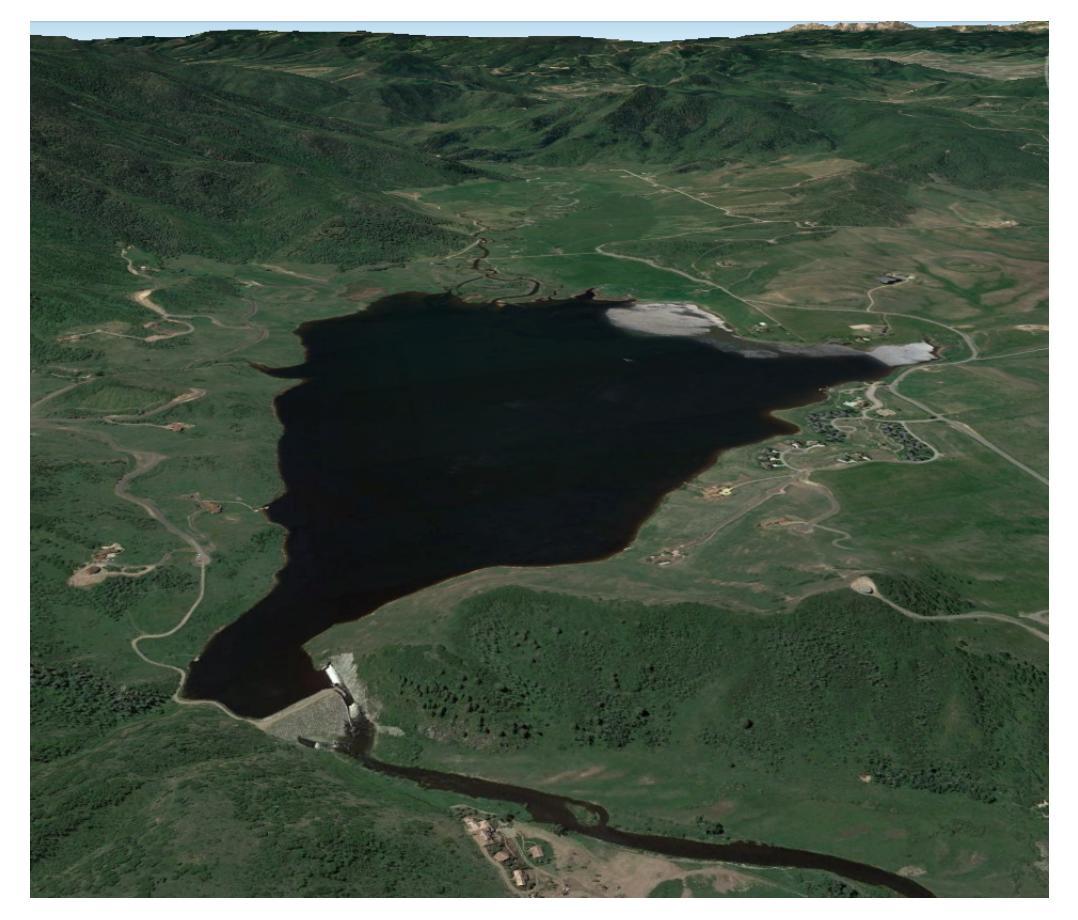
These characteristics of the flow regime are also impacted by managed releases of water from the Stagecoach, Catamount and Fish Creek Reservoirs. Reservoirs dampen and attenuate peak flows, increase baseflows, and reduce the transport of sediment from the watershed to downstream reaches (Figure 2). Unique thermal stratification and nutrient dynamics present in small and large reservoirs alike additionally alter the physicochemical properties of water released from the outlet works.

Figure 2: In-line dam and reservoir on the Yampa River at Lake Catamount.

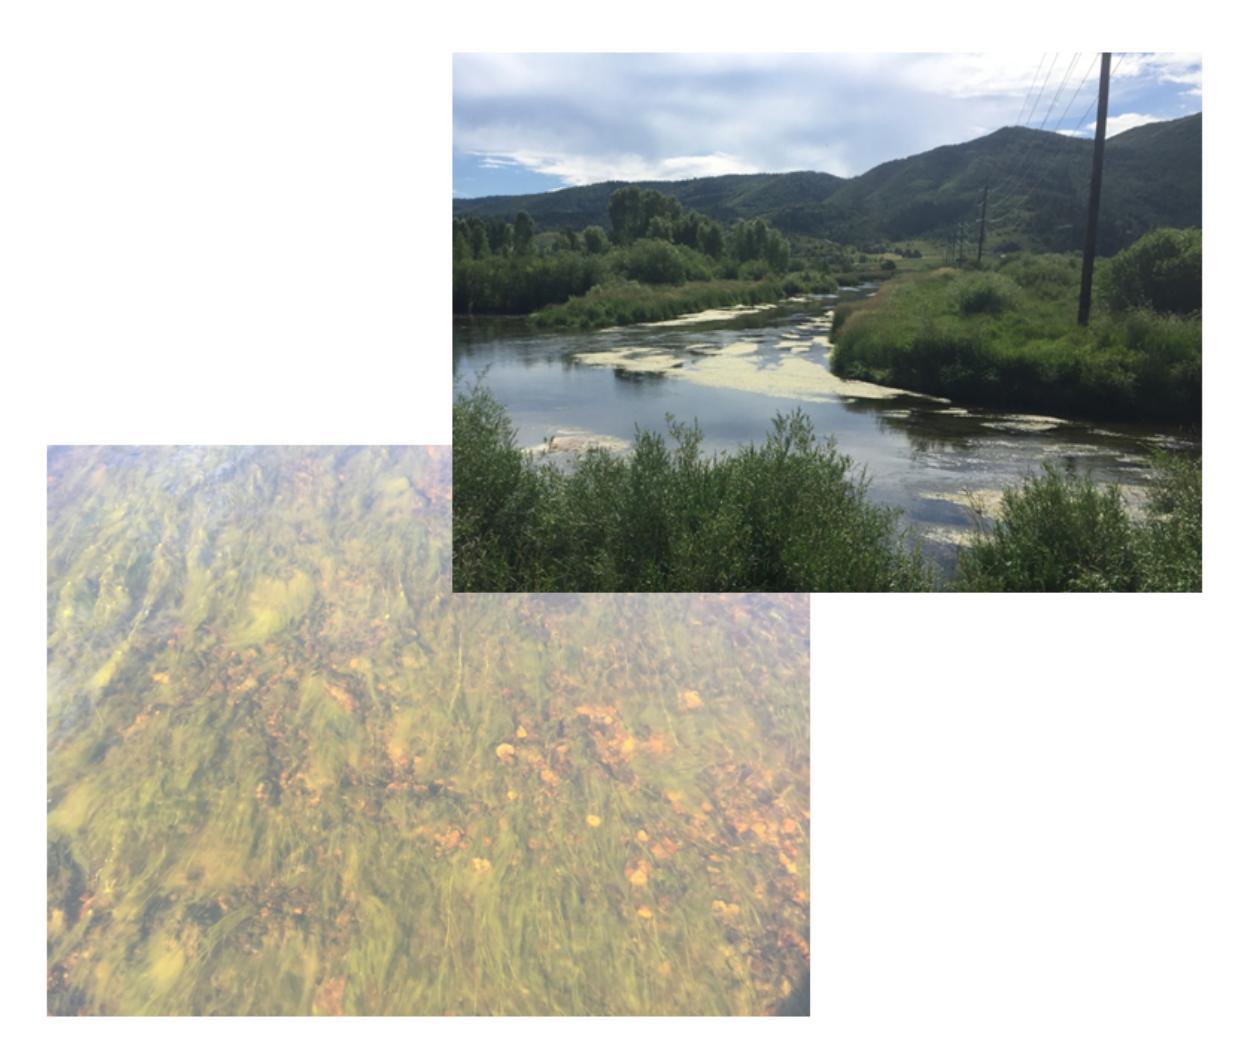
Alteration of reach scale hydrological regime behavior and water quality are also related to irrigation return flows and storm-water runoff. Runoff from urban areas often entrains pollutants associated with residential, commercial, industrial activities. Sheet flow over impervious surfaces may also experience elevated thermal loading, which can impact temperature patterns in receiving waters. Return flows from agricultural activities may include elevated nutrient concentrations that increase aquatic vegetation cover. While return flows may negatively impact ecological conditions, return flows making their way back to the river as slow-moving groundwater may support wetland and riparian vegetation on floodplains (Figure 3).

Figure 3. The driving factor behind elevated aquatic vegetation cover on the Chuck Lewis SWA and Rotary Park segments is unknown, but it could indicate nutrient enrichment from agricultural runoff or reservoir eutrophication

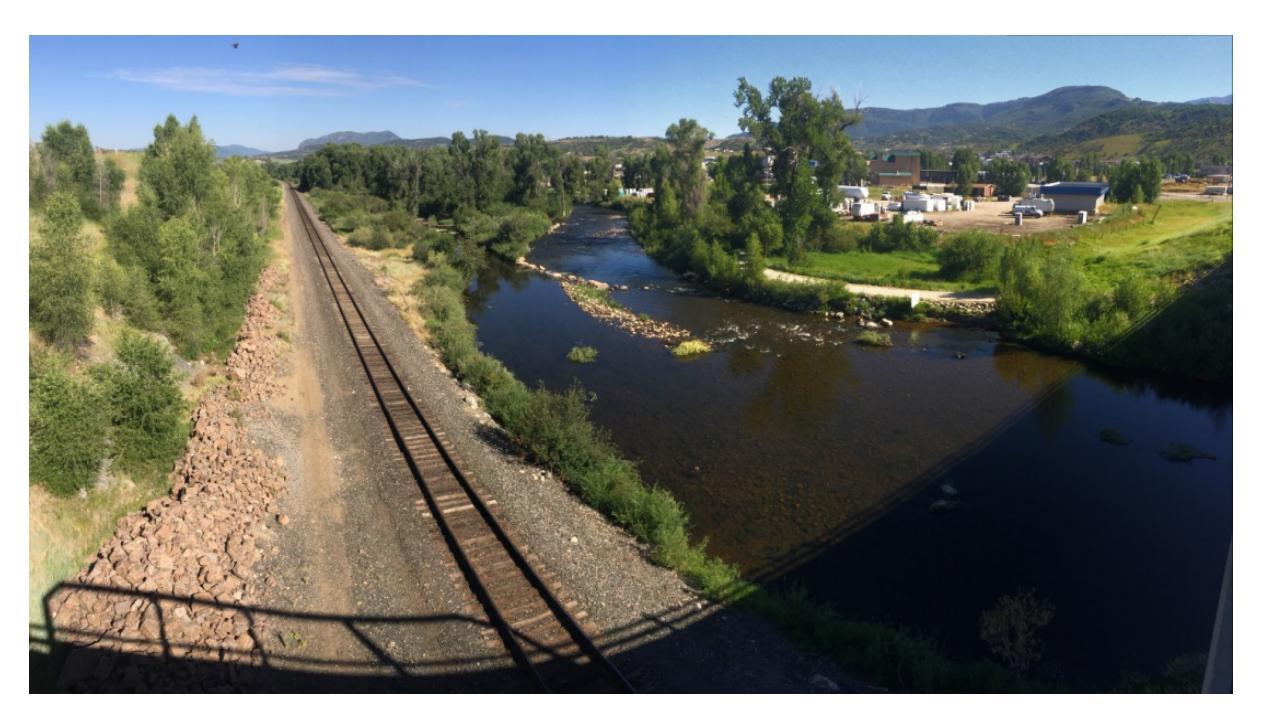
Most of the Upper Yampa watershed is undeveloped forestland. Road density is low and there are few major disturbances that affect either hillslope or channel erosion processes. Development in areas adjacent to riparian areas do have significantly decrease buffer capacity, and terrestrial habitat connectivity is decreased where roads, bridges, and other development acts as migration barriers, especially in the segments above and through town (Figure 4).

Figure 4. Railroad lines, roads, and other development may act as migration and dispersal barriers, limiting the movement of terrestrial organisms into and out of riparian areas.

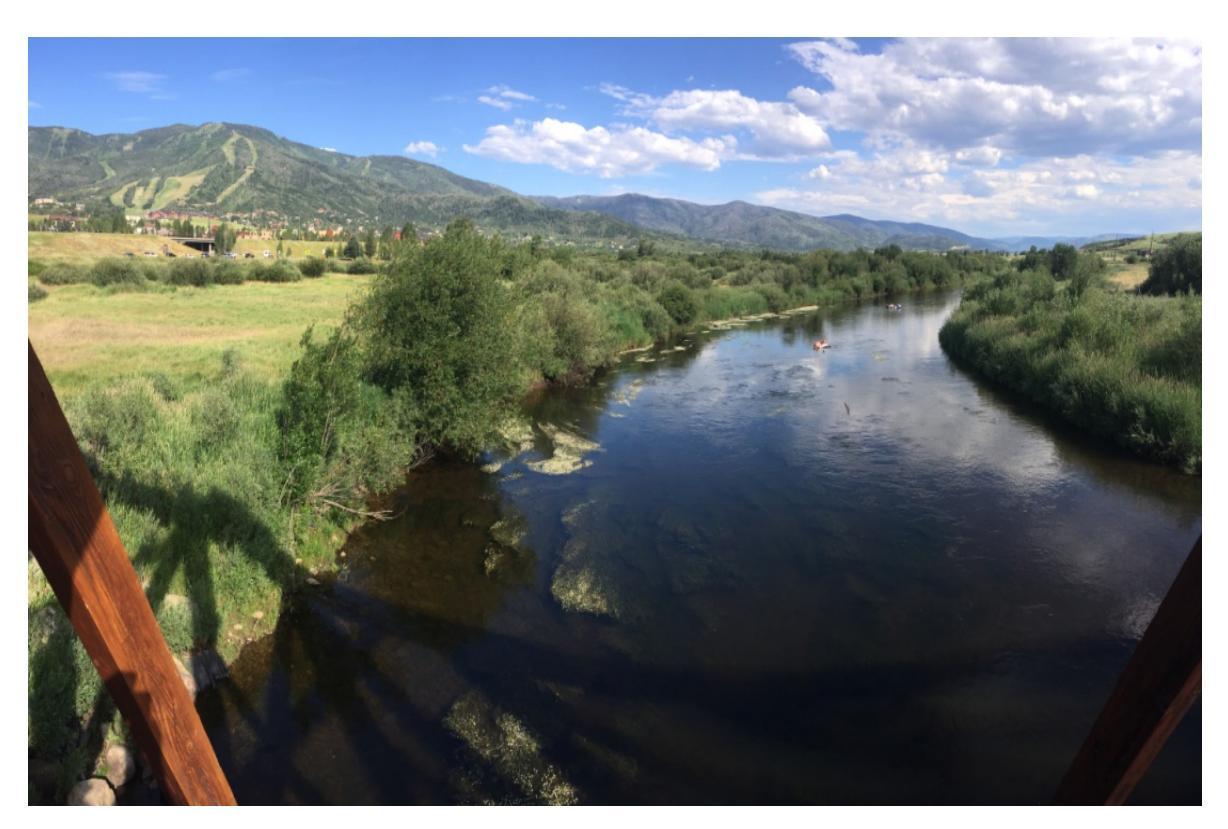
Figure 5. Shrub cover, like that lining the stream banks on this reach of the Rotary Park segment, historically spread across the width of the valley bottom. On some reaches, as much as 80% of the riparian areas were cleared for agricultural land use.

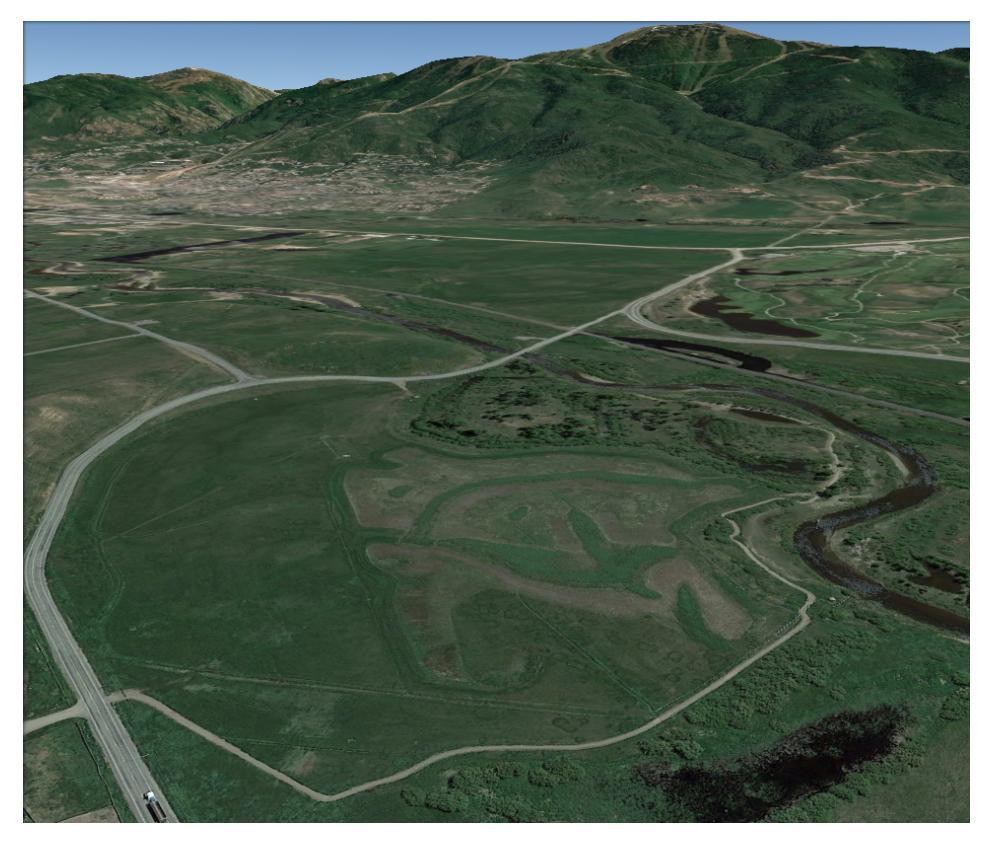
Figure 6. Agricultural land use on the Chuck Lewis SWA segment.

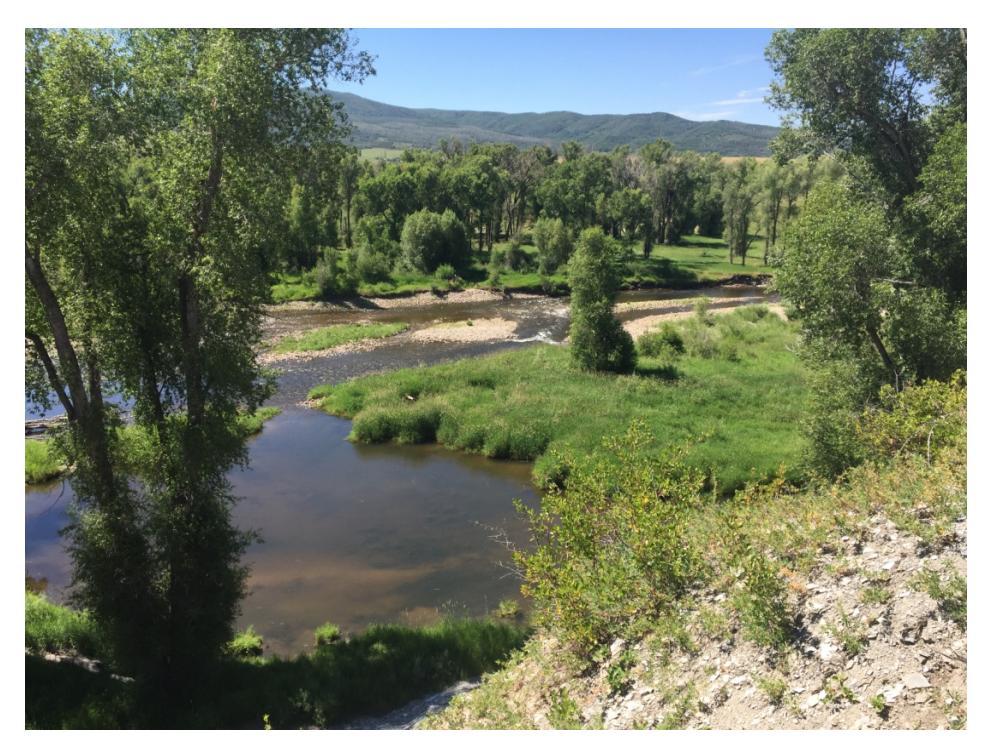
Figure 7. A section of riparian area below town with mature cottonwood forest.

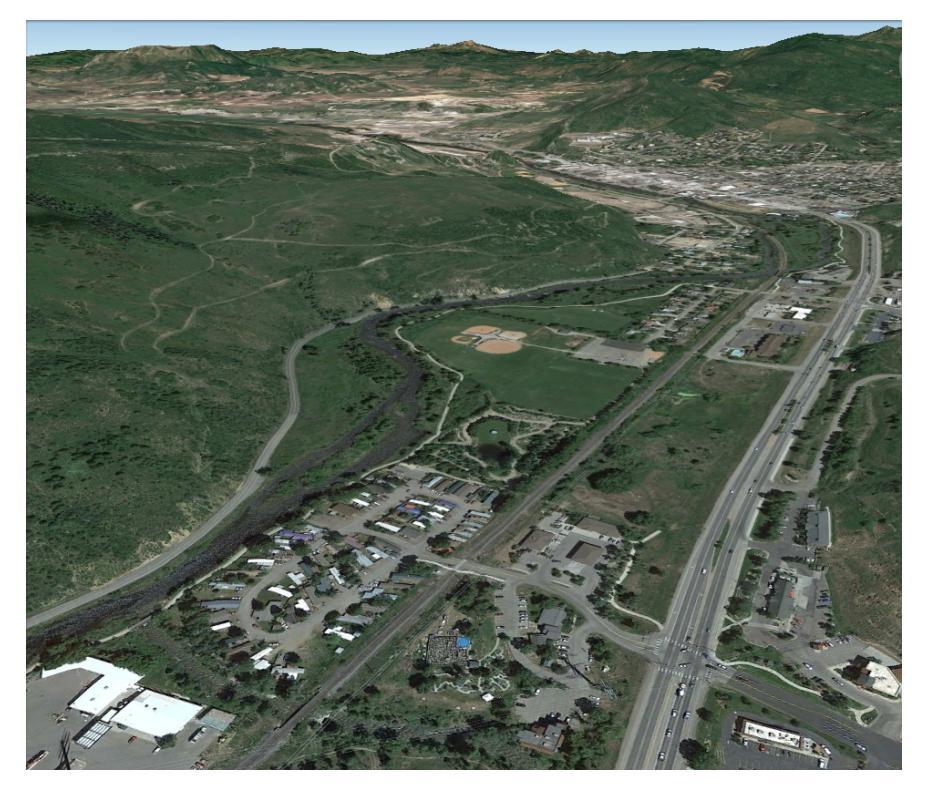
Urbanization resulted in conversion of portions of the riparian area above and through town to commercial or industrial uses, infrastructure, transportation corridors, and residential areas. Conversion of riparian areas into buildings and paved areas make up a significant portion of historic floodplain through town. Less intensive developmentinduced changes occurred following development of streamside parks and the rodeo grounds (Figure 8).

Figure 8. Most of the historical riparian area in the segments above and through town have been developed for land uses that vary in intensity from buildings and paved surfaces to parks.

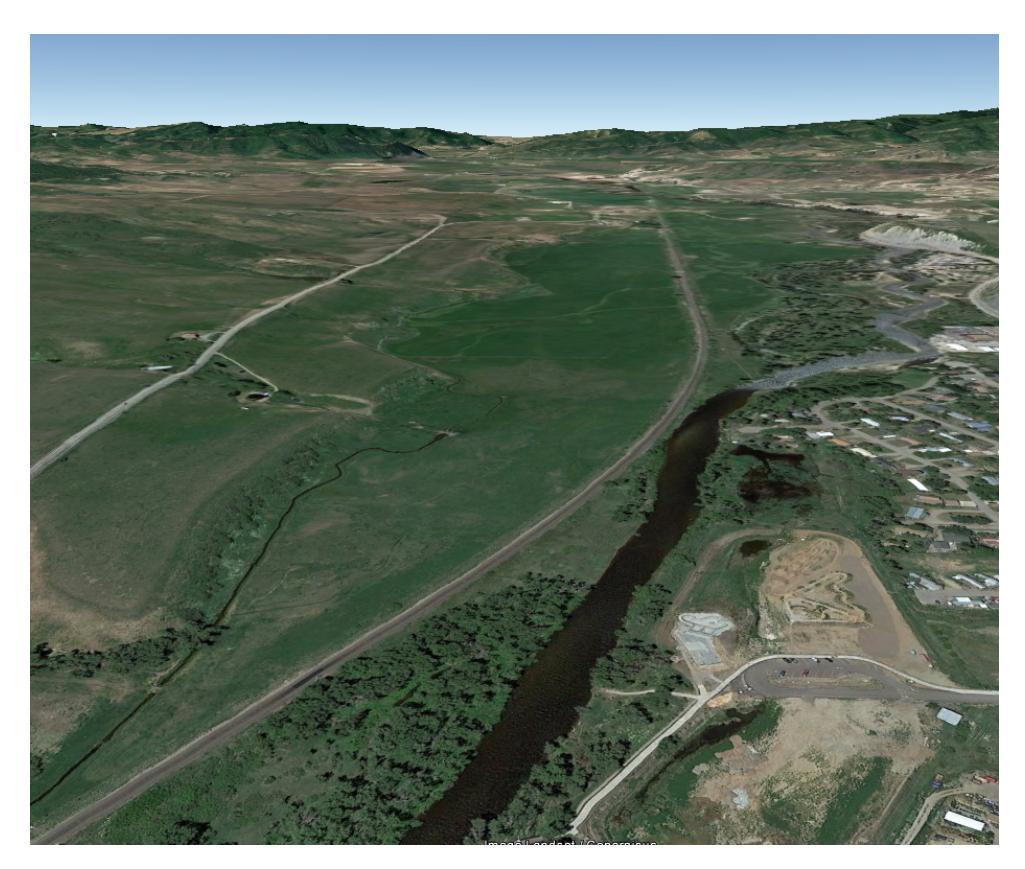
Roads, railroad lines, and bridges affect river health primarily by limiting floodplain access. Road and railroad fill act like dams and levees that prevent flood flows from spreading laterally or constrict them through narrow bridge openings. There are only a few bridges crossing the river on the Chuck Lewis, Rotary Park, and Below Town segments, but the segments Above and Through Town have dozens. The railroad line that runs through the study area was constructed as a linear mound of fill that often runs through the middle of the floodplain—limiting water access to one side or the other (Figure 9). Roads and trails that are similarly constructed on fill have similar impacts.

Figure 9. Floodplain and riparian area cut off by railroad line.

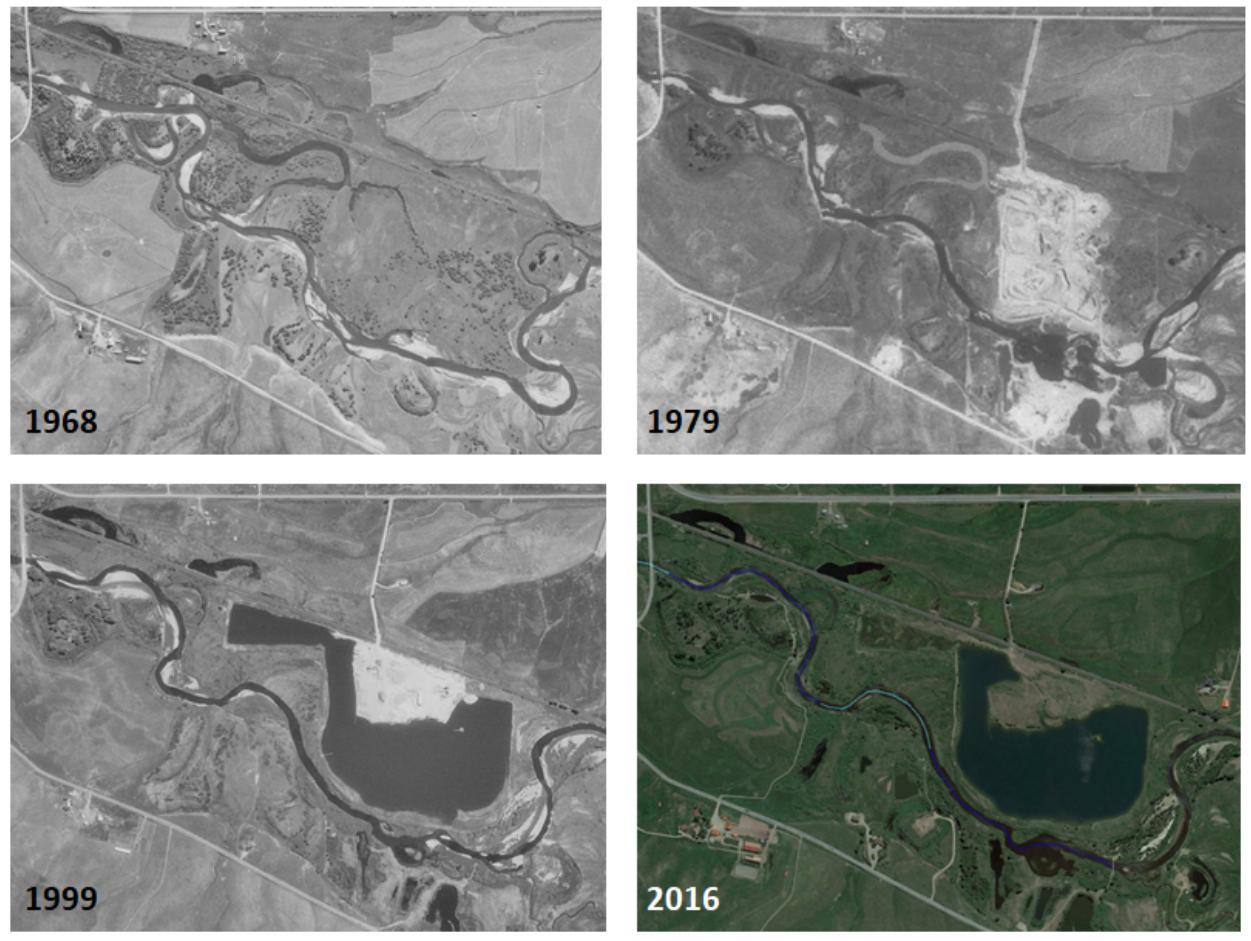
Aggregate mining was a severely invasive floodplain land use practice that occurred on reaches in the Chuck Lewis, Rotary Park, and Below Town segments. Most of these operations occurred in the 1970s, 80s, and 90s (Figure 10). Gravel was mined directly from the stream and floodplain and the river was routed through entrenched channels bounded by levees. Floodplain areas were subsequently reclaimed for development or repurposed as ponds, parks, or depressional wetlands. Many of the channelized river form and levees remain intact. Some river sections appear to persist in an over-widened state, indicating that reclamation in all historical mining area may not have occurred (Figure 11). The long-term impacts of aggregate mining on localized sediment dynamics are unknown, but channel planform became progressively less complex over the last half of the twentieth century. This reduced complexity coincided with geomorphic indicators consistent with reduced lateral migration of channels across the floodplain areas.

Figure 10. Aggregate mining was an invasive land use on the Chuck Lewis SWA segment in the 1970s through 1990s. Mined lands were reclaimed as gravel pit ponds and depressional wetland, but the channelized river form and floodplain levees remain.

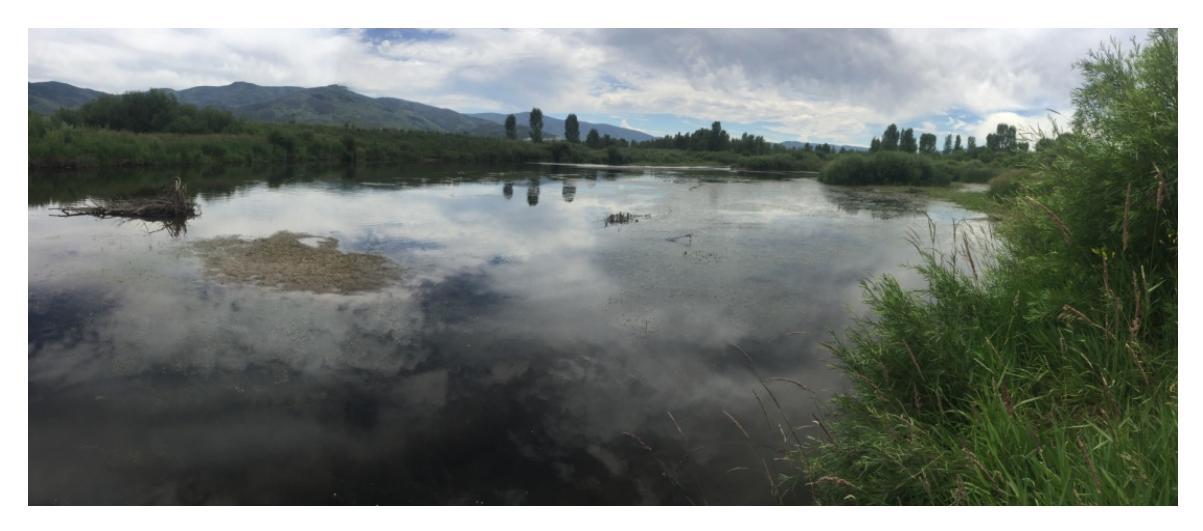
Figure 11. A reach of the Yampa River on Chuck Lewis SWA where the river was excavated for aggregate mining.

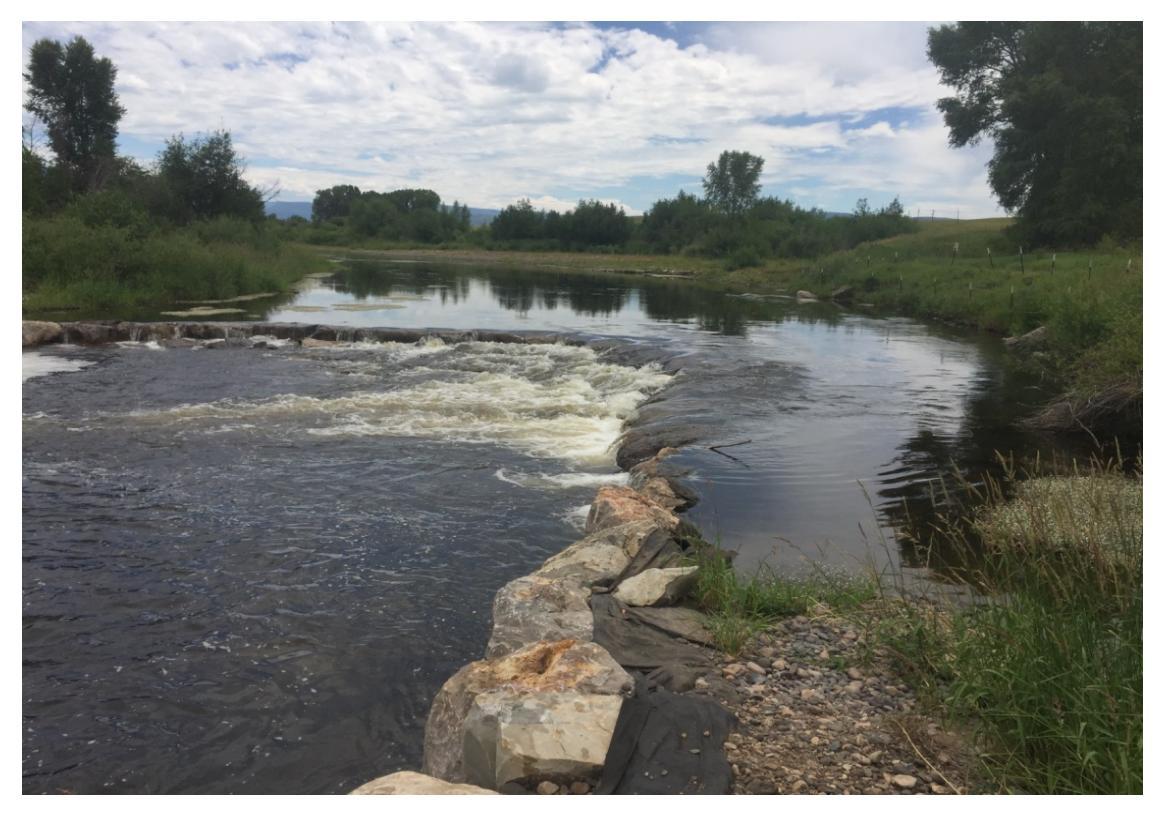
Around 200 artificial in-stream structures, such as weirs, vanes, spurs, and boulder clusters have been installed on the study reach over the past 20-30 years (Figures 12-16). Most of these structures were intended to create physical habitat features for sport fish and increase structural diversity. Some structures serve other purposes, such as maintaining the efficiency of surface water diversions, stabilizing or protecting eroding streambanks, or promoting recreational boating. Armored banks are also common on all segments, and are especially prevalent above and through town.

Figure 12. Diversion structure on Chuck Lewis SWA.

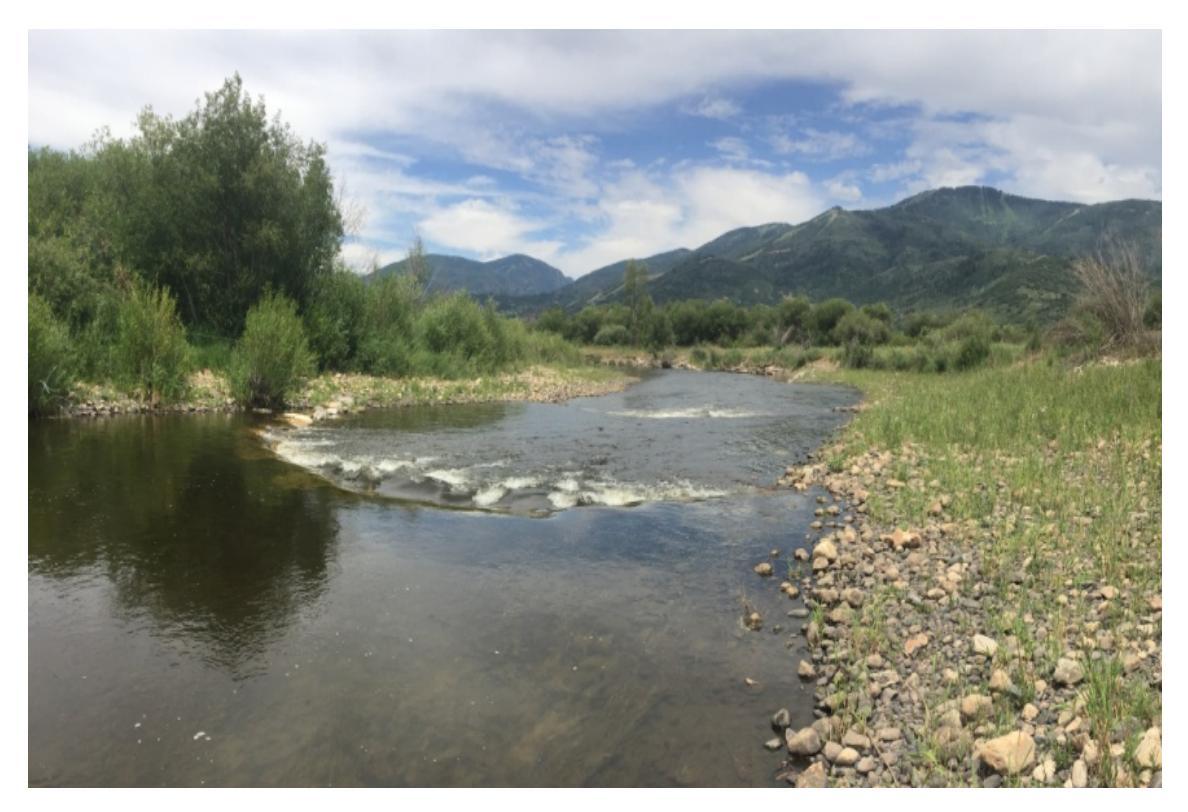
Figure 13. Fish habitat structures on Chuck Lewis

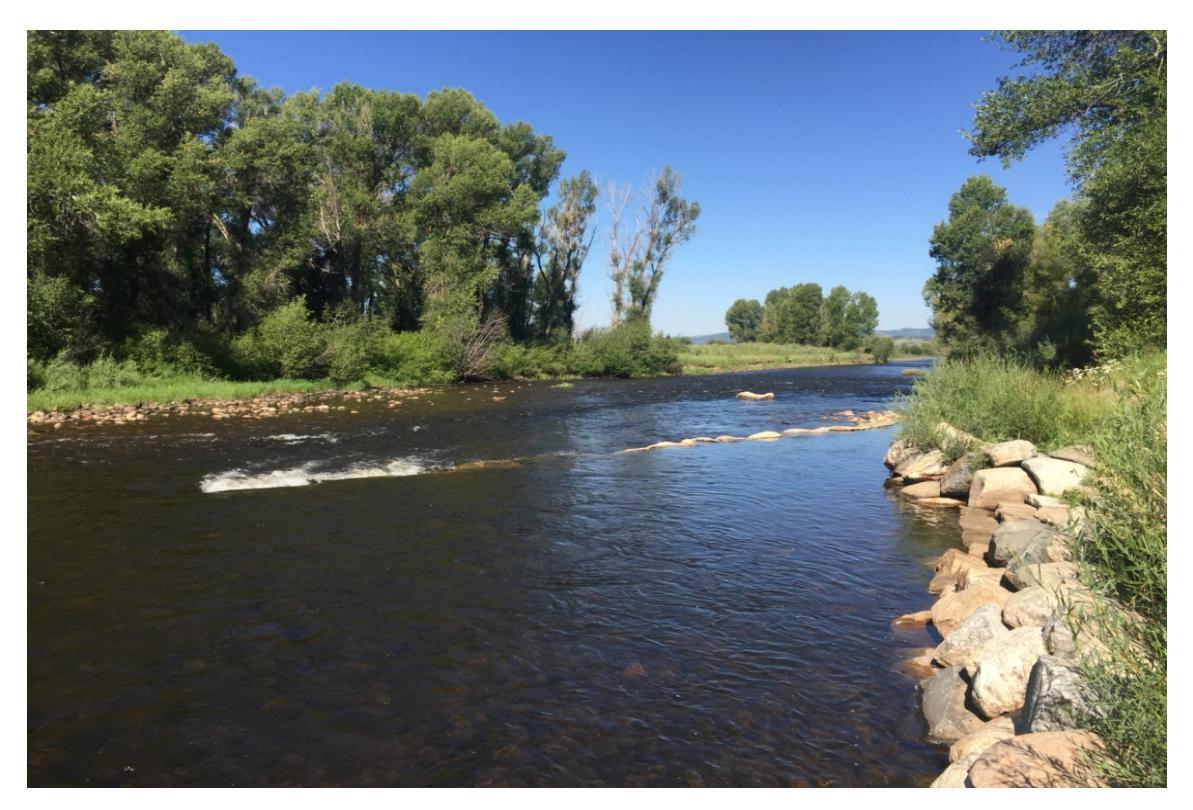
Figure 14. Diversion structure Below Town

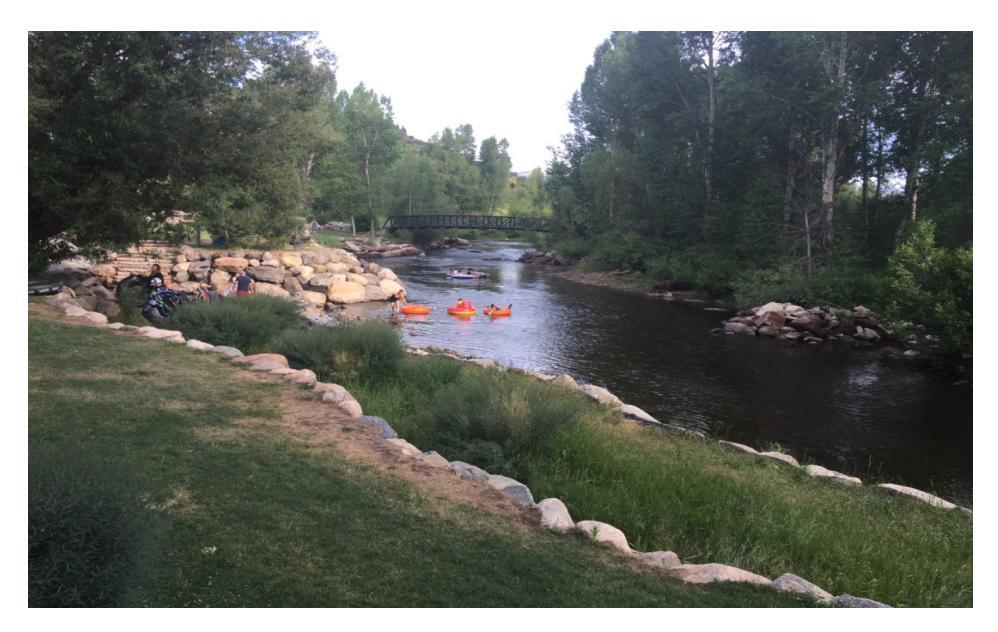
Figure 15. Recreation and bank stabilization structures Above Town

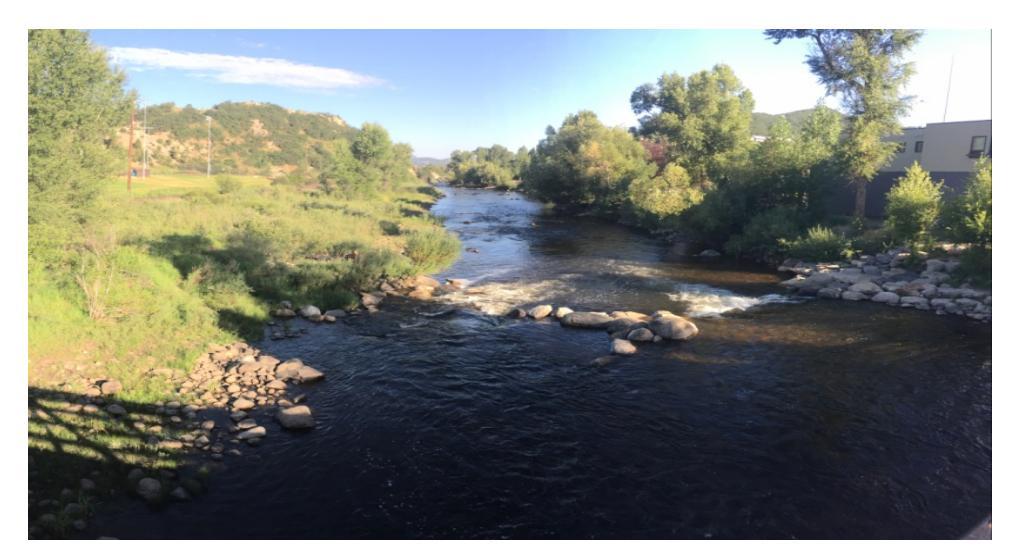
Figure 16. Recreational boating structures Through Town
