The Division of Reclamation, Mining and Safety has conducted an inspection of the mining operation noted below. This report documents observations concerning compliance with the terms of the permit and applicable rules and regulations of the Mined Land Reclamation Board.

MINE NAME:	MINE/PROSPECTING ID#:	MINERAL:	COUNTY:
Coal Creek Resources	M-1988-044	Sand	Arapahoe
INSPECTION TYPE:	INSPECTOR(S):	INSP. DATE:	INSP. TIME:
Surety-Related Inspection	Berhan Keffelew	June 28, 2012	13:30
OPERATOR:	OPERATOR REPRESENTATIVE:	TYPE OF OPERATION:	
Schmidt Construction Company	Mark Heifner	112c - Construction Regular Operation	
		the state of the s	
REASON FOR INSPECTION:	BOND CALCULATION TYPE:	BOND AMOUNT:	
Normal I&E Program	Complete Bond	\$1,083,044.00	
DATE OF COMPLAINT:	POST INSP. CONTACTS:	JOINT INSP. AGENCY:	
NA	None	None	
WEATHER:	INSPECTOR'S SIGNATURE:	SIGNATURE DAT	`E:
Clear	-	July 13, 2012

PERMIT #: M-1988-044 INSPECTOR'S INITIALS: BMK INSPECTION DATE: June 28, 2012

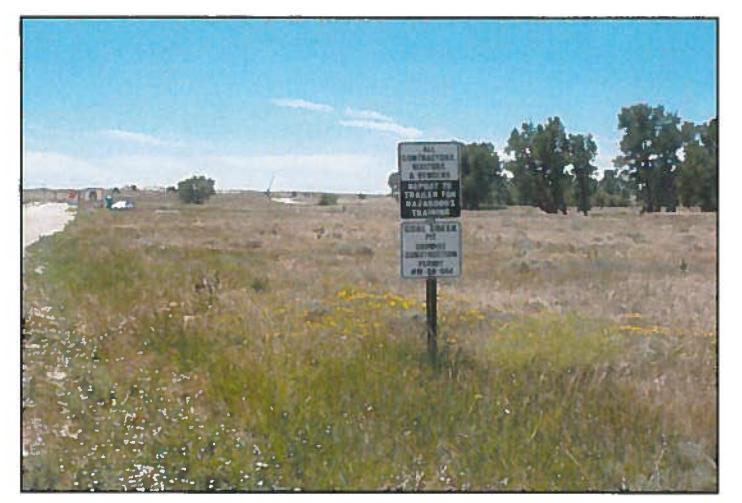
Figure 1 permit sign

- 5) The permit sign was properly posted at the access to the property. The current financial warranty for the site is \$1,083,044.00. The operator is allowed to affect a maximum of 500 acres at any given time. Even though the operator has requested a surety reduction, warranty will not be reduced at this time. The request was submitted because the operator was reaching the maximum affected limits set by the State Land Board as part of their lease approval. With the release of the 84.5 acres from the permit, the operator will have another 84.5 acres that can be affected under the current mining permitted area. A new map was provided delineating these two areas from the permit.

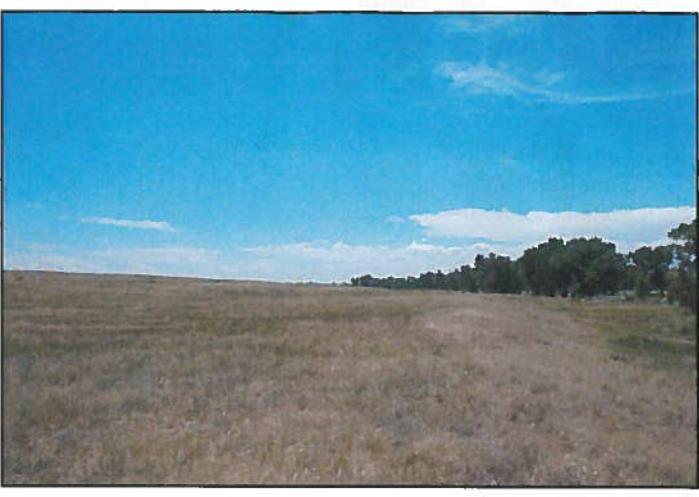
Figure 2 looking at reclaimed area 1 (.57 acres)

- 3) The reclaimed areas consisting of five parcels of land for a total 84.5 acres were walked and inspected and found to be fully reclaimed. The parcels have been in reclamation for the past five years. The reclaimed areas were covered with diverse species of native grasses. There was no noxious weed infestation.

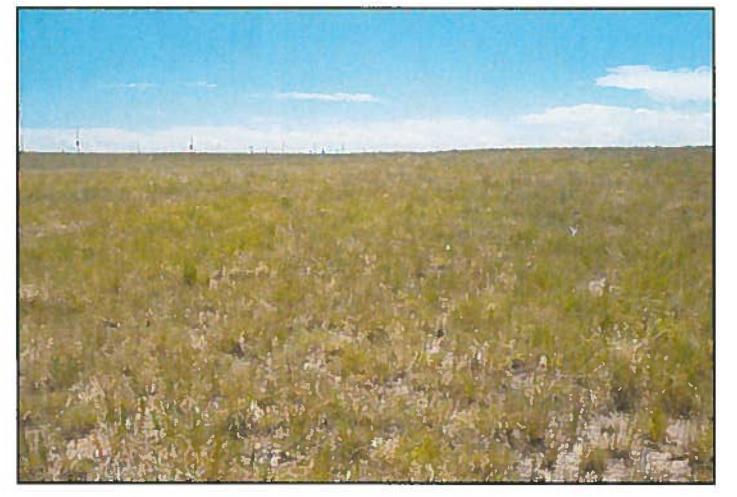
Figure 3 looking @ the reclaimed area 2 & 3

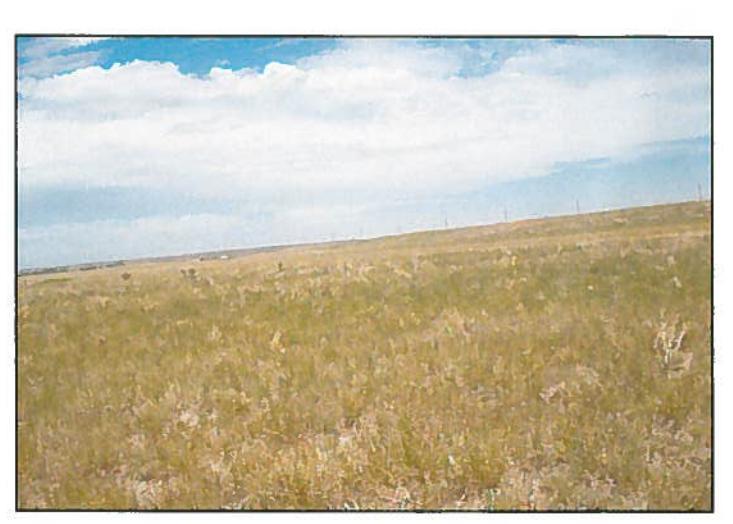
Figure 4 looking at the reclaimed are 5&6

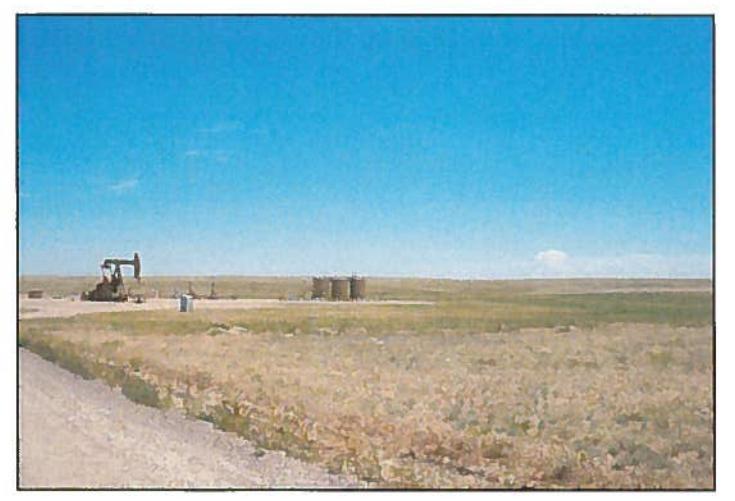
Figure 5 looking at the are now lease by oil production appx 88 acres

- 4) The parcel of land that is now covered under an oil lease and requested to be removed from the permit was observed. There are a couple of oil wells in place with supporting structures. The land will be released from the permit area.
