COLORADO DIVISION OF RECLAMATION, MINING AND SAFETY COAL PROGRAM INSPECTION REPORT

Permit Number: C-1981-013 Mine Name: Golden Eagle Mine Operator: New Elk Coal Company, LLC Operator Address: Mr Ron Thompson 12250 State Highway 12 Weston, CO 81091 **County:** Las Animas **Operation Type:** Underground **Permit Status:** Permanent Cessation **Ownership:** Private

Inspection Start Date: November 5, 2013 Inspection Start Time: 12:00 Inspection End Date: November 5, 2013 Inspection End Time: 12:30			Inspection Type: Coal Partial Inspection Inspection Reason: Normal I&E Program Weather: Snowing	
Joint Inspection Agency:		Joint Inspection Contacts:		
None				
Post Inspection Agency:		Post Inspection Contacts:		
None				
Inspector(s):	Inspector's Sign		nature: Signature Date:	
Leigh D. Simmons	tofins		November 13, 2013

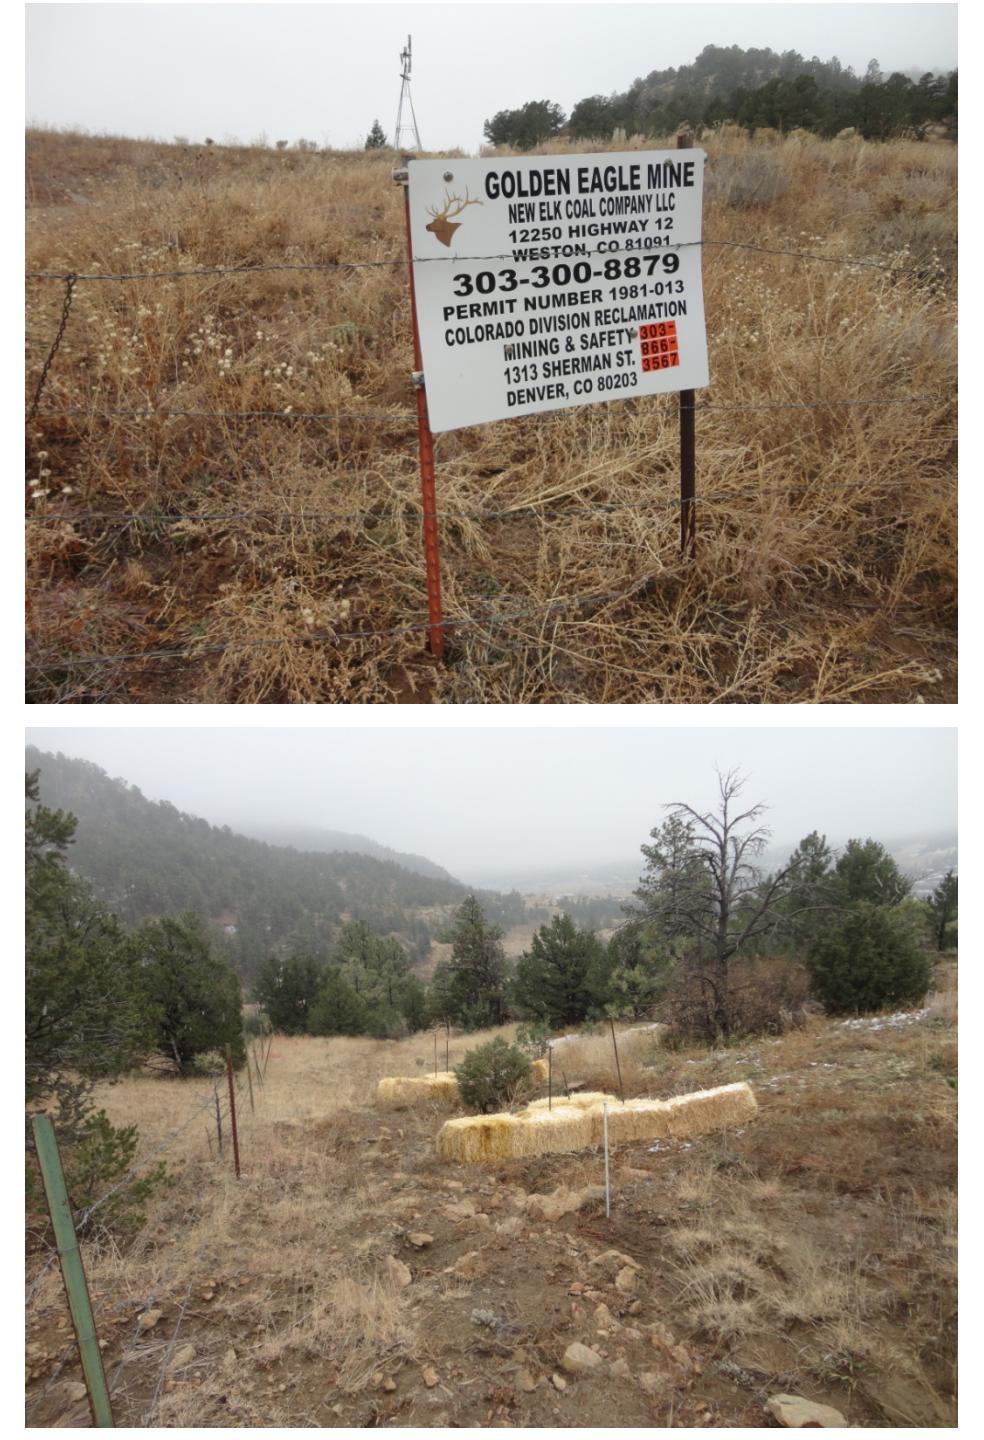
PHOTOGRAPHS

At the north edge of the disturbance boundary two rows of bales had been placed in such a way as to slow the flow of water through an area prone to erosion.
