The Division of Reclamation, Mining and Safety has conducted an inspection of the mining operation noted below. This report documents observations concerning compliance with the terms of the permit and applicable rules and regulations of the Mined Land Reclamation Board.

MINE NAME:	MINE/PROSPECTING ID#:	MINERAL:	COUNTY:
Cross Creek Ranch	M-2013-036	Sand & Gravel	La Plata
INSPECTION TYPE:	INSPECTOR(S):	INSP. DATE:	INSP. TIME:
Illegal(Unpermitted Operation)	Kate A. Pickford	May 19, 2014	10:00
OPERATOR:	OPERATOR REPRESENTATIVE:	TYPE OF OPERATION:	
John Avery – LUKE THE DUKE, LLC	John Avery	IM - Is it Mining	
REASON FOR INSPECTION:	BOND CALCULATION TYPE:	BOND AMOUNT:	
High Priority	None	None	
DATE OF COMPLAINT:	POST INSP. CONTACTS:	JOINT INSP. AGENCY:	
May 16, 2014	None •	None	
WEATHER:	INSPECTOR'S SIGNATURE:	SIGNATURE DATE:	
Clear	Kate ///////	June 16, 2014

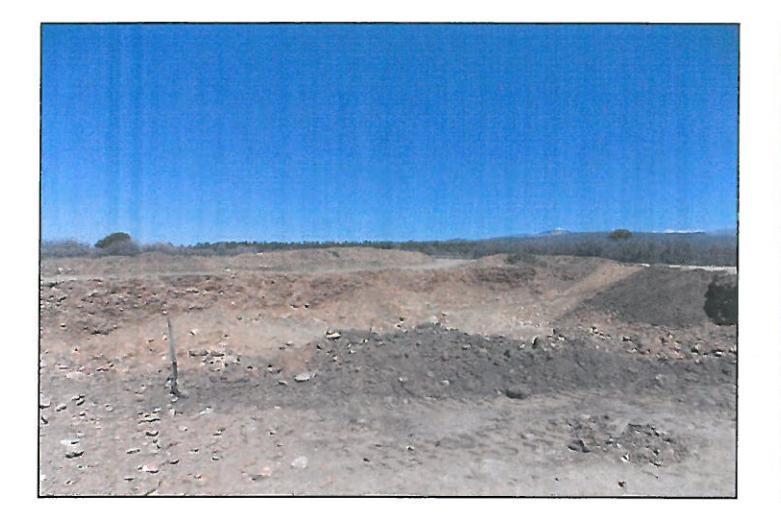
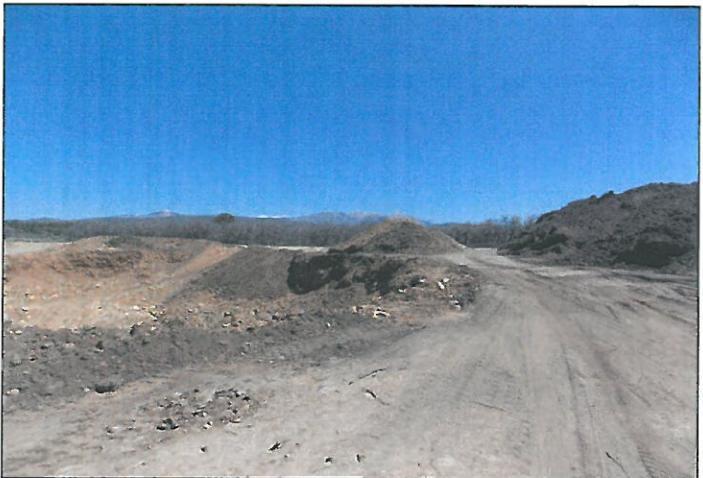
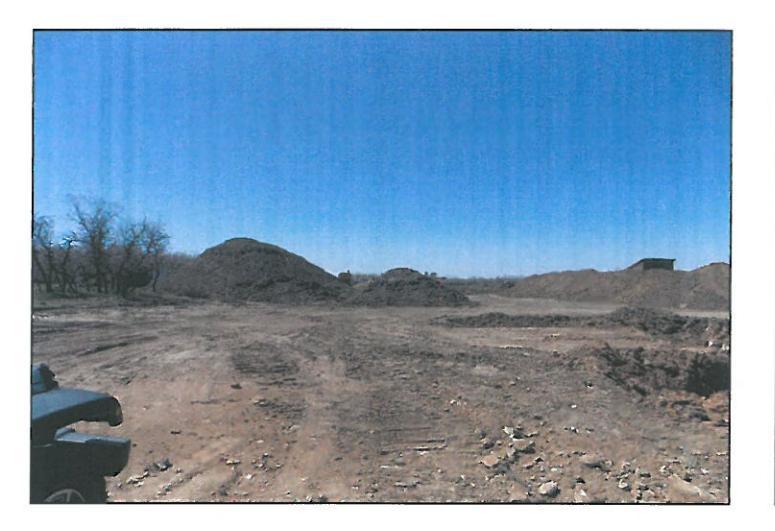
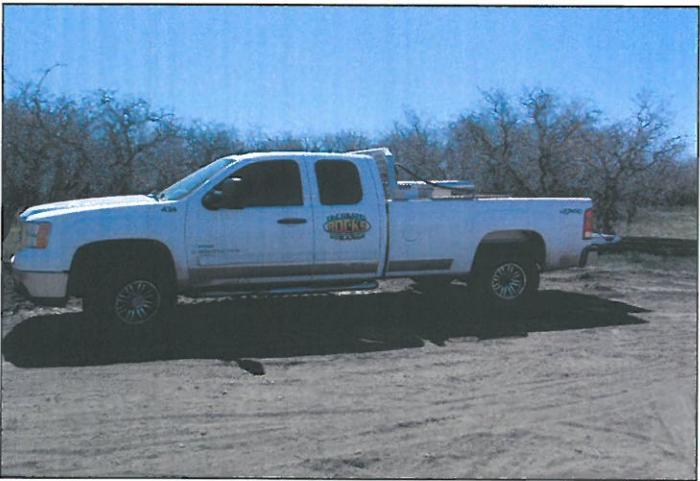
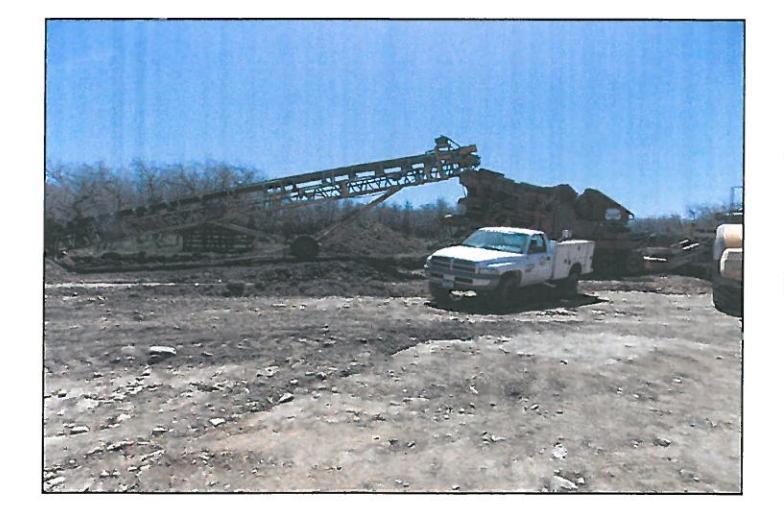
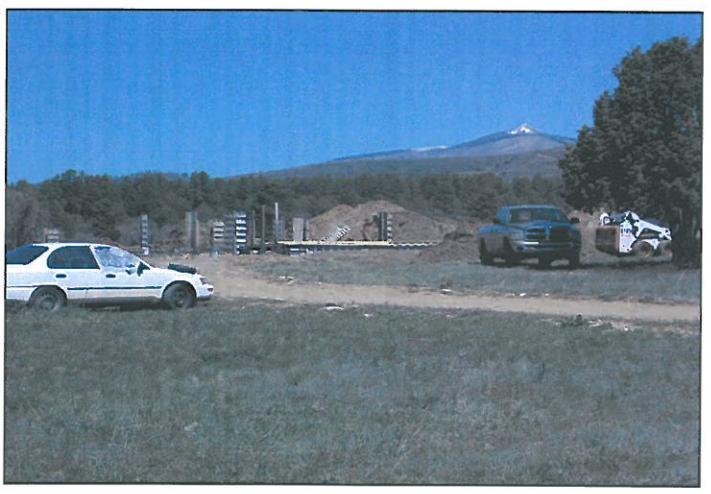
PHOTOGRAPHS

This inspection was conducted in response to a complaint of illegal mining received by a neighbor. The condition of the site is similar to that of last year when Mr. Avery submitted an "Is It Mining" letter after the inspection conducted on June 5, 2013. The letter indicated that he was simply installing an irrigation pond and that the material was going to be used for road improvements within his subdivision. Based on the information in this letter, the Division determined that no mining permit was needed. At the time of this inspection, it appeared that the same scope of activity was present. There was a crusher on site, operated by C & J gravel, but that was the only change. Mr. Avery stated that the material was being hauled to the property across the road from the property where the activity was occurring. He stated it was being used for a foundation for a barn that Mr. Avery was building for his personal use. He said that only the piles of material that were already present would be crushed, and then the operation would be complete. Follow up investigation with the county indicated that the property to which the material was being hauled

does not belong to Mr. Avery. Additionally, there is a building permit for a house on the property that was purchased by the landowner, Thomas Jeffry and Jill Layne. The county could not verify who purchased the permit for the barn, but it appeared that the foundation being built may be, in fact, for use by the land owner. Further investigation with the County indicated that Mr. Avery does not have water rights to fill the pit with water.

PROBLEM/POSSIBLE VIOLATION: Problem: Failure to first obtain a reclamation permit from the Mined Land Reclamation Board before engaging in a new mining operation as required by 34-32.5-109(1) C.R.S. **CORRECTIVE ACTIONS:** This possible violation will require a hearing before the Mined Land Reclamation Board. The schedule and other details for the MLRB hearing will be provided under a separate document to be sent via certified mail to the operator.
