The Division of Reclamation, Mining and Safety has conducted an inspection of the mining operation noted below. This report documents observations concerning compliance with the terms of the permit and applicable rules and regulations of the Mined Land Reclamation Board.

MINE NAME:	MINE/PROSPECTING ID#:	MINERAL:	COUNTY:	
Riverside Parkway	M-2007-005	Borrow material for	Mesa	
INSPECTION TYPE:	INSPECTOR(S):	INSP. DATE:	INSP. TIME:	
Monitoring	Travis H. Marshall	April 20, 2015	09:30	
OPERATOR:	<b>OPERATOR REPRESENTATIVE:</b>	TYPE OF OPERATION:		
City of Grand Junction	Paul Jagim, Trent Prall and Jerod Timothy	111 - Construction by Goverment Agency

## **INSPECTION TOPIC:** Reclamation Success

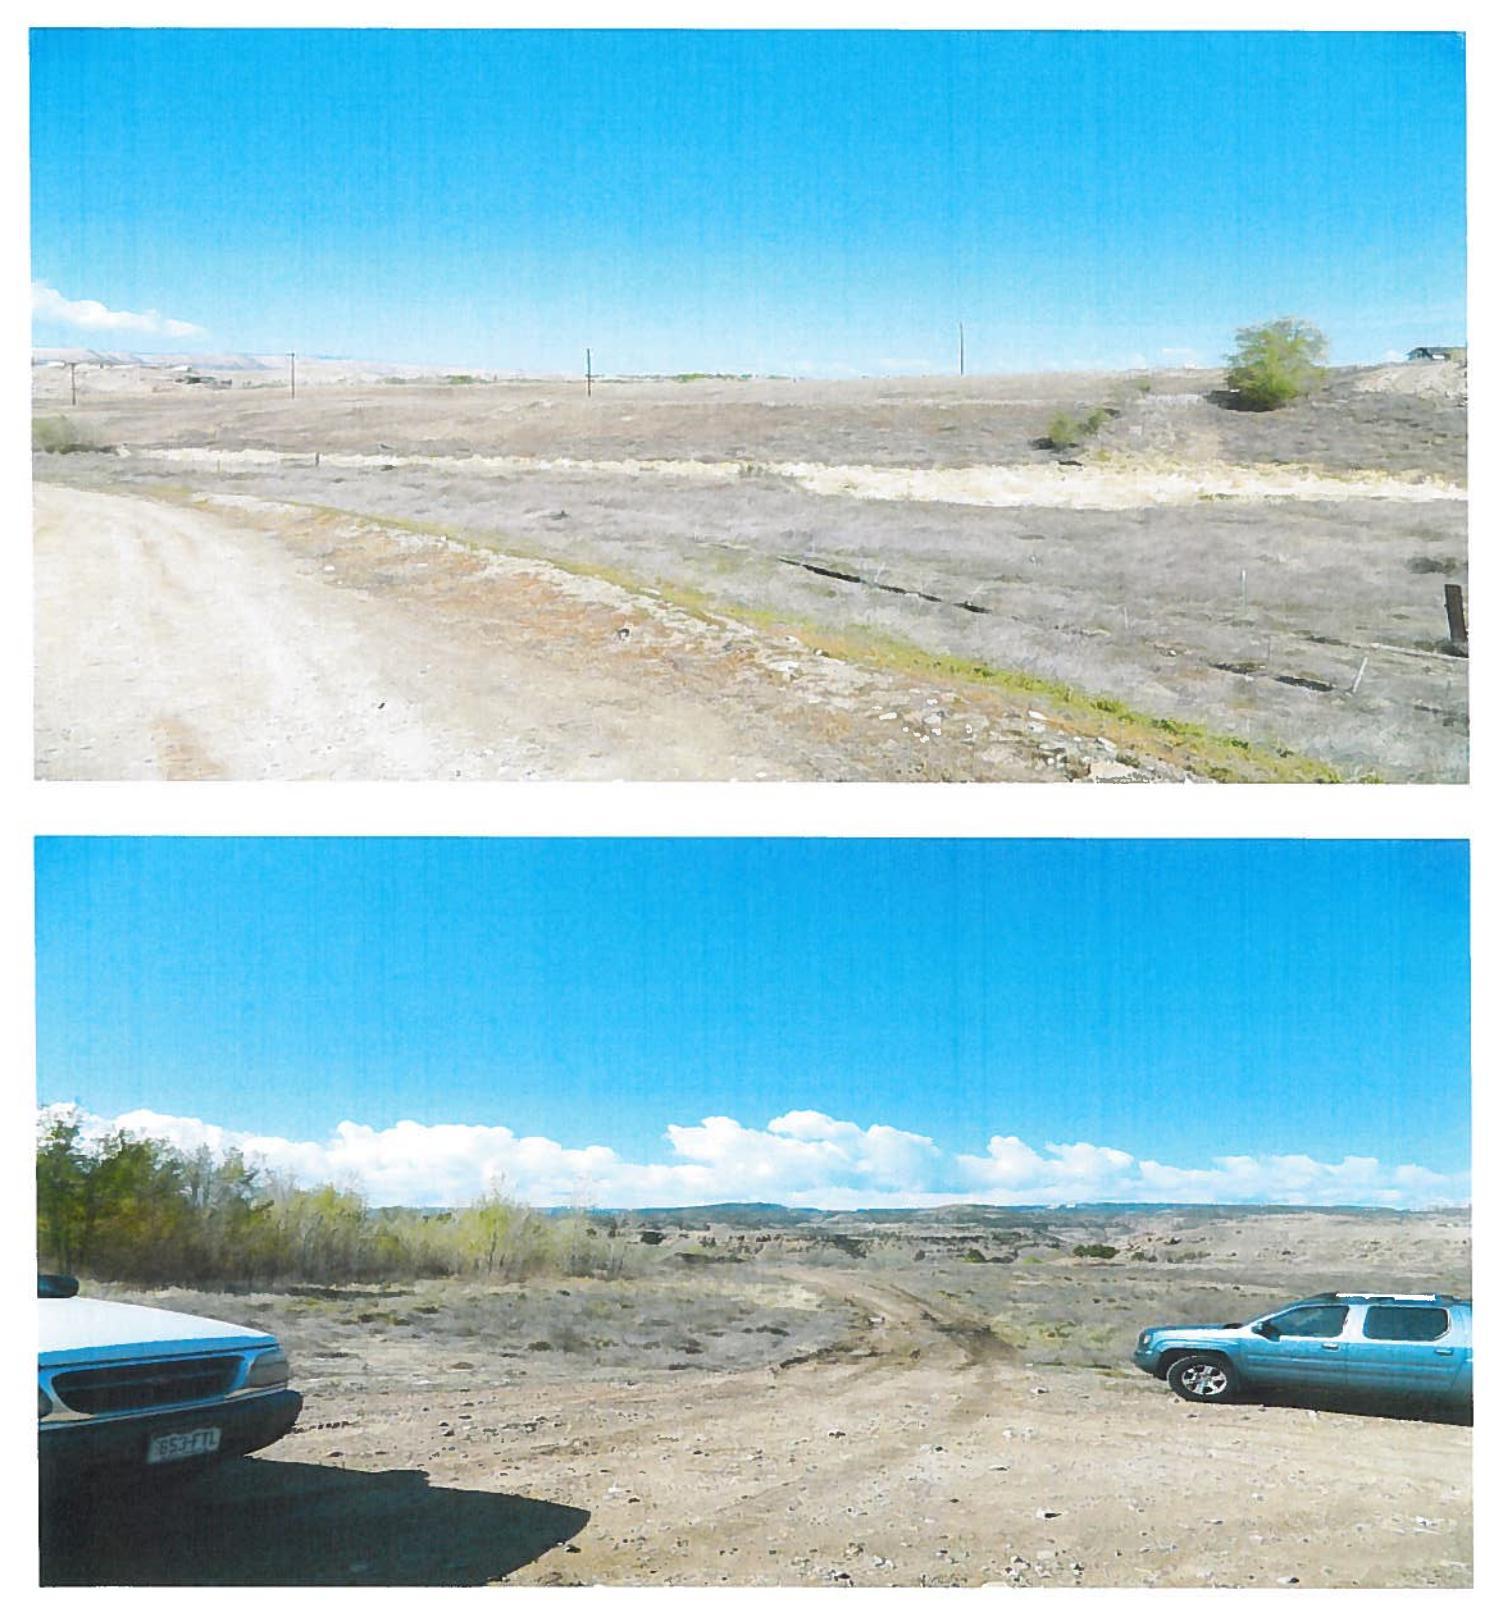
## **PHOTOGRAPHS**

The site is inactive and most of the required reclamation has been completed at the site. All reclaimed slopes appeared to be no steeper than the required 3H:1V.

The site lacked any significant perennial vegetation. Many areas are bare with no vegetation and the majority of the site is covered with annual weeds. This is considered a problem and the Division is requiring a submittal of a technical revision to the reclamation plan that will implement a new strategy for revegetating the site. The **Deadline for submitting a revised reclamation plan is June 19, 2015. If the required technical revision is not received prior to the June 19, 2015 corrective action deadline enforcement action will be initiated.**

**CORRECTIVE ACTIONS:** The operator shall submit a Technical Revision, with the required \$216 revision fee, to update and clarify how the operator proposes to successfully revegetate the mine site by the corrective action date.
