MINE NAME:	MINE/PROSPECTING ID#:	MINERAL:	COUNTY:
Uncompany Pit	M-2013-007	Gravel and sand	Montrose
INSPECTION TYPE:	INSPECTOR(S):	INSP. DATE:	INSP. TIME:
Monitoring	Dustin Czapla	August 6, 2015	10:00
OPERATOR:	OPERATOR REPRESENTATIVE:	TYPE OF OPERATION:	
Lazy K-Bar Land & Cattle Company, LLLP	Jay Jutton, Zane Luttrell	112c - Construction Regular Operation

INSPECTION TOPIC: Availability Of Records/Compliance with Mine Plan

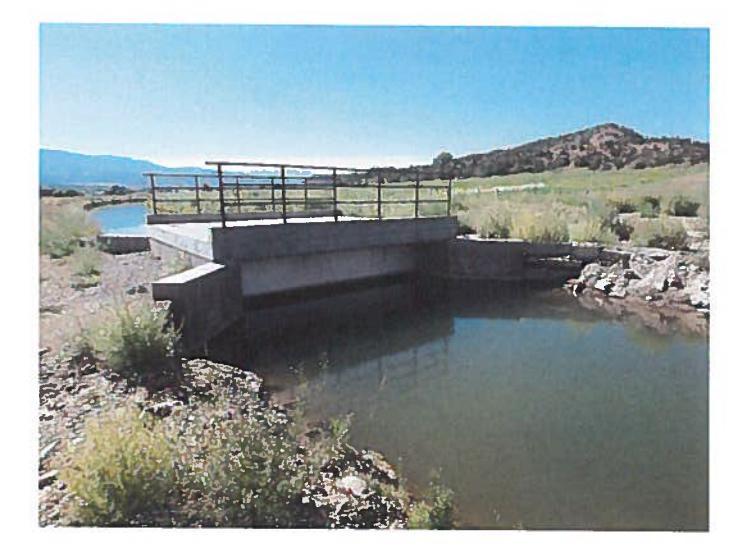
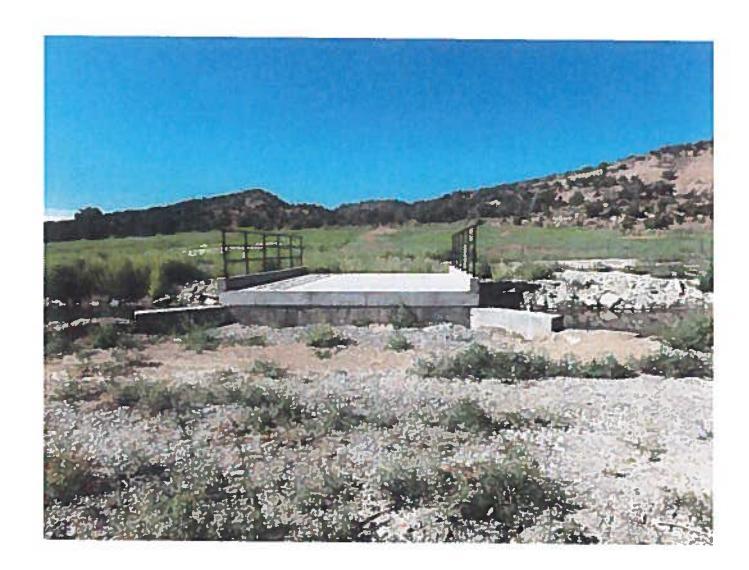
PHOTOGRAPHS

PROBLEM/POSSIBLE VIOLATION: Problem: The operator has constructed the bridge crossing the Montrose West Canal prior to receiving Division approval.

This inspection was conducted in response to a citizen complaint, received on August 3, 2015, from Barbara Bernhardt regarding construction of the bridge crossing the Montrose West Canal. Mrs. Bernhardt's complaint stated that the bridge had been constructed. During the permitting process the operator committed to submitting certified engineering plans for the bridge design to the Division for review and approval prior to commencing construction of the bridge. The operator also committed to submitting "as-built" certifications within sixty days after the bridge was completed. This inspection verified that the bridge had been constructed. This has been noted as a problem on the first page of this report. The operator shall submit the certified engineering plans and the "as-built" certifications for the bridge construction to the Division by the corrective action due date. No other mine related disturbance was noted at the site. No other problems or violations were observed.

CORRECTIVE ACTIONS: Submit to the Division the certified engineering plans and the "as-built" certifications for the bridge construction.
