OSMRE Concurrence: West Elk SL-10

Re: Phase I (SL-10) Bond Release Application, West Elk Mine, C-1980-007

Denver Field Branch Bond Release Evaluation Report

Company:	Mountain Coal Company, LLC		
Mine:	West Elk Mine		
Permit No:	C-1980-007		
Date of Inspection:	June 20 - 22, 2016		
Weather:	Hot and sunny with dry ground		
Company Officials:	Jessica Loveland and Weston Norris		
State Officials:	Leigh Simmons and Jim Stark		
BLM Official:	None present		
USFS Official:	Dan Gray		
OSMRE Official:	Tom Medlin (#562)		
NGO:	Alyssa Clarida, Dave Noe, and Morgan Rubanow (Western Slope		
	Conservation Center)

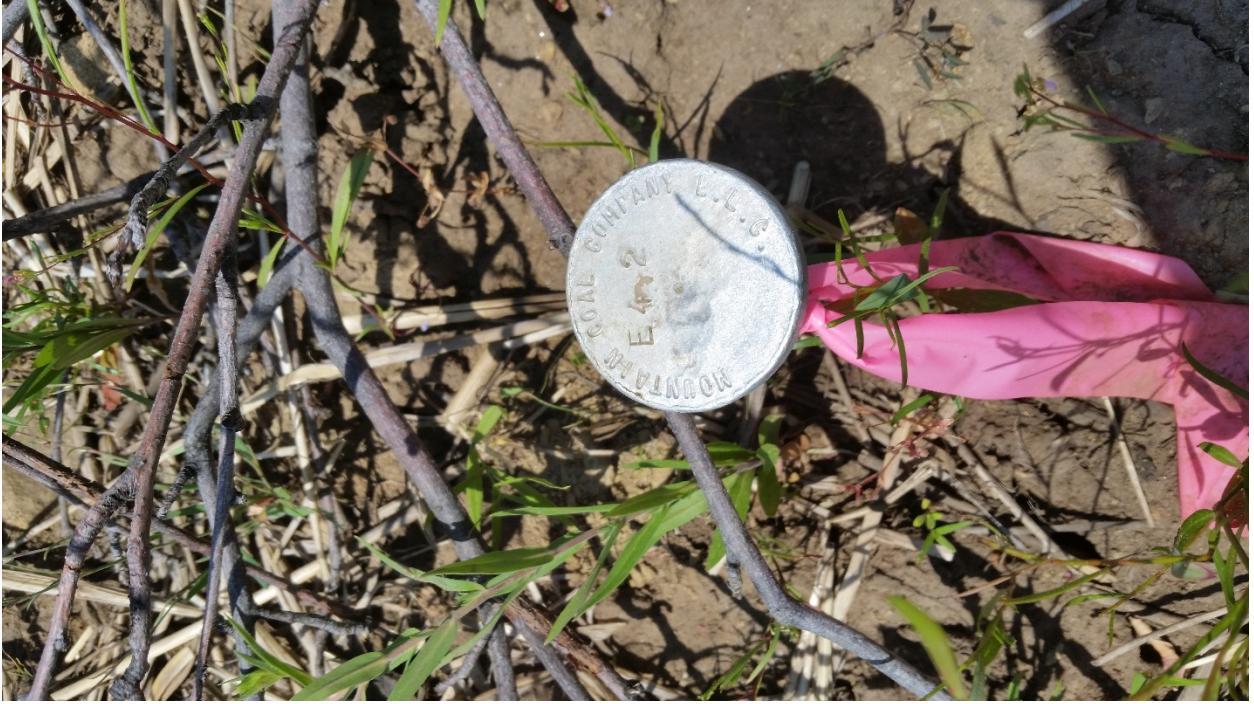
utilized electric fencing (Figure 2) to prevent overgrazing by livestock. Field monuments (Figure 1) were installed by MCC at each pad upon borehole abandonment and plugging. MCC utilized close-interval surface micro-pocking (approximately 6-8" deep) to reduce erosive overland sheet flow, as well as straw to foster a microclimate conducive to vegetative germination. Slash piles, which enhance soil nutrient-content upon breakdown and can serve as habitat for a number of wildlife species, were also observed. Gradient readings were generally found to be between 15% and 45%. Recently established vegetation was primarily composed of grasses and forbs and was generally between 8" and 24" tall. Minor infestations, where present and typically of the Canada thistle variety, were mechanically treated on-the-spot by the USFS official and permittee, to the satisfaction of the Team.

Figure 1: typical borehole plugging and abandonment monument.

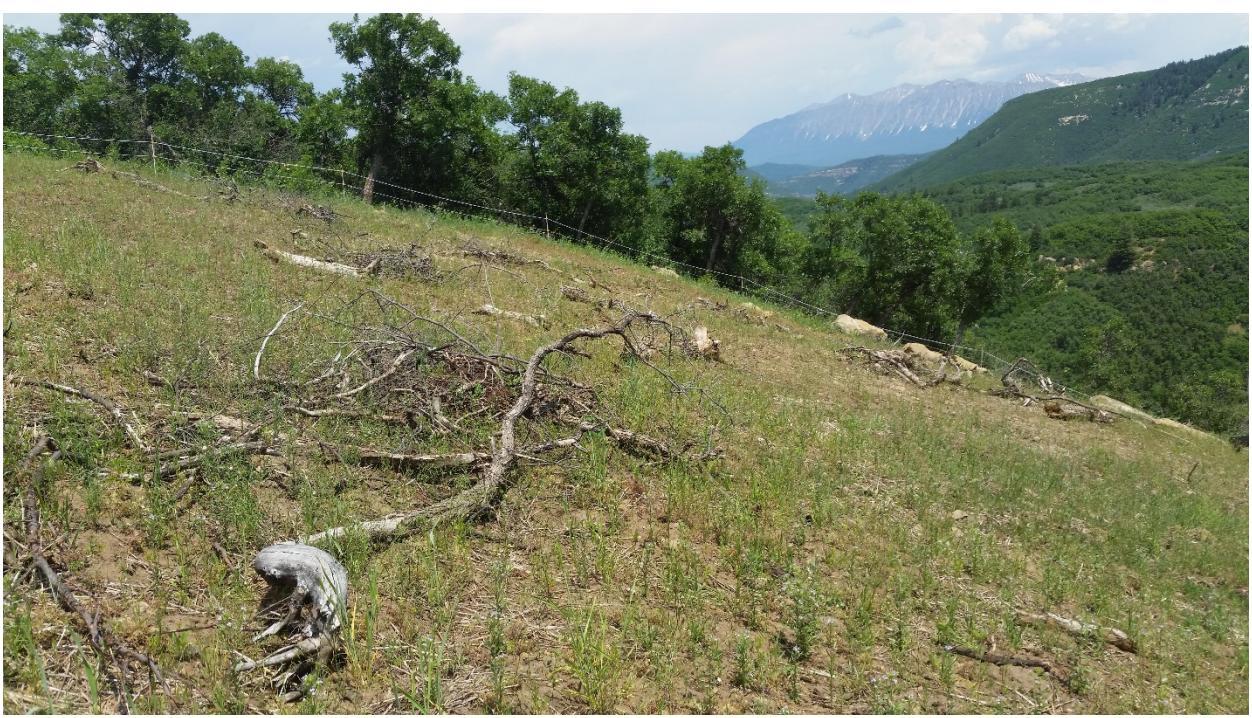
Figure 2: typical reclaimed drill pad featuring slash in the foreground, electric fencing in the midground, and undisturbed background.
