COLORADO Division of Reclamation, Mining and Safety Department of Natural Resources

MINERALS PROGRAM INSPECTION REPORT PHONE: (303) 866-3567

MINE NAME:	MINE/PROSPECTING ID#:	MINERAL:	COUNTY:
State Pit	M-1990-112	Gravel	Pueblo
INSPECTION TYPE:	INSPECTOR(S):	INSP. DATE:	INSP. TIME:
Monitoring	Elliott R. Russell	February 28, 2018	09:00
OPERATOR:	OPERATOR REPRESENTATIVE:	TYPE OF OPERAT	TION:
Fremont Paving & Redi-Mix, Inc.	Jodi Schrieber	112c - Construction I	Regular Operation

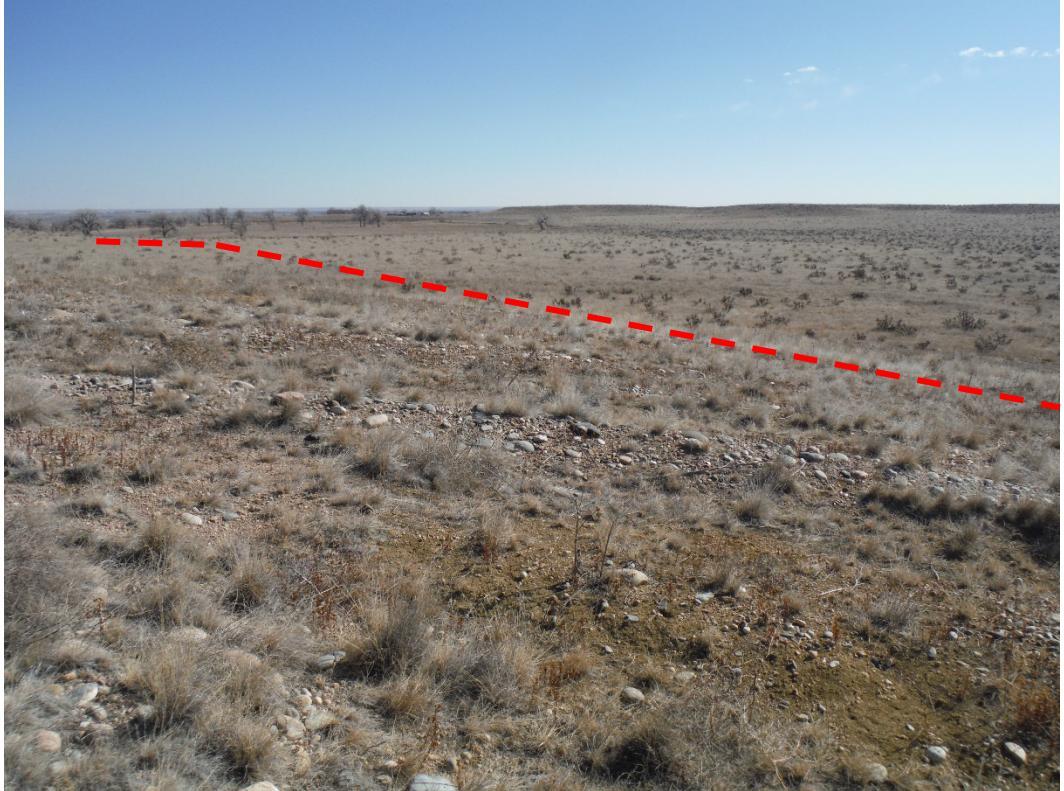
Photo 1. Reclaimed disturbance in northeast portion of the site near the affected lands boundary (approximately delineated by red-dashed line); looking northeast.

- B. <u>Mining outside of the boundary</u>: Ms. Kern indicated the northeast portion of the disturbance could be outside of the boundary. The northern portion of the permit was mined by previous Operators until roughly 2004. This area is in final reclamation and the Operator has stated no further mining will re-disturb this area as the operation is now advancing to the south. The Division inspected the northeast area of the permit and observed no evidence of disturbance beyond the affected lands boundary (Photos 1 & 2). Additionally, the Division acquired GPS data of the affected area boundary and compared that to a Google Earth aerial image to confirm all mining disturbances have remained within the affected area boundary.

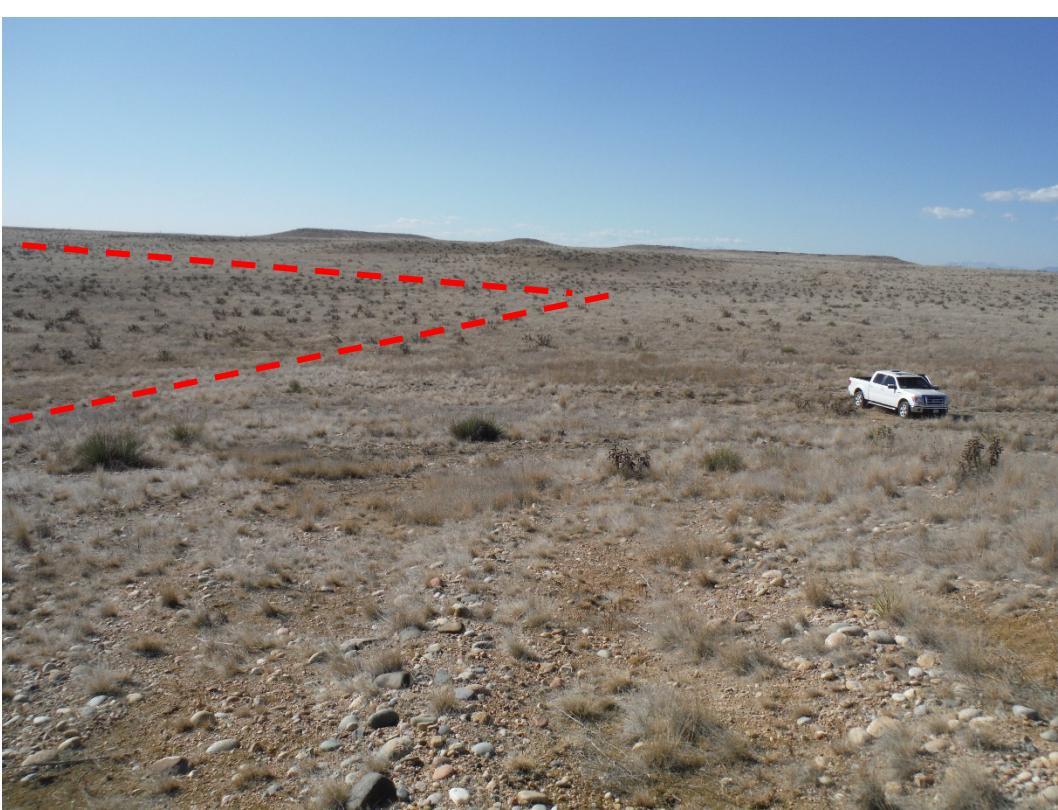
Photo 2. Reclaimed disturbance in northeast portion of the site near the affected lands boundary (approximately delineated by red-dashed line); looking southwest.

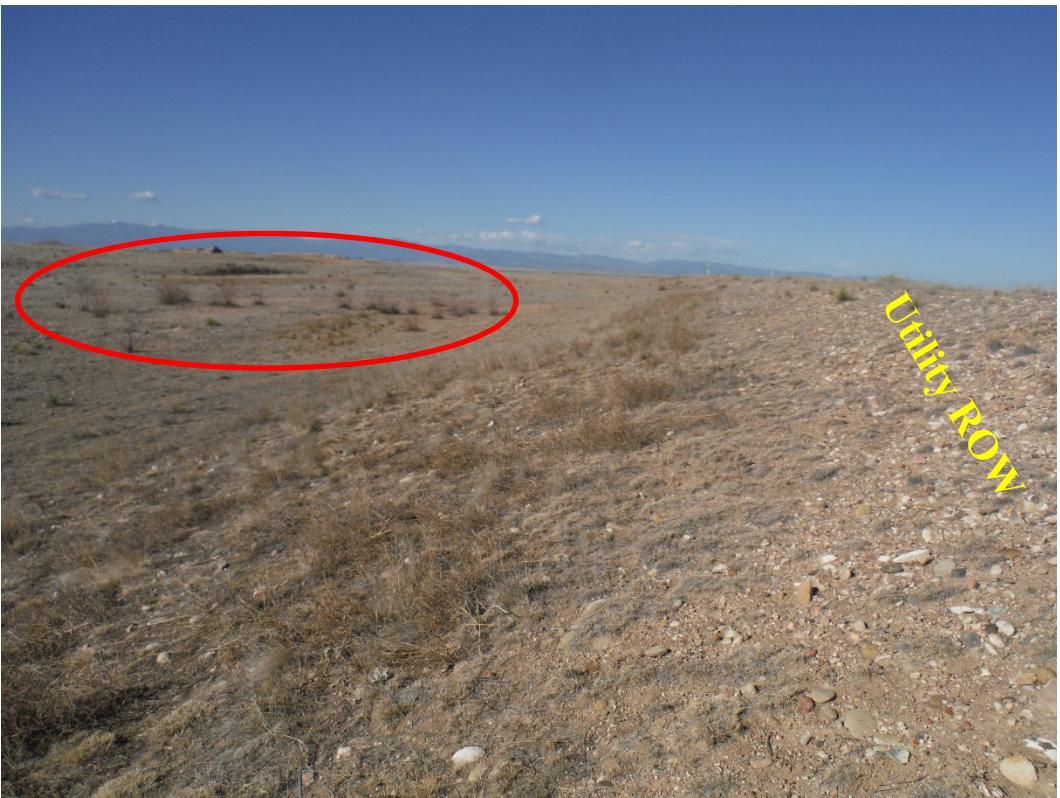
Photo 3. Portion of the southern slope along gas utility line, tamarisk circled in red; looking west.

- C. <u>Slopes near a gas utility line:</u> The northern portion of the permit is bisected by a gas utility line. The 1990 permit application includes information regarding the established slopes leading away for the gas line. The gas utility structure owner asked the Operator to stay 50 feet away from the gas line and have a maximum gradient of 1.5H:1V. The Operator felt this was too steep to revegetate and committed to replacing the excavations near the pipeline with a slope not steeper than 3H:1V on the south facing side and not steeper than 2.5H:1V on the north facing slope. A 2013 structure agreement, executed between the Operator and gas utility structure owner, states that no mining is to occur within 50 feet of the gas line and a minimum of 4H:1V slope will be maintained as a back-slope to the existing right of way (ROW) easement "from this time forward of the current operations." The Division observed the side slopes away from the gas utility line ROW during the inspection (**Photos 3 6**). Based on the revegetation and time since the mining operation was near the gas line (before 2004), these slopes have not been re-disturbed since the 2013 agreement. These slopes appear stable and well vegetated and appropriately graded. The Division recommends the Operator contact the utility company to verify and document there are no issues with the slopes prior to submitting any future release requests of these areas.

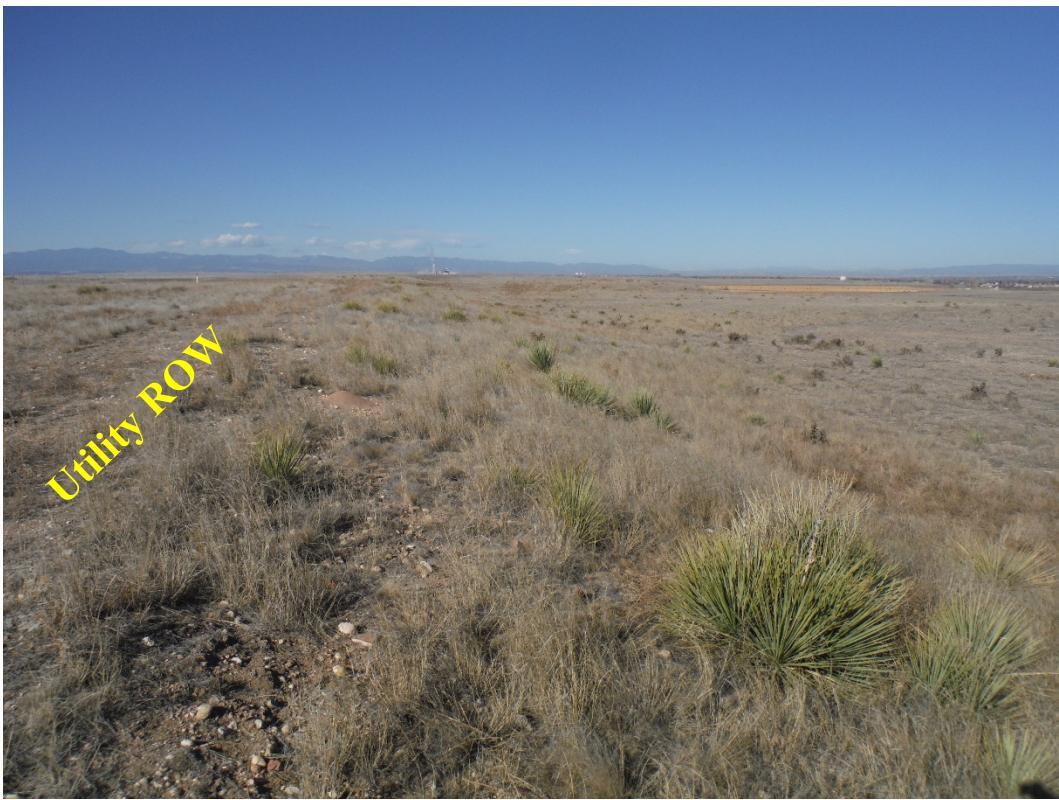
Photo 4. Portion of the northern slope along gas utility line; looking west.

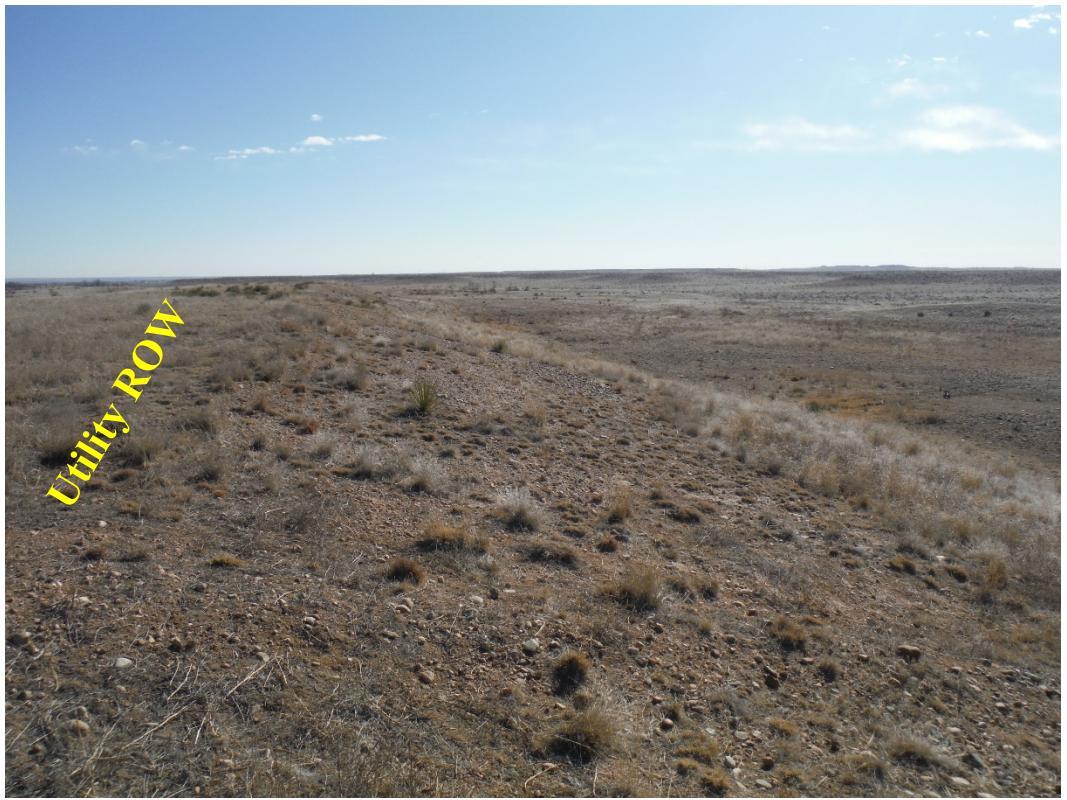
Photo 5. Portion of the southern slope along gas utility line; looking west.

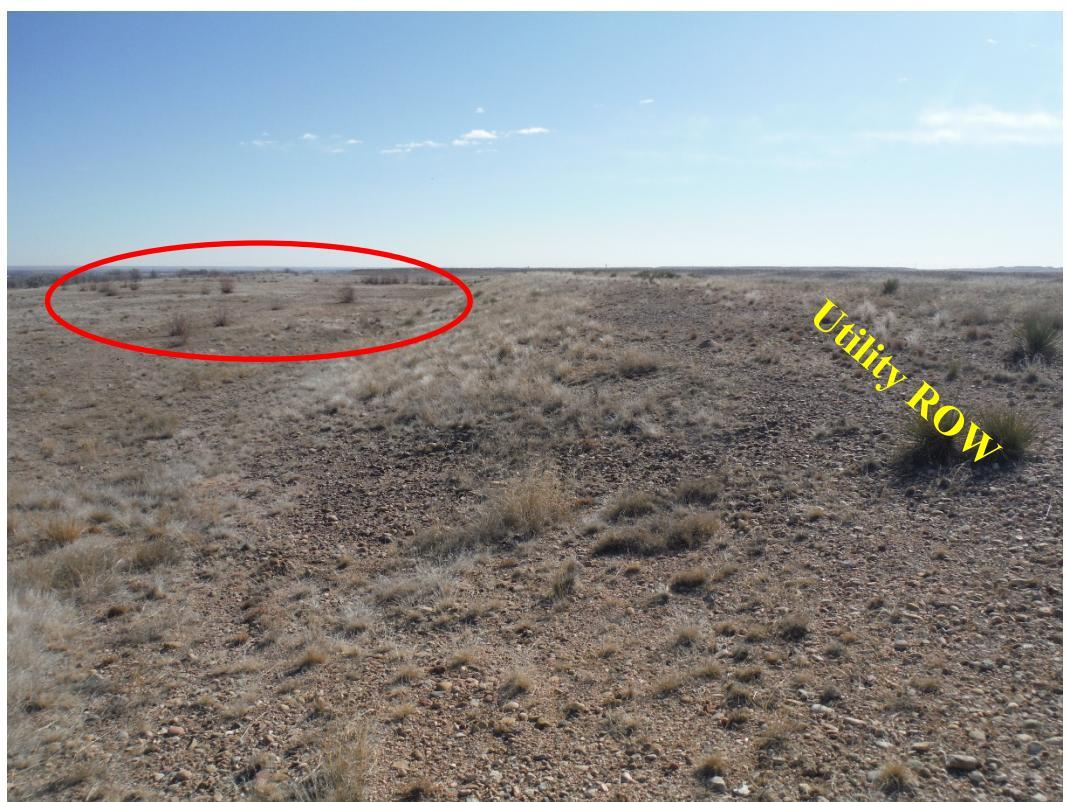
Photo 6. Portion of the northern slope along gas utility line, tamarisk circled in red; looking east.

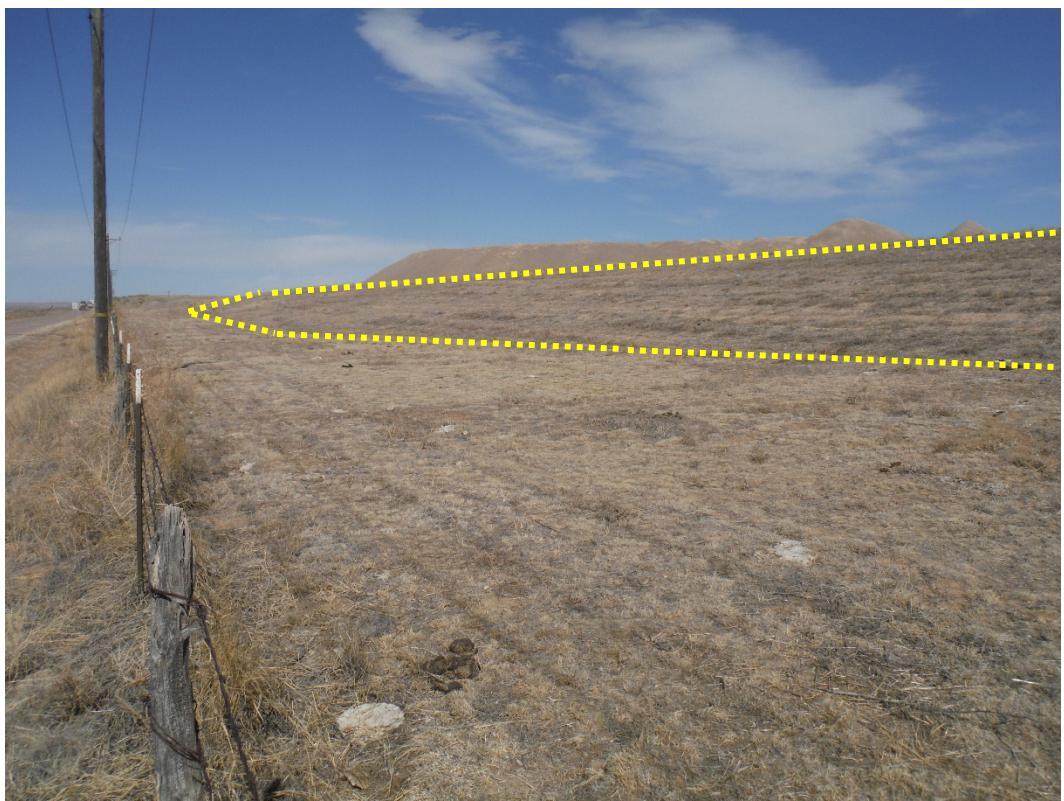
Photo 7. Backfilled and seeded area (circled in dotted yellow) along western portion of the site; looking northeast.

- D. <u>Use of topsoil to build berms</u>: The Operator has mined, backfilled, and started to reclaim portions of the affected lands along the western and southern sides of the active mining area (Photos 7 & 8). The Division believes these backfilled areas are the referenced berms in the complaint. The Operator stated these areas were backfilled with overburden, topsoiled, seeded, and mulched in accordance with the approved Reclamation Plan. These areas help contain storm water on the active mining and processing areas from leaving the site. It appears these also serve as a slight visual barrier of the processing area from 36th Lane. The outward slopes of this backfilled area have been seeded and mulched, but have yet to be established with vegetation.

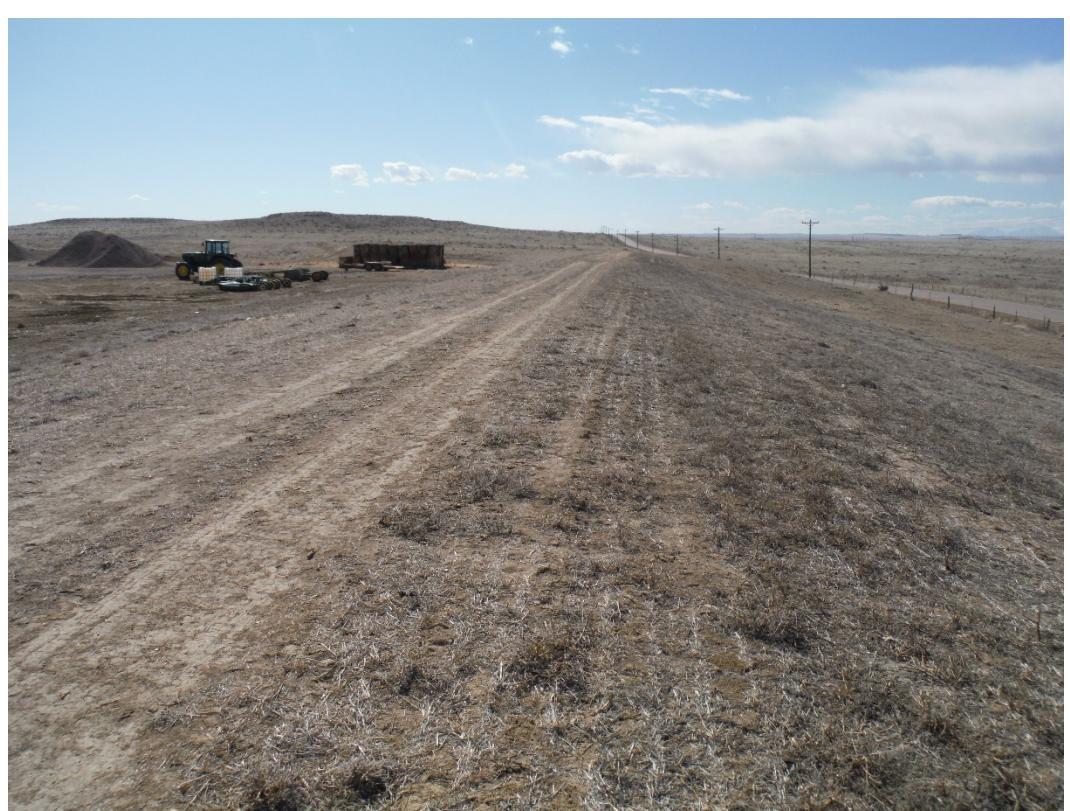
Photo 8. Backfilled and seeded area along western portion of the site; looking south from on top of the backfilled and seeded area.

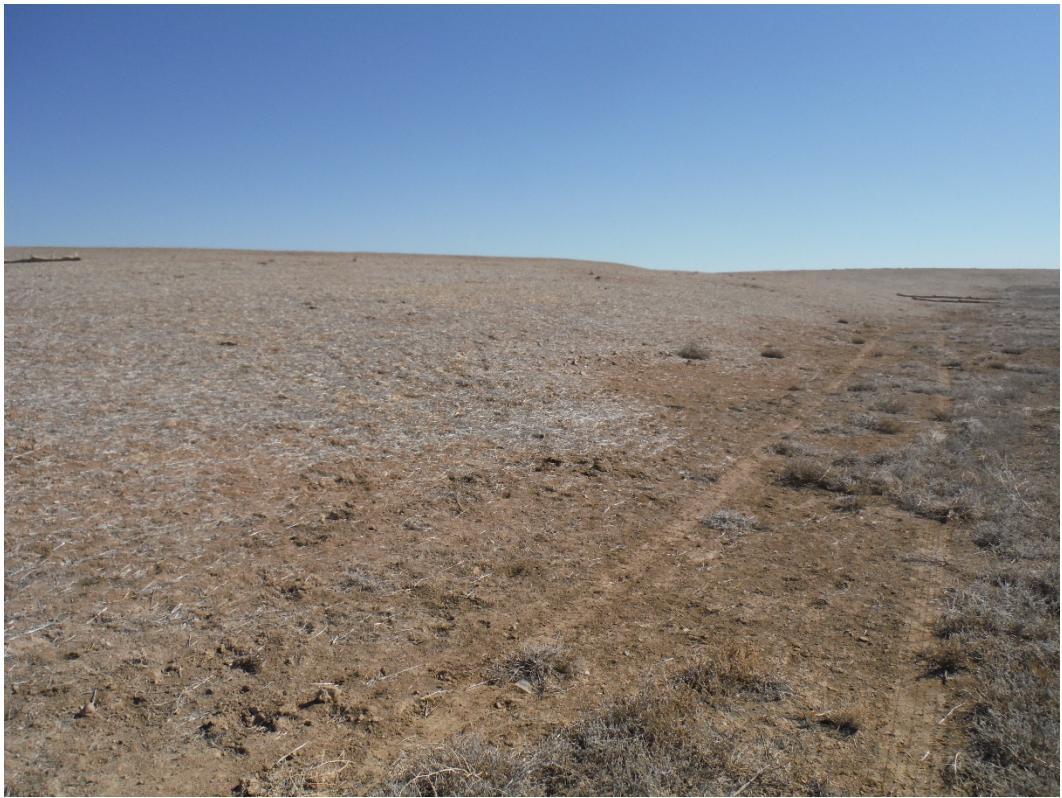
permit states contour furrows and rough grading would control erosion during reclamation. The compliant and subsequent emails from Ms. Kern describe and show storm water leaving the site near the southwest portion of the active disturbance. The outward slopes of the backfilled areas (referenced in Issue D above) directly report to undisturbed lands and a small drainage, within the permit boundary, which travels to the west under 36th Lane via a culvert (**Photos 9 & 10**). The Operator had recently installed new erosion control wattles on various portions of this outward slope as well as across the drainage. There was also an older wattle across the drainage near the permit boundary. The Operator stated a discharge permit from the Colorado Department of Public Health and Environment (CDPHE) has been obtained for the operation. The Division has determined the original permit's storm water and erosion control discussion and the methods being implemented on-site do not appear adequate. The Division recommends establishing more appropriate storm water controls on these un-vegetated outward facing slopes as they currently exhibit the potential for erosion and sedimentation. Such controls could include contour ditches and berms, silt fencing, more wattles, or other Best Management Practices (BMPs). This issue has been cited as Compliance Problem #1 on page two of this report. The Operator is required to submit a Technical Revision to the permit to address improved erosion control BMPs and an updated Exhibit M regarding the discharge permit in accordance with C.R.S. 34-32.5-116(4)(j) and Rules 3.1.5(3), 6.4.7(2)(c), and 6.4.13.

Photo 9. Backfilled and seeded area in need of improved erosion control BMPs; looking east.

COMPLIANCE PROBLEM #1: The Operator needs to update the permit regarding current storm water controls. The Operator must provide sufficient information to describe or identify how the operator intends to stabilize and protect all surface areas of the affected lands to effectively control erosion and prevent sedimentation. Additional details regarding this compliance problem are provided in this inspection report. **CORRECTIVE ACTIONS:** The operator shall submit a Technical Revision, with the required \$216 revision fee, to update and clarify the current plan to control erosion and sedimentation.

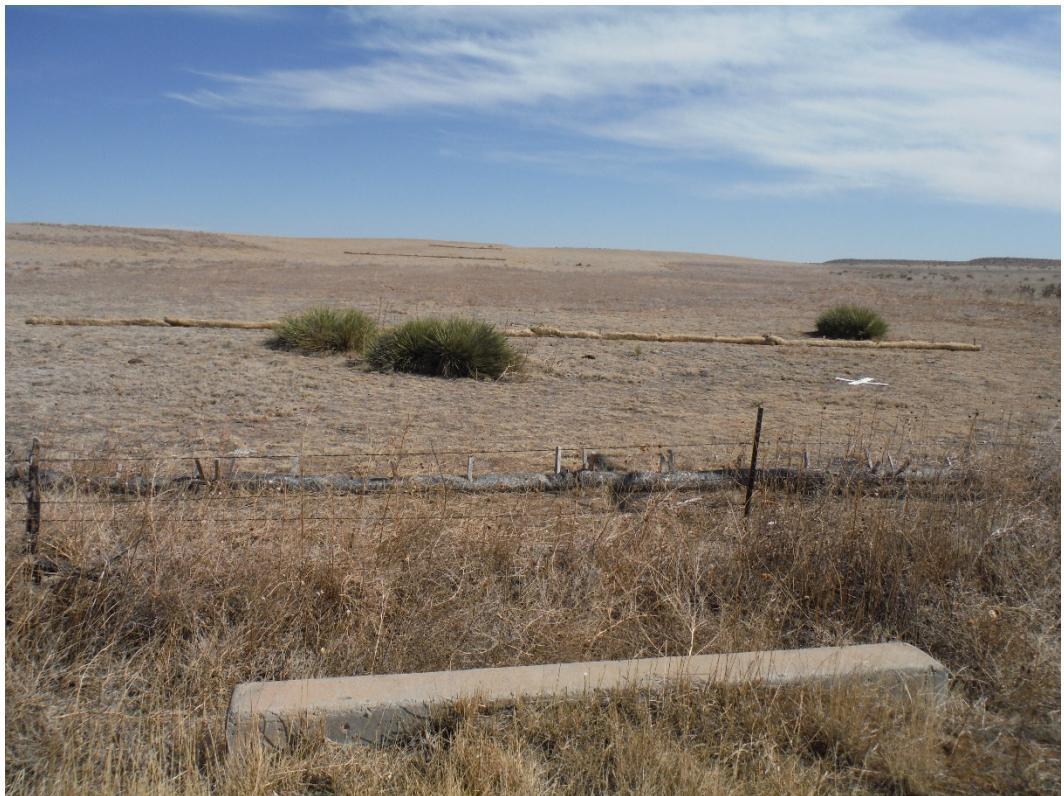
Photo 10. Drainage located to the south of the backfilled and seeded areas, 36th Lane culvert headwall in foreground; looking east.

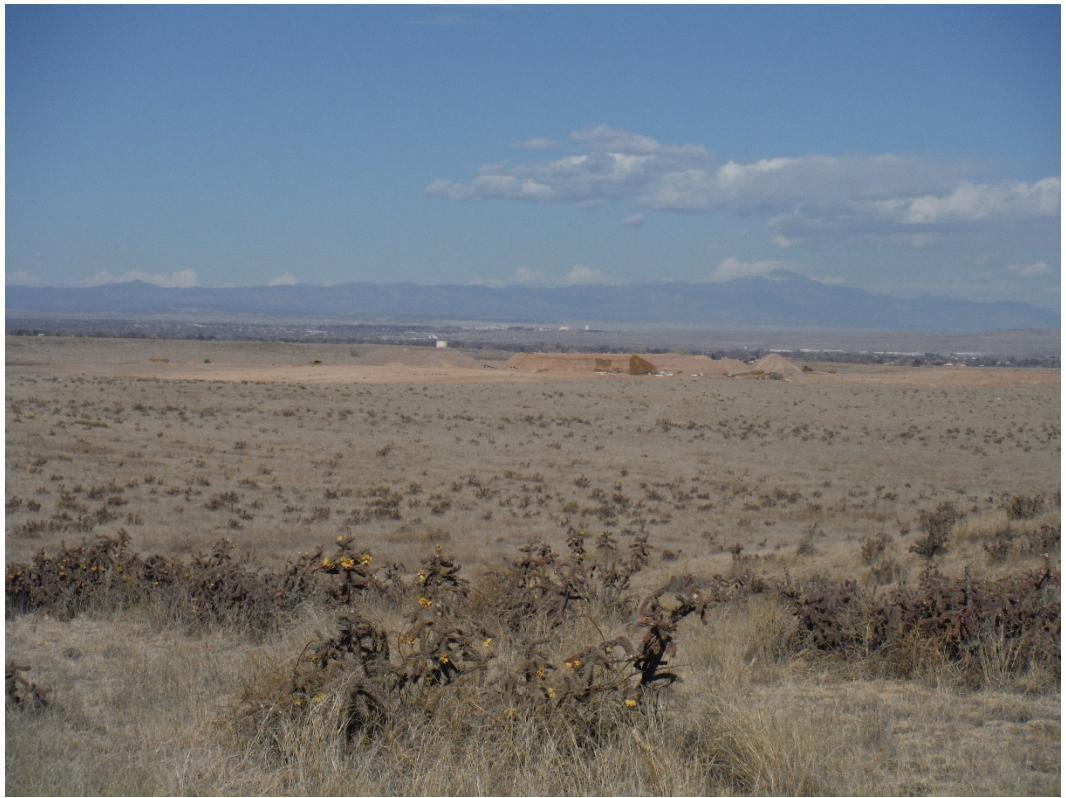
<u>General Compliance with Mine Plan:</u> The operation extracts gravel from eroded river terraces and processes the material with a mobile crushing and screening plant (**Photos 11 & 12**). The Operator states the operation is currently removing approximately 3-12 feet of overburden and mining approximately 15 feet of gravel. The active mining highwall is currently located along the east portion of the pit (**Photo 13**). Various product stockpiles are located around and to the west of the processing plant (**Photo 14**).

Photo 11. Active operation overview; looking northwest from the southern portion of the permit.

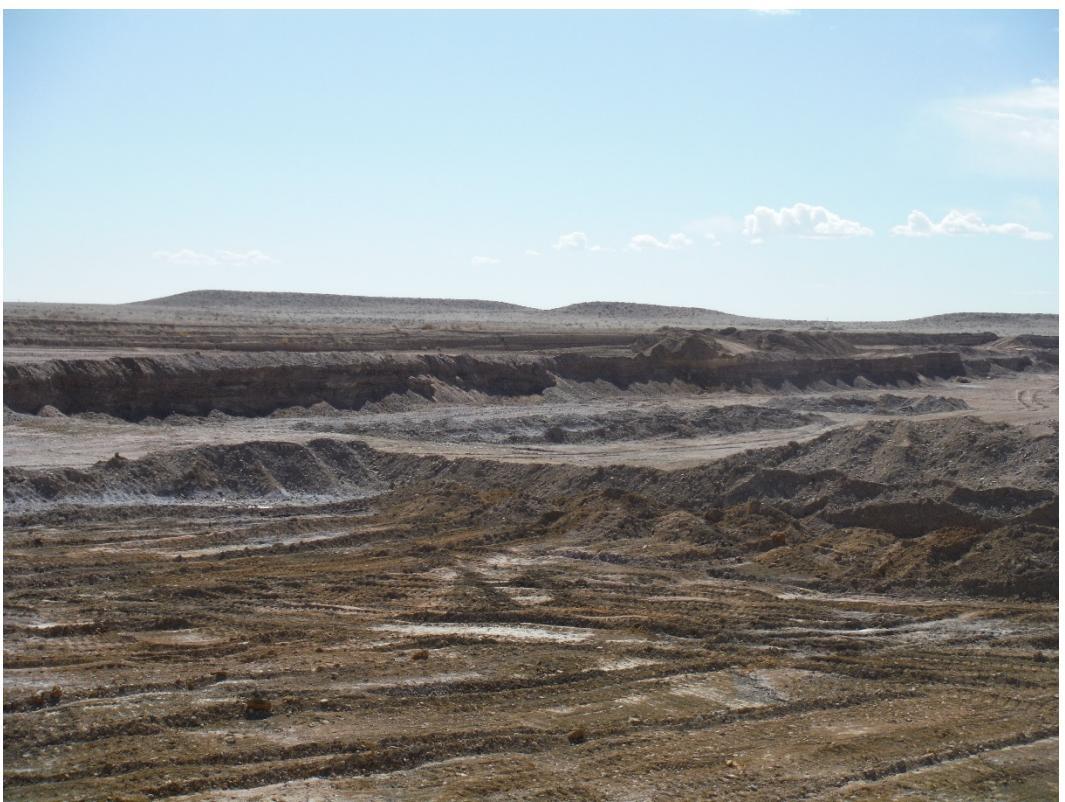
Photo 12. Active mining face along east side of the pit; looking southeast.

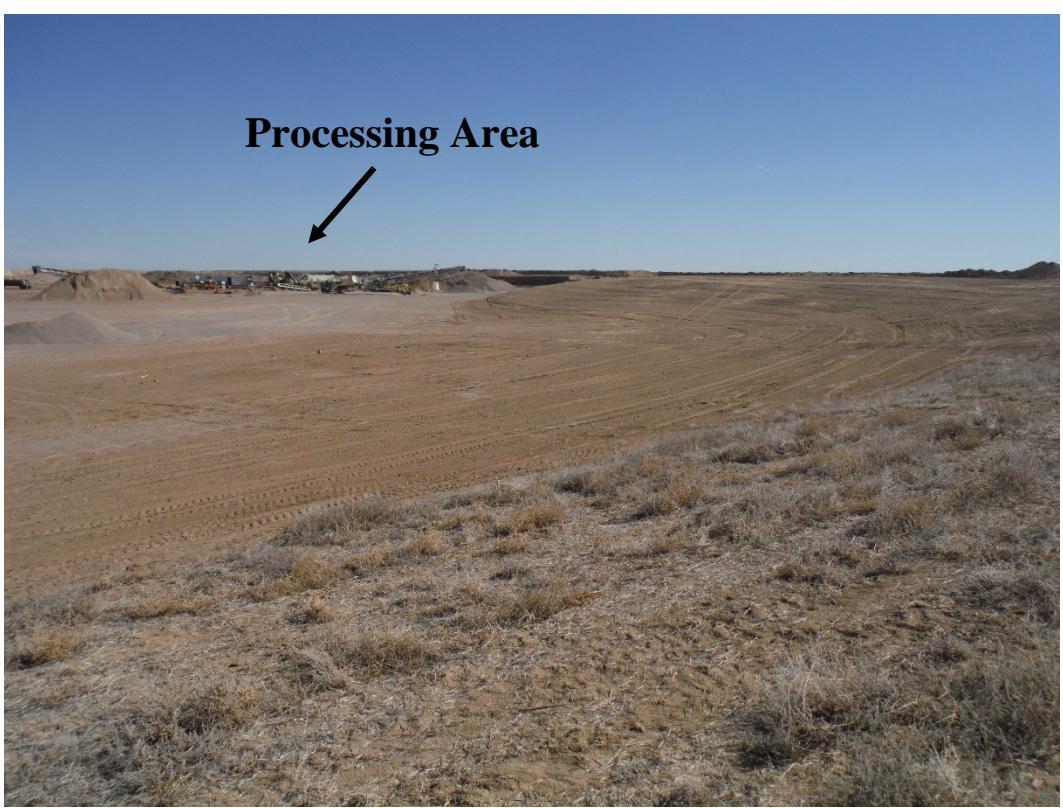
Photo 13. Inward facing slope of the backfilled area south of the active mining and processing areas; looking northeast.

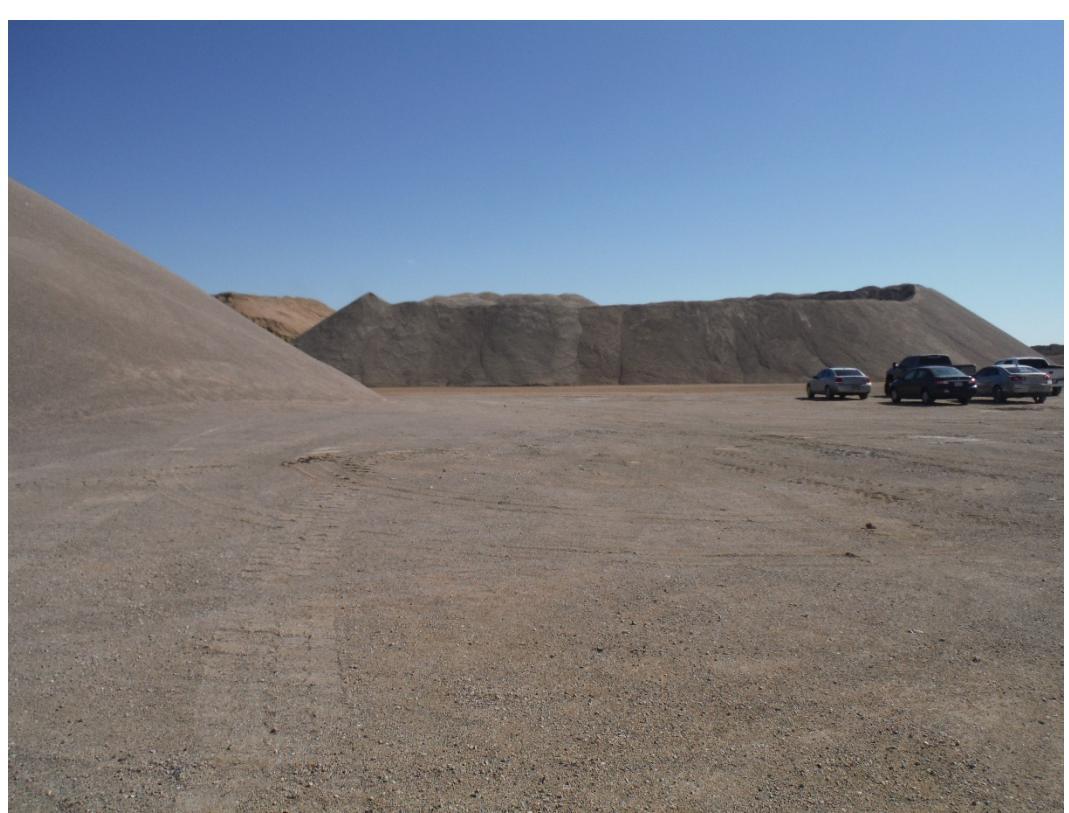
Photo 14. Various product stockpiles located west of the active pit and processing area; looking east.

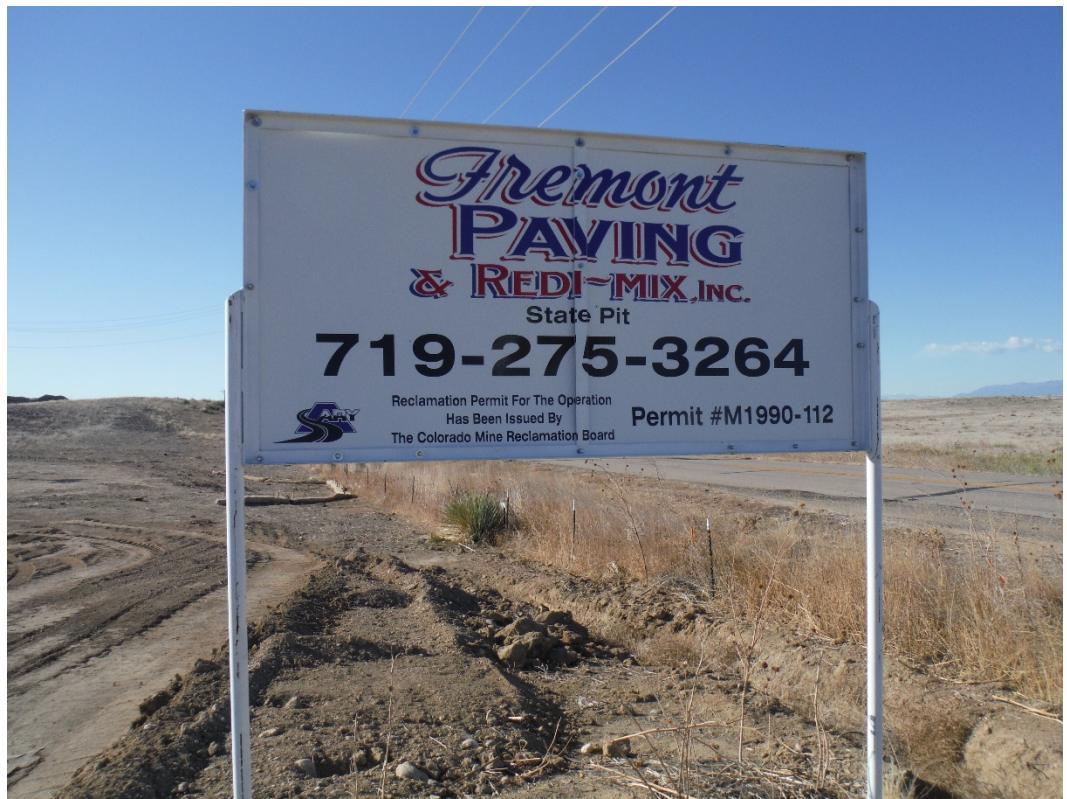
Signs and Markers: The mine identification sign was posted at the entrance of the mine site along the east side of 36th Lane (**Photo 15**). The Affected lands boundary was recently survey by the Operator and was delineated with tall PVC pipes painted with florescent green (**Photo 16**). The GPS location of these markers were recorded with a Trimble Juno 3b unit. The attached *DRMS 2-28-18 Inspection Map M1990112* delineates the GPS location of these boundary markers. The Operator stated that the original hand-drawn Mine Plan and Reclamation Plan Maps contain various errors and inaccuracies based on the total affected and permit acreages. The Division suggests the Operator submit updated Mine and Reclamation Plan Maps, in accordance with Rules 6.4.3 and 6.4.6, as a Technical Revision to the permit.

Photo 15. Permit identification sign posted at the entrance to the site along 36th Lane; looking south.

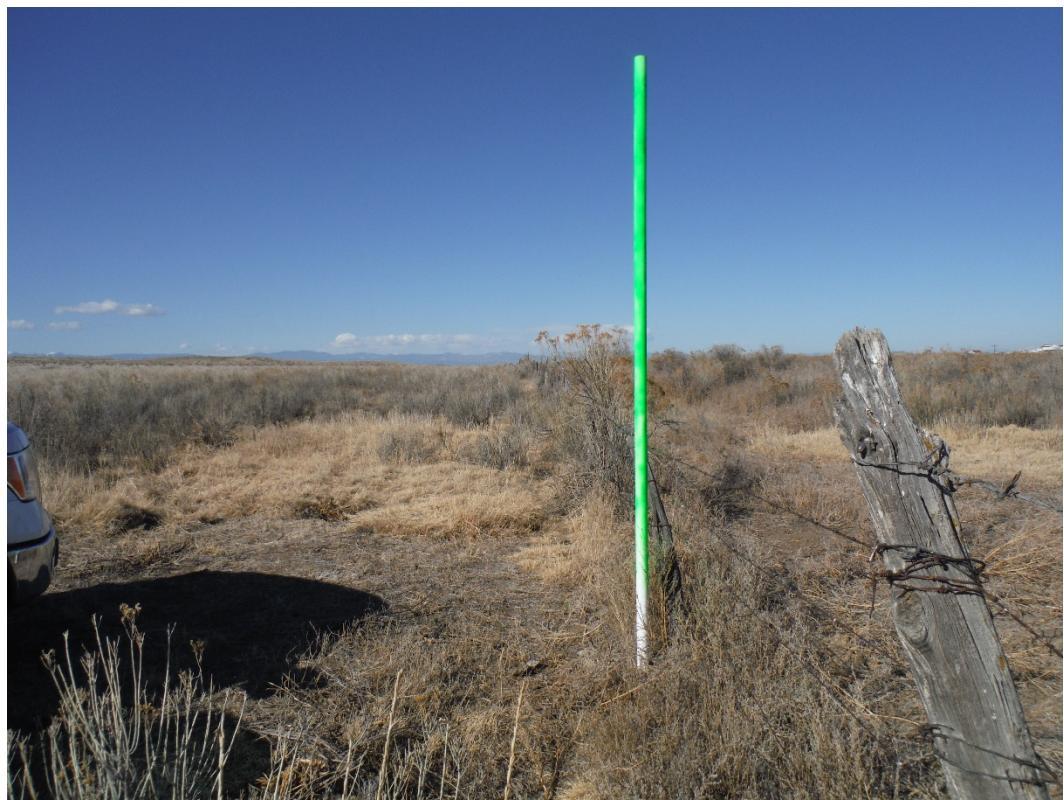
Photo 16. Sample photo of the affected area boundary markers; looking west.

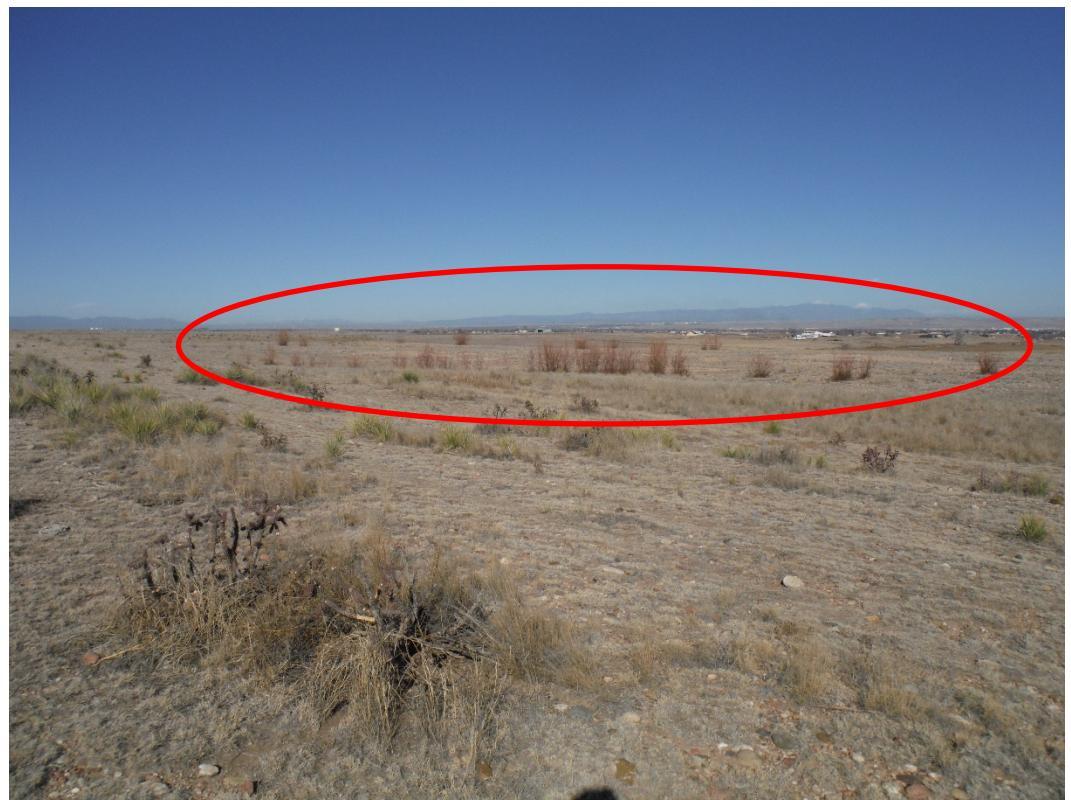
COMPLIANCE PROBLEM #3: Tamarisk (salt cedar) trees are present within or have volunteered into the permit area and are becoming established. This is a problem for failure to employ weed control methods for a state listed noxious weed species within the permitted area, and to reduce the spread of weeds to nearby areas as required by Rule 3.1.10(6). Additional details regarding this compliance problem are provided in this inspection report.

Revegetation: As discussed above, the northern portion of the site, approximately 122 acres has been mined and is in final reclamation. The southern half of this area (approximately 56 acres) has yet establish appropriate vegetative cover and may need to be re-seeded. The northern half of this area (approximately 66 acres) has vegetation established. This 66-acre area is located from the northern edge of the mining disturbance to the toe of the southern gas utility line slope as well as a section on the south side of the utility line in the northeast portion of the mining distubnace. This area could be eligible for release through an Acreage Reduction request, however, Tamarisk is starting to establish on the reclaimed lands (Photos 3, 6, & 17). Tamarisk is a noxious weed List B species which will need to be controlled. The current permit does not contain a weed control and management plan in accordance with Rule 3.1.10(6). This issue has been cited as Compliance Problem #3 on page two of this report. The Operator is required to submit a Technical Revision to the permit to address the control and management of Tamarisk. The Weed Control Plan shall provide the control methods, a schedule for when control measures will be applied, and a post-treatment monitoring plan. The Division recommends you contact the Pueblo County Weed Manager for assistance with this plan. The 12th edition of the Noxious Weeds of Colorado handbook by the Colorado Weed Management Association lists Bill Alt at 719-586-9768 and balt7302@gmail.com as the Pueblo County Weed Manager. Please note, a Technical Revision to the Weed Control Plan will be required if the Operator intends to modify this plan in the future to include new treatment methods and time tables for other noxious weed species. The Division recommends the Operator develop specific management plans for several common noxious weed species that occur in the area of the State Pit and submit those with the required Weed Control Plan, as this will avoid having to submit future Technical Revision(s) for any new species. The Pueblo County Weed Manager should be able to assist you in determining which noxious weed species are likely to occur within the area of the State Pit and provide you with the management plans for those species.

Photo 17. Tamarisk infestation (circled in red) in northern portion of the site; looking northwest.

CORRECTIVE ACTIONS: The operator shall develop a weed control and management plan in accordance with Rule 3.1.10(6). This plan should be developed in consultation with the county extension agency, or weed control district office and should include specific control measures to be applied, a schedule for when control measures will be applied and a post-treatment monitoring plan. This weed control plan shall be submitted to the Division as a Technical Revision to the permit with the appropriate Technical Revision fee of \$216.00 by the corrective action date.
