MINERALS PROGRAM INSPECTION REPORT PHONE: (303) 866-3567

MINE NAME:	MINE/PROSPECTING ID#:	MINERAL:	COUNTY:
19 Road Pit	M-2002-110	Sand and gravel	Mesa
INSPECTION TYPE:	INSPECTOR(S):	INSP. DATE:	INSP. TIME:
OSM Follow-up Inspection	Amy C. Yeldell	June 7, 2018	12:30
OPERATOR:	OPERATOR REPRESENTATIVE:	TYPE OF OPERATION:	
Oldcastle SW Group, Inc. dba United Compar	Tyra Monger	110c - Construction Limited Impact	
County			
REASON FOR INSPECTION:	BOND CALCULATION TYPE:	BOND AMOUNT:	
Surety Release Requested	None	\$49,157.00	
DATE OF COMPLAINT:	POST INSP. CONTACTS:	JOINT INSP. AGE	NCY:
NA	None	None	
WEATHER:	INSPECTOR'S SIGNATURE:	SIGNATURE DAT	'Е:
Clear	Amy Geldell	June 18, 2018

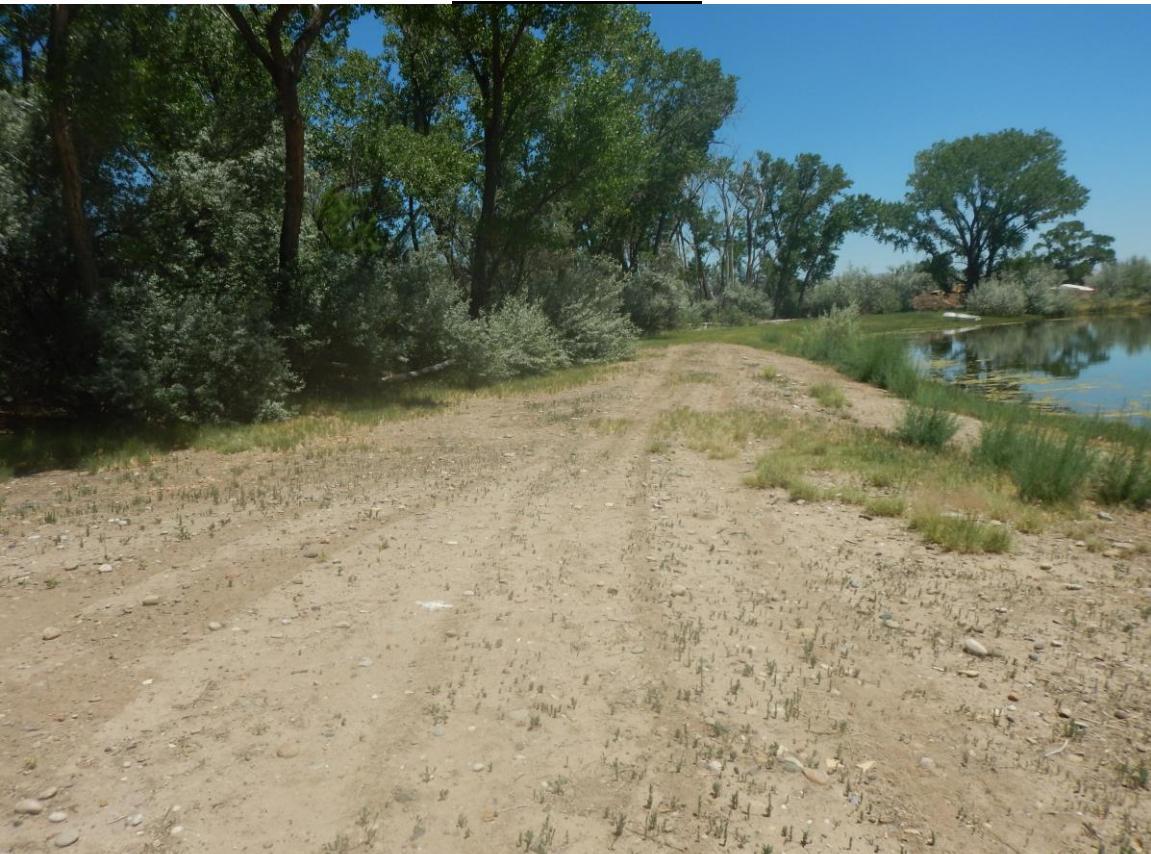
During the inspection Mr. Schreiner indicated that based on dead vegetation and bald patches it appears that a non-selective herbicide has been used. That type of herbicide will kill all plants rather than targeting a specific noxious species. There were several patches where vegetation was completely void, dead bunch grass crowns were observed and only new emerging Kochia grew.

Bare soil patches adjacent to dense vegetation. Only young Kochia present.

The previous inspection report noted weeds as a problem and required treatments as a corrective action. During this inspection it was discussed that the time for treatments has now passed. The Division will accept a written commitment to treatment infestations when timing allows as an acceptable corrective action. The plan needs to be species specific and include the plan for treatment and timing.

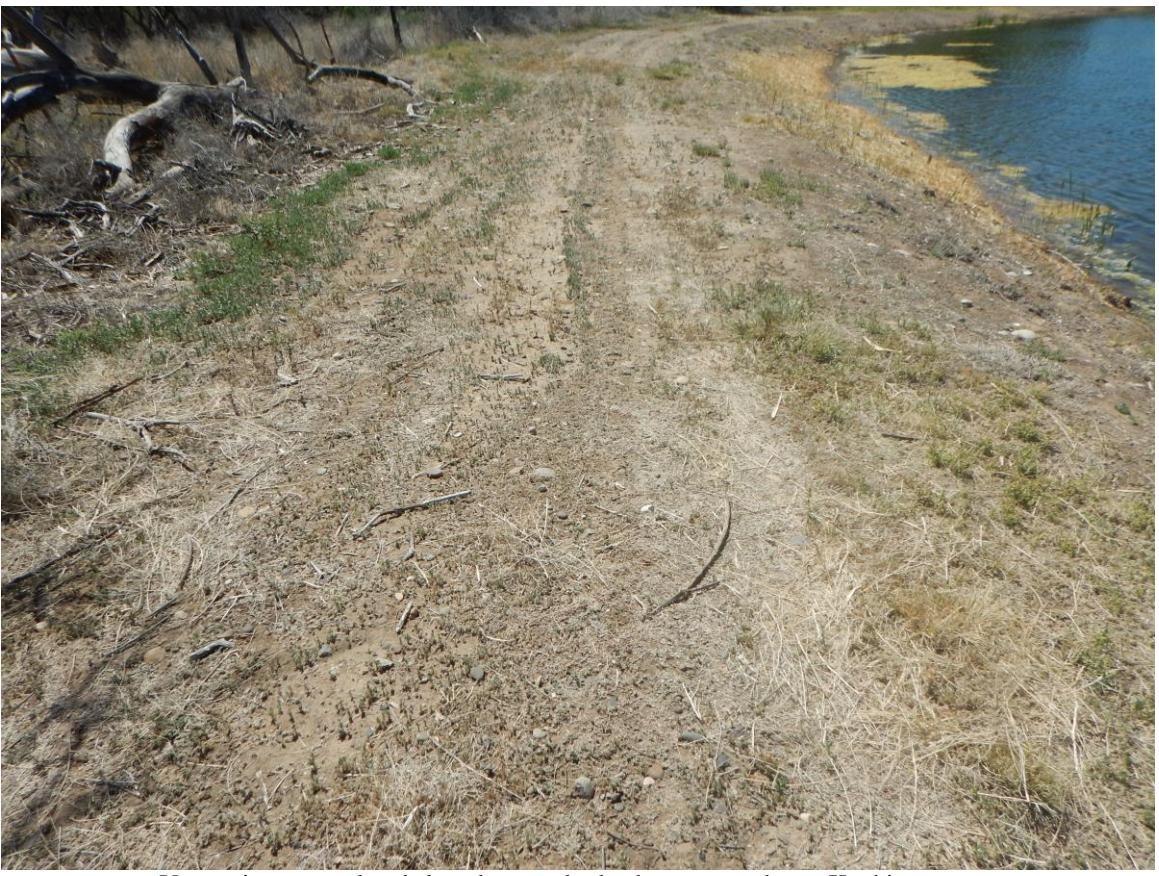
Vegetation on road and slope bare, only dead crowns and new Kochia present.

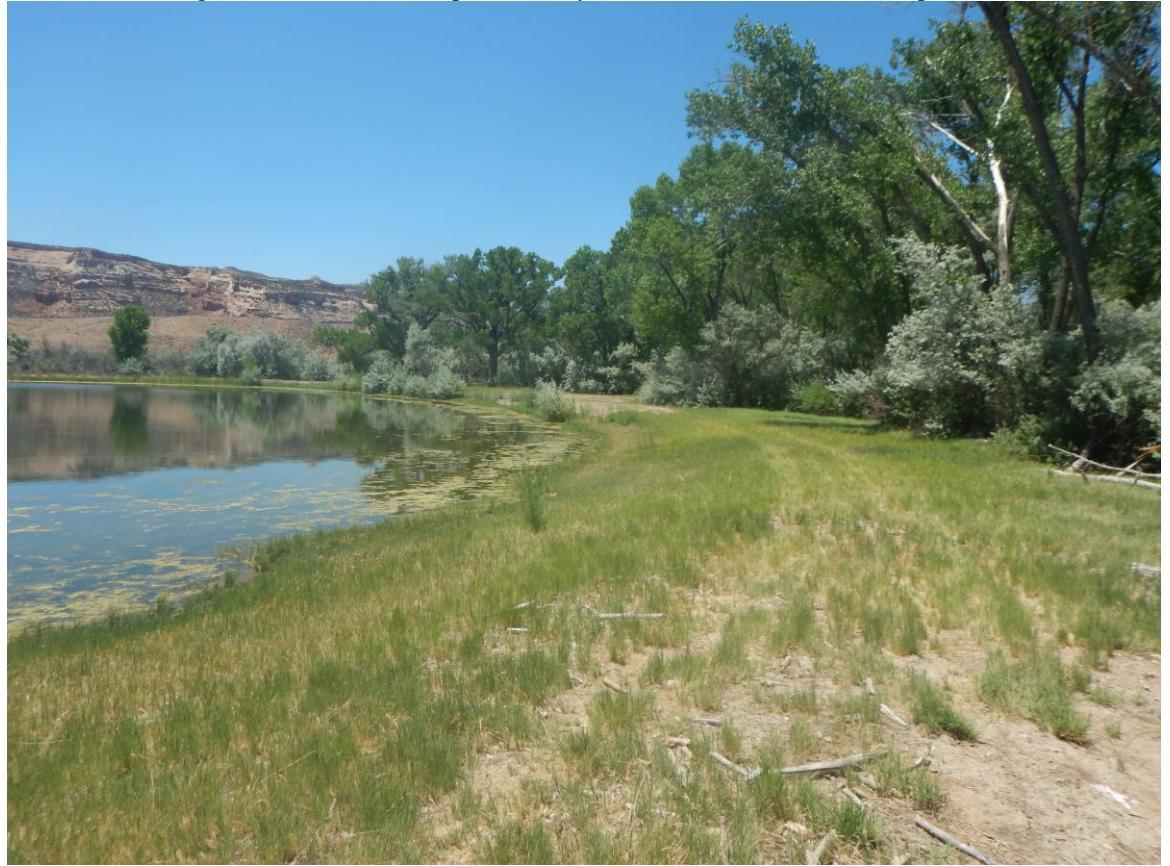
Area where reclamation has continued to thrive. Some patchiness in bottom left corner.

The operator is encouraged to submit a partial acreage release for those areas where desirable vegetation has been established.

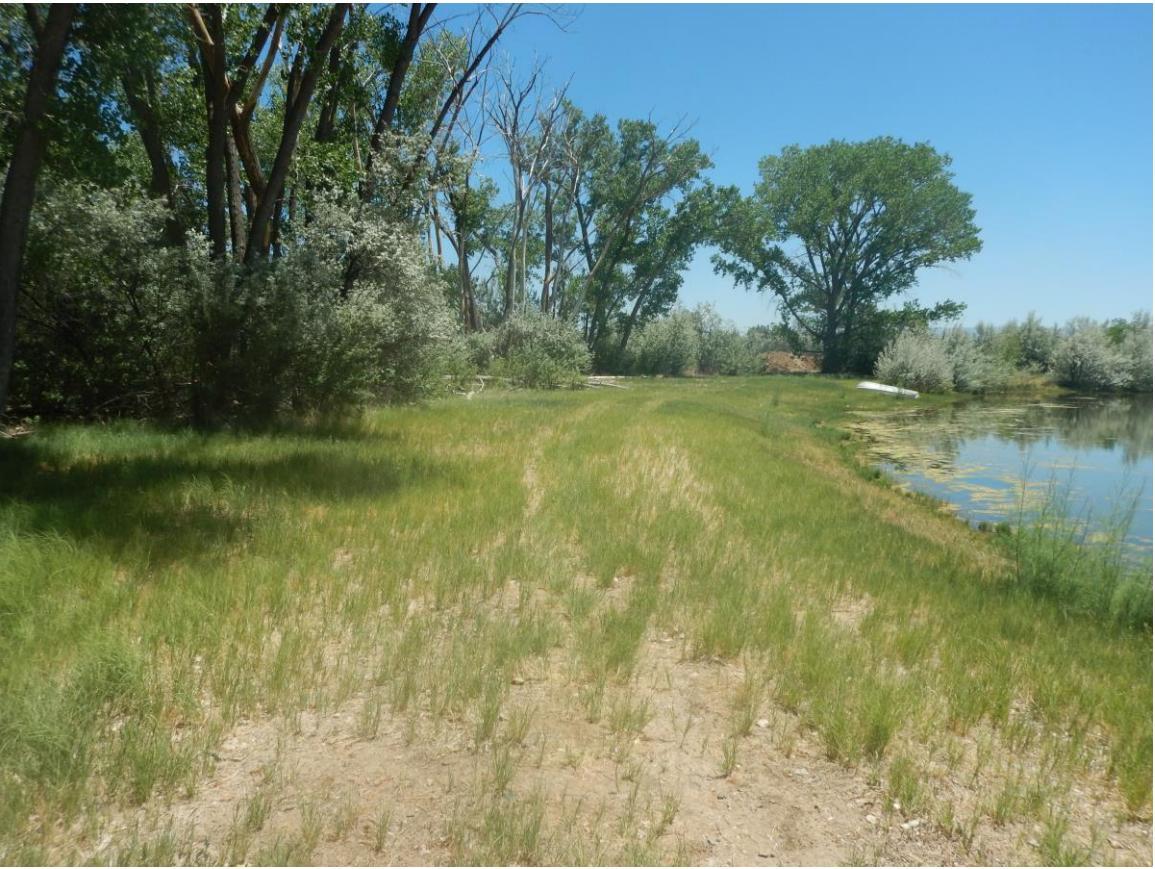
Vegetation resistant to traffic on road around lake. Varying vegetation densities.
