## RE: Goddard Pit #1, M-2018-050, 111(c) Permit Application Adequacy Review No. 1

# Goddard Pit #1, M-2018-050, 200 Foot Buffer Map

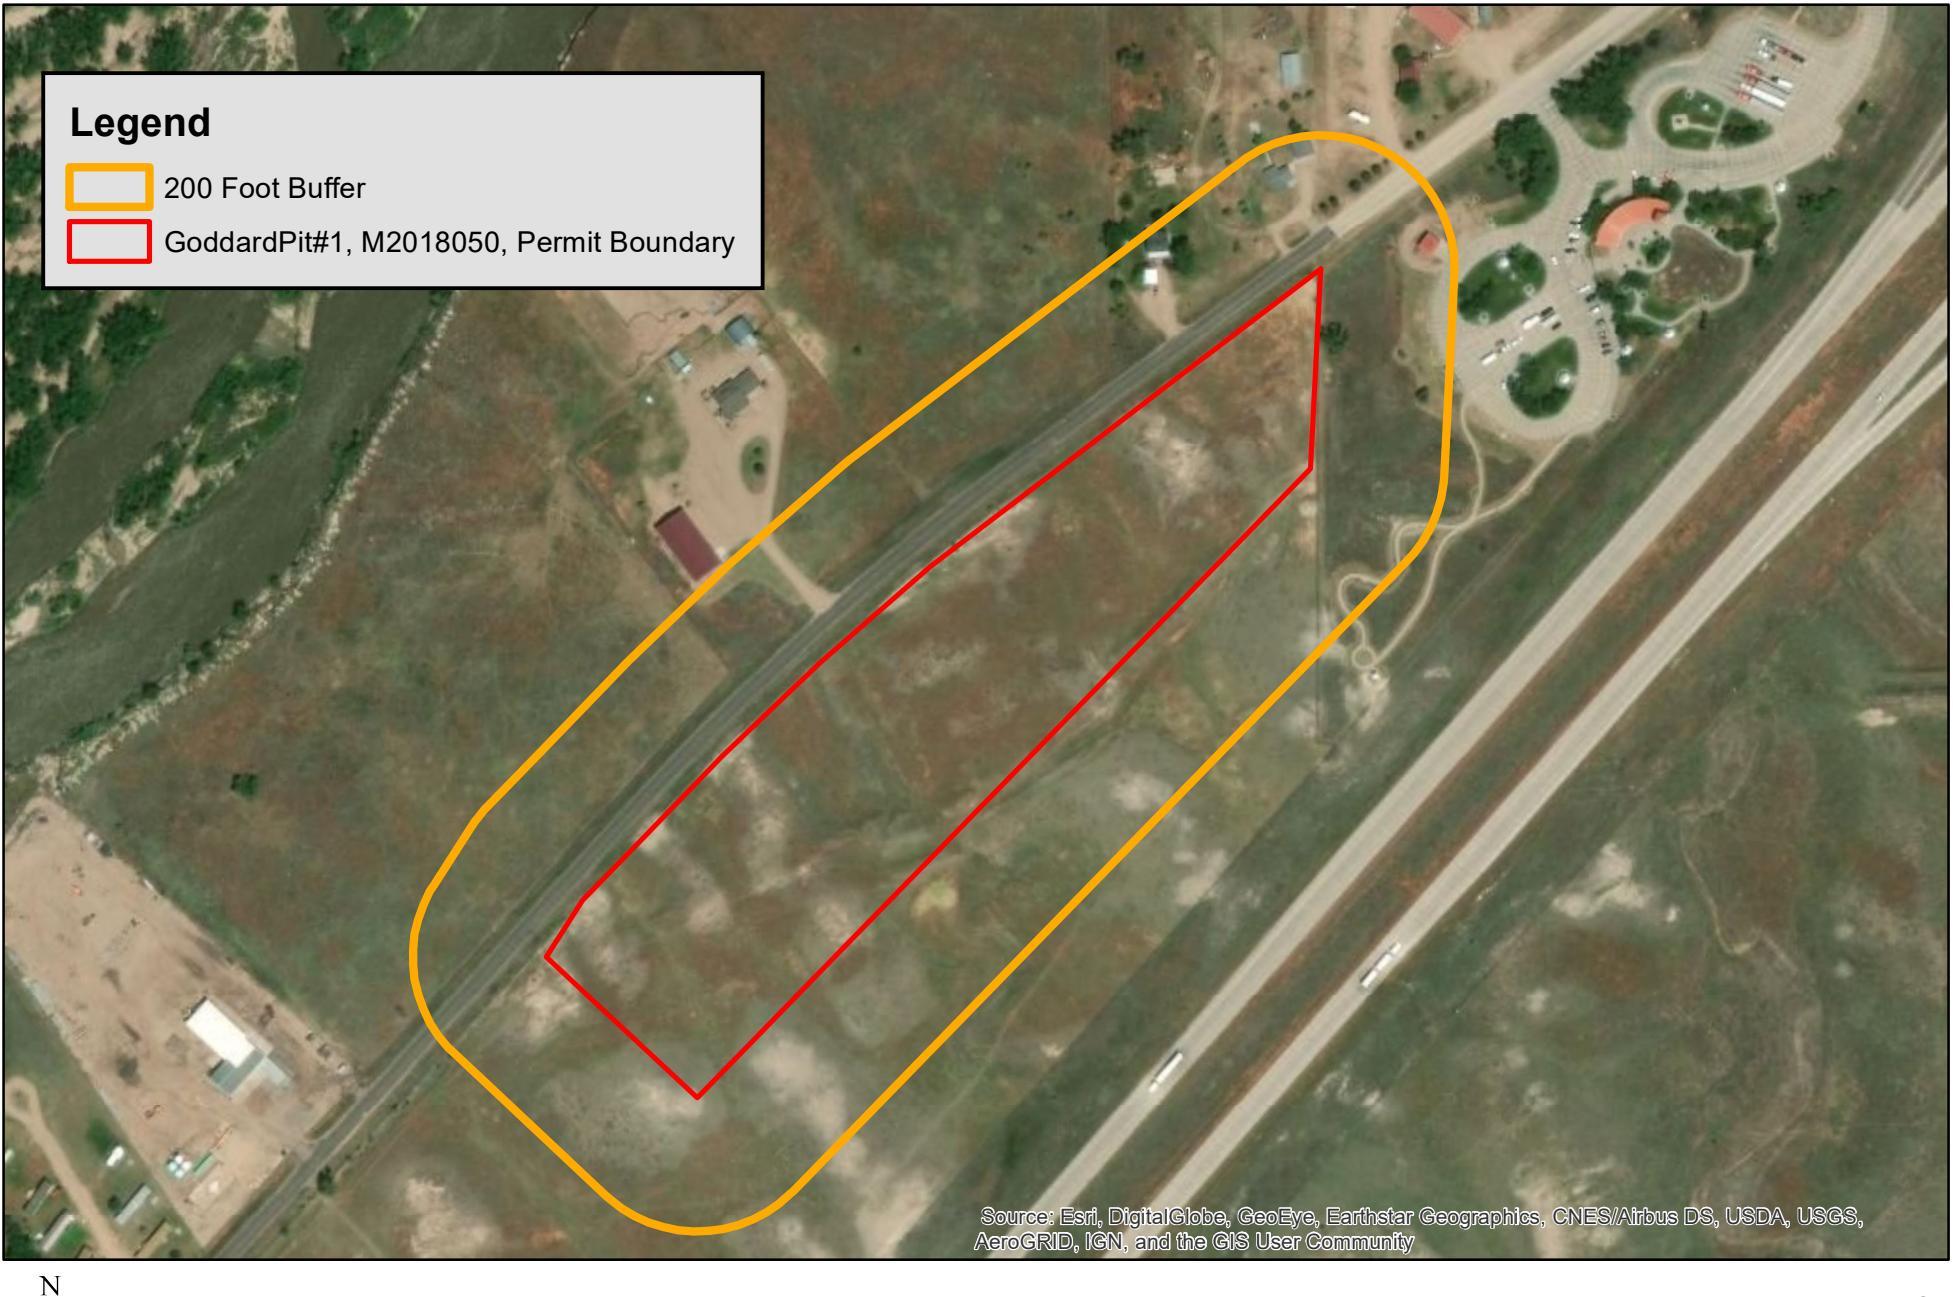
- 2.) Based on the soils series description for the site, there is a viable A and B horizon eight inches deep. Please revise Exhibit B to indicate the soil depth is eight inches at the site or provide further justification for only designating the top four inches as topsoil.
- 3.) Attached is a map that the Division created with the permit boundary depicted and a 200 foot buffer around the proposed affected area. There appears to be more permanent man-made structures within 200 feet of the affected area than was identified in the application. Based on the Division's review, these are the structures within 200 foot of the affected land not included in the application:
  - a. Driveway into Reicks property
  - b. County Road 28
  - c. Driveway into Mendoza property
  - d. Two buildings on Mendoza property
  - e. Two building on Bieber property

- f. Driveway into Beiber property
- g. Building on Department of Highway's property
- h. Parking Lot on Department of Highways Property
- i. Path on Department of Highway's property.

Please revise exhibit B to list these structures that are located within 200 feet of the affected land.

- 10.)Please see item #3 above. Please depict and label the type of structure and owners of record of any permanent or man-made structure within 200 feet of the affected area.
- 11.)Please identify the owner of the substance to be mined and indicate this information on the mining plan map.

- 15.) As discussed in Item #3 above, there are a number of other structures located within 200 feet of the affected land that were not identified in Exhibit B. For each of these structures, the applicant shall either:
  - a. provide a notarized agreement between the Applicant and the Person(s) having an interest in the structure, that the Applicant is to provide compensation for any damage to the structure; or
  - b. where such an agreement cannot be reached, the Applicant shall provide an appropriate engineering evaluation that demonstrates that such structure shall not be damaged by activities occurring at the mining operation; or
  - c. where such structure is a utility, the applicant may supply a notarized letter, on utility letterhead, from the owner(s) of the utility that the mining and reclamation activities, as proposed, will have "no negative effect" on their utility.
