Re: Permit No. M-1980-244; Cripple Creek & Victor Gold Mining Company; Cresson Project; Written Notification – Process Water Spill, December 11, 2018

In accordance with Rule 8, Section 8.2.3 of the Mineral Rules And Regulations of the Colorado Mined Land Reclamation Board For Hard Rock, Metal, And Designated Mining Operations (Rules), Newmont Mining Corporation - Cripple Creek and Victor Gold Mining Company (CC&V) hereby provides the Division of Reclamation, Mining and Safety (Division) with a formal report regarding the process water spill that occurred at the High Grade Mill (HGM) on December 11, 2018.

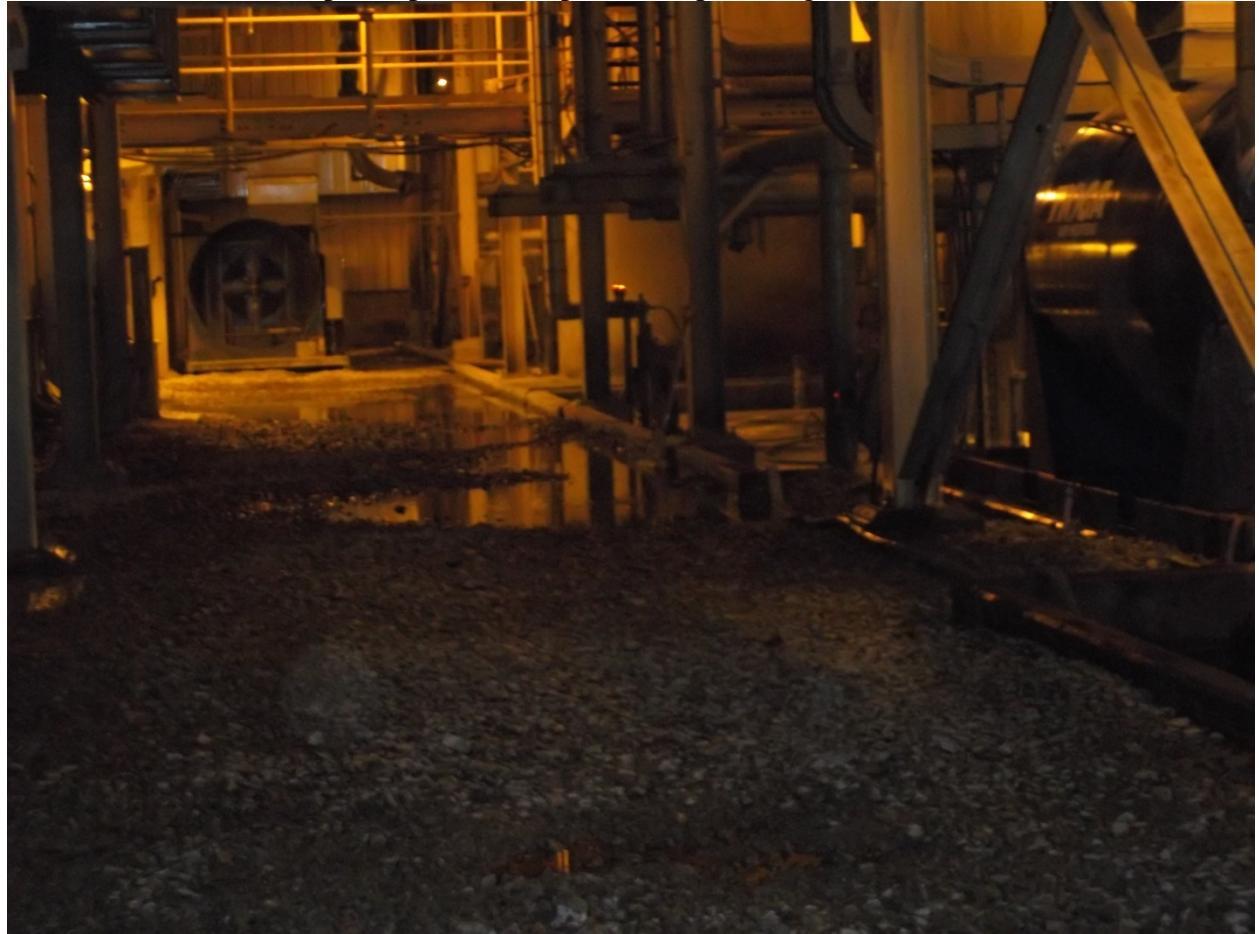
- At approximately 6:00 pm on December 11, 2018, a process water conveyance pipeline separated. The separation occurred on the East side of the HGM near the Process Ore Thickener Tank (PO Tank). Approximately 400 gallons of process water overtopped primary containment, but remained on the HGM pad. The process water consists of fresh water and sediment originating from the milling and filtering processes that occur in the HGM. No cyanide is utilized anywhere in the mill circuit, therefore there is no risk that this process water contains cyanide.

Photo 1. Process water spill impacted area pre-cleanup looking north.

- Upon discovery, the leaking conveyance pipeline was isolated and the separated pipe was repaired.
- A skid steer was used to over-excavate the spill-impacted soil.

- The excavated soil was transferred to the ore feed pile to be re-processed in the HGM. Approximately 3 cubic yards of soil was excavated in the cleanup efforts. Clean gravel was placed in the over-excavated area.

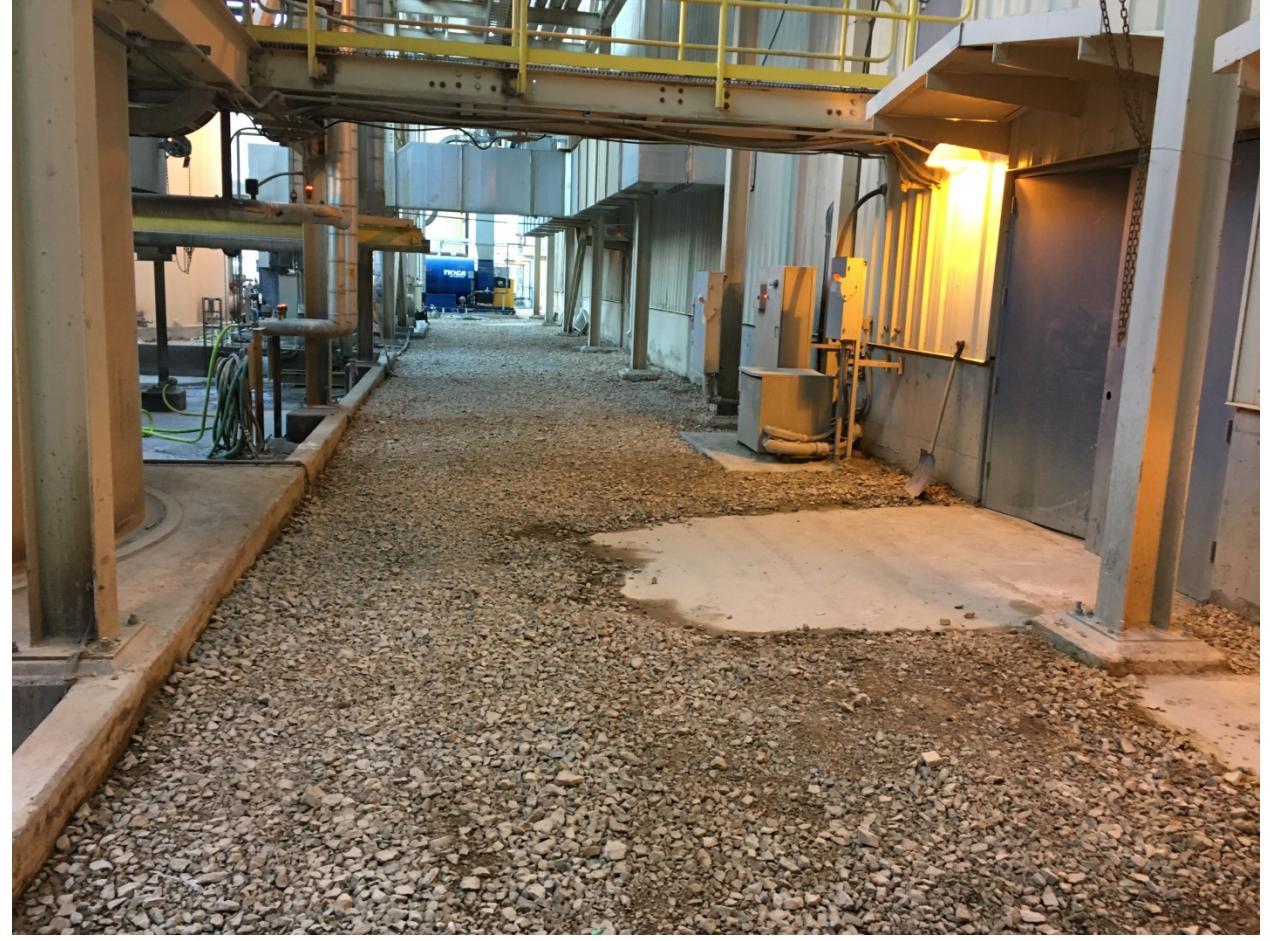
Photo 2. Process water spill impacted area post-cleanup looking south.

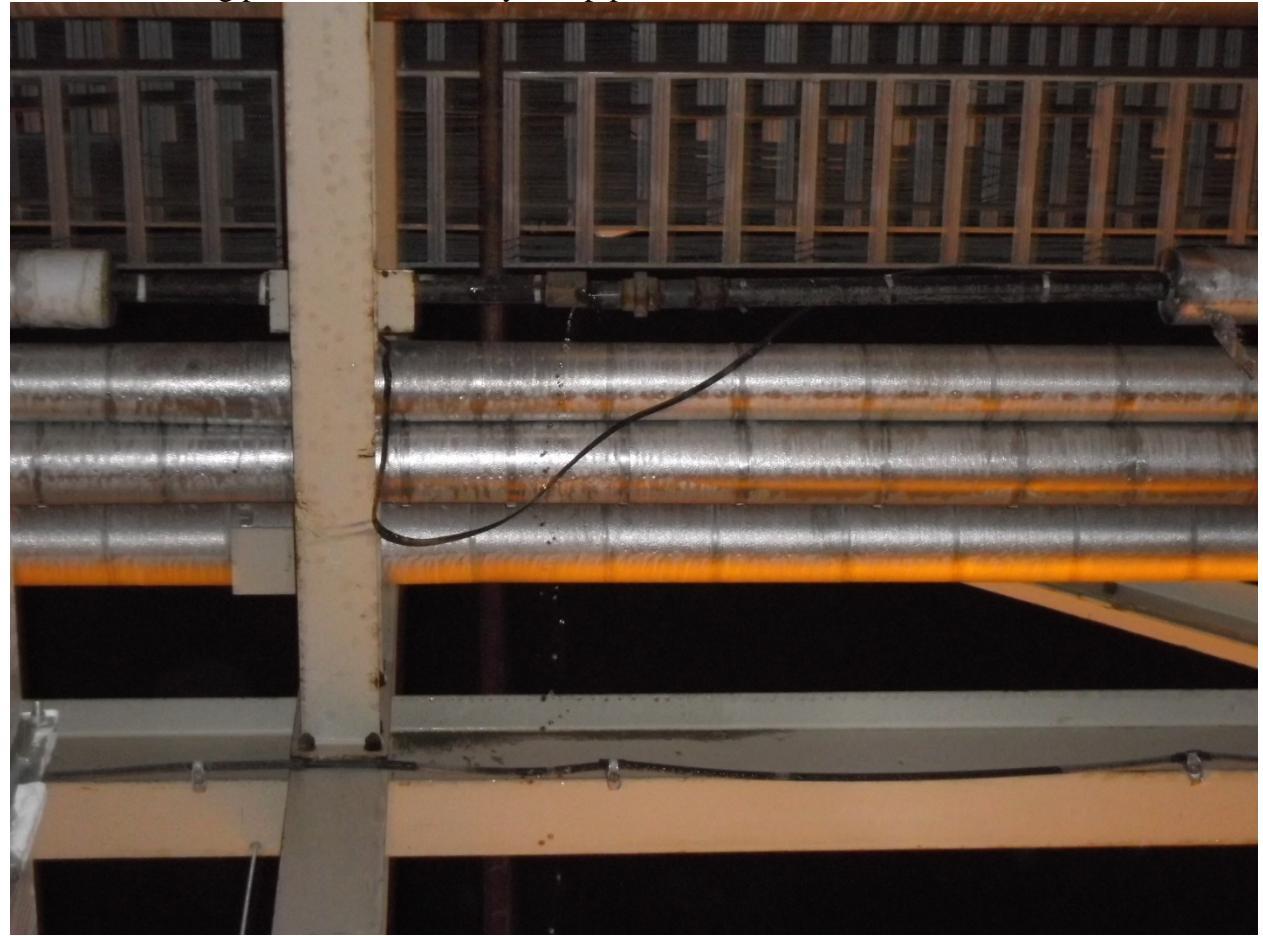
The root cause of the spill was determined to be the separation of a pipe. Photos of the spill impacted area before and after cleanup efforts are included as an attachment to this submittal. In addition, a photo of the leaking process water conveyance pipeline is included as an attachment to this submittal.

Photo 3. Leaking process water conveyance pipeline.
