Minerals Plan of Operations Inspection U.S. Department of the Interior Bureau of Land Management Royal Gorge Field Office

Operation Type: \Box 3600 ☑ 3809 w/ occupancy □ 3809 w/o occupancy Date: May 31, 2019 **Operation Name:** David Harvey-Blue Bee Diggins **Time:** 12:06 Weather: Sunny Case Number: COC078456 CDRMS Number: Pending 110 permit authorization **Attendees** General **Operation**(s) are in compliance with documentation on file BLM: A. Sanderson ☑ Yes □ No \square N/A **Operation(s) and disturbance on-site coincide with the Operator(s):** David Harvey operations and access on file Other(s): None ☑ Yes □ No \Box N/A

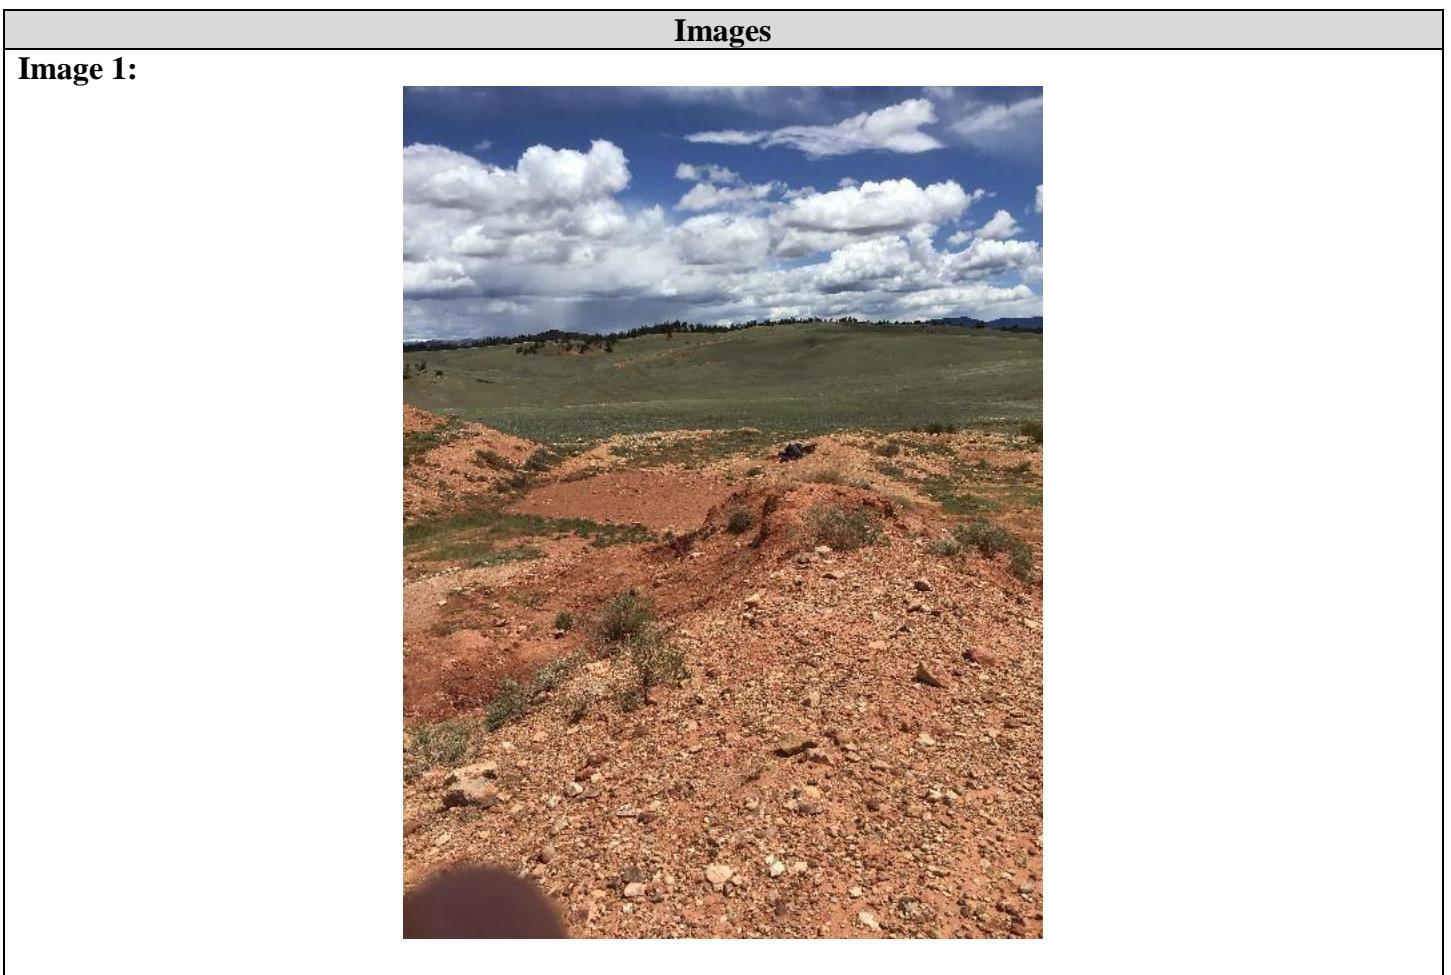
Comment: Eastern view of the mine

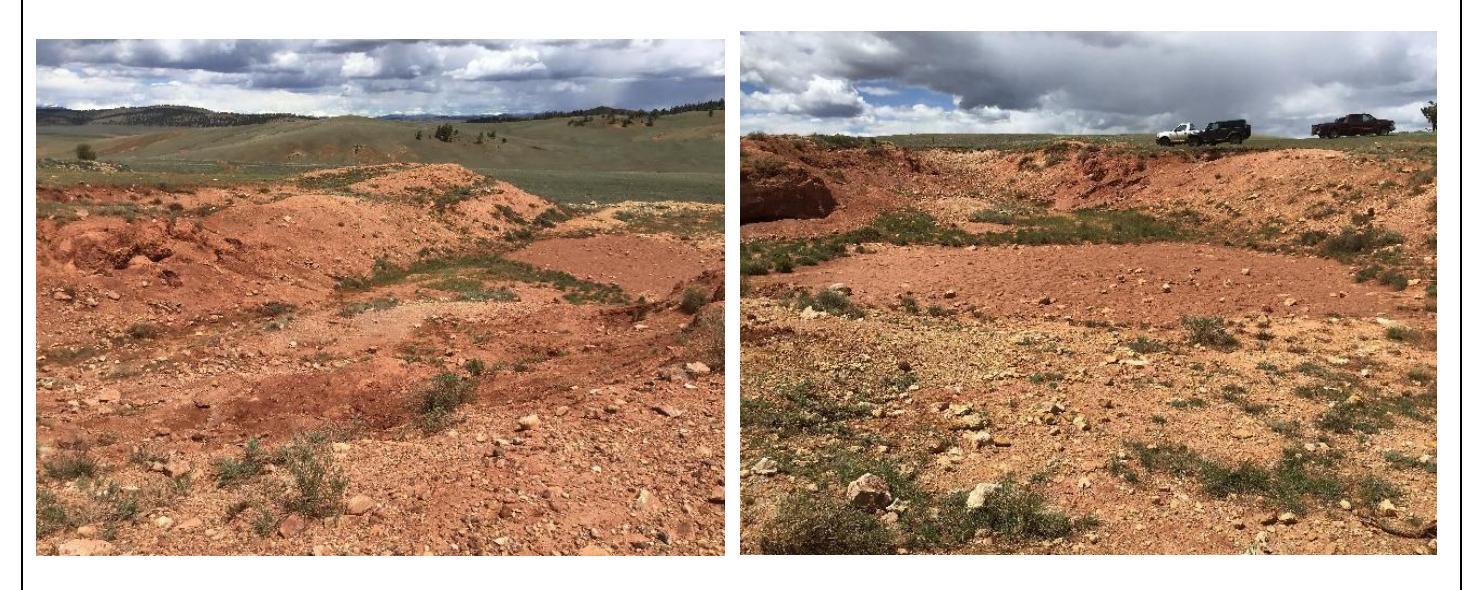
Image 2-3:

Comment: Lower elevated areas will be refilled with overburden material and the southern region will be resloped to a lower topographic relief. This will decrease the amount of storm/meltwater accumulation onsite.

- The operator plans to stake signs to designate specific locations for fee site digging.
- Construct stormwater berms to divert stormwater from the active mine site.
- Due to an abundant amount of snow/meltwater runoff, standing water has been accumulating in the NE lower elevated area (Image 2-3). The operator plans to refill these lower elevated areas with overburden material and reslope the higher elevated regions in order to prevent water accumulation in the active mining areas.
- Operator gives safety talks to clubs and groups prior to fee designated mining activities

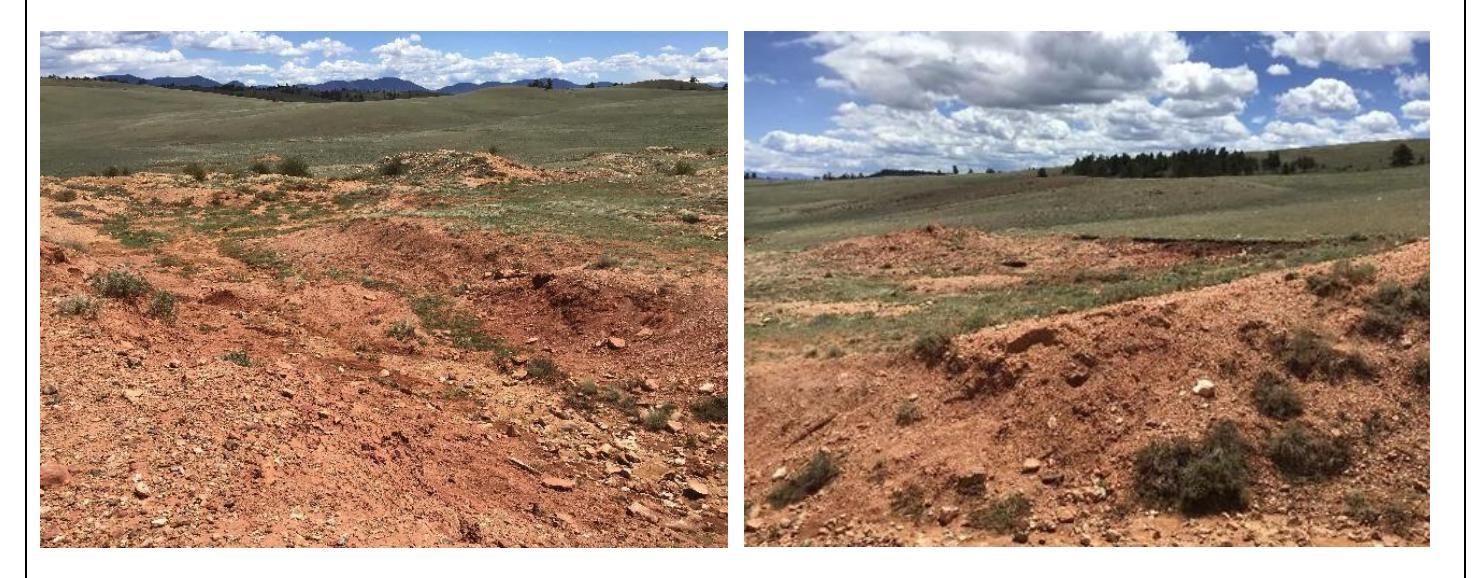
Image 4-5:

Comment: Southern region of the claim that will be bermed and seeded. Operator is planning to do this work during summer/fall. This area was pre-disturbed prior to the David Harvey's claim ownership

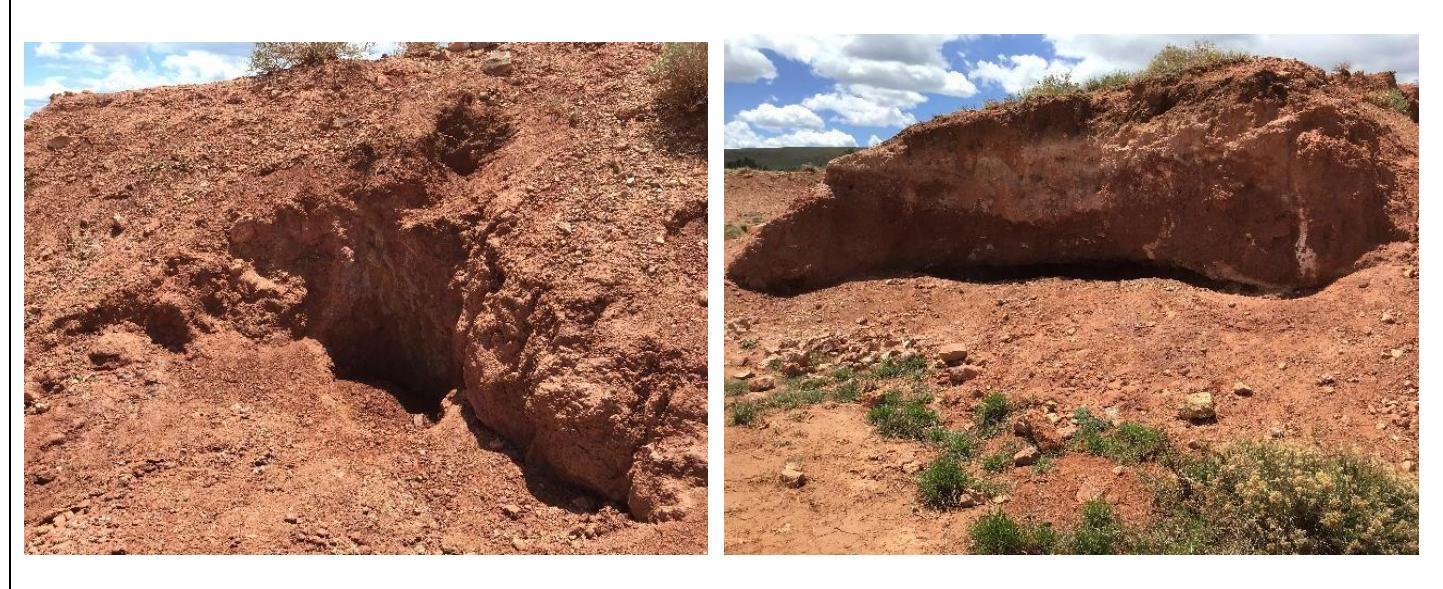
Image 6-8:

Comment: Coyote holes from fee charged prospector (Images 6-7). Operator plans to reslope this area and display "digging area" signs in order to prevent coyote holes and potential safety issues.

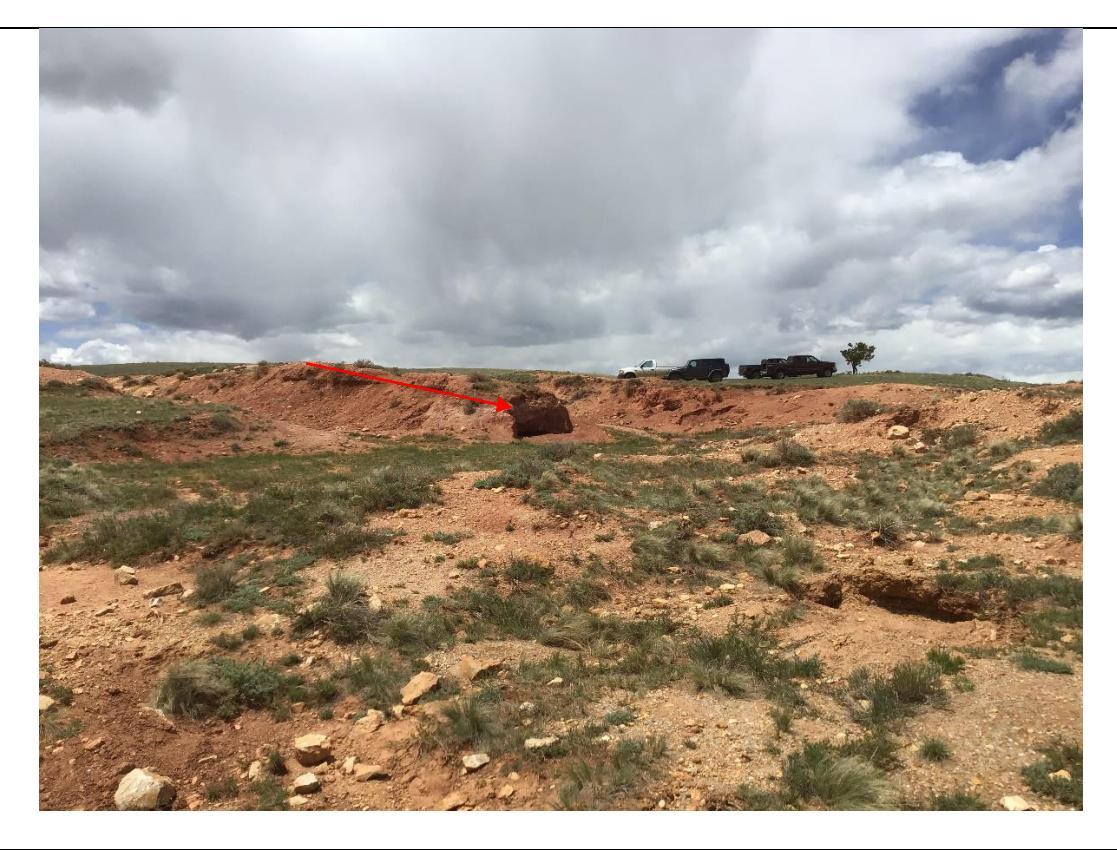
Western view of the site (Image 8) depicting the reslope/regrading direction (red arrow) and lower elevated pond

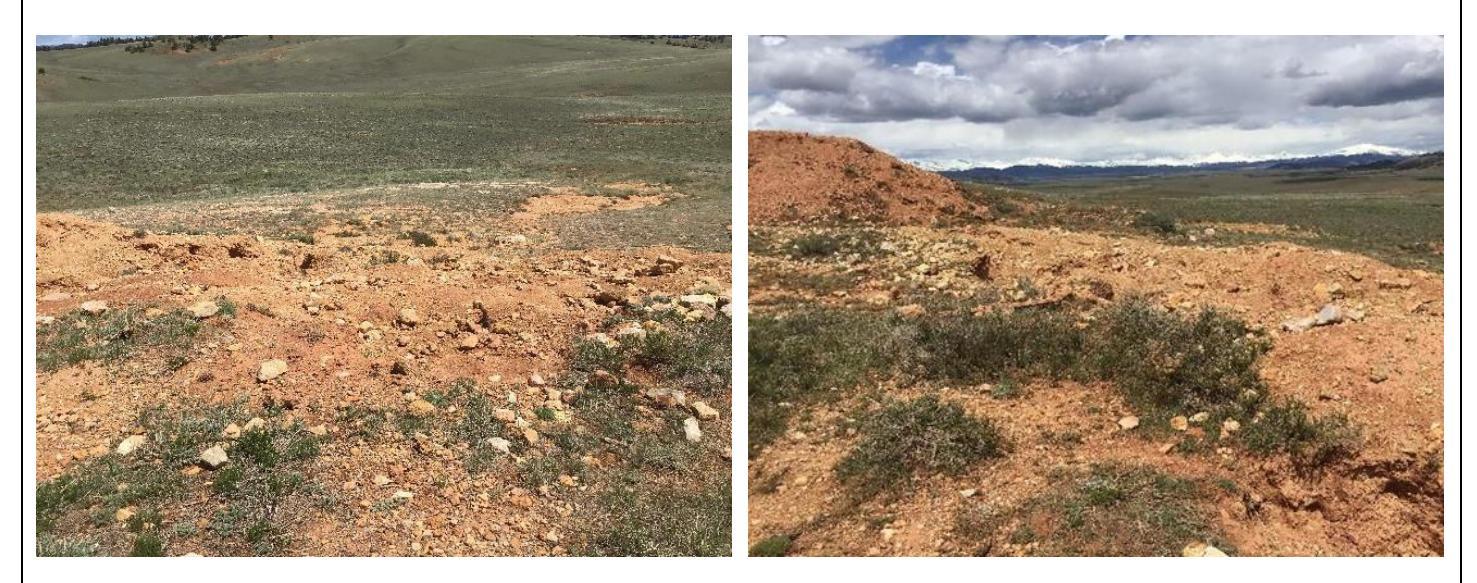
Image 9-10:

Comment: Eastern view that will eventually be resloped and regraded to help present stormwater runoff

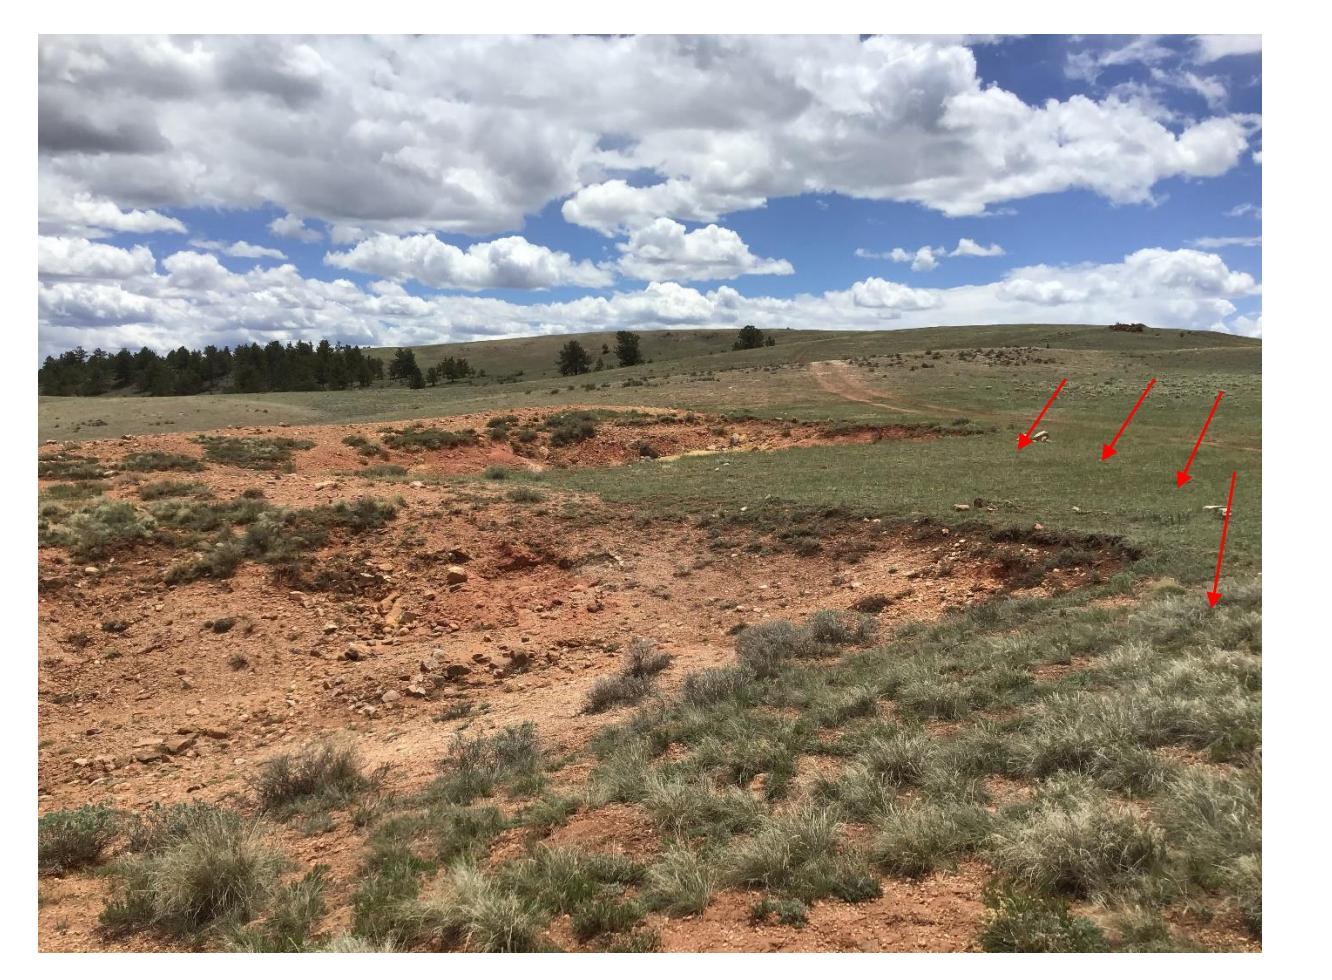
Image 11:

Comment: Southern & western view of the site where the stormwater berms will be emplaced (red arrows) in order to prevent runoff onto the active site.

4.b. & **4.e.** Access – Due to an abnormally long winter season, the stormwater berms/controls have not yet been constructed along the western disturbance boundary. The operator was waiting for the ground to defrost and plans to construct the berms during the summer/fall season.
