Newmont Goldcorp Cripple Creek & Victor Gold Mine 100 North 3<sup>rd</sup> Street P O Box 191 T 719-689-4029 F 719-689-3254 www.newmont.com

## Re: <u>Permit No. M-1980-244; Cripple Creek & Victor Gold Mining Company ("CC&V"); Cresson Project –</u> Notification of Water Quality Analysis Parameter Exceedances September 26, 2019

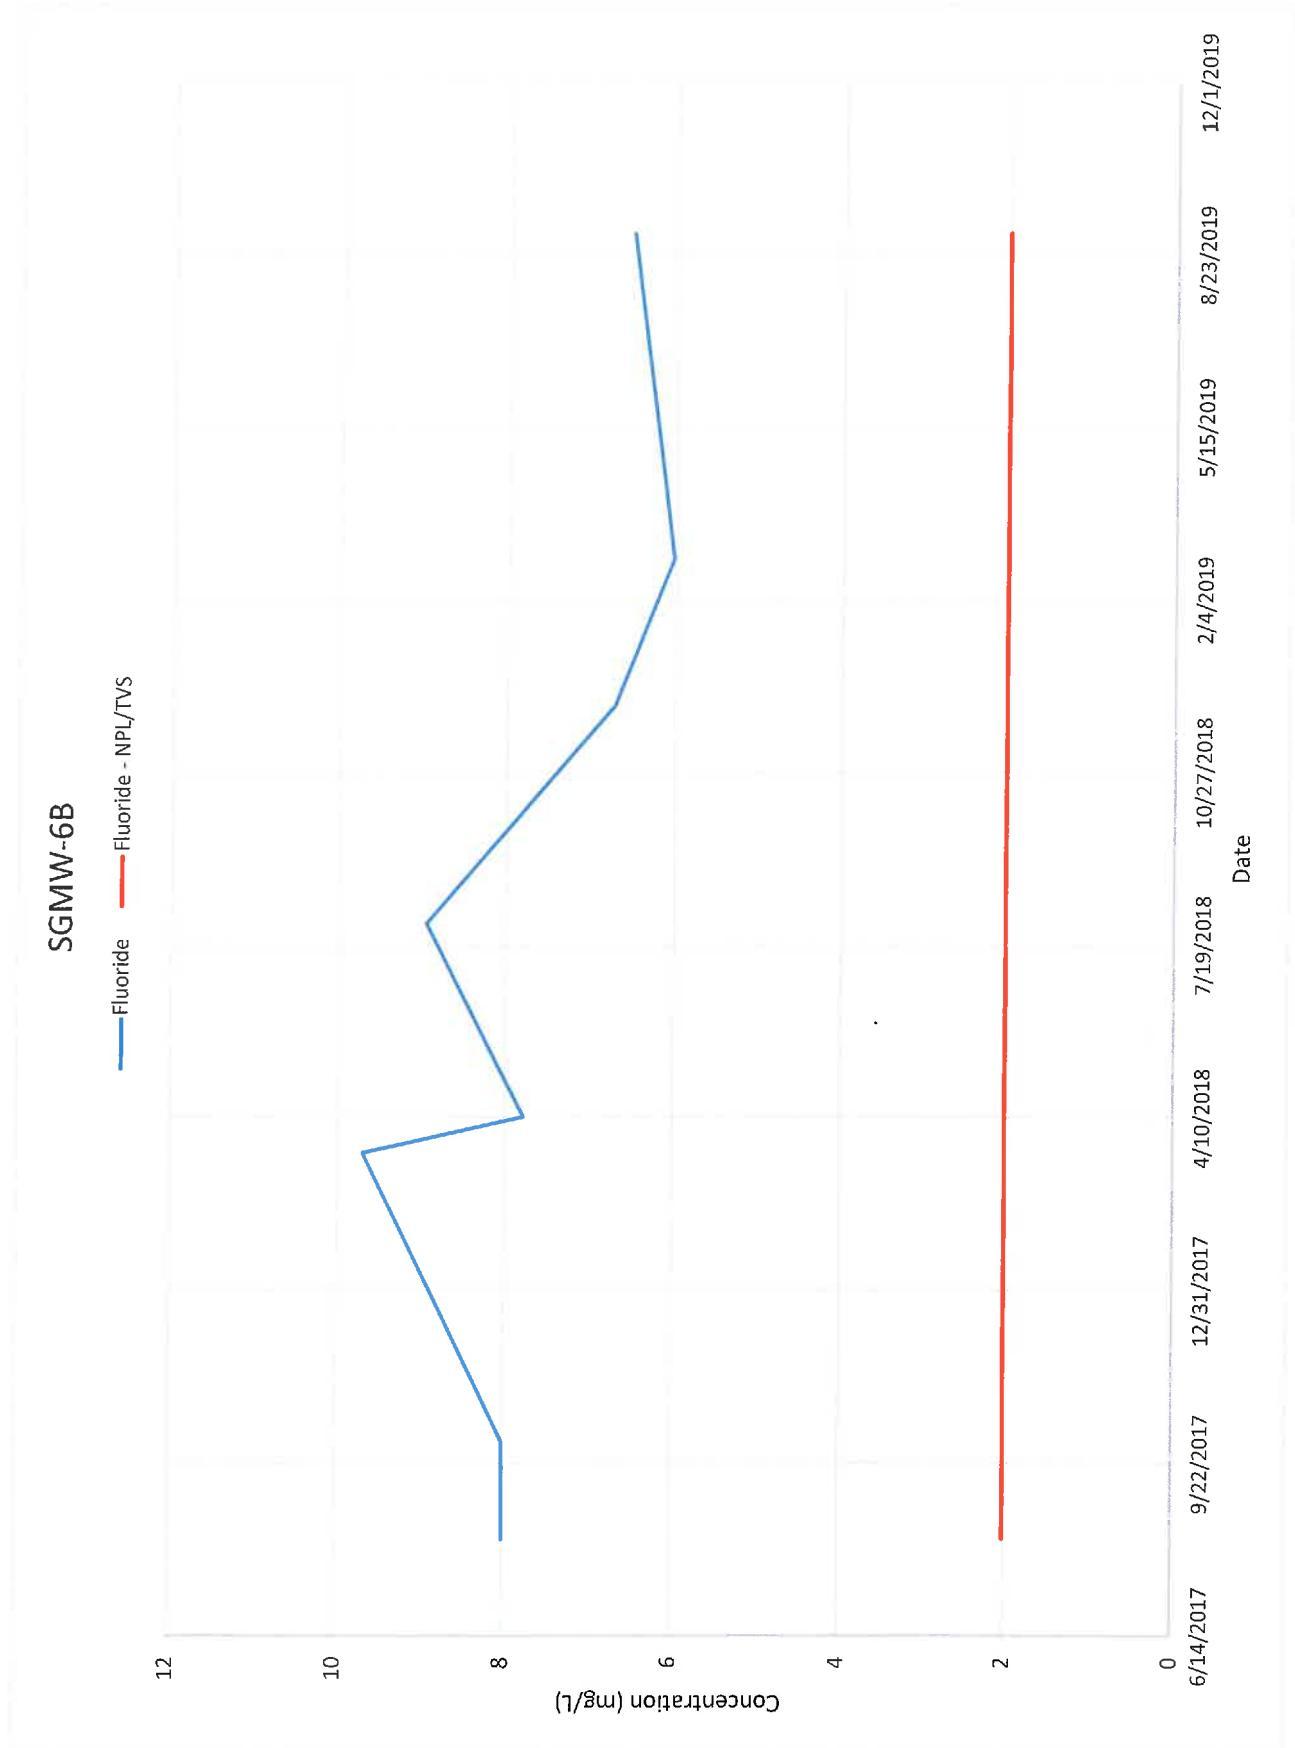
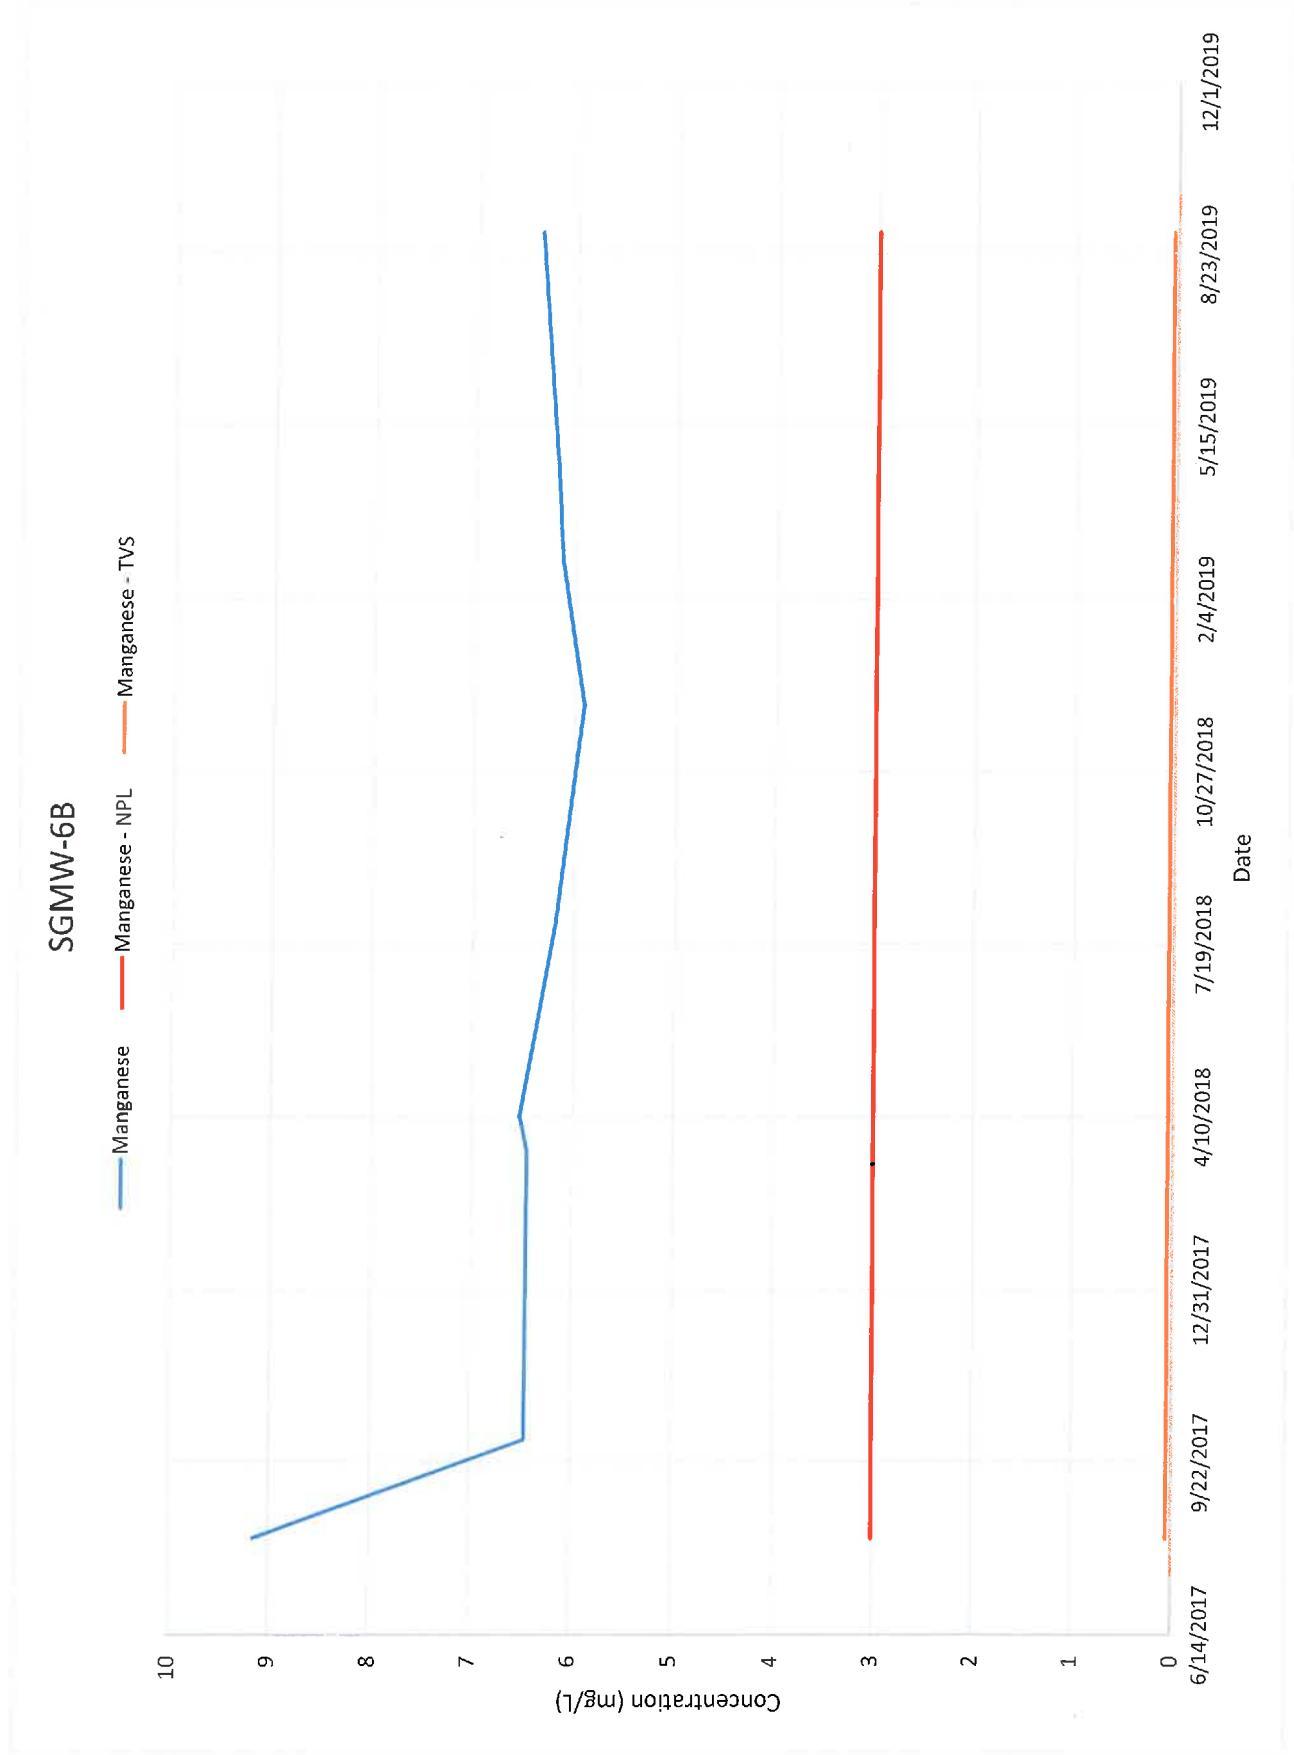
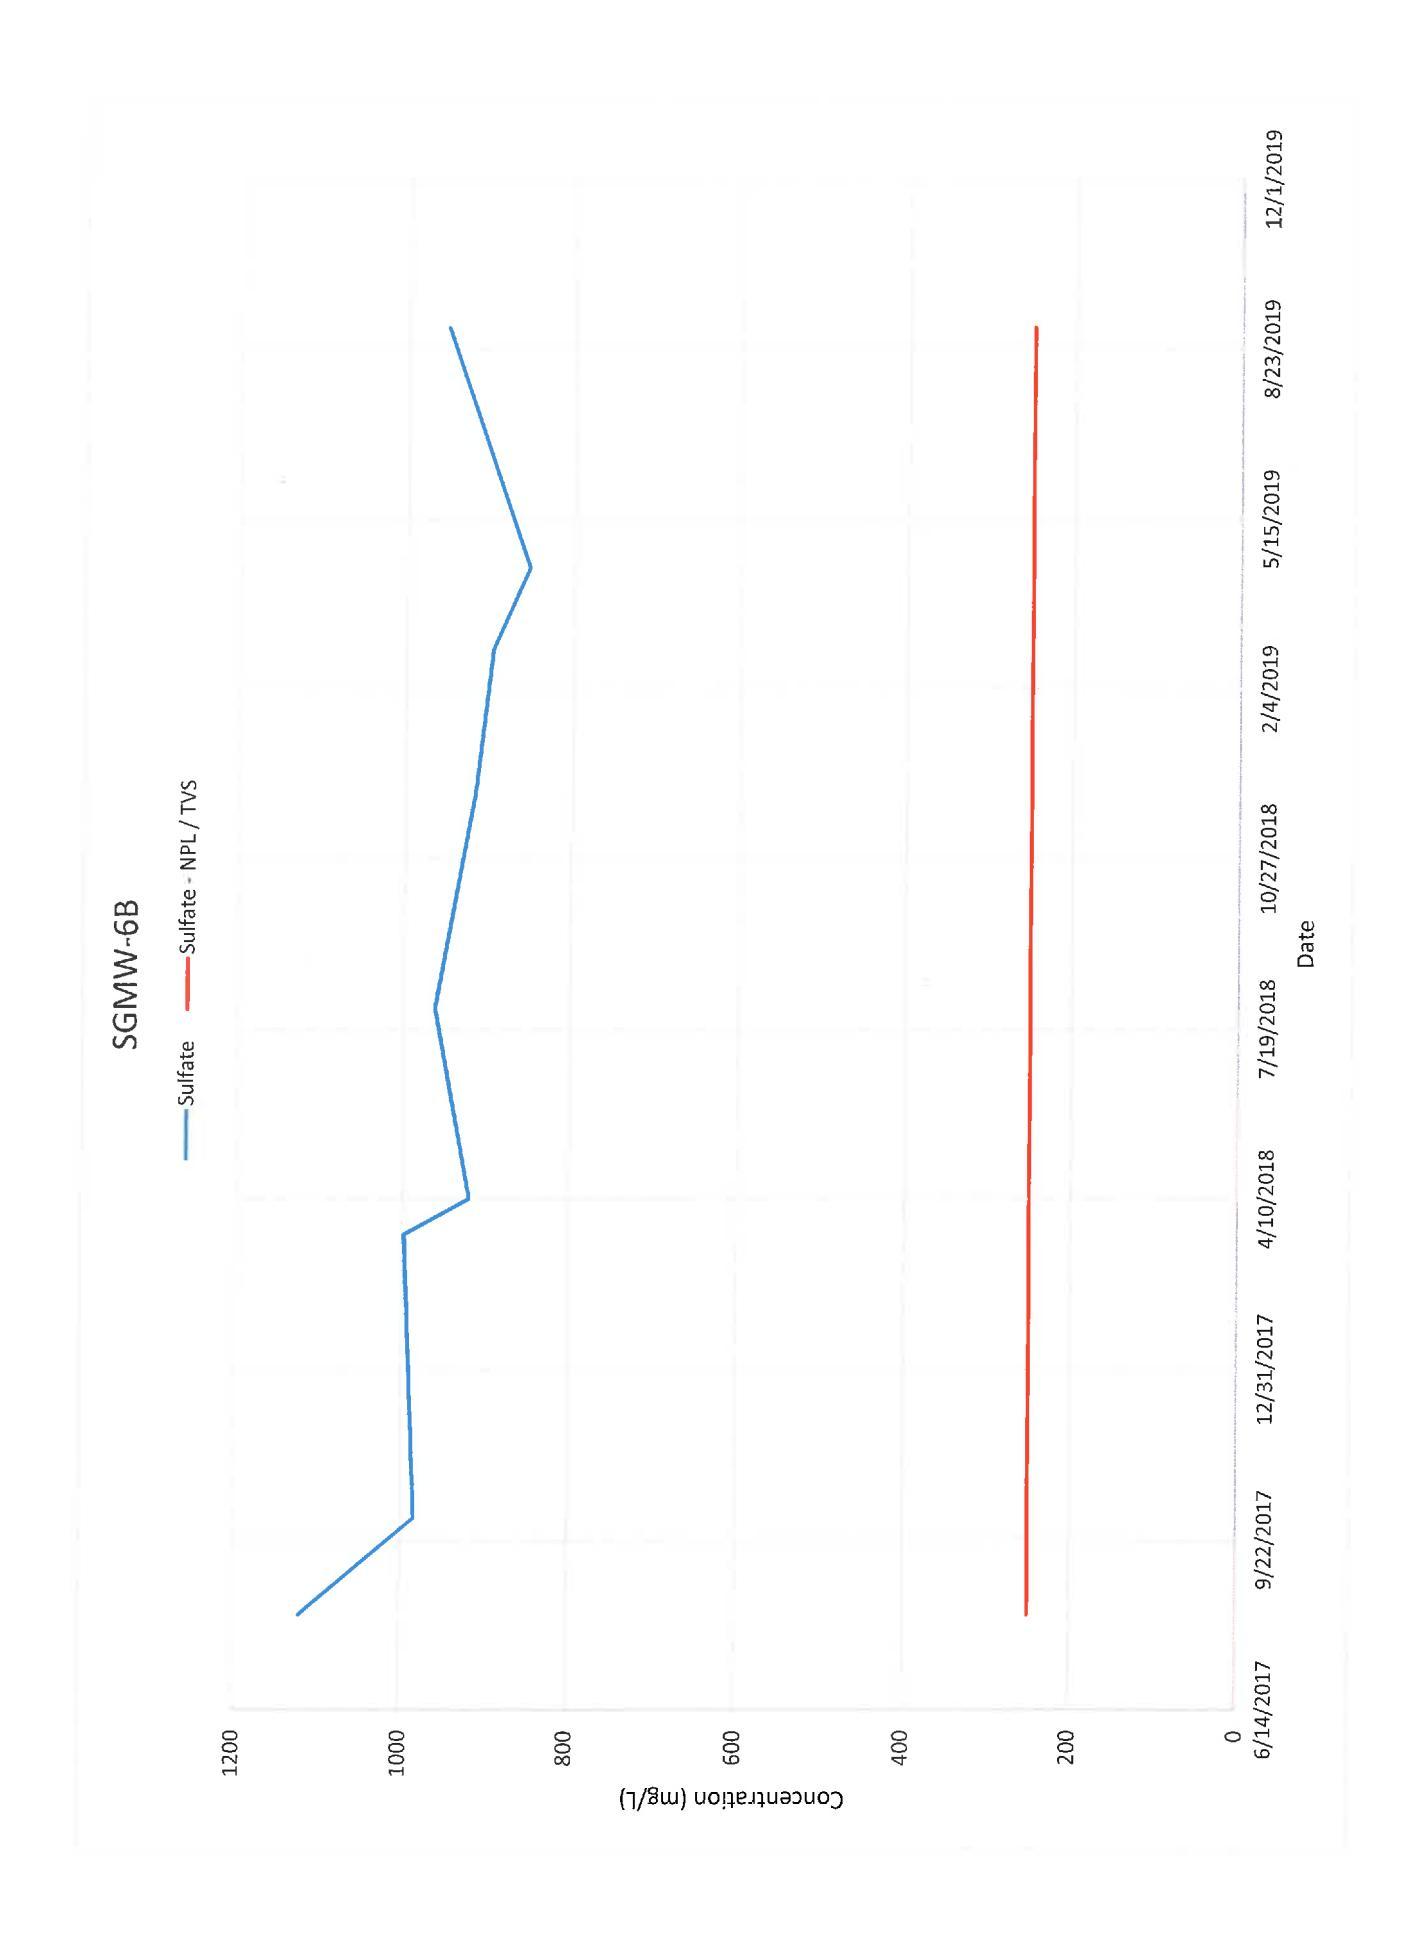
## Attachments

CC&V collected third quarter compliance groundwater samples from monitoring wells SGMW-6B, on September 4, 2019. CC&V received the lab report for these analyses on September 20, 2019, and upon review, determined that SGMW-6B exceeded established numeric protection limits for fluoride, manganese, and sulfate. The table below lists the exceedance for the location and the associated parameter and the attached graph demonstrates the parameter trend from Q3 2017 to present.

Location	Sample Date	Parameter	Value (mg/L)	NPL (mg/L)	Table Standard (mg/L)
SGMW-6B	9/4/2019	Fluoride	6.53	2	2
SGMW-6B	9/4/2019	Manganese	6.36	3	0.05
SGMW-6B	9/4/2019	Sulfate	953	250	250
